## EXECUTIVE SUMMARY

PROPERTY NAME: South Milwaukee Properties  
LOCATION: 1010 Davis, 211 11<sup>th</sup>, and 230 North Chicago Avenues  
South Milwaukee, Milwaukee County, Wisconsin

1010 DAVIS, 211 11<sup>TH</sup>, AND 230 NORTH CHICAGO  
AVENUES, SOUTH MILWAUKEE, WISCONSIN  
PHASE I ENVIRONMENTAL SITE ASSESSMENT REPORT  
CELERITY ENVIRONMENTAL PROJECT NO. C24012

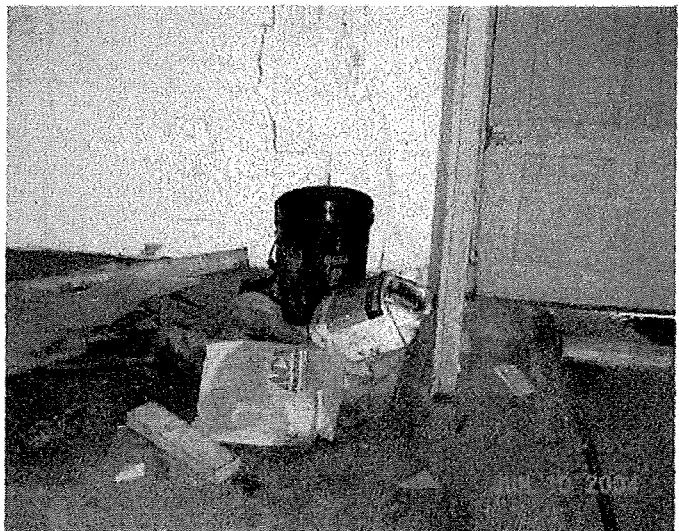
PHOTOGRAPH 3

A 5-GALLON PAIL FILLED WITH AN OILY LIQUID IN THE 1010 DAVIS AVENUE BUILDING.

During our reconnaissance of the 1010 Davis Avenue property we observed at least two 55-gallon drums containing oily liquids, one was labeled waste oil the other was unlabeled. We observed at least one 5-gallon unlabeled and uncovered pail that contained an oily liquid. We observed two oil pumps that contained a small amount (probably less than 10 gallons) of an oily liquid stored in the building. Mr. Brewer stated that the pumps were given to Badger Equipment and that they were not used, but only stored in the building.

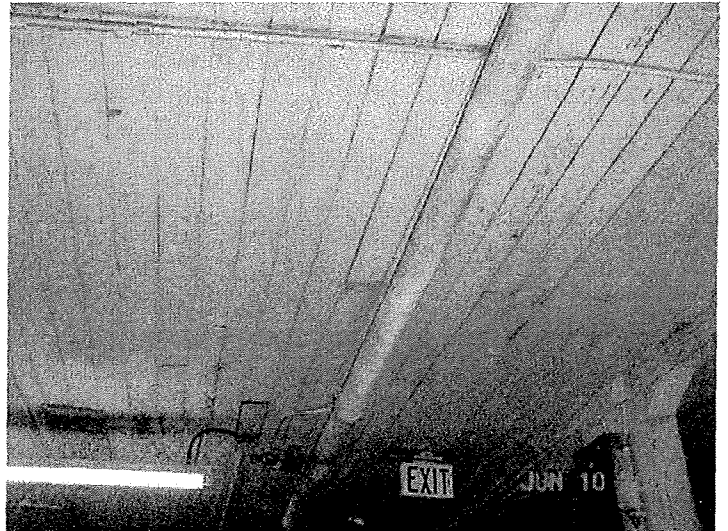
PHOTOGRAPH 8

A PIPE THAT MAY BE INSULATED WITH AN ASBESTOS CONTAINING MATERIAL ON THE 2ND STORY OF THE 1010 DAVIS AVENUE BUILDING.
