**Re: Basement Survey – 3200 Block South Side of 60<sup>th</sup> Street:  
Suggar Property  
3301 – 60<sup>th</sup> St.  
Kenosha, WI 53144  
PECFA# 53144-4143-05  
BRRTS# 03-30-004964  
FID# 230156410**

MEC has conducted a survey of the basements of buildings located on the south side of 60<sup>th</sup> Street within the 3200 block of 60<sup>th</sup> Street in Kenosha, Wisconsin. The basement survey was conducted to evaluate the depths of the basements and type of construction, along with the presence of odors, floor and wall cracks, penetrations such as sumps and drains, and for the occurrence of dampness or water seeps to assist in screening for potential of contaminated vapor or groundwater intrusion into the structures. The nature of the mechanical systems present in the basements and serving the buildings was also assessed.

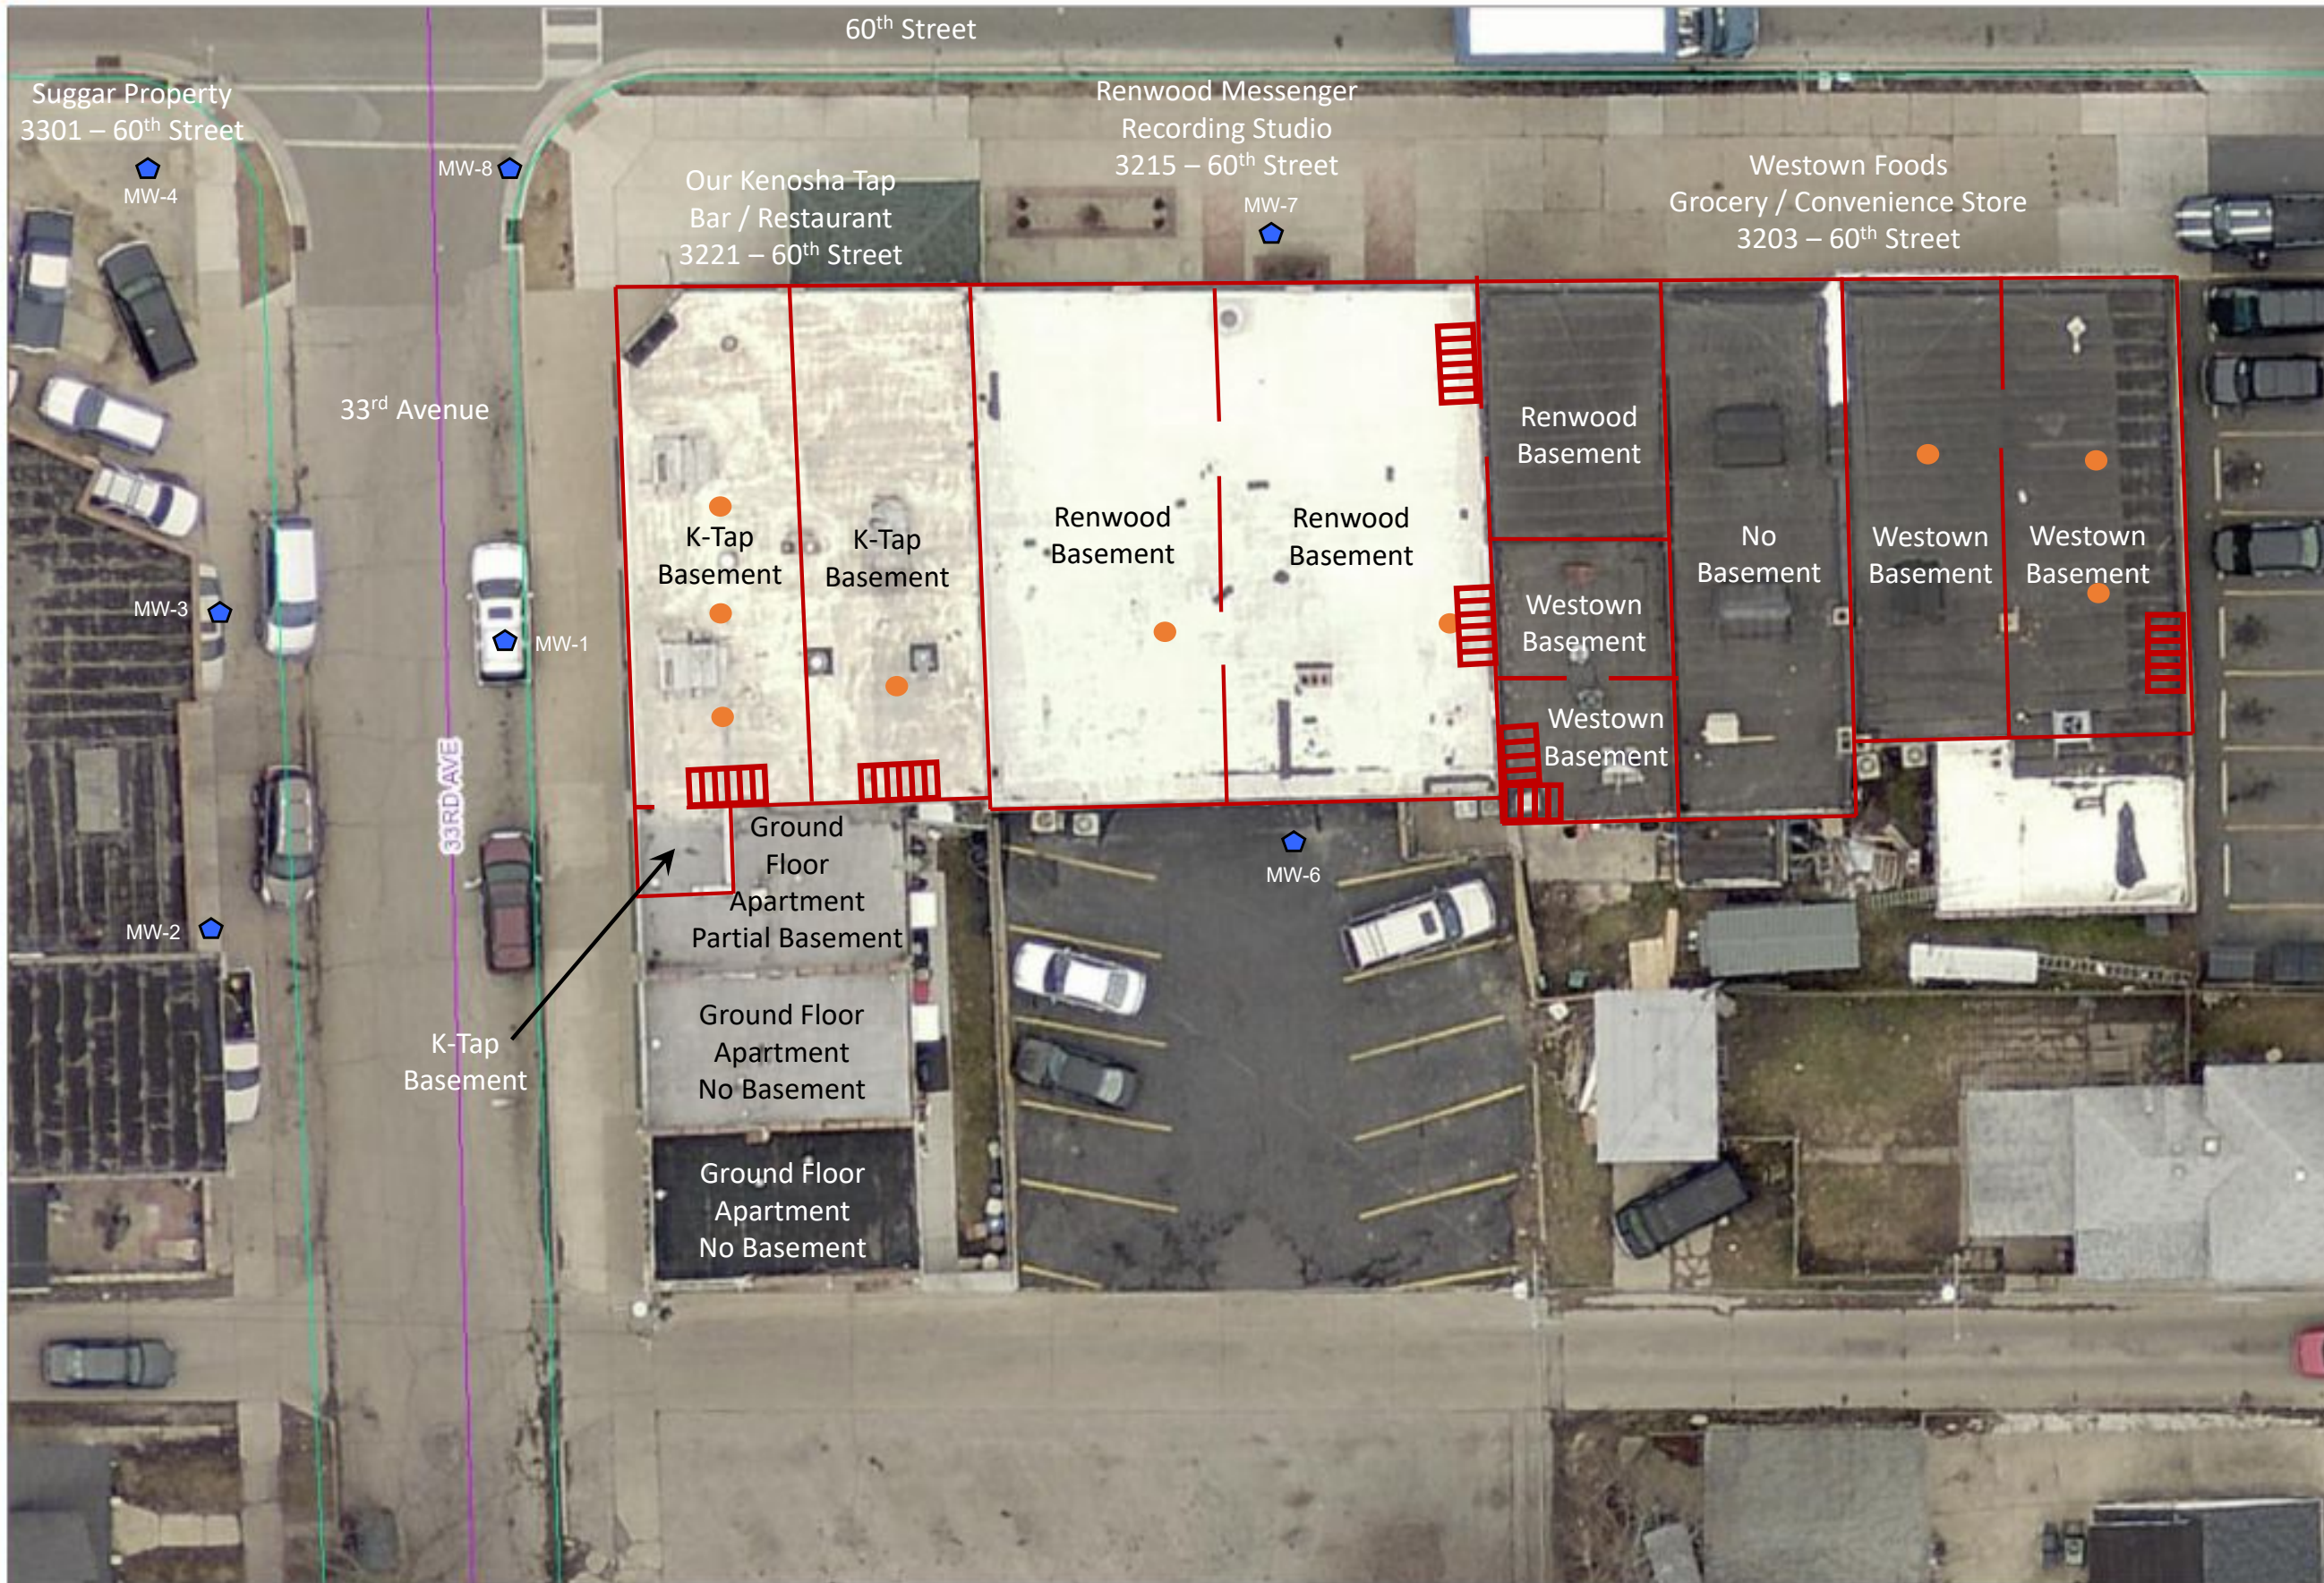
FIGURE 1  
BASEMENT CONFIGURATION  
3200 BLOCK – SOUTH SIDE OF  
60<sup>TH</sup> STREET KENOSHA, WI

The basement survey was to be conducted prior to planned sub-slab vapor sampling of the basement onsite at the Suggar Property so that if additional sub-slab vapor sampling is warranted, such sampling can be conducted during one field mobilization. The layout of the basements is illustrated on Figure 1.

The building has two separate basement areas, east and west, both of which extend to approximately eight feet below land surface. Both sections have exterior walls of poured concrete with concrete block and brick walls in the interior portions and poured concrete floors. A small section of the western basement extends beneath a ground floor apartment attached to the south end of the bar/restaurant building. Two remaining attached ground floor apartments are of concrete slab-on-grade construction with no basement beneath. The basements are used for storage with a small office located in the western basement. The building is served by natural gas forced air heat.

Three floor drains were observed in the western basement and one in the eastern basement. The basements in general and the floor drains specifically were screened for volatile organic vapors and lower explosive limit with a PID and four-gas meter. No elevated readings and no odors were observed. No sumps were present and no cracks or water seeps were noted. According to the occupant the basement remains dry.

The building has a full basement and an additional basement room that extends beneath the northwest corner of the building adjacent to the east. The basement extends to approximately eight feet below land surface. The exterior walls are poured concrete with concrete block, brick and wood-frame walls in the interior portions and a poured concrete floor. A small section of the concrete floor in the southern portion of the basement has deteriorated exposing sand beneath. The basement is used for music recording and rehearsal. The building is served by natural gas forced air heat.

Two floor drains were observed, one in the southwestern portion and one in the southeastern portion of the basement. The basement in general and the floor drains specifically were screened for volatile organic vapors and lower explosive limit with a PID and four-gas meter. No elevated readings and no odors were observed. No sumps were present and no cracks or water seeps were noted. According to the occupant the basement remains dry.

The building has a basement in the southwest corner and a basement room occupied by Renwood Messenger to the west that extends beneath the northwest corner of the building. An additional basement area is located on the east end of the building. According to the building owner there is no basement beneath the central portion of the building. The basements extend to approximately eight feet below land surface. The exterior walls are poured concrete with concrete block and brick walls in the interior portions and poured concrete floors. The basements are used for storage. The building is served by natural gas forced air heat.

No floor drains were observed in the southwest corner basement. Three floor drains were observed in the western basement. The basements in general and the floor drains specifically were screened for volatile organic vapors and lower explosive limit with a PID and four-gas meter. No elevated readings and no odors were observed. No sumps were present and no cracks or water seeps were noted. According to the owner the basement remains dry.
