SUBJECT: Final Case Closure with Continuing Obligations
Monarch Development Lots 9 & 10, Beaver Dam, WI
DNR BRRTS Activity #: 02-14-556767

CAP MAINTENANCE PLAN

Property Location: Monarch Development Lots 9 & 10 (Former MIR) Site; 715 North Spring Street, Beaver Dam, Wisconsin (now the site of Dodge Central Credit union, 106 East Main Street, Beaver Dam, Wisconsin). See Figure 1.¹

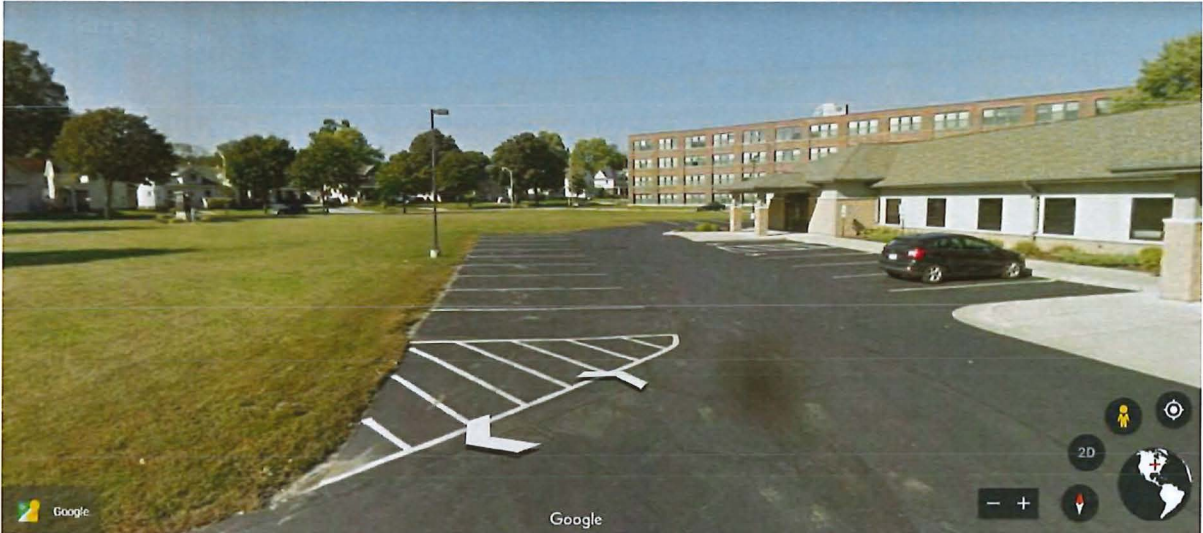
Photograph is taken from Google Street View, image dated 2018. The photo is facing north in the Credit Union parking lot and shows the current extent and condition of the asphalt parking lot which covers remaining soil impacts.

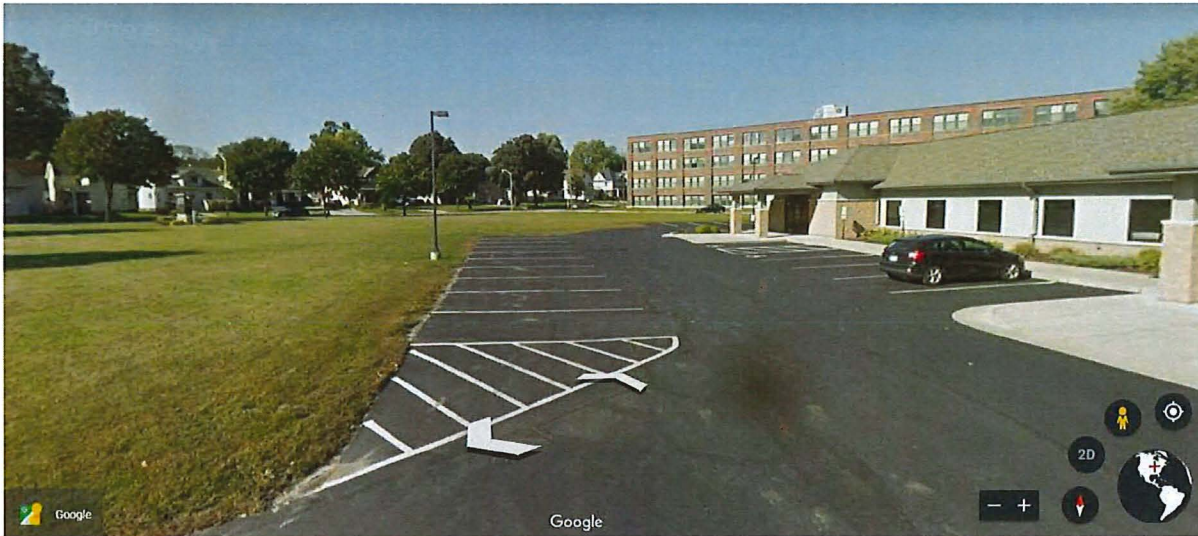
B.5. Structural Impediment Photos

The pavement and building shown on the attached page titled **B.5. Structural Impediment Photos** made complete investigation and/or remediation of the soil contamination on this property impracticable. If the structural impediment is to be removed, the property owner shall notify the DNR at least 45 days before removal and conduct an investigation of the degree and extent of PCB contamination below the structural impediment. If contamination is found at that time, the contamination shall be properly remediated in accordance with applicable statutes and rules.

Photograph is taken from Google Street View, image dated 2018. The photo is facing north in the Credit Union parking lot and shows the current extent and condition of the asphalt parking lot was a structural impediment to removal of all impacted soil

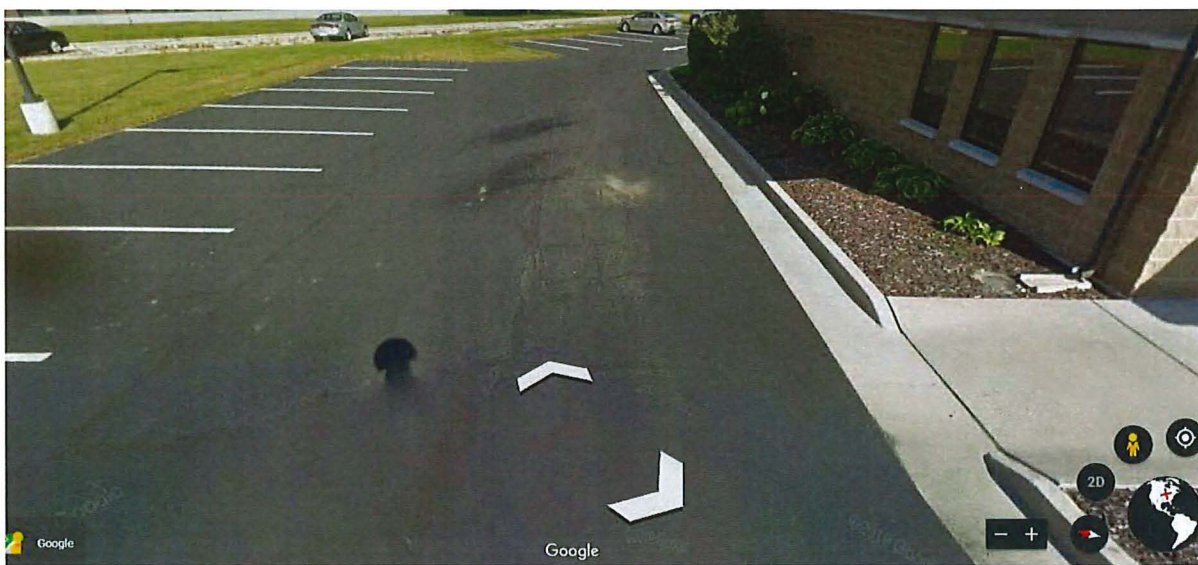
The second photo shows the same Credit Union parking lot facing to the east. The remedial excavation took place in the grassy area in the left hand portion of the photo.
