BRRTS No. 02-41-556811		VPLE No.	
Parcel ID No. 20-70-833000			
FID No. 241417330		WTM Coordinates	
		X 687027	Y 294558
BRRTS Activity (Site) Name Lloyd's Cleaners		WTM Coordinates Represent: <input type="checkbox"/> Source Area <input checked="" type="checkbox"/> Parcel Center	
Site Address 4837 North Teutonia Avenue		City Milwaukee	State ZIP Code WI 53209
Acres Ready For Use 0.5

SITE LAYOUT MAP											
Lloyd's Cleaners 4837 N. Teutonia Avenue Milwaukee, WI											
	Figure B.1.b										
ENVIRONMENTAL FORENSIC INVESTIGATIONS, INC. 825 North Capitol Avenue • Indianapolis, IN 46204 EnviroForensics.com	Project 6229

**BASEMENT COLLECTION TRENCH AND SSDS
LAYOUT DETAIL**

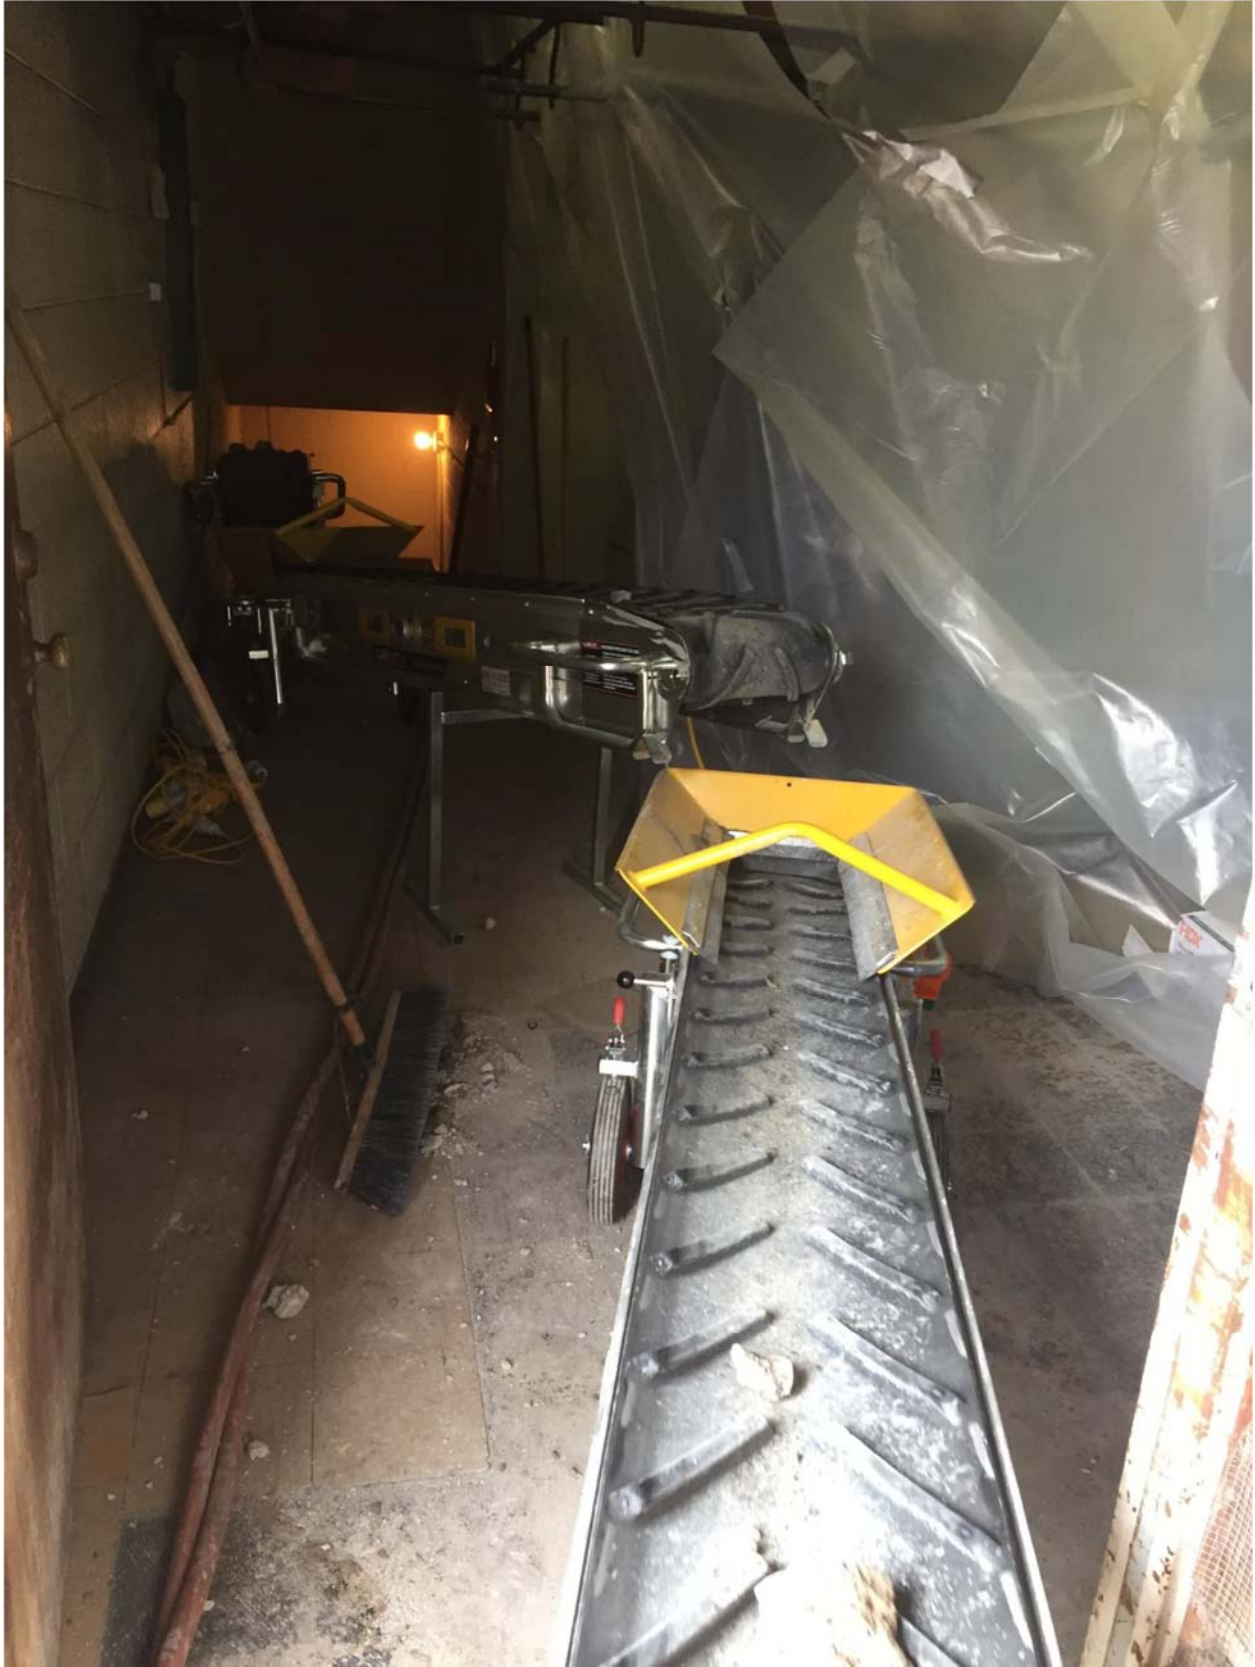
Conveyor moving material out the southeast building entrance. Facing west.

The concrete slab was saw-cut around the perimeter of the excavation area, and the slab itself was broken into pieces by jackhammer. The concrete pieces were loaded onto a conveyor system that moved material up the stairs and outside to a staging area on the south side of the building. The limited fill material beneath the floor slab and native clay soil was removed by hand to a depth of approximately 12 inches below the bottom of the slab. Soil was also transported by the conveyor system to the staging area. All soil excavated from the basement was loaded into dump trucks and sent to the Waste Management Orchard Ridge Landfill in Menomonee Falls, Wisconsin. A total of 15.27 tons of excavated material was managed and disposed of as special solid waste.

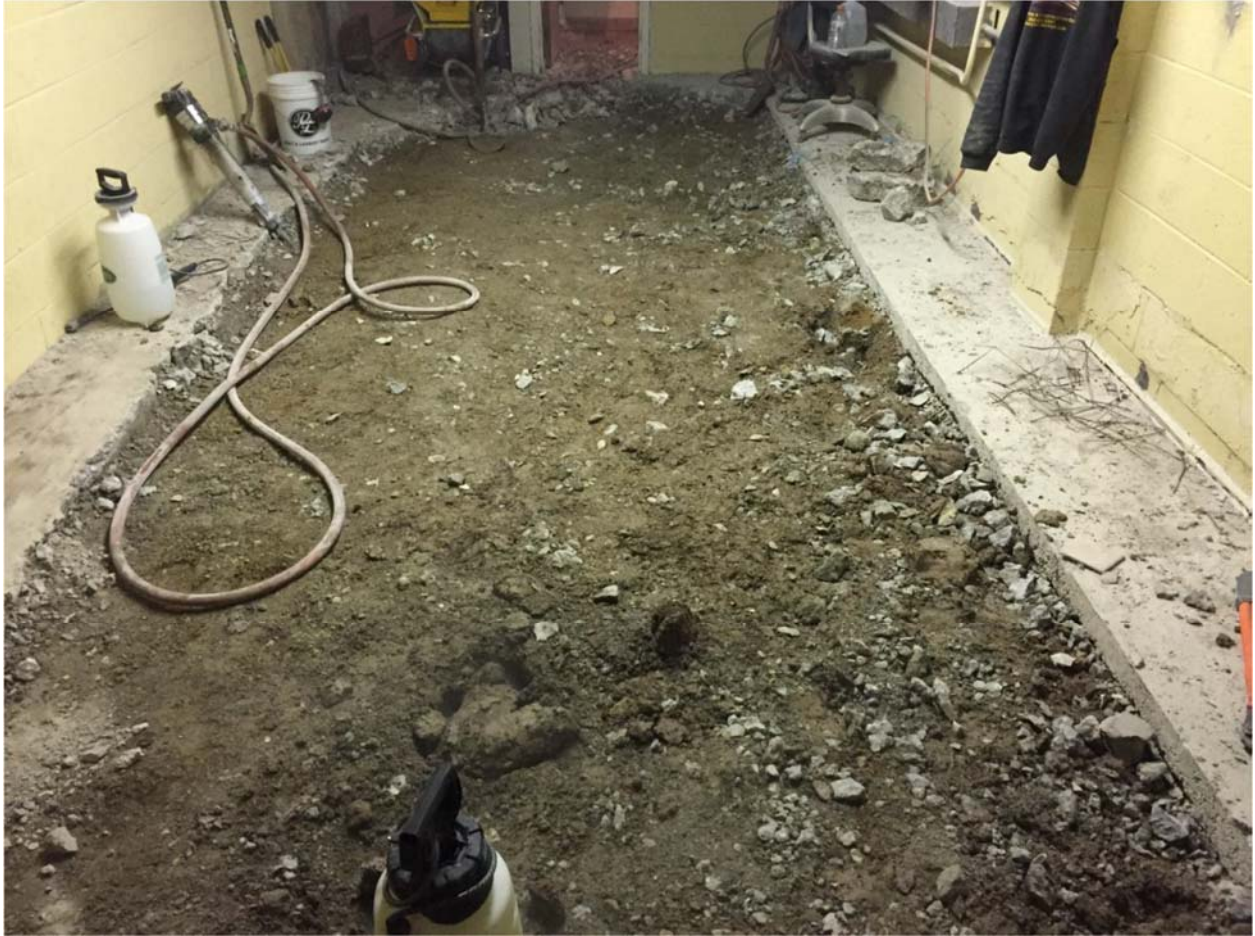
Main storage room with concrete slab removed. Facing south.

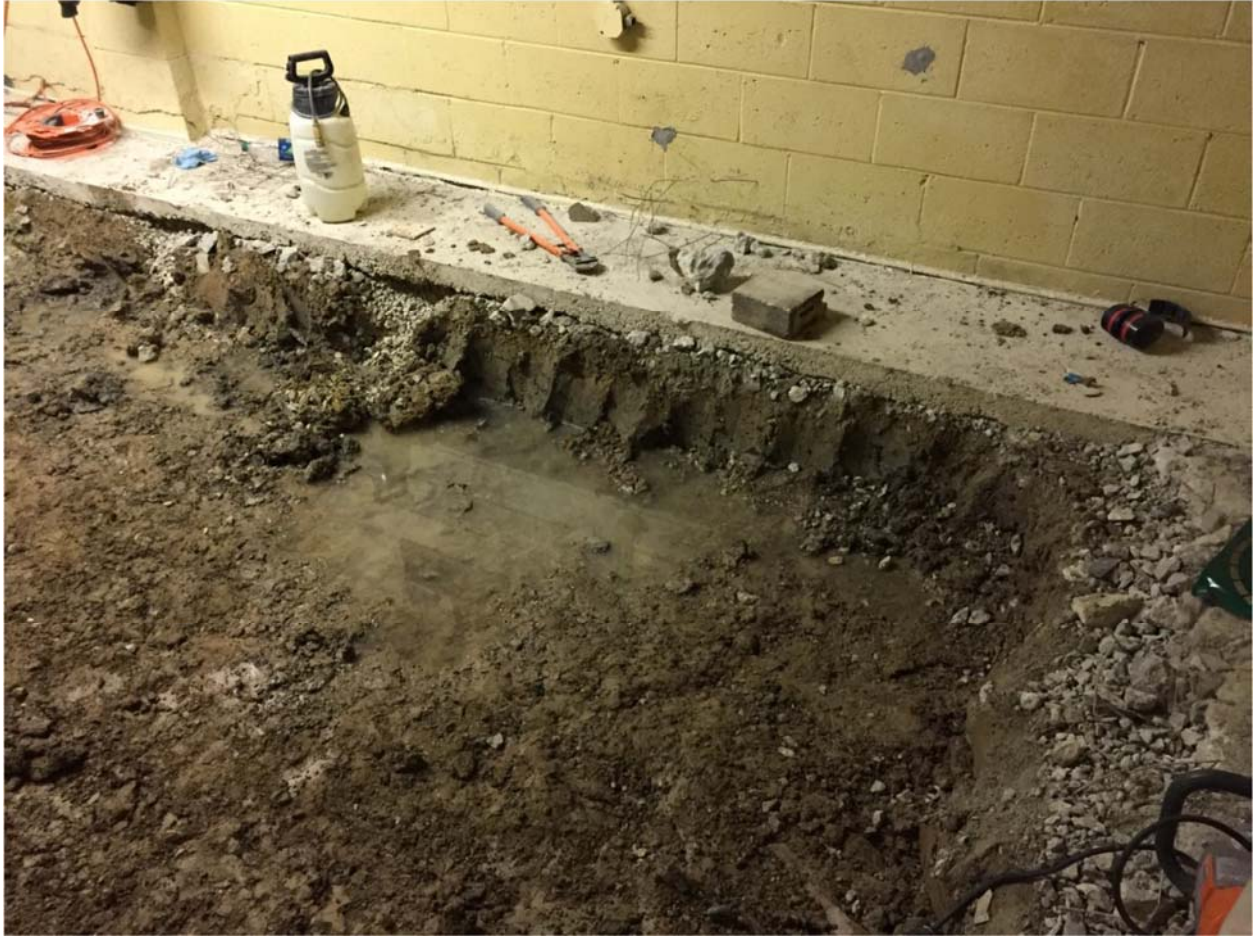
Soil excavation along west wall of storage room.

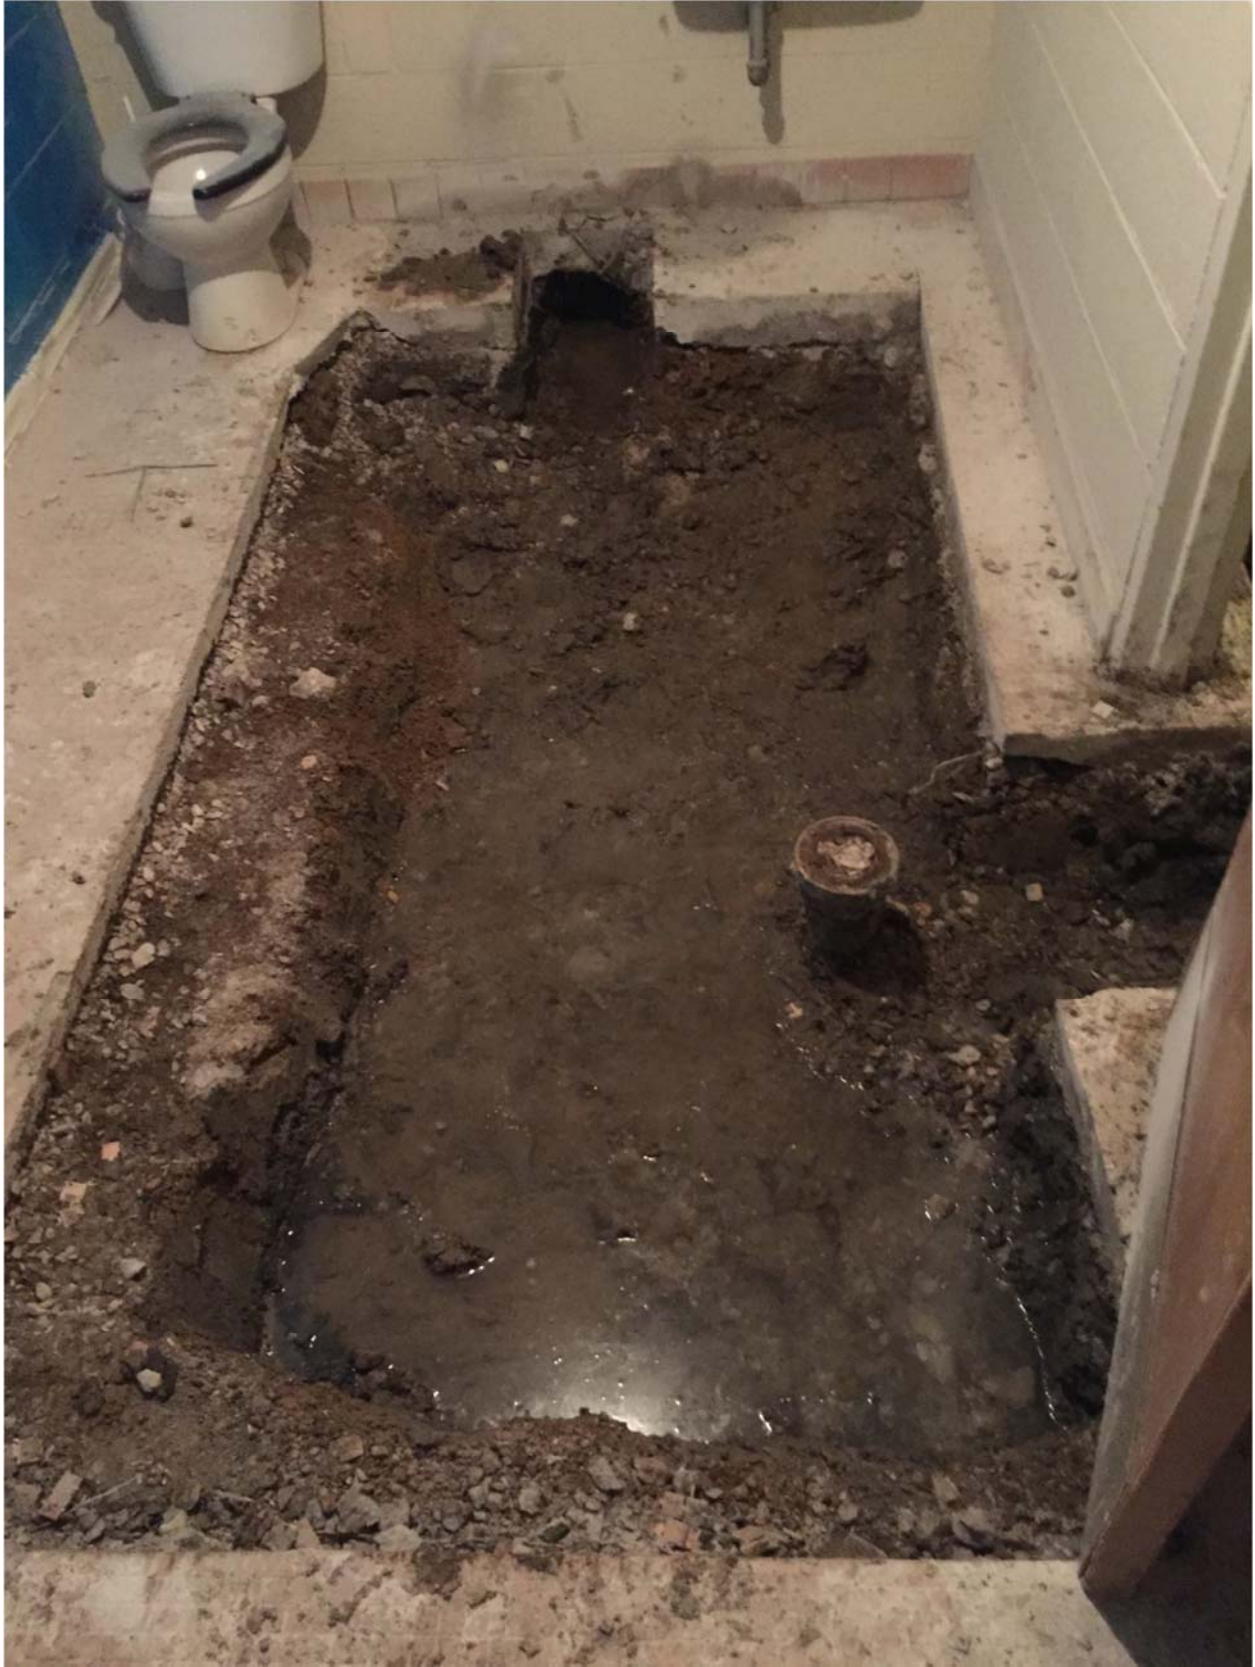
Excavation in south restroom.

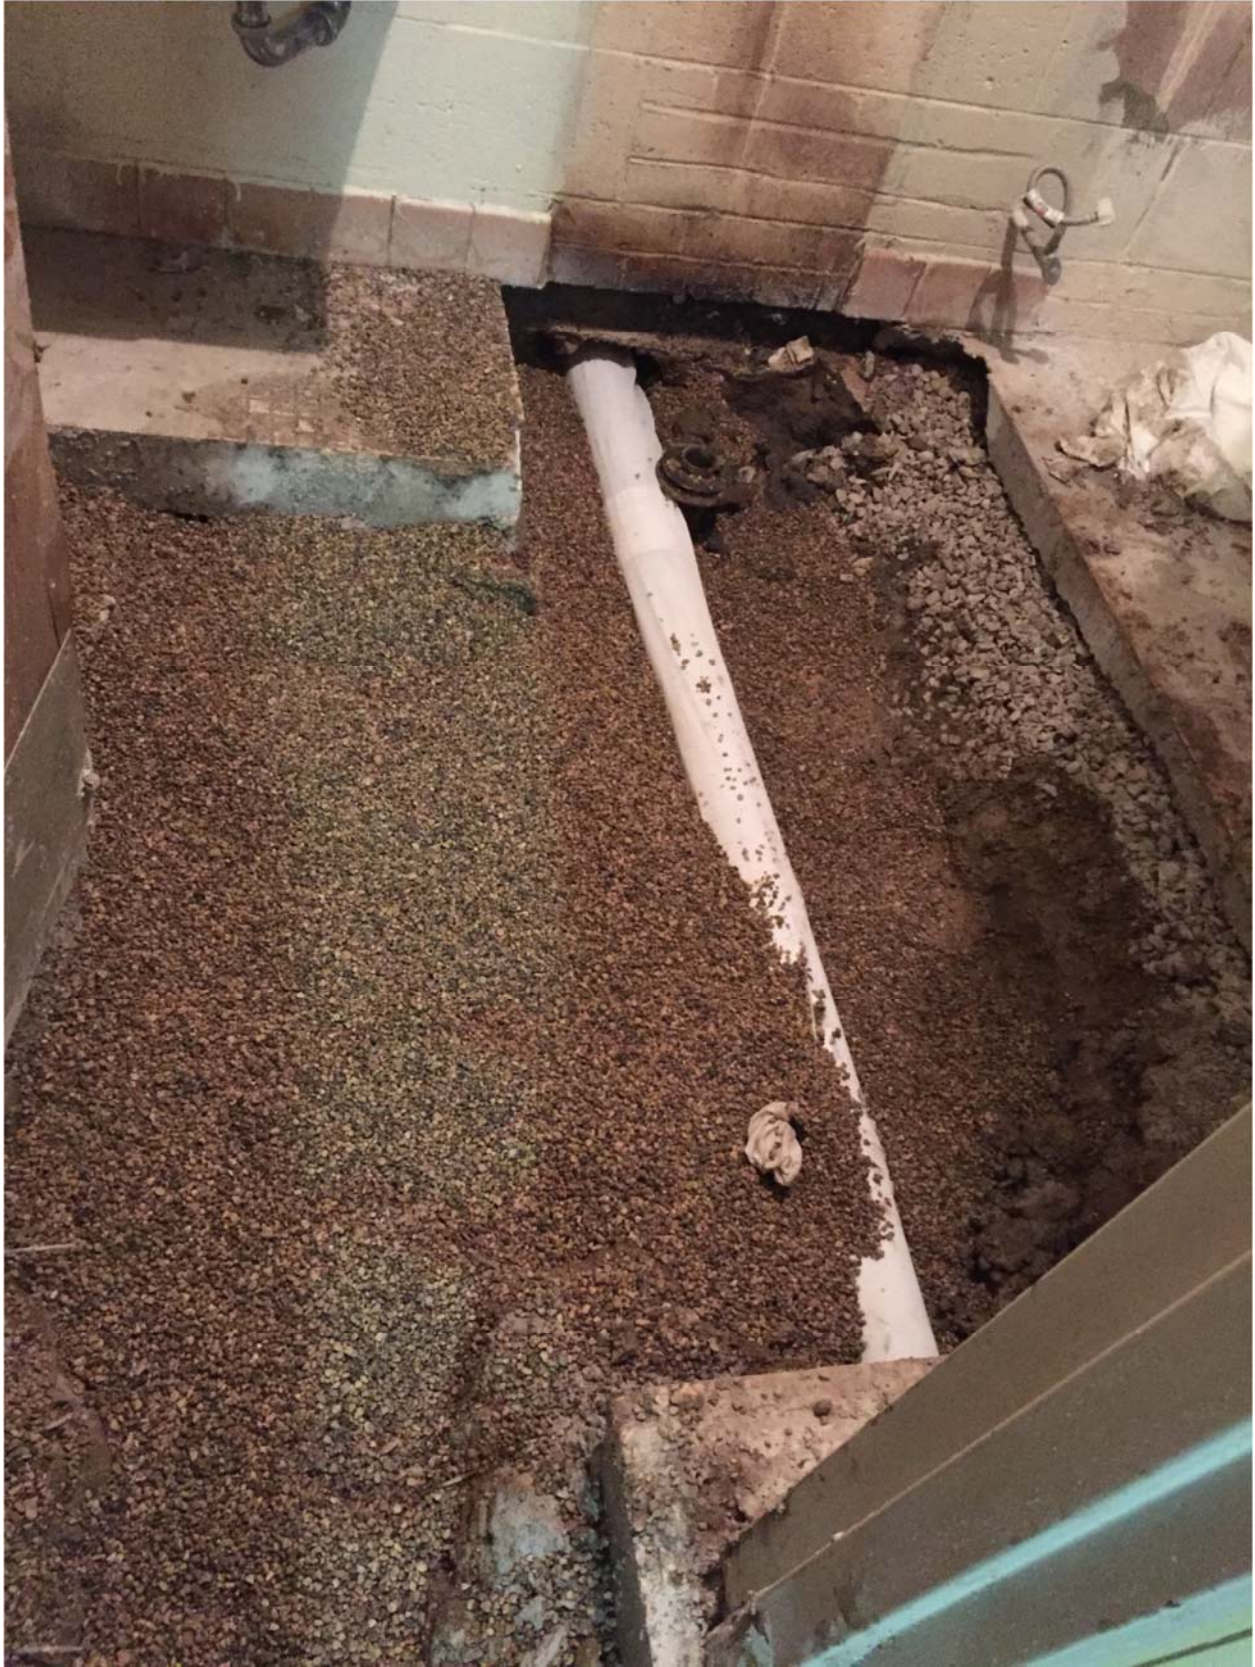
North restroom backfill and horizontal vent pipe.

The excavation area was backfilled with pea gravel. Two lengths of 4-inch diameter perforated PVC vent pipes were bedded within the pea gravel to facilitate sub-slab venting. The pipe was wrapped in filter fabric to prevent entry of soil particles. A vapor barrier (6-mil sheet plastic) was placed on top of the pea gravel. The concrete slab was replaced to an equivalent thickness as the existing slab, having an approximate thickness of 4-5-inches. In addition, a concrete barrier was poured immediately adjacent to the previously installed drain tile along the west basement wall. In that area, the concrete is now 14-inches thick and is intended to prevent groundwater in the foundation drain tile from entering into the excavation backfill.

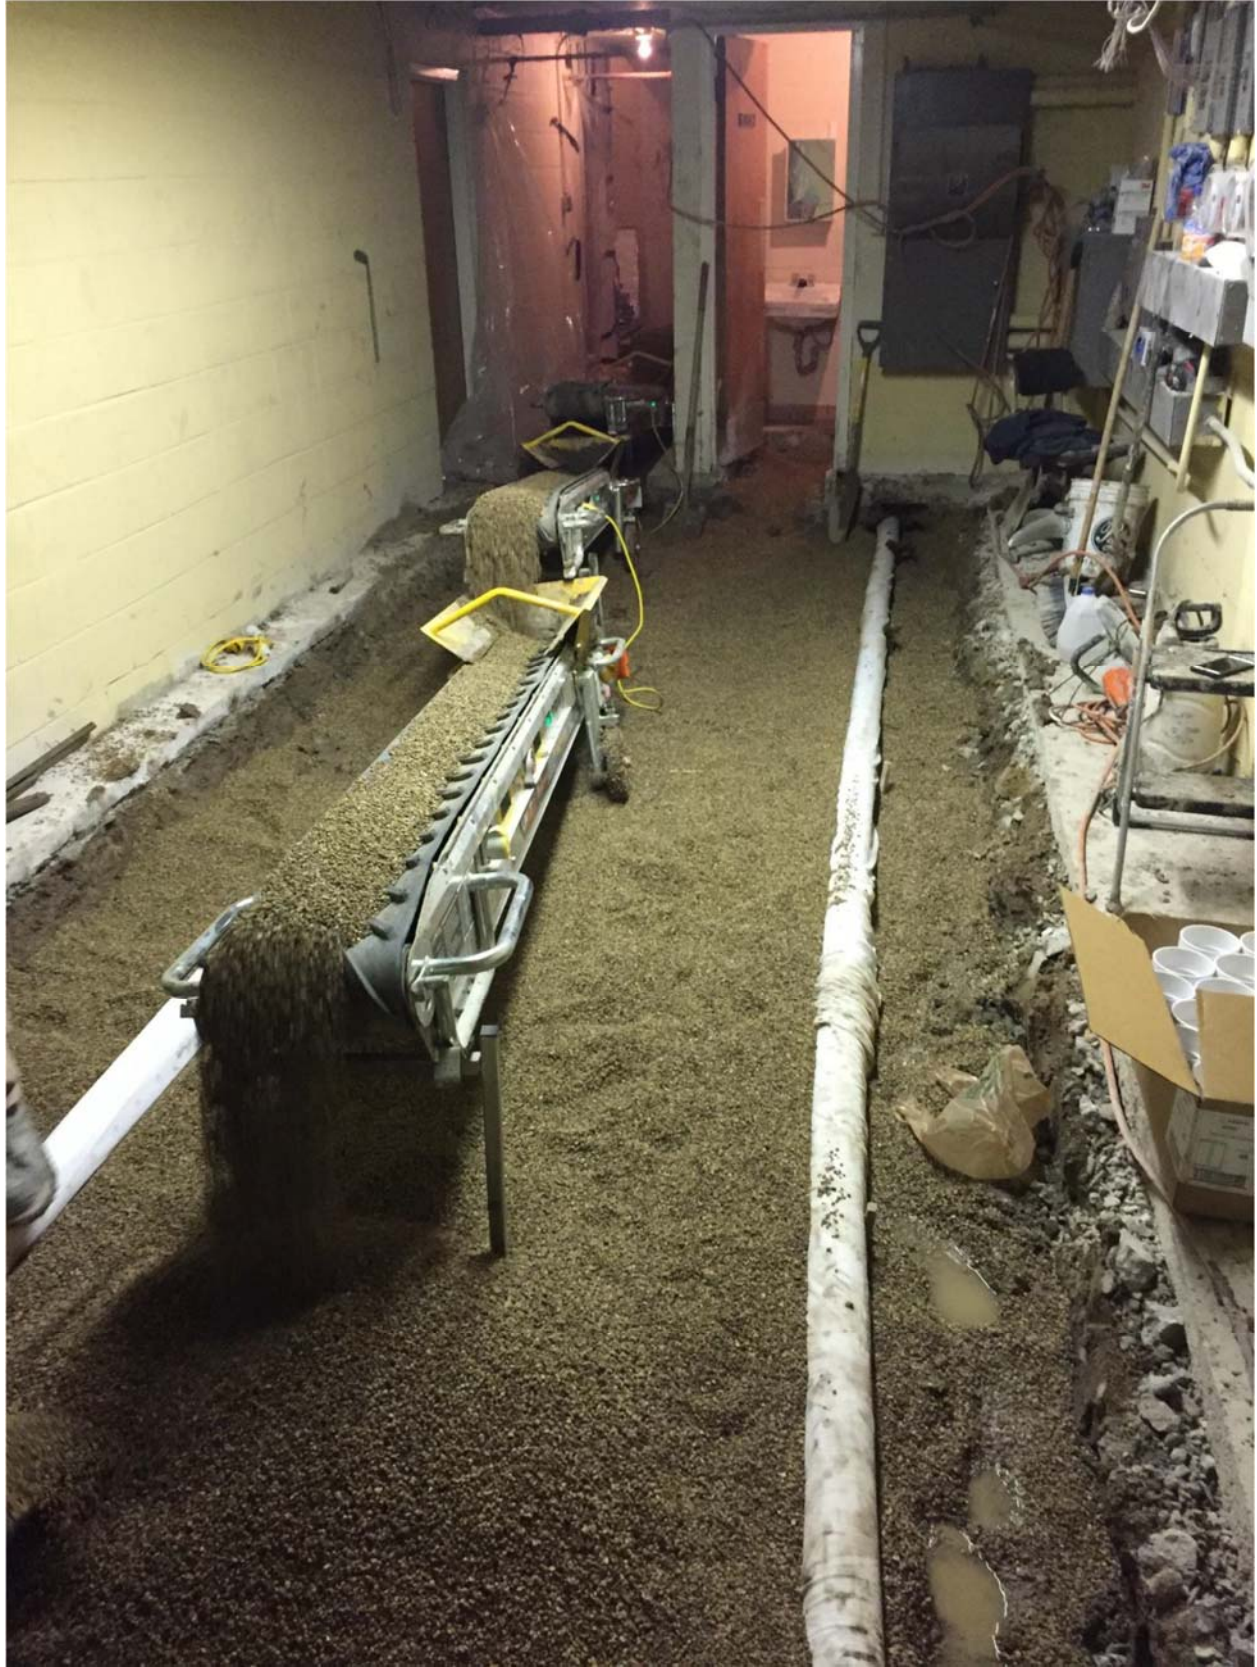
Horizontal vent pipes and pea gravel backfill in main storage room. Facing south.

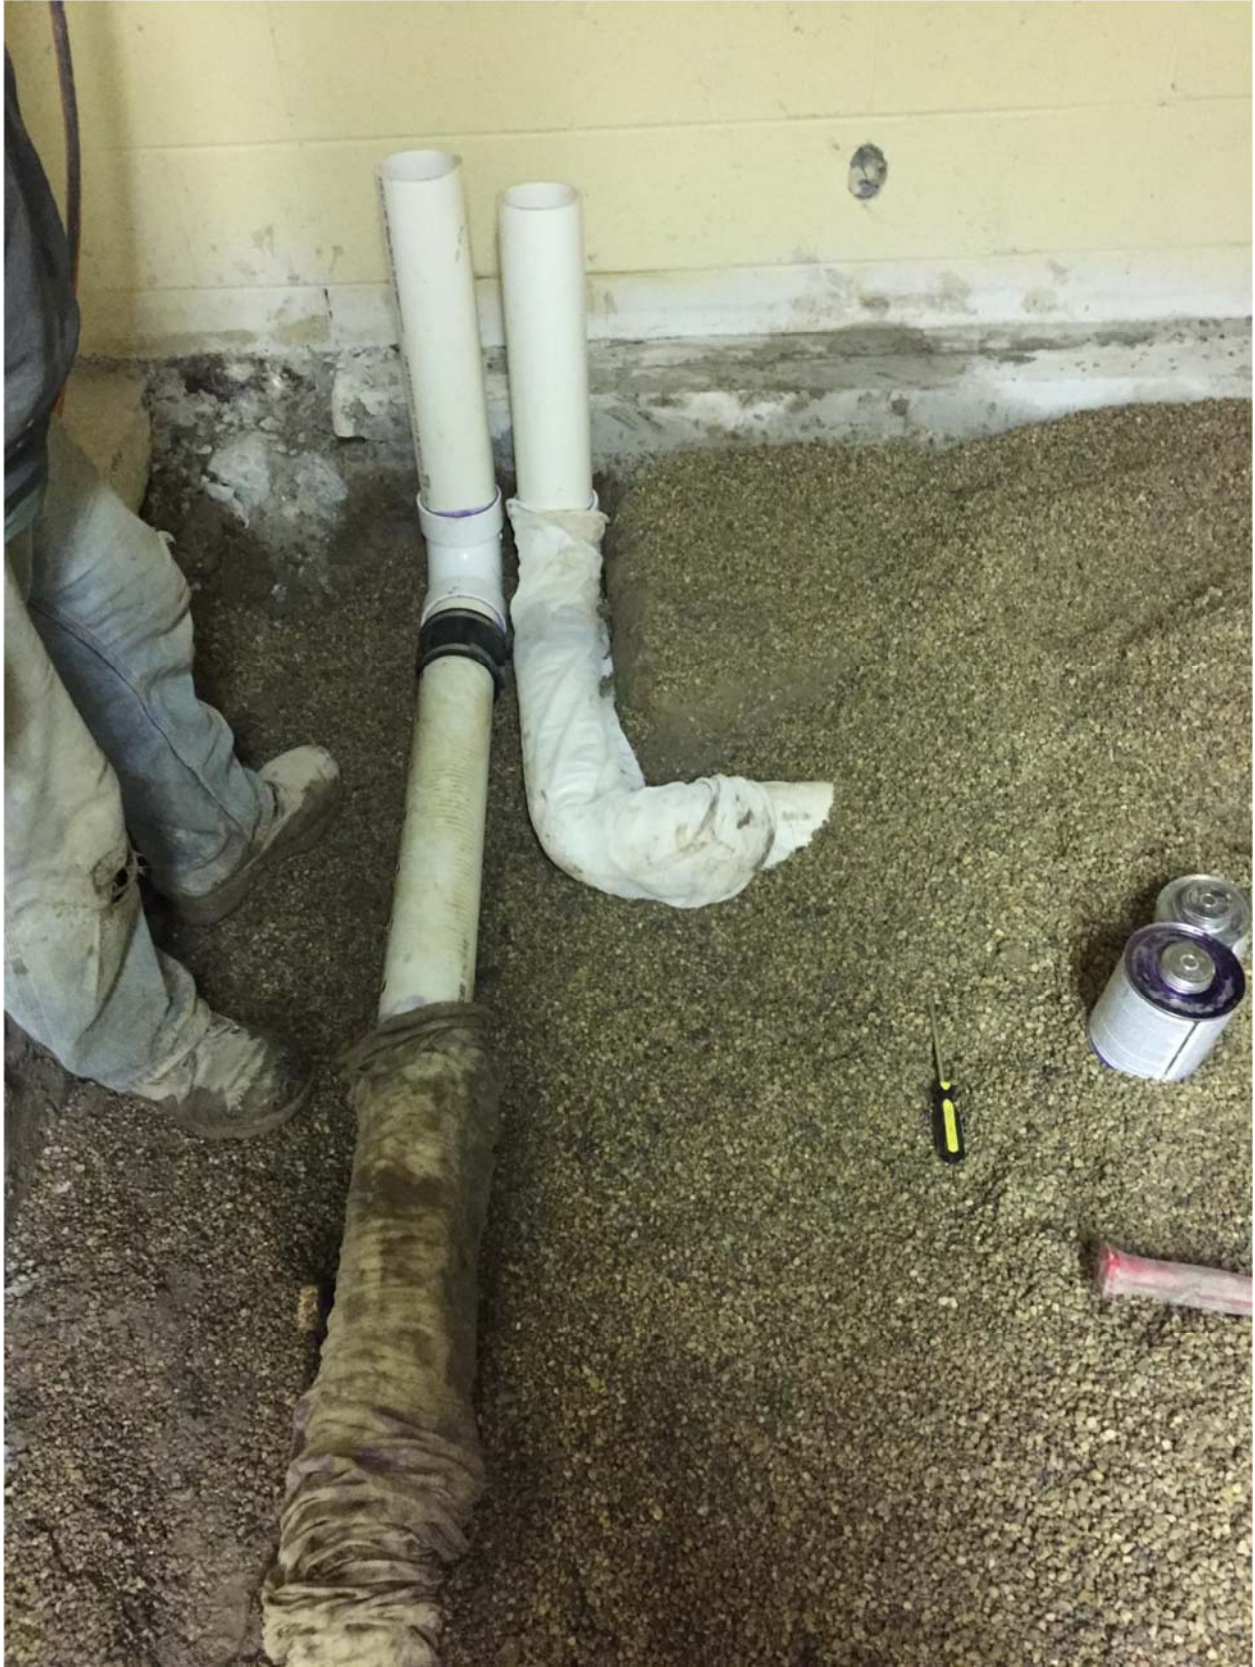
Vent pipe risers. Facing north.

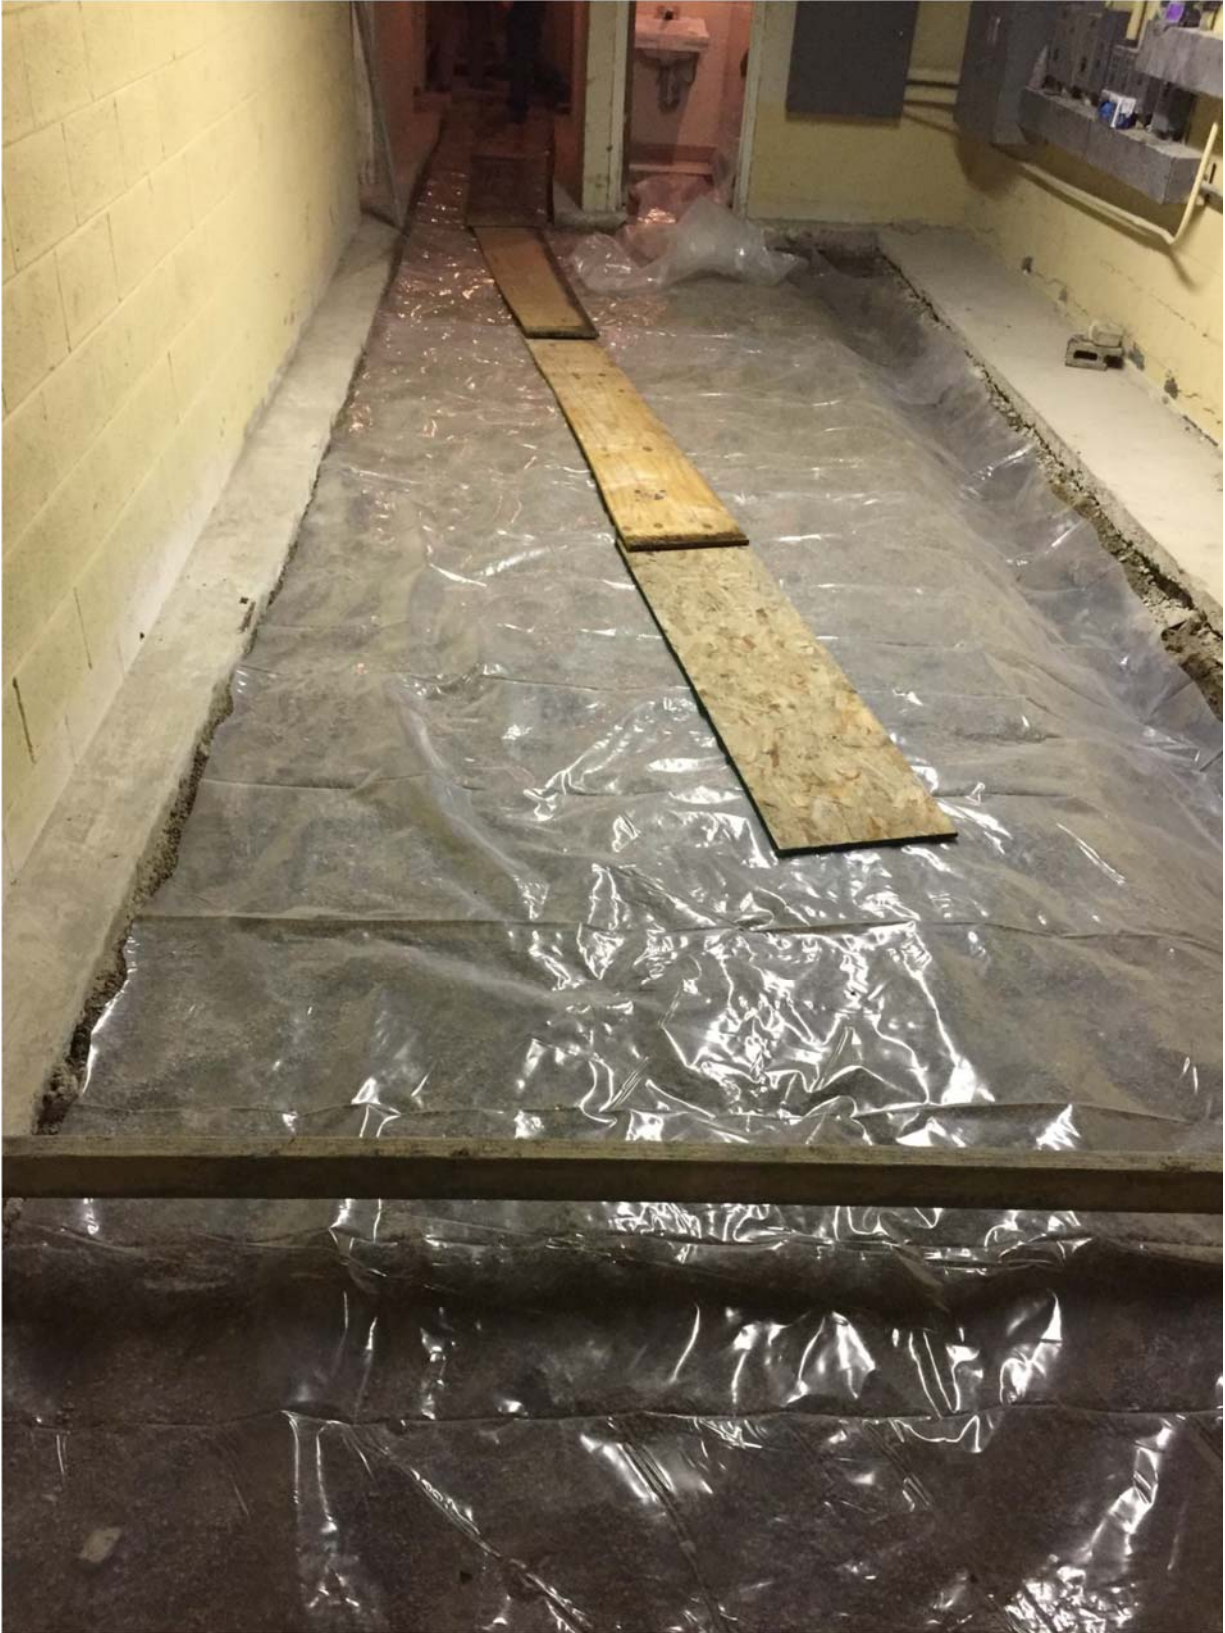
Vapor barrier and preparation for concrete slab replacement

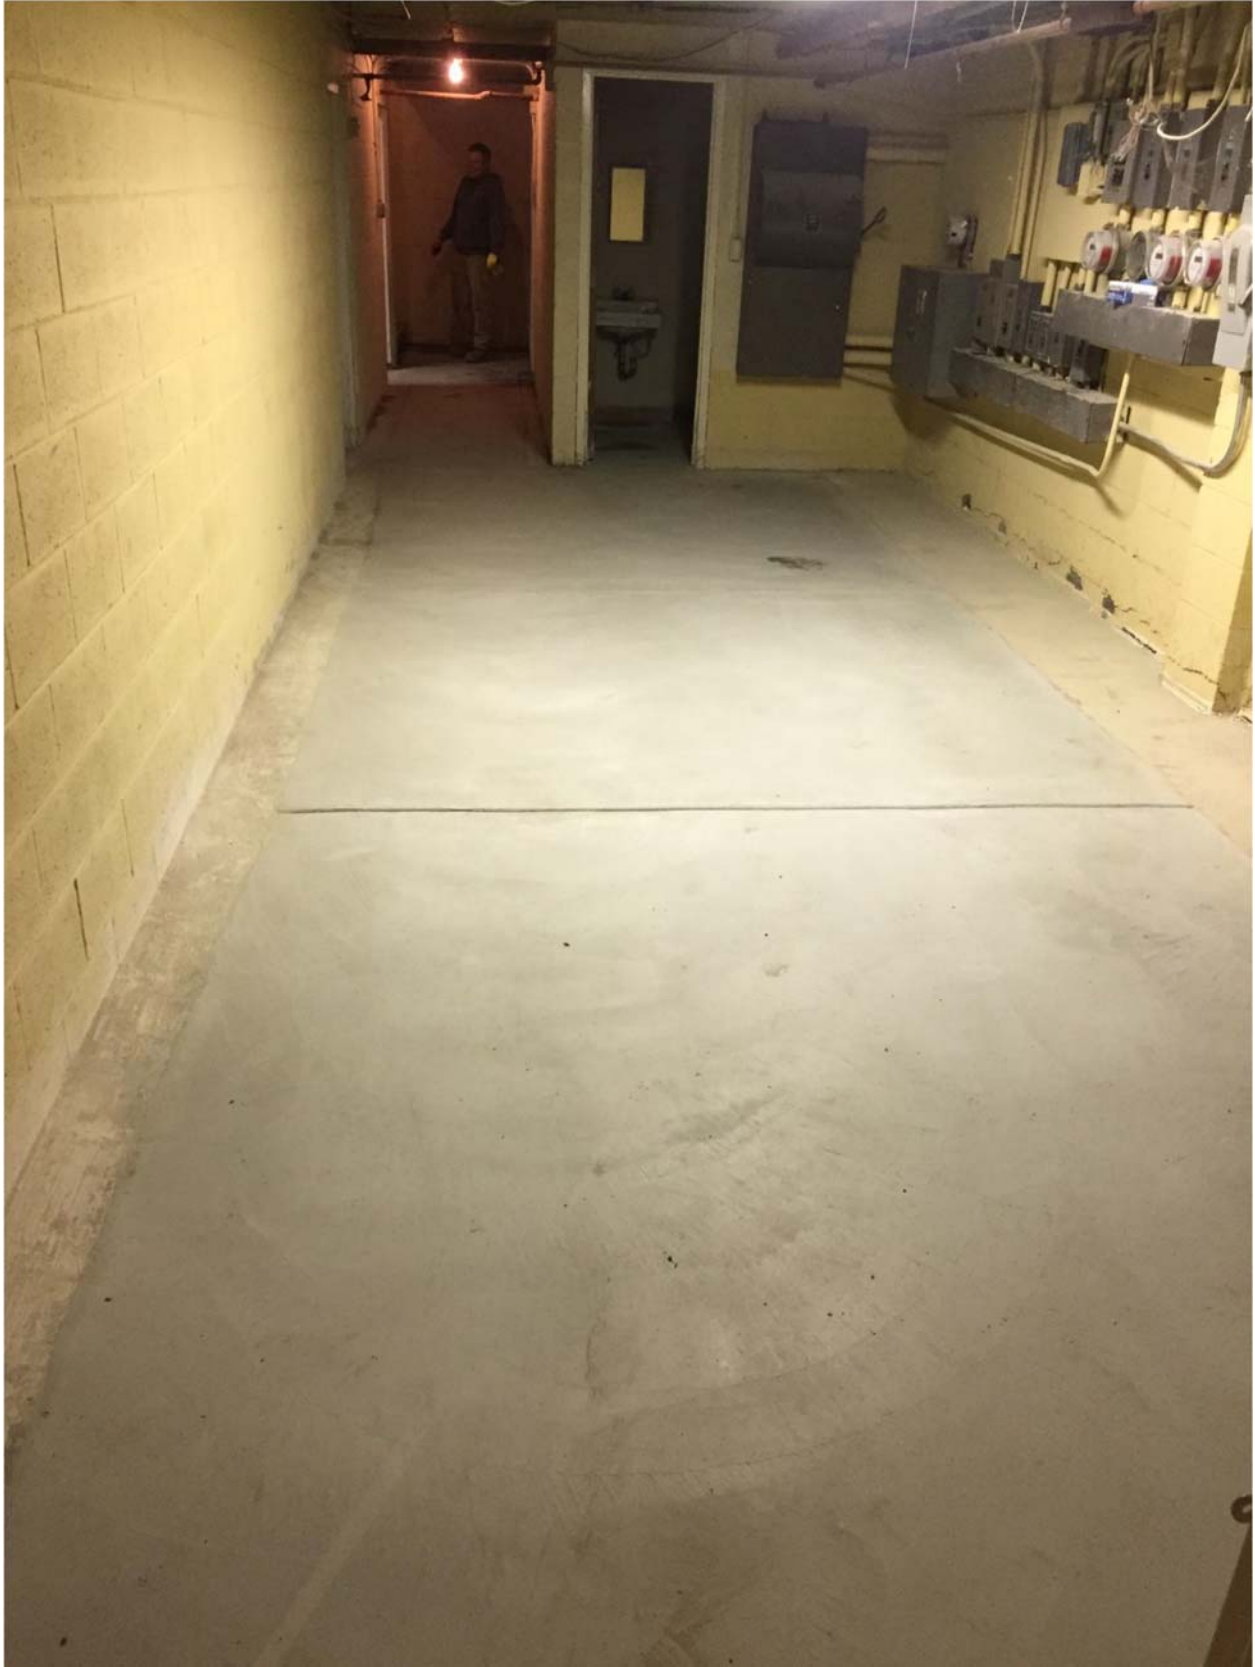
Excavation work completed.

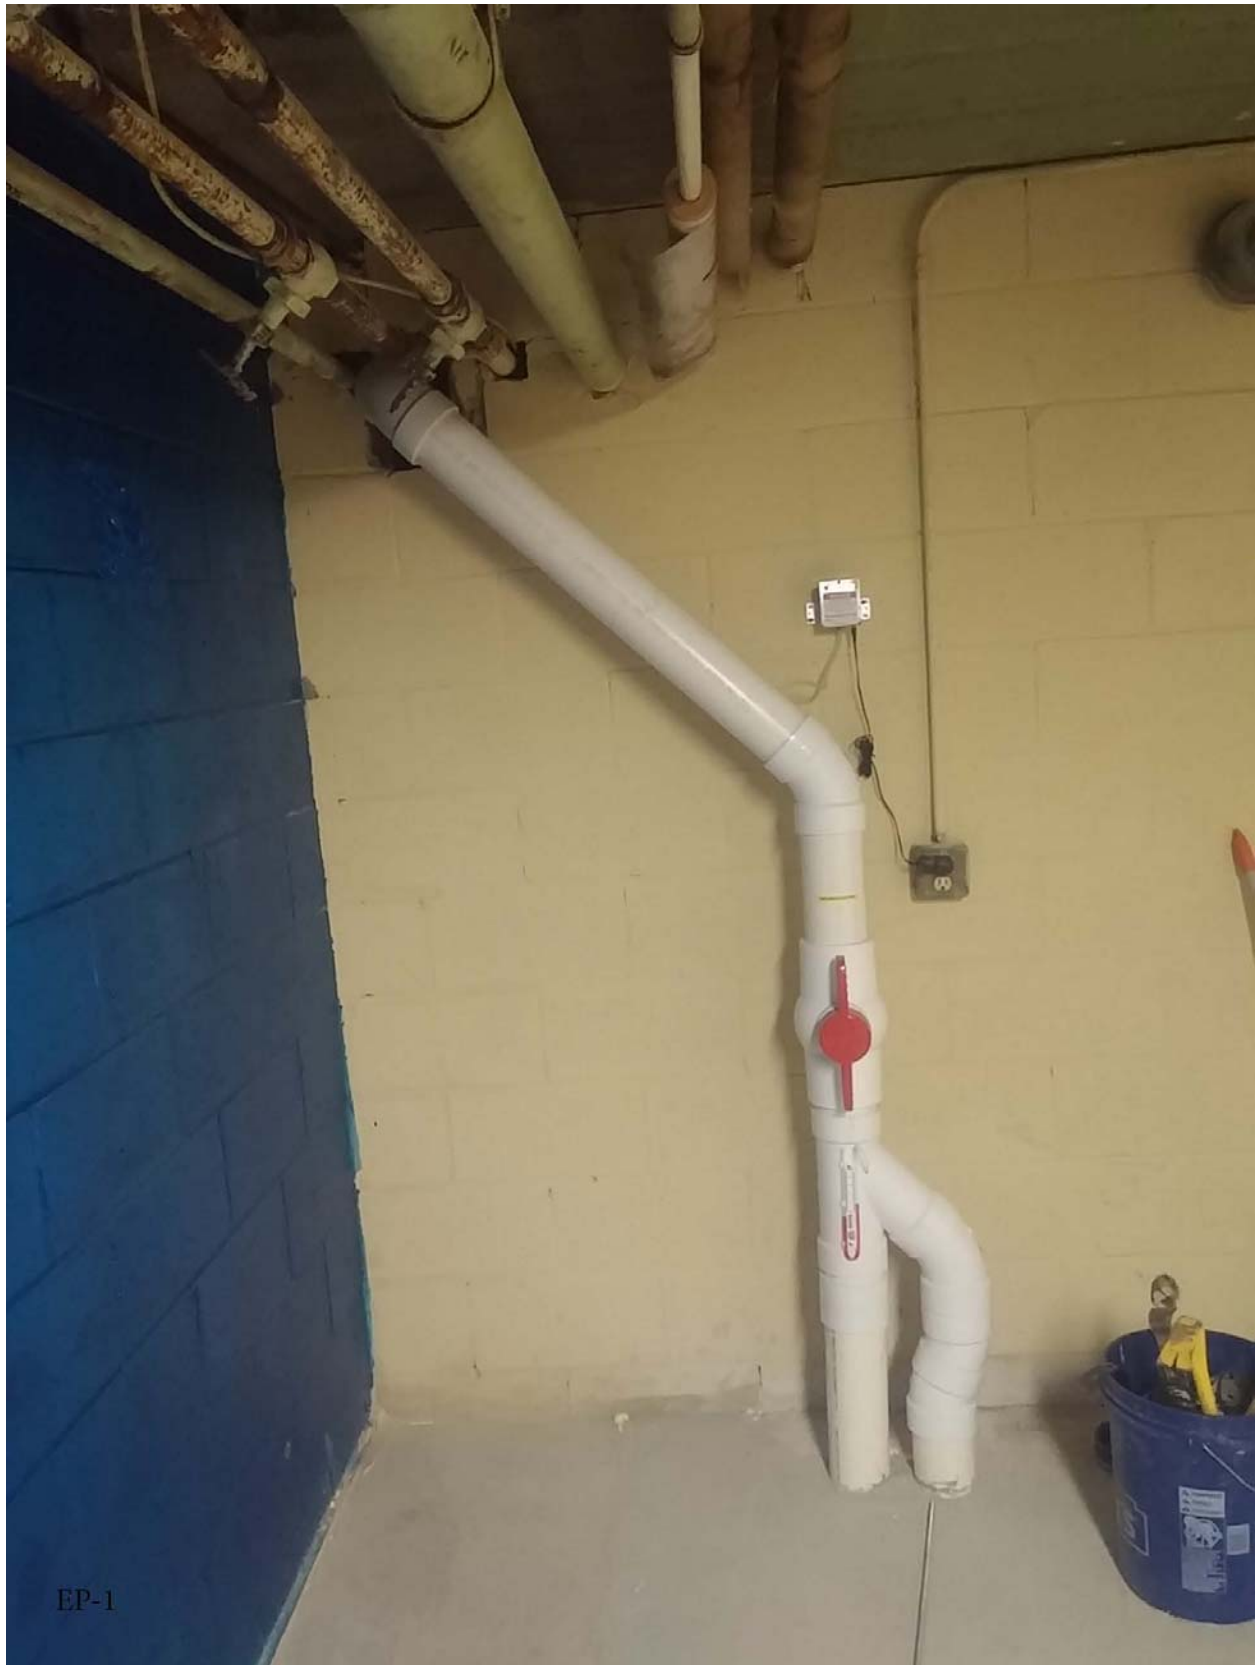
SSDS extraction points at north end of main storage room.

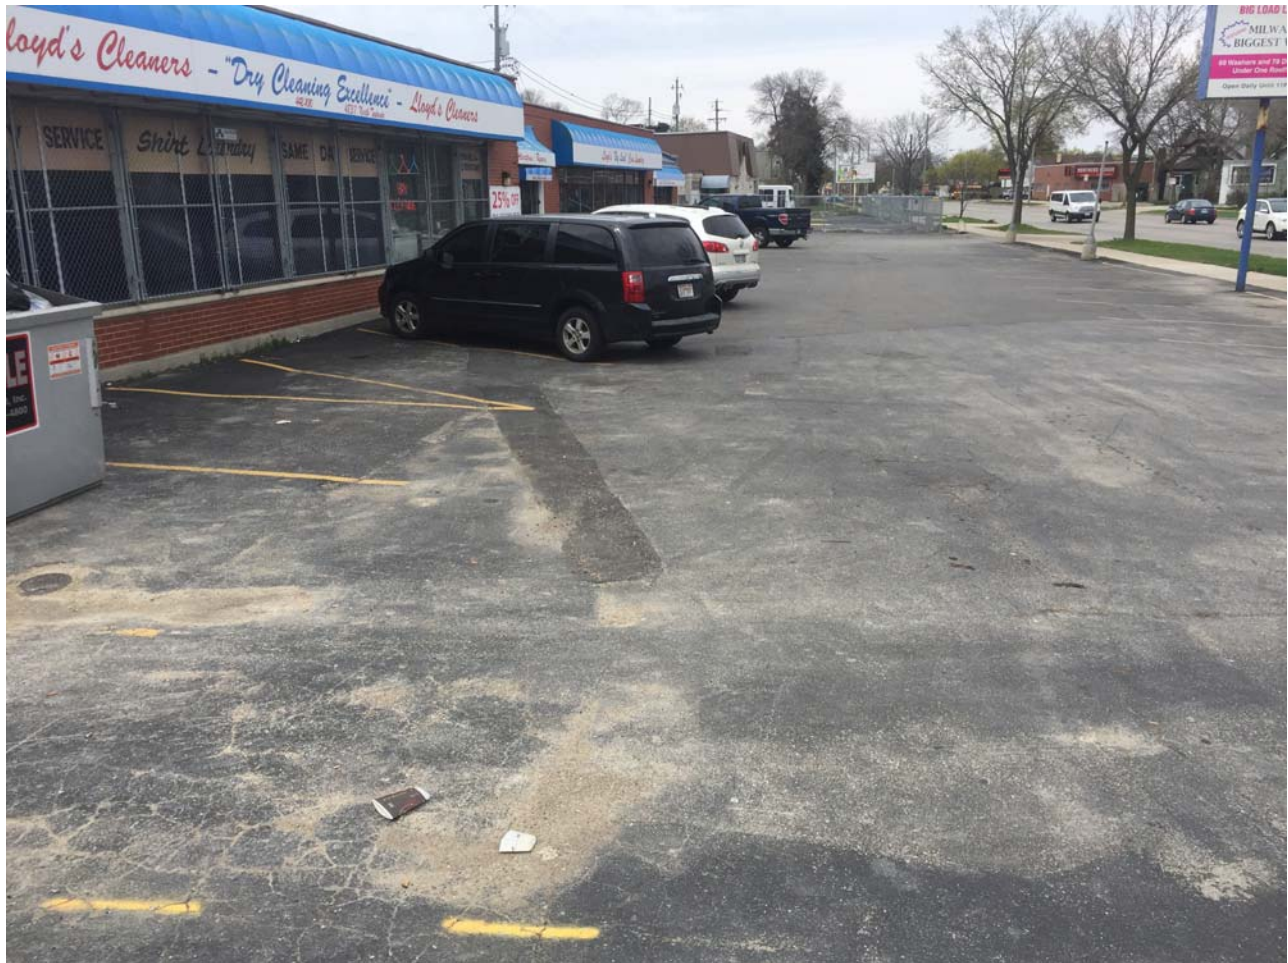
Overview of asphalt cap – facing north

An engineered cover (i.e., the portion of the building used as a drop-off for dry cleaned goods and the asphalt parking lot) will be maintained as a performance standard barrier to protect against infiltration of storm water and subsequent "flushing" of soil impacts to the water table.

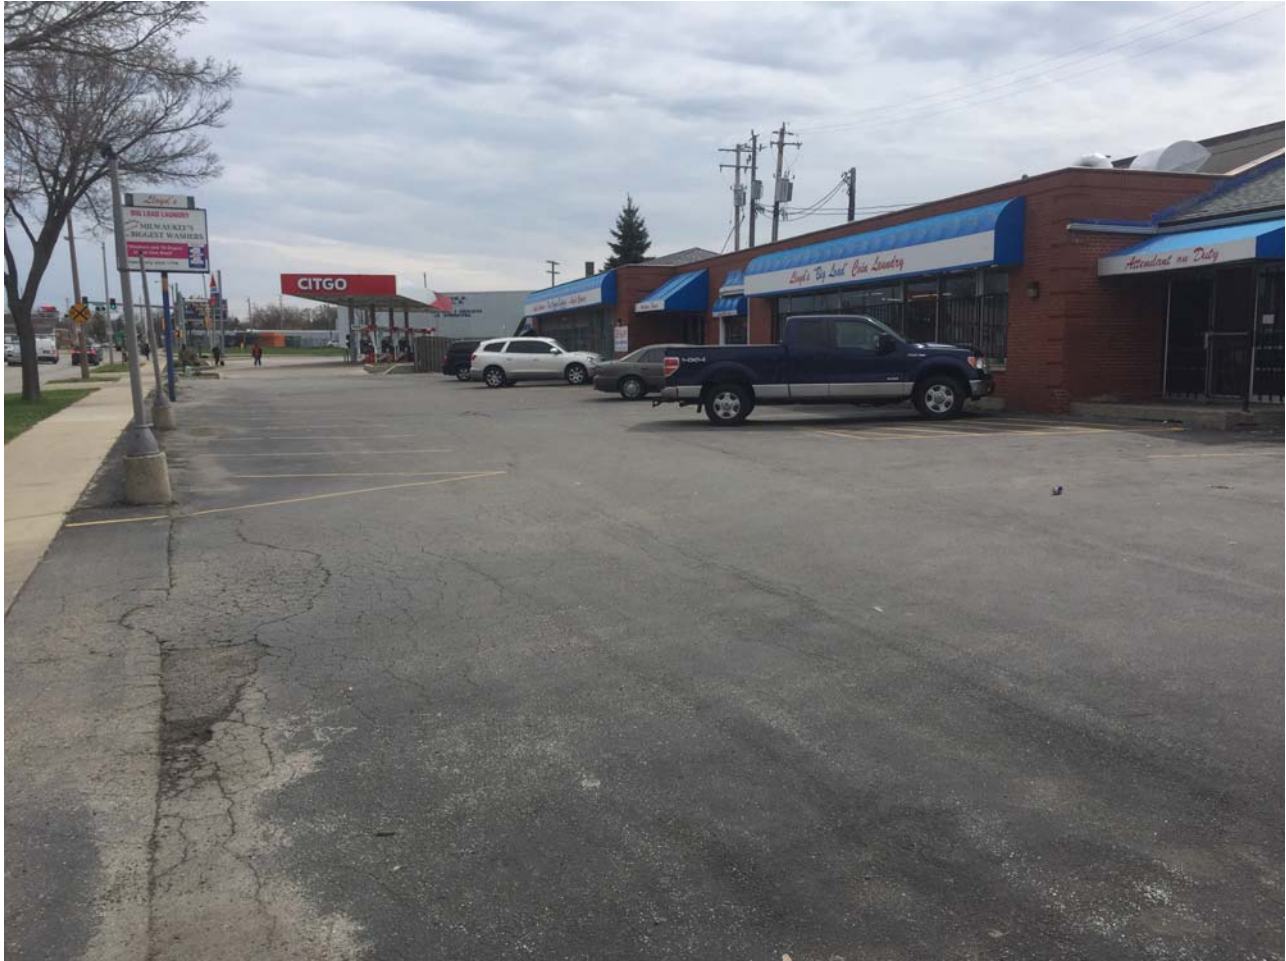
Overview of asphalt cap – facing south
