BRRTS No. 02-41-556811		VPLE No.	
Parcel ID No. 20-70-833000			
FID No. 241417330		WTM Coordinates	
		X 687027	Y 294558
BRRTS Activity (Site) Name Lloyd's Cleaners		WTM Coordinates Represent: <input type="checkbox"/> Source Area <input checked="" type="checkbox"/> Parcel Center	
Site Address 4837 North Teutonia Avenue		City Milwaukee	State ZIP Code WI 53209
Acres Ready For Use 0.5

SITE LAYOUT MAP											
Lloyd's Cleaners 4837 N. Teutonia Avenue Milwaukee, WI											
	Figure B.1.b										
ENVIRONMENTAL FORENSIC INVESTIGATIONS, INC. 825 North Capitol Avenue • Indianapolis, IN 46204 EnviroForensics.com	Project 6229

**BASEMENT COLLECTION TRENCH AND SSDS
LAYOUT DETAIL**

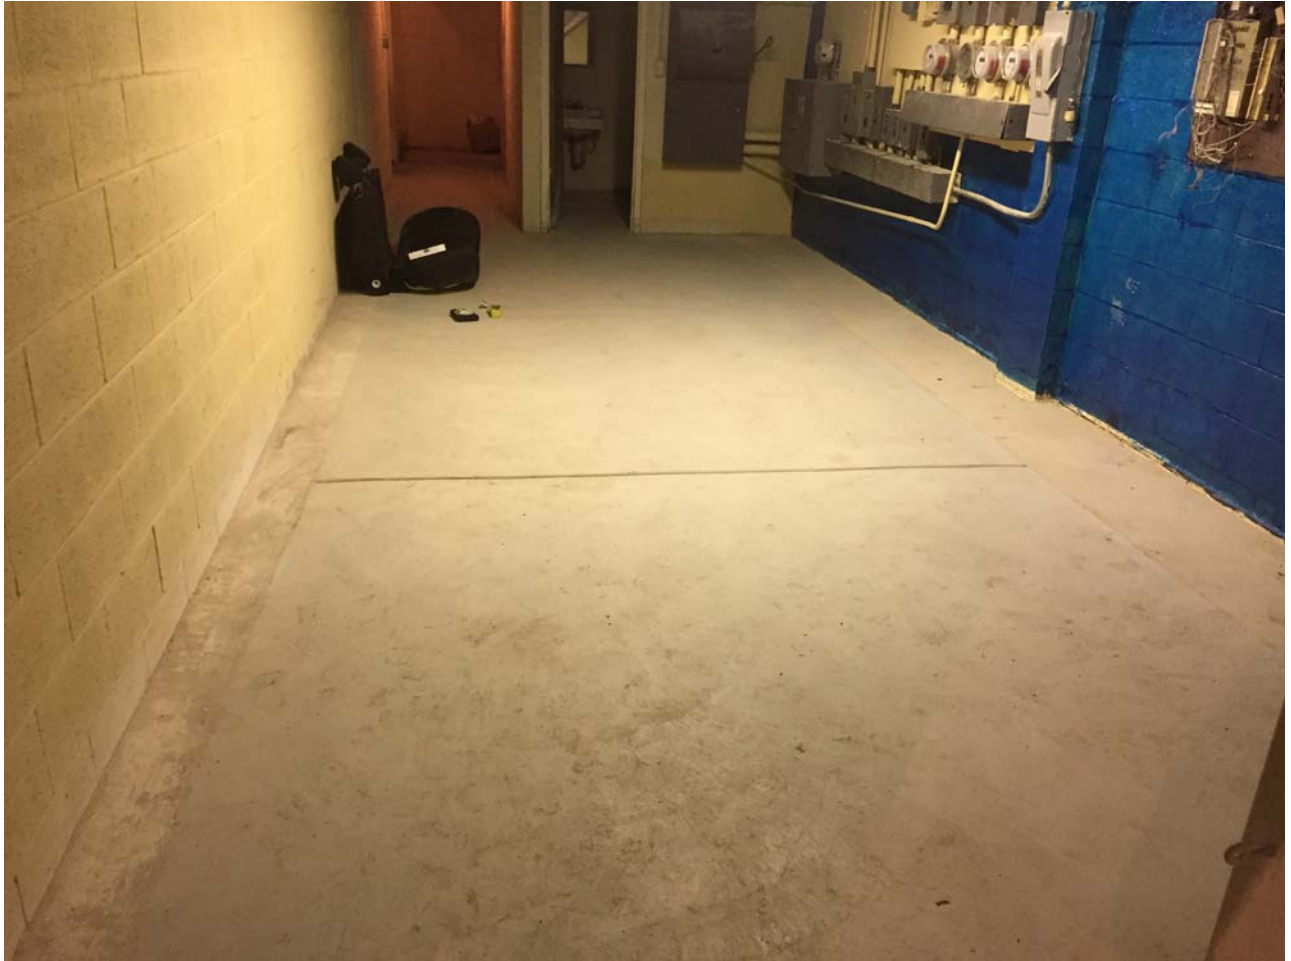
Basement concrete floor slab

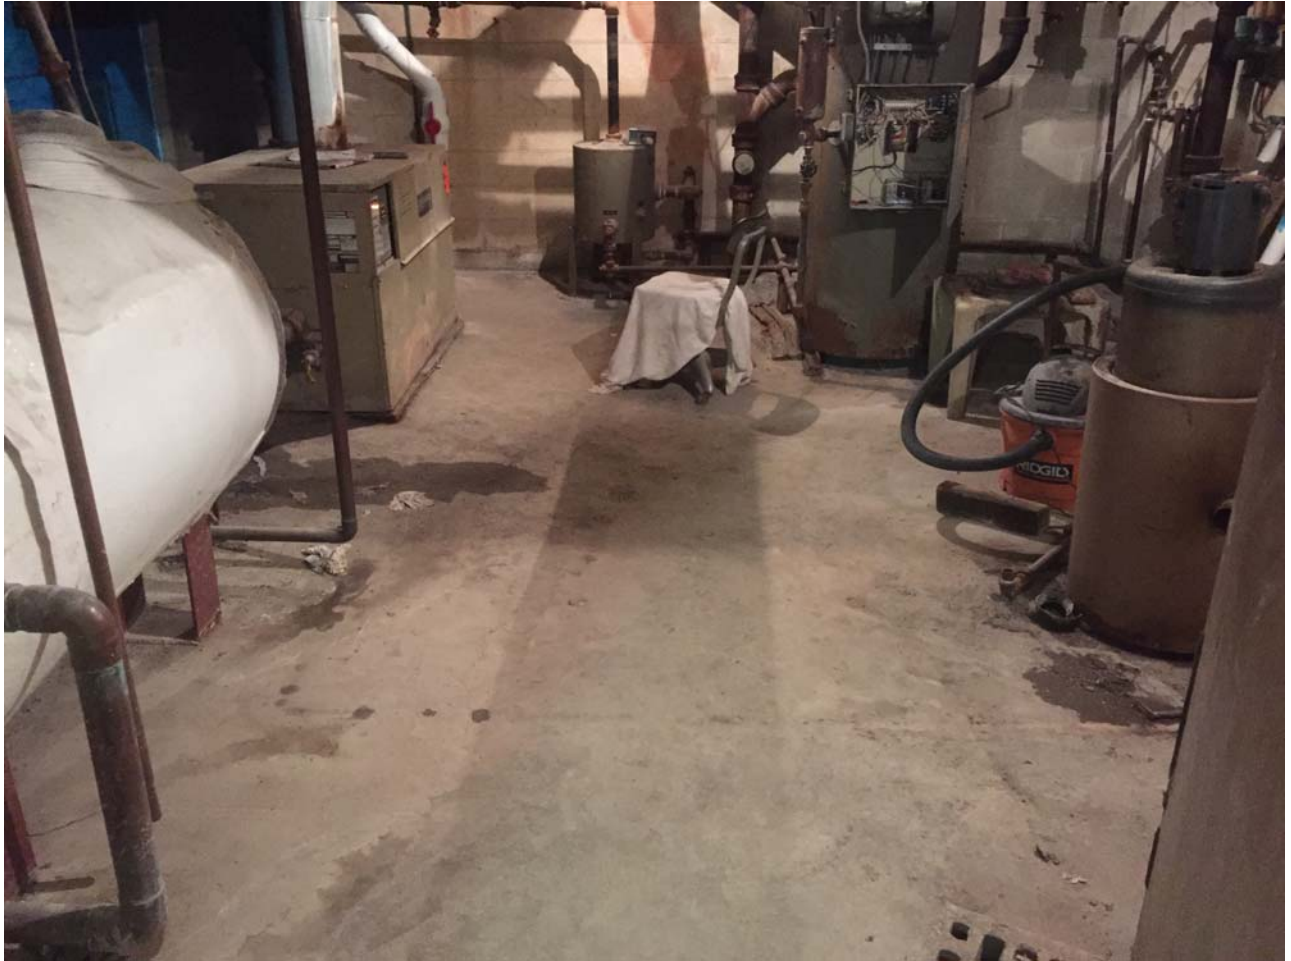
Basement mechanical room concrete floor slab
