BRRTS #:	<input type="text" value="03-60-557729"/>	CLOSURE DATE:	<input type="text" value="04/21/2016"/>
ACTIVITY NAME:	<input type="text" value="Richard A. DeZoute Property"/>	FID #:	<input type="text"/>
PROPERTY ADDRESS:	<input type="text" value="729 S Sauk Trail Rd"/>	DATCP #:	<input type="text"/>
MUNICIPALITY:	<input type="text" value="Oostburg"/>	PECFA#:	<input type="text" value="53070158029A"/>
PARCEL ID #:	<input type="text" value="59165719730"/>

This site is a former rural gas station that ceased operation in 1965; the tank system was removed from the site in 1972. The site is zoned "Residential" and a house on the site remains occupied at this time. Four hundred and fifty two tons of contaminated soil was removed from the site. Subsequent sampling indicates that petroleum contaminated soil and groundwater remains on the site and the abutting road rights of way. The conditions of closure and continuing obligations required were based on the property being used for residential purposes.

TITLE: Groundwater Isoconcentration					
SITE: Richard A DeZoute Property 729 Sauk Trail Rd., Oostburg, WI 53070				DATE: 11/19/12	DWG #: F:DeZoute/Rem OEX-GW Mon/Figures/ Base Map-Kalina-1

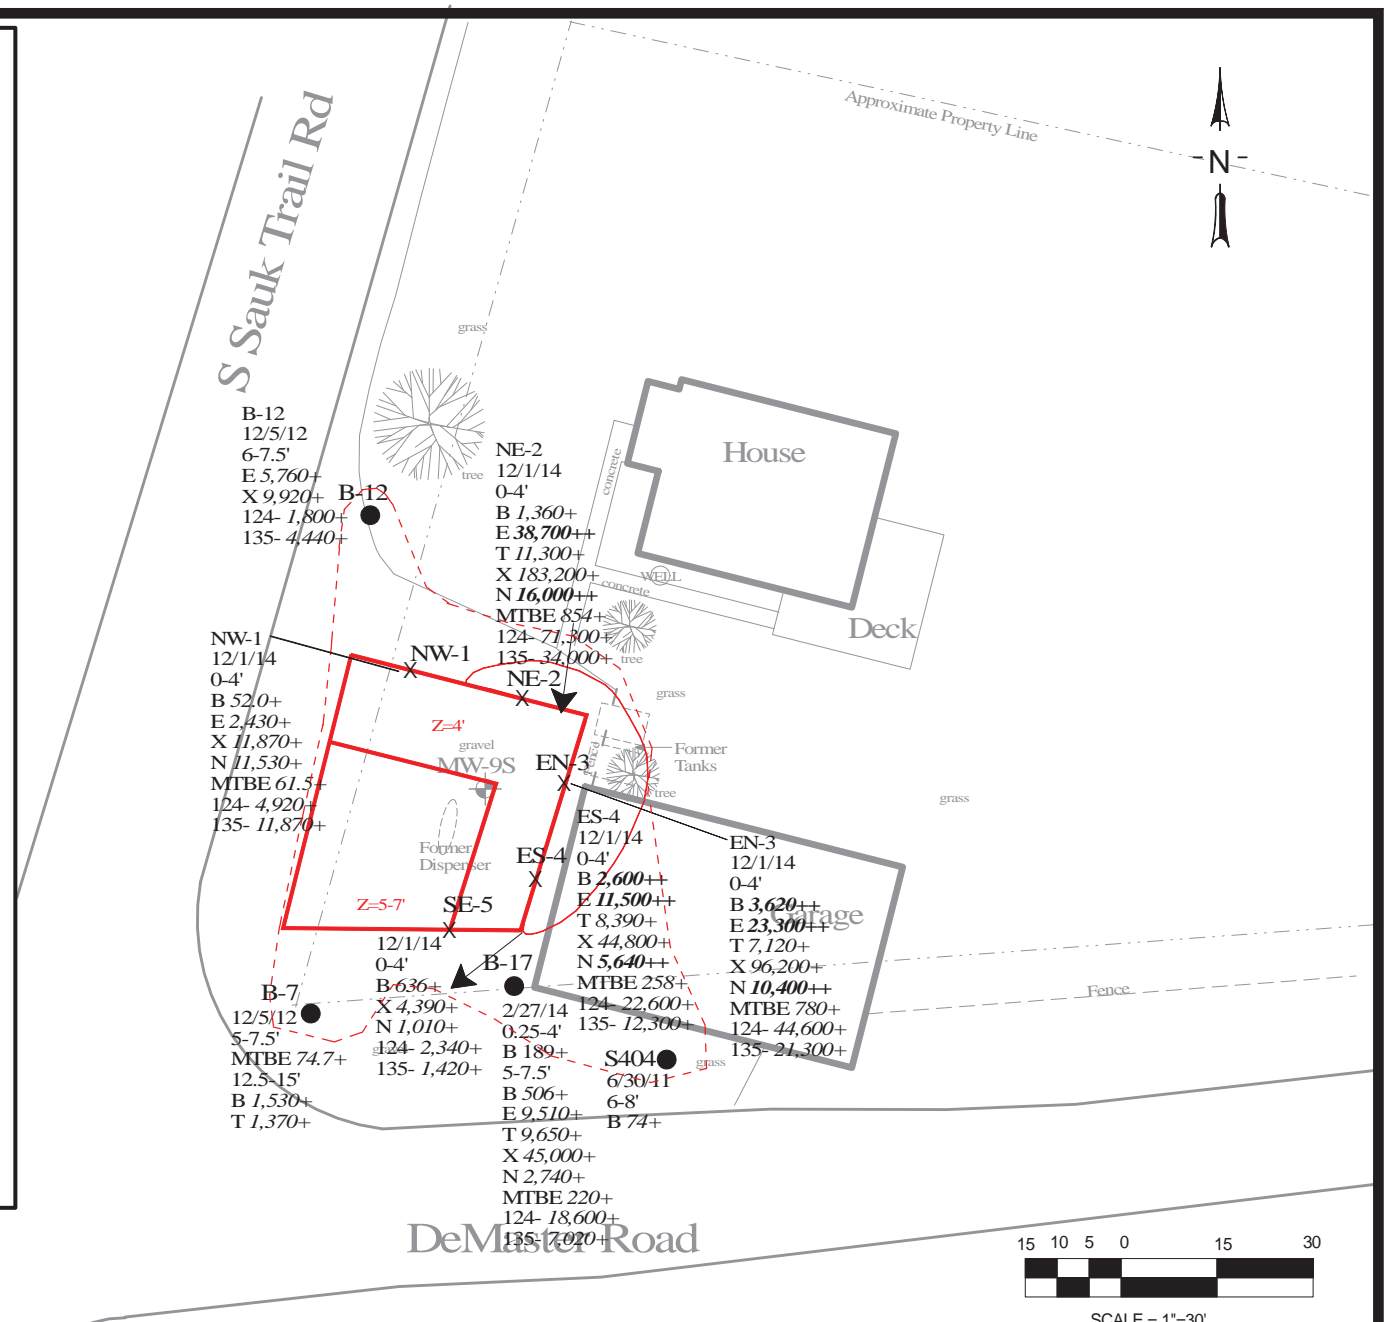
TITLE: Residual Soil Contamination

Soil chemistry results indicate remaining soils at the site contain levels of PVOCs+N at levels above regulatory residual contaminant levels for non-industrial sites. The observed concentrations are present in soil within and beyond the limits of the December 2014 excavation (Figure B.2.b).

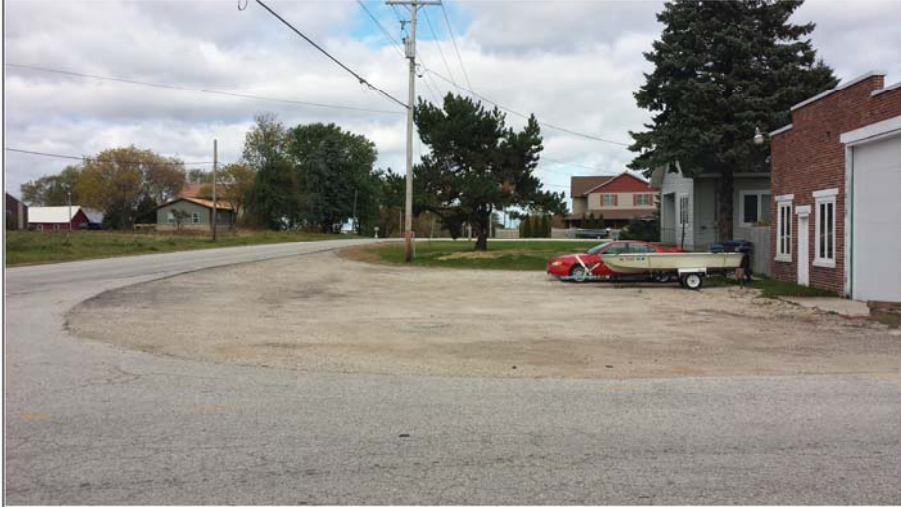
Title: Cap to be maintained, looking North from DeMaster Road

The grass vegetation cover, gravel parking lot, and 1,500 square foot garage building overlying the contaminated soil and as depicted in Figure D.2 will be inspected once a year, normally in the spring after all snow and ice is gone, for deterioration, cracks and other potential problems that can cause additional infiltration into or exposure to underlying soils. The inspections will be performed by the property owner or their designated representative. The inspections will be performed to evaluate damage due to settling, exposure to the weather, wear from traffic, increasing age and other factors. Any area where soils have become or are likely to become exposed and where infiltration from the surface will not be effectively minimized will be documented.

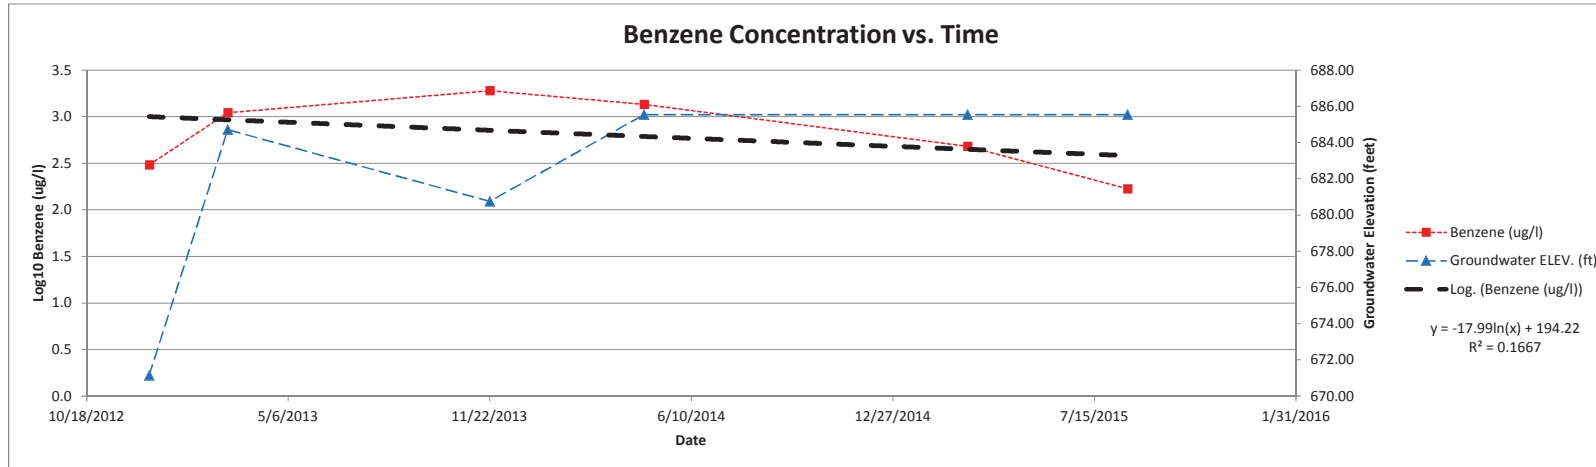
The logarithm (to the base 10) of the benzene concentration data is plotted as a function of time.

For the graph below, benzene concentrations appear to increase as a function of increasing water levels.

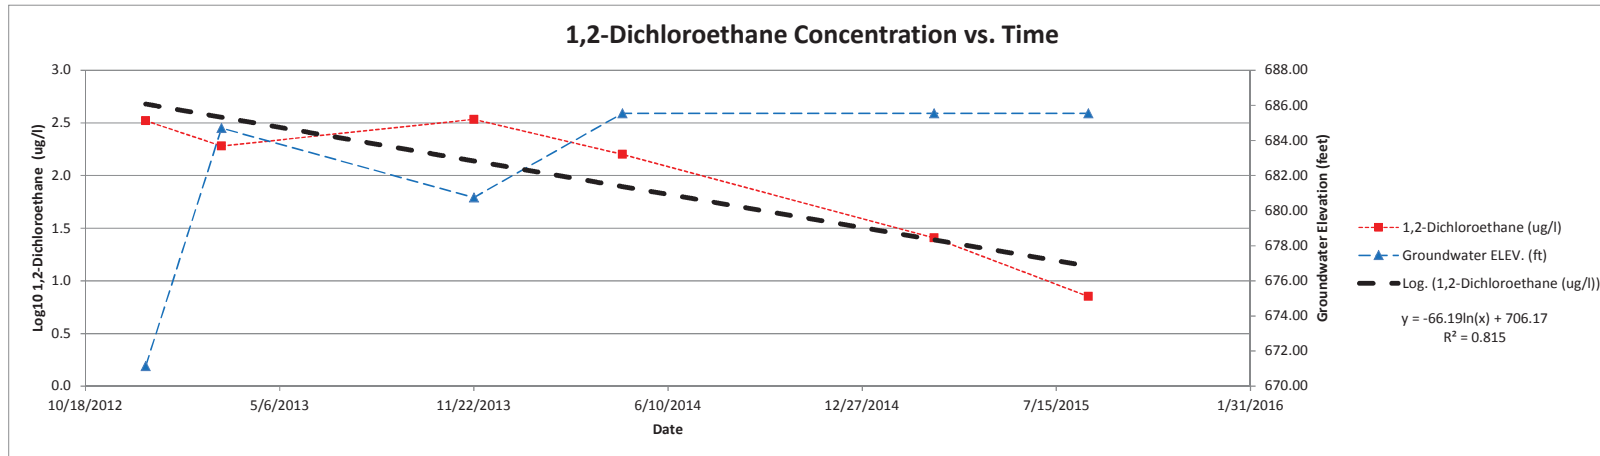
The logarithm (to the base 10) of the 1,2-Dichloroethane concentration data is plotted as a function of time. The trend line is the semi-log10-transformed regression line. Groundwater elevation data is superimposed on the concentration data. For the graph above, 1,2-Dichloroethane concentrations appear to be decreasing, and it appears groundwater levels have risen since December 2012. For the graph below, 1,2-Dichloroethane concentrations appear to decrease as a function of increasing water levels. It should be noted that April 2014 groundwater level data from MW-9 is used for MW-9S March/August 2015 groundwater levels since this well has not been surveyed.

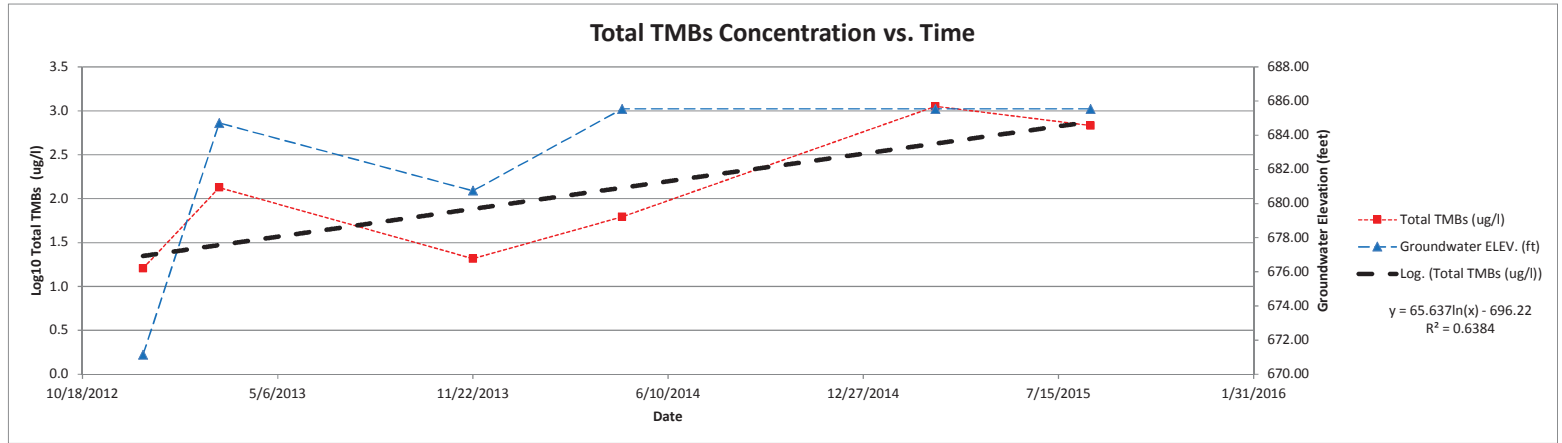
The logarithm (to the base 10) of the Total TMBs concentration data is plotted as a function of time.

Even though the semi-log plot shows total TMBs increasing over time, the last event shows total TMB levels significantly dropped from 1,124 to 679 ug/l.

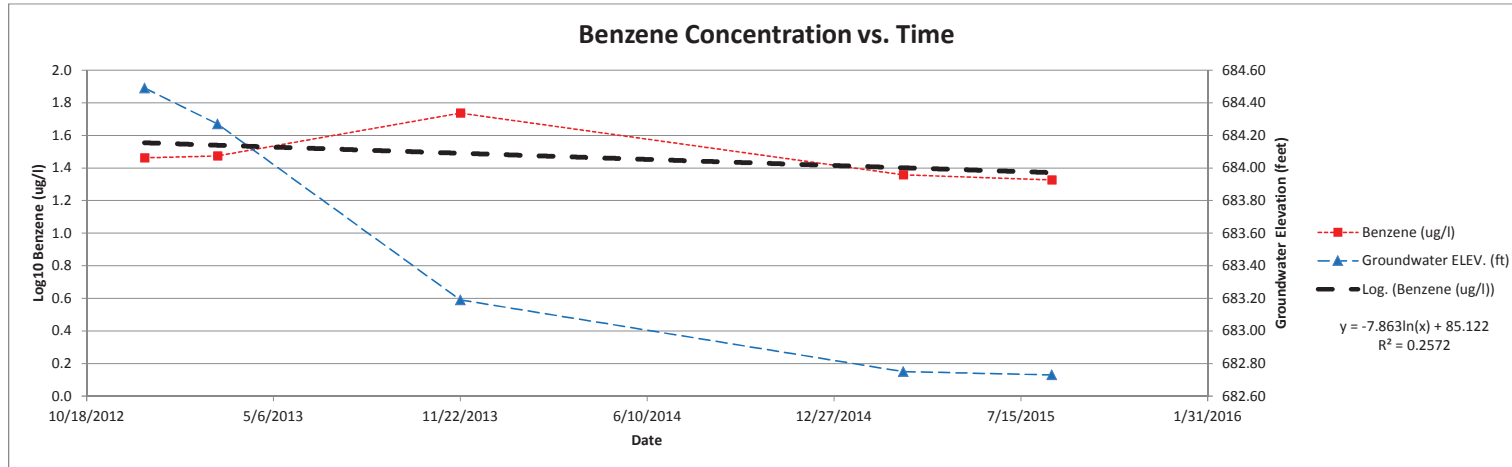
The logarithm (to the base 10) of the benzene concentration data is plotted as a function of time.
 The trend line is the semi-log₁₀-transformed regression line.
 Groundwater elevation data is superimposed on the concentration data.
 For the graph above, benzene concentrations appear to be increasing, and there seems to be an decreasing water level with time.
 For the graph below, benzene concentrations appear to increase as a function of increasing water levels.

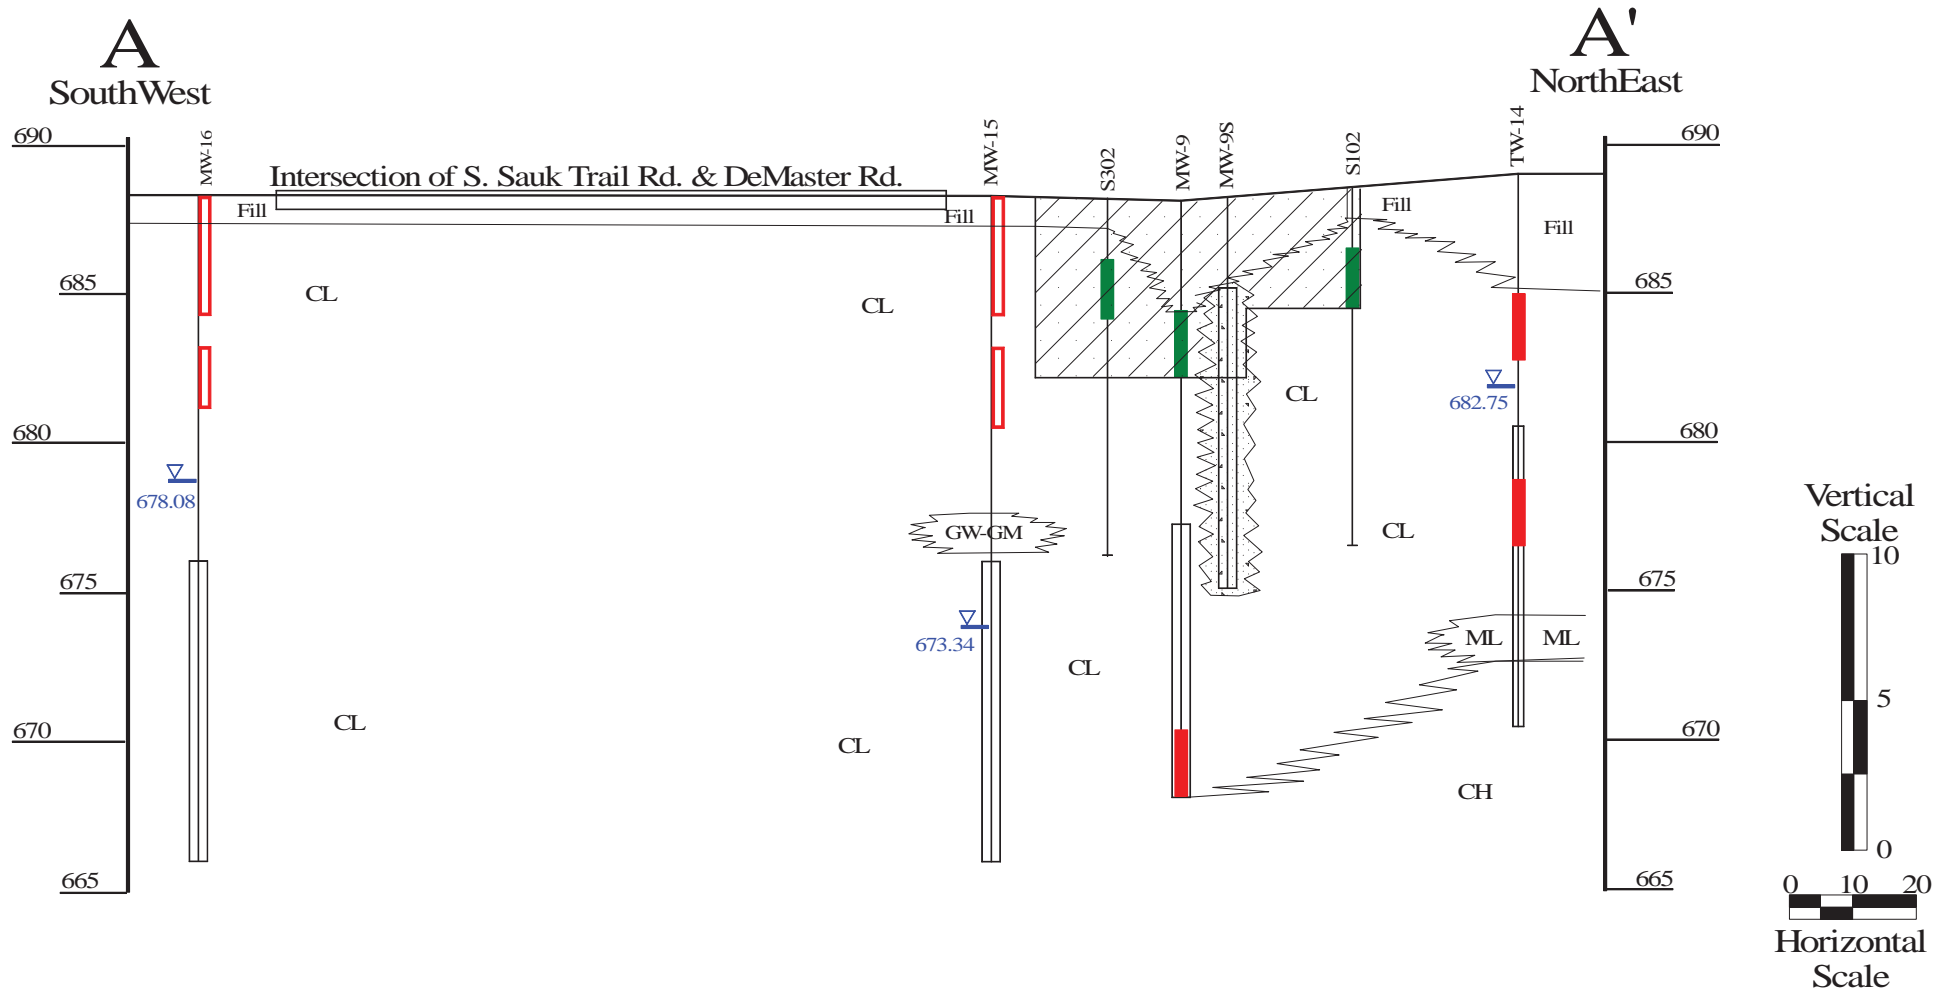
TITLE: Geologic Cross Section A-A'		FEHR GRAHAM ENGINEERING & ENVIRONMENTAL	
SITE: 729 Sauk Trail Rd., Oostburg, WI 53070		DATE: 11/19/12	DWG #: O:Base Map-Kalina-14-1440.skf
SCALE:	ATS PROJECT NUMBER: Kalina 14-1440	APPVD:	FIGURE: B.3.a.II
REV	DATE	DESCRIPTION:	DRAWN BY: MKH

1. Elevation referenced to the North American Vertical Datum of 1988 (NAVD88) in feet above mean sea level (amsl)
2. For detailed lithologic descriptions and well construction details, see boring logs & well construction reports in Attachment E
3. Water table elevation averaged from March 2013 to April 2014
4. See Figure 1 for location of cross section

- A. Soil/Geology
- i. Describe soil type(s) and relevant physical properties, thickness of soil column across the site, vertical and lateral variations in soil types.
Gravel, grass/topsoil, and asphalt covers the surface of the site. These surficial layers are all underlain by native silty clay, typically reddish brown to the investigated depth of 20 feet. Occasional sand or gravel intervals were noted in a few logs, but in general, the site consists of tight clay.

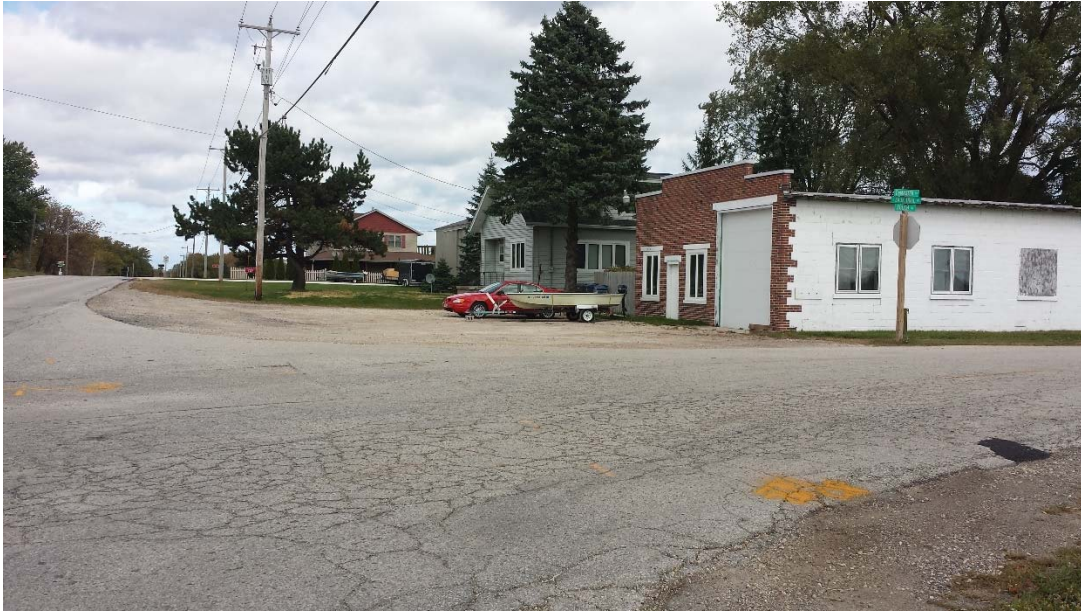
Corner Sauk Trail & DeMaster facing North; Gravel Cap & Garage

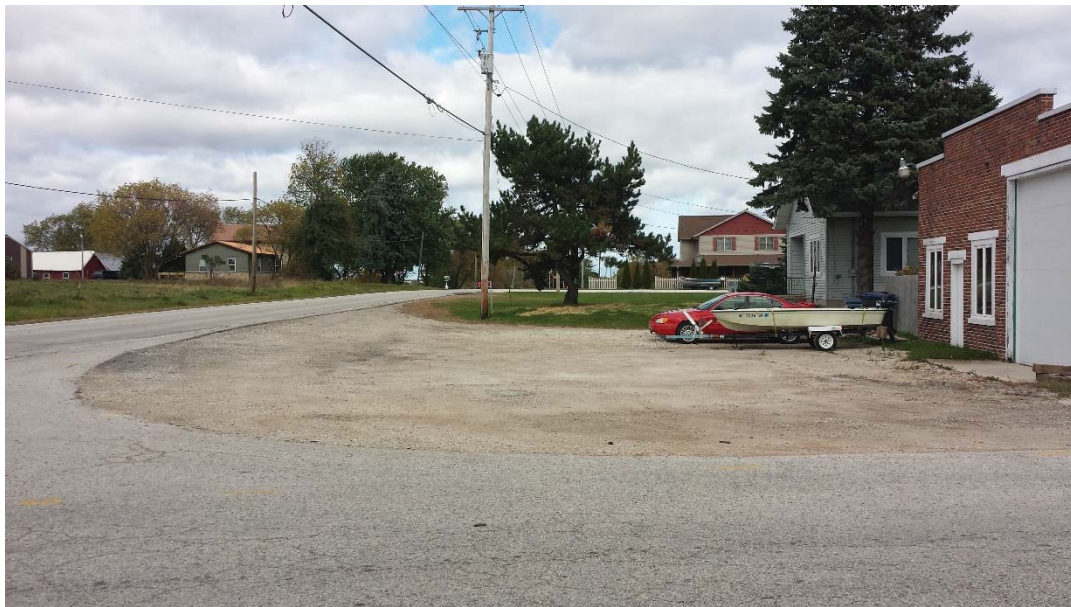
Close-Up Cap

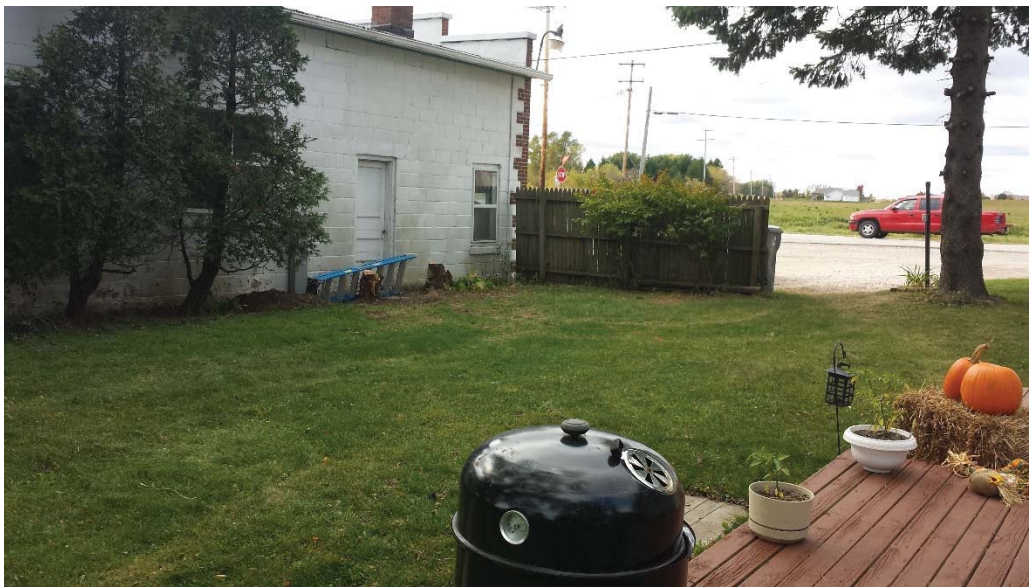
Grass Cap (TW-14) facing Southwest; Garage
