BRRTS #:	02-35-557756	CLOSURE DATE:	02/16/2016
ACTIVITY NAME:	Radlinger Property	FID #:	735037930
PROPERTY ADDRESS:	401 South Park Street, Merrill	DATCP #:	
MUNICIPALITY:	Merrill	PECFA#:	54452268001A
PARCEL ID #:	25131061320120

The Department of Natural Resources (DNR) considers the Radlinger Property closed, with continuing obligations. No further investigation or remediation is required at this time. However, you, future property owners, and occupants of the property must comply with the continuing obligations as explained in the conditions of closure in this letter. Please read over this letter closely to ensure that you comply with all conditions and other on-going requirements. Provide this letter and any attachments listed at the end of this letter to anyone who purchases, rents or leases this property from you

B.2b RESIDUAL SOIL CONTAMINATION RADLINGER PROPERTY

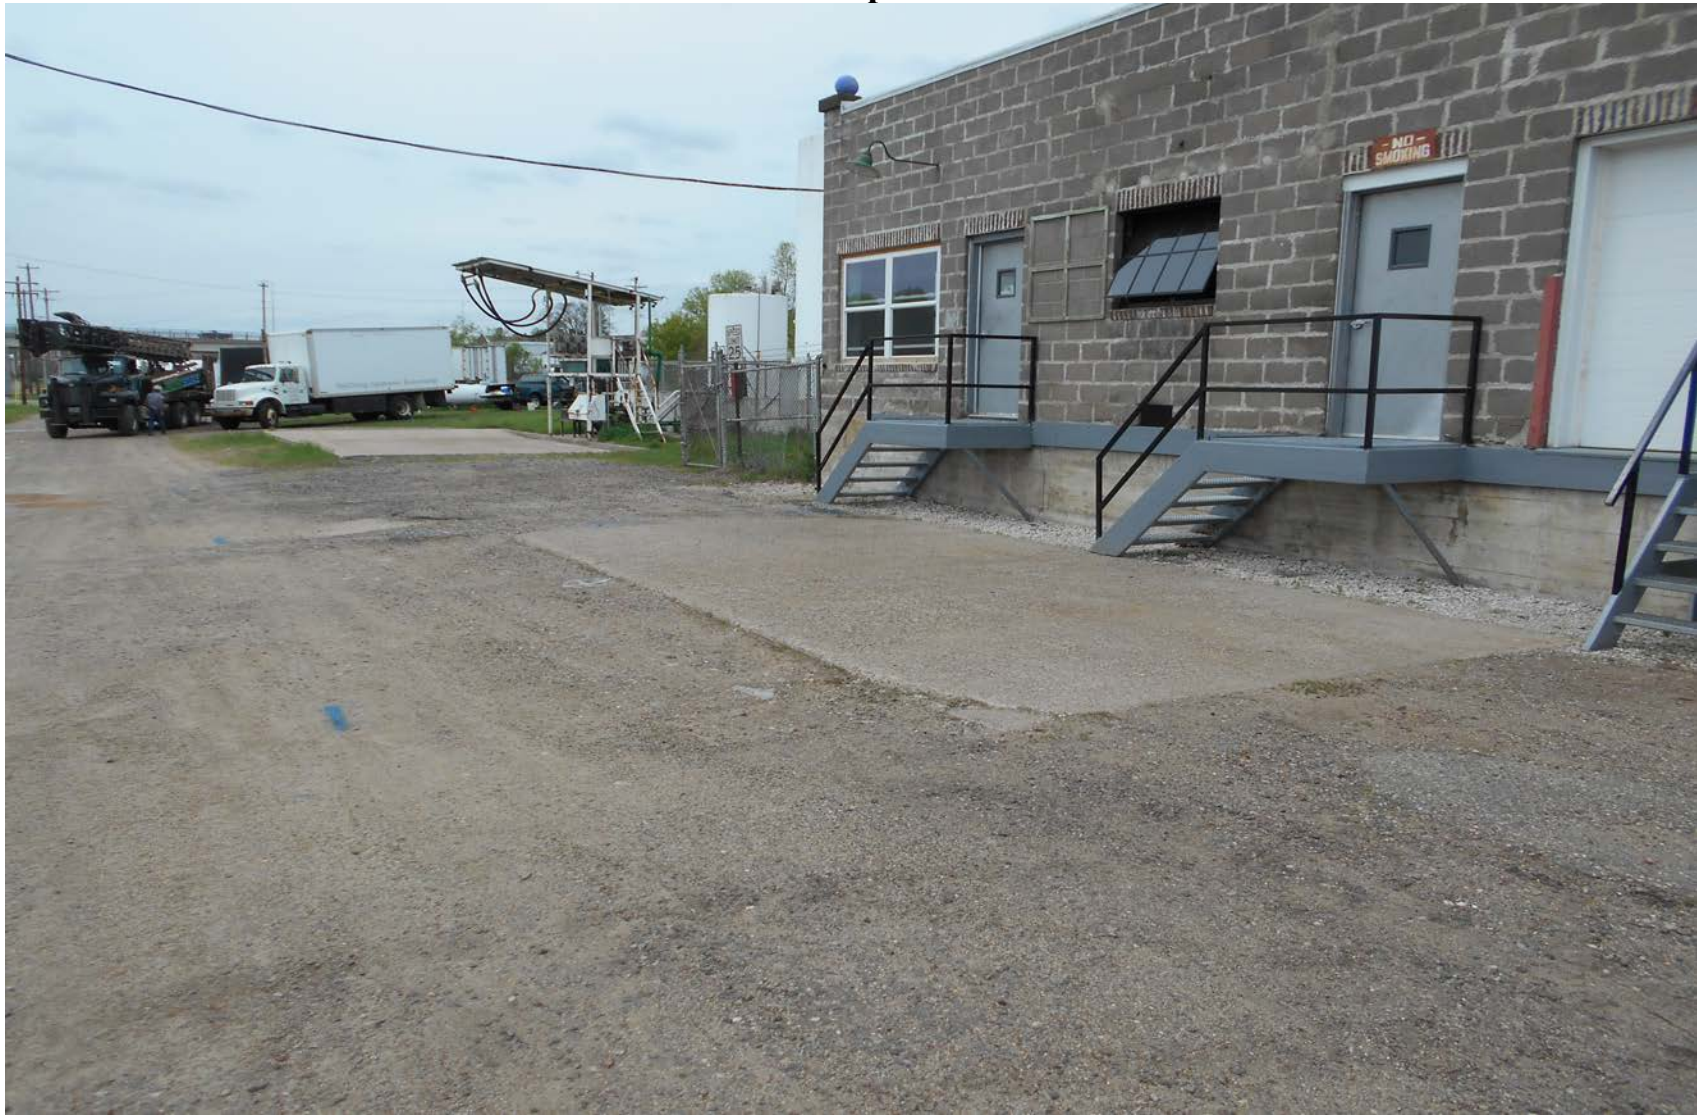
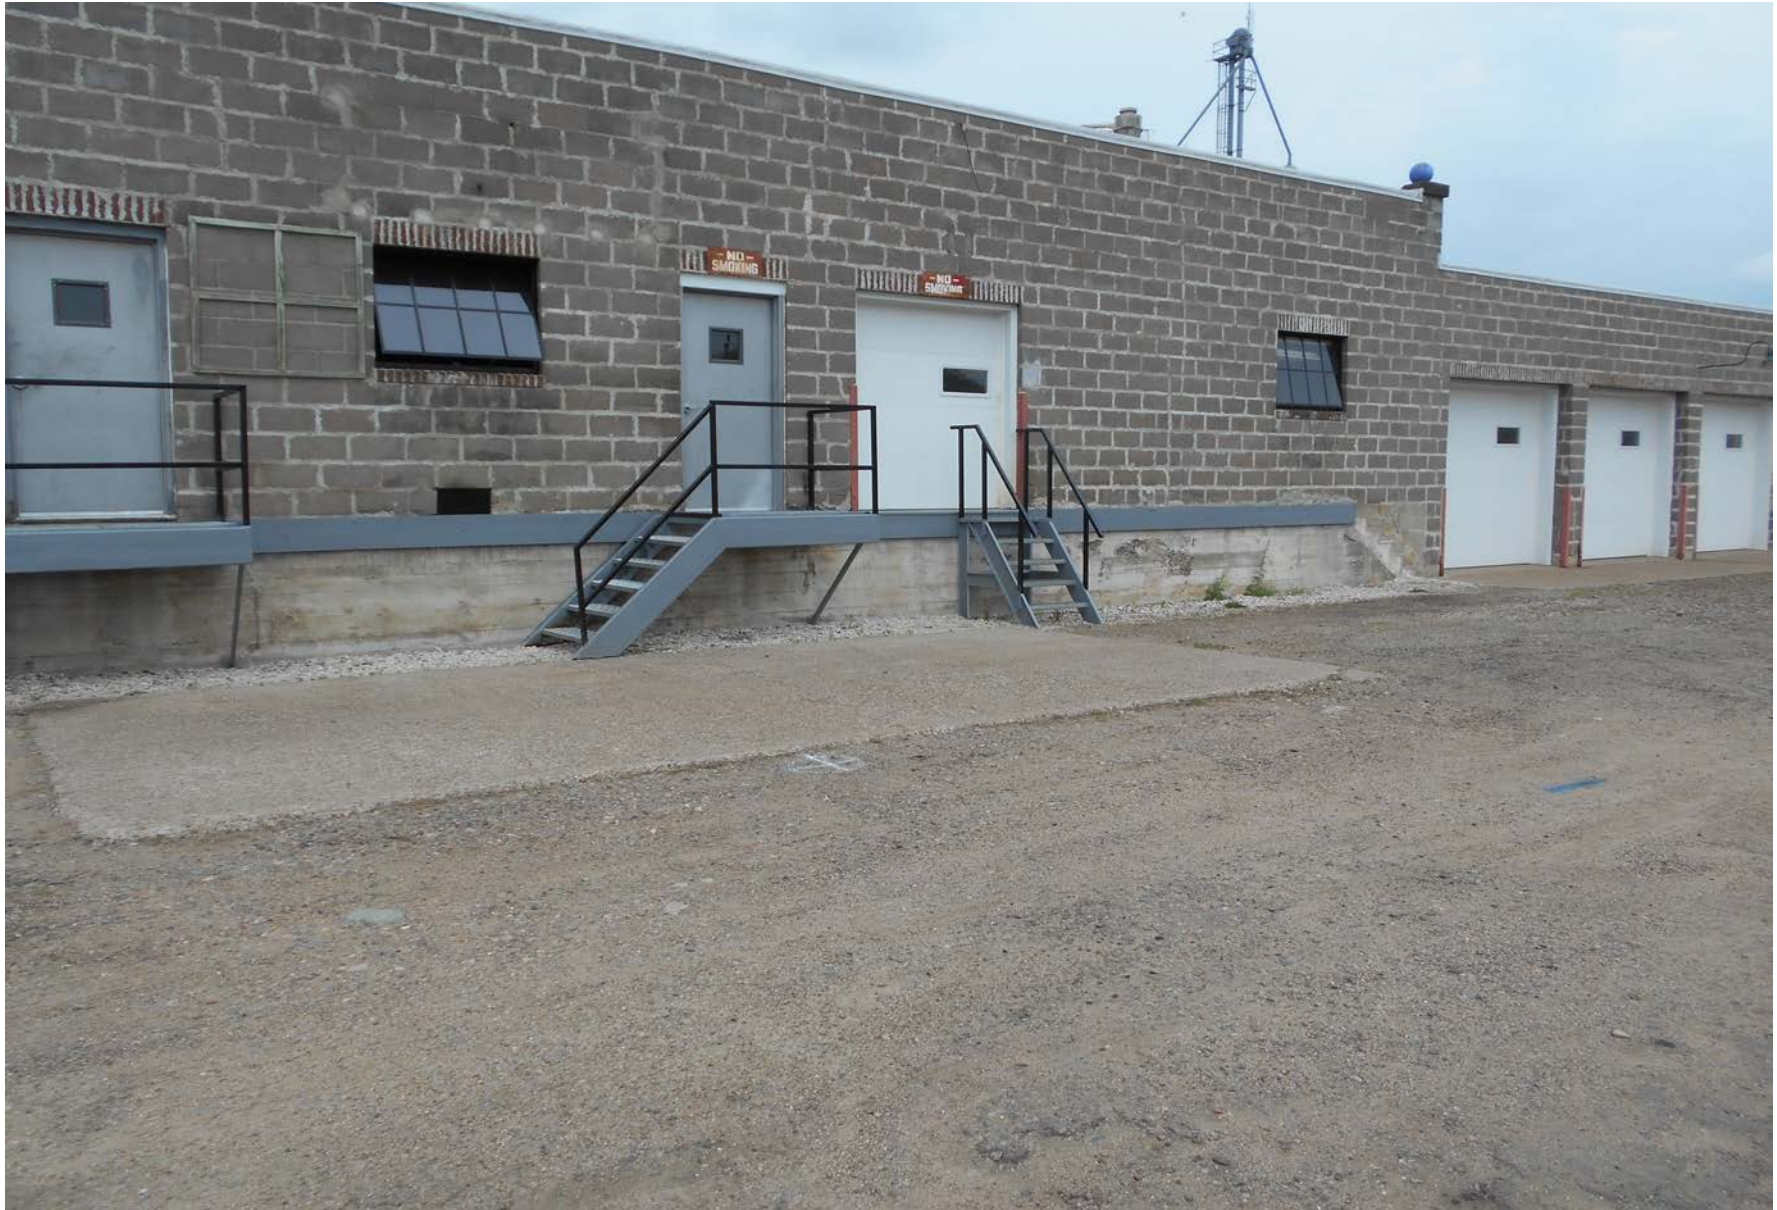
B.5 Structural Impediment Photo

B.5 Structural Impediment Photos – **The on-site building is considered a structural impediment that interfered with the investigation.**

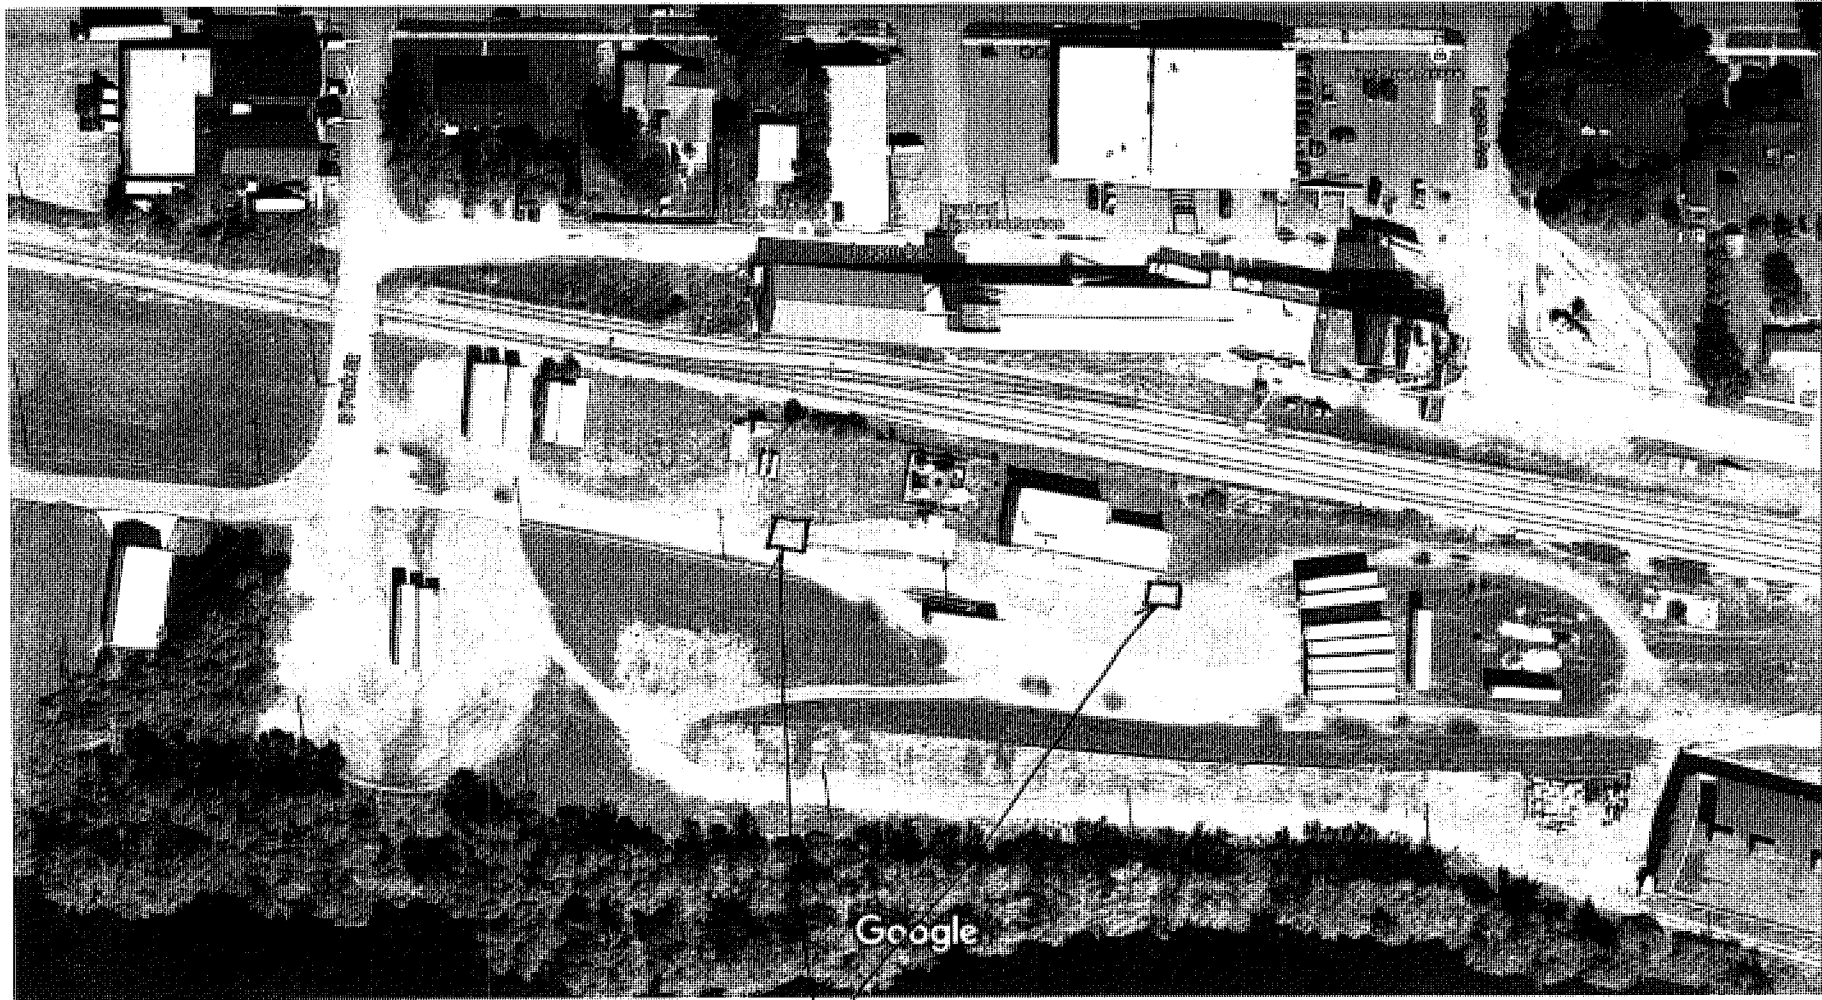
D.3 Photographs

Area of Cap to be maintained
