SUBJECT: Final Case Closure with Continuing Obligations  
Ahlgrimm Explosives Co Inc – Burn Pit,  
W9899 Givens Rd, TN of Hortonville, Outagamie County, WI  
DNR BRRTS Activity #: 02-45-558039

**DETAILED SITE MAP-2**

AHLGRIMM EXPLOSIVES  
W9899 GIVENS ROAD  
HORTONVILLE WISCONSIN

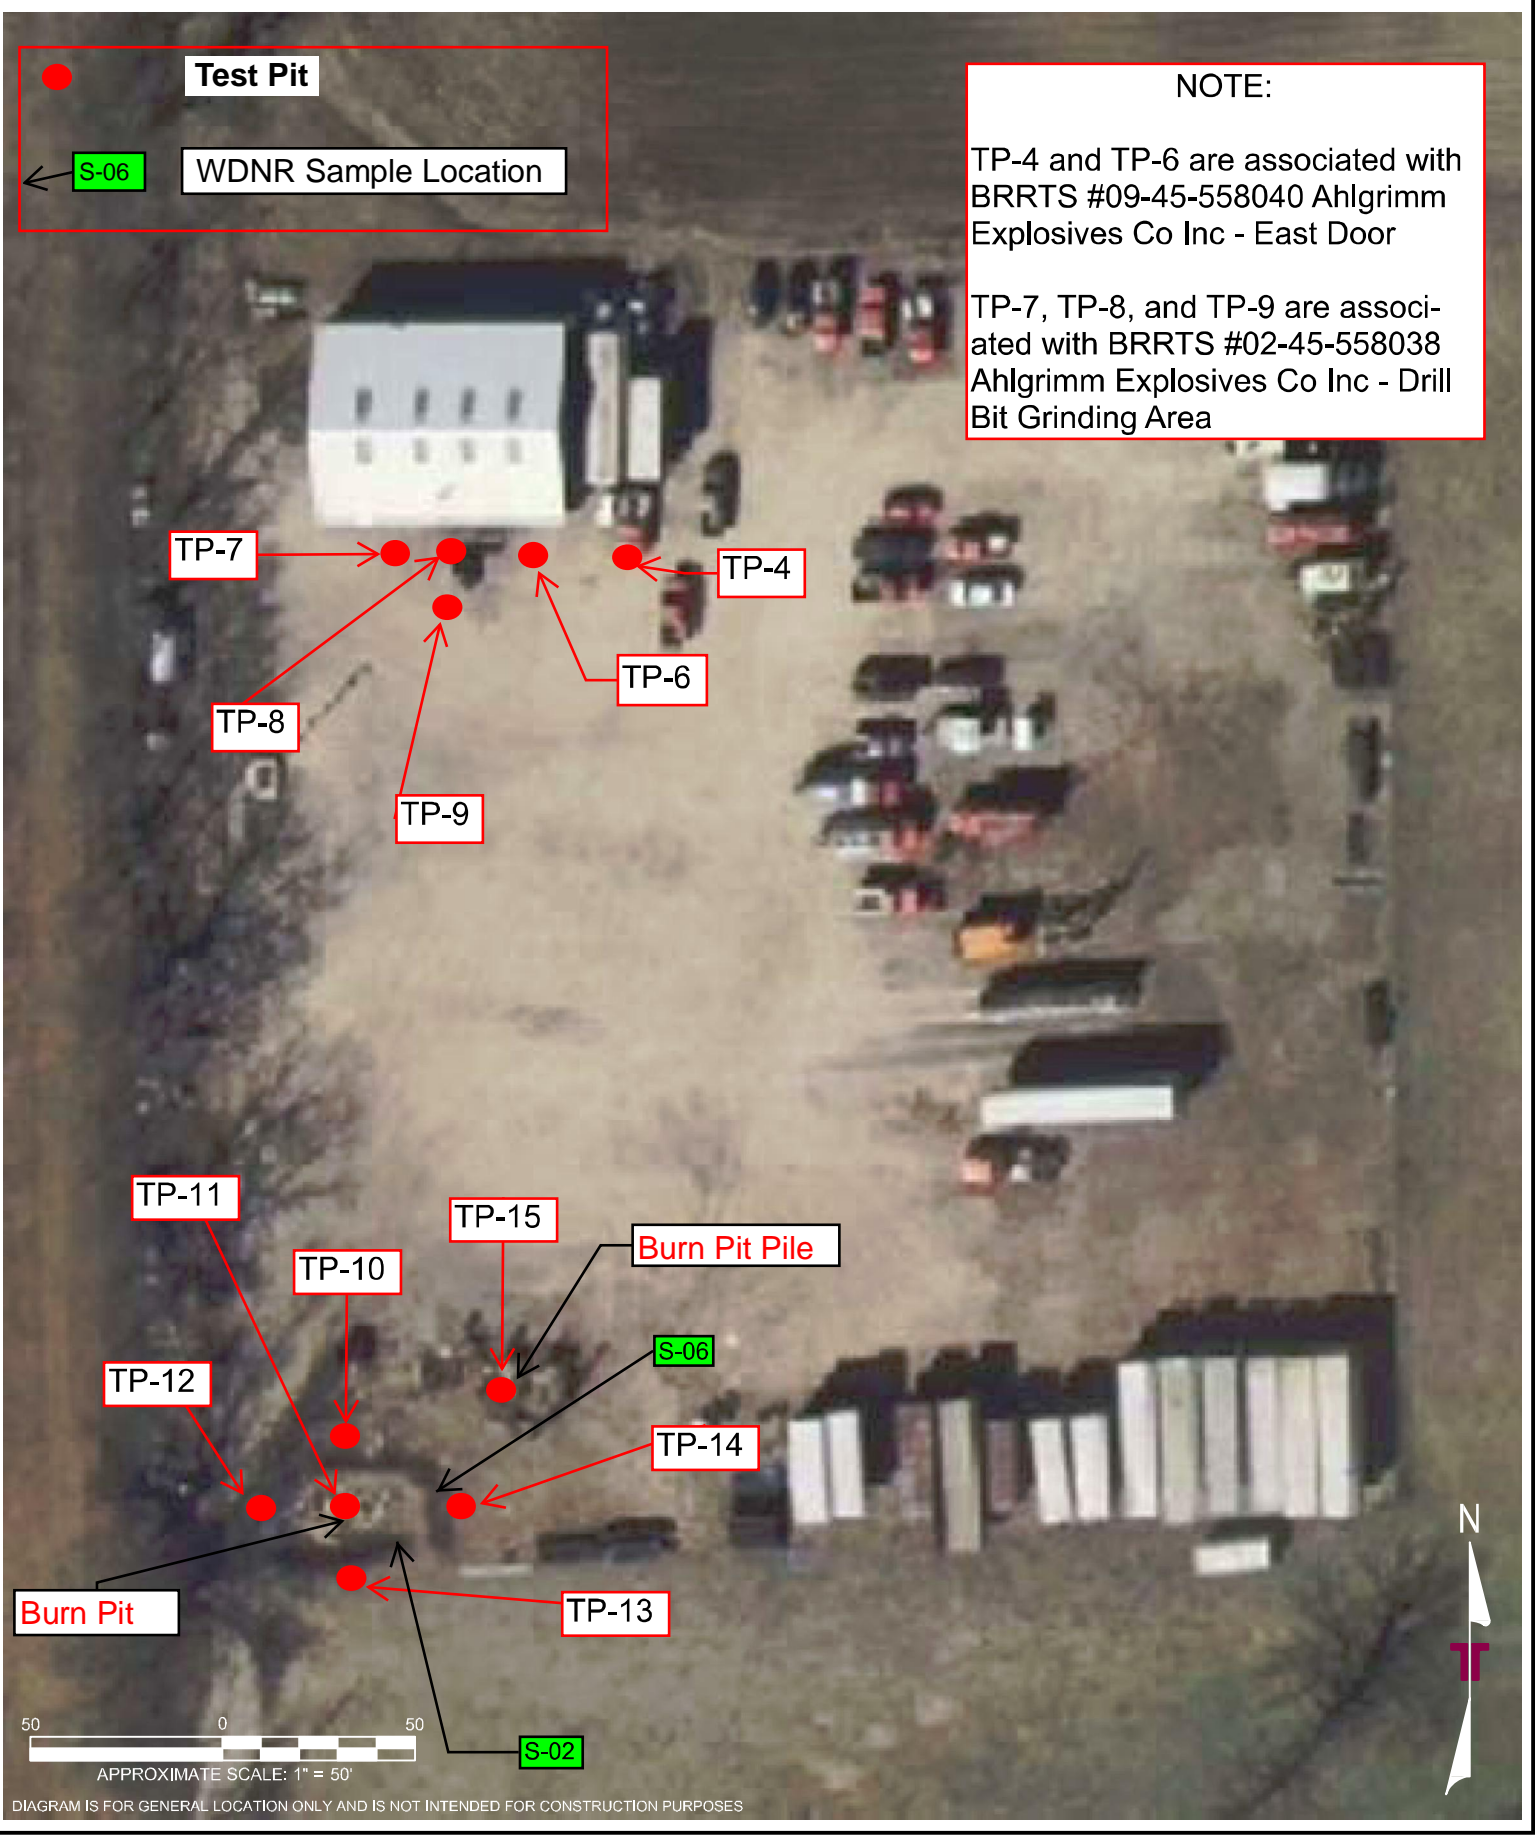
**B.1.b**

A small amount of soil contamination (copper) remains at test pit, TP-12, at one ft bgs but was not detected at 5.6 ft bgs. The location of TP-12 is shown on the attached map, *Fig. B.1.b., Detailed Site Map-2, Terracon, 3/26/12*. If soil in the specific location described above is excavated in the future, the property owner at the time of excavation must sample and analyze the excavated soil to determine if contamination remains. If sampling confirms that contamination is present, the property owner at the time of excavation will need to determine whether the material is considered solid or hazardous waste and ensure that any storage, treatment or disposal is in compliance with applicable standards and rules. Contaminated soil may be managed in accordance with ch. NR 718, Wis. Adm. Code, with prior DNR approval.

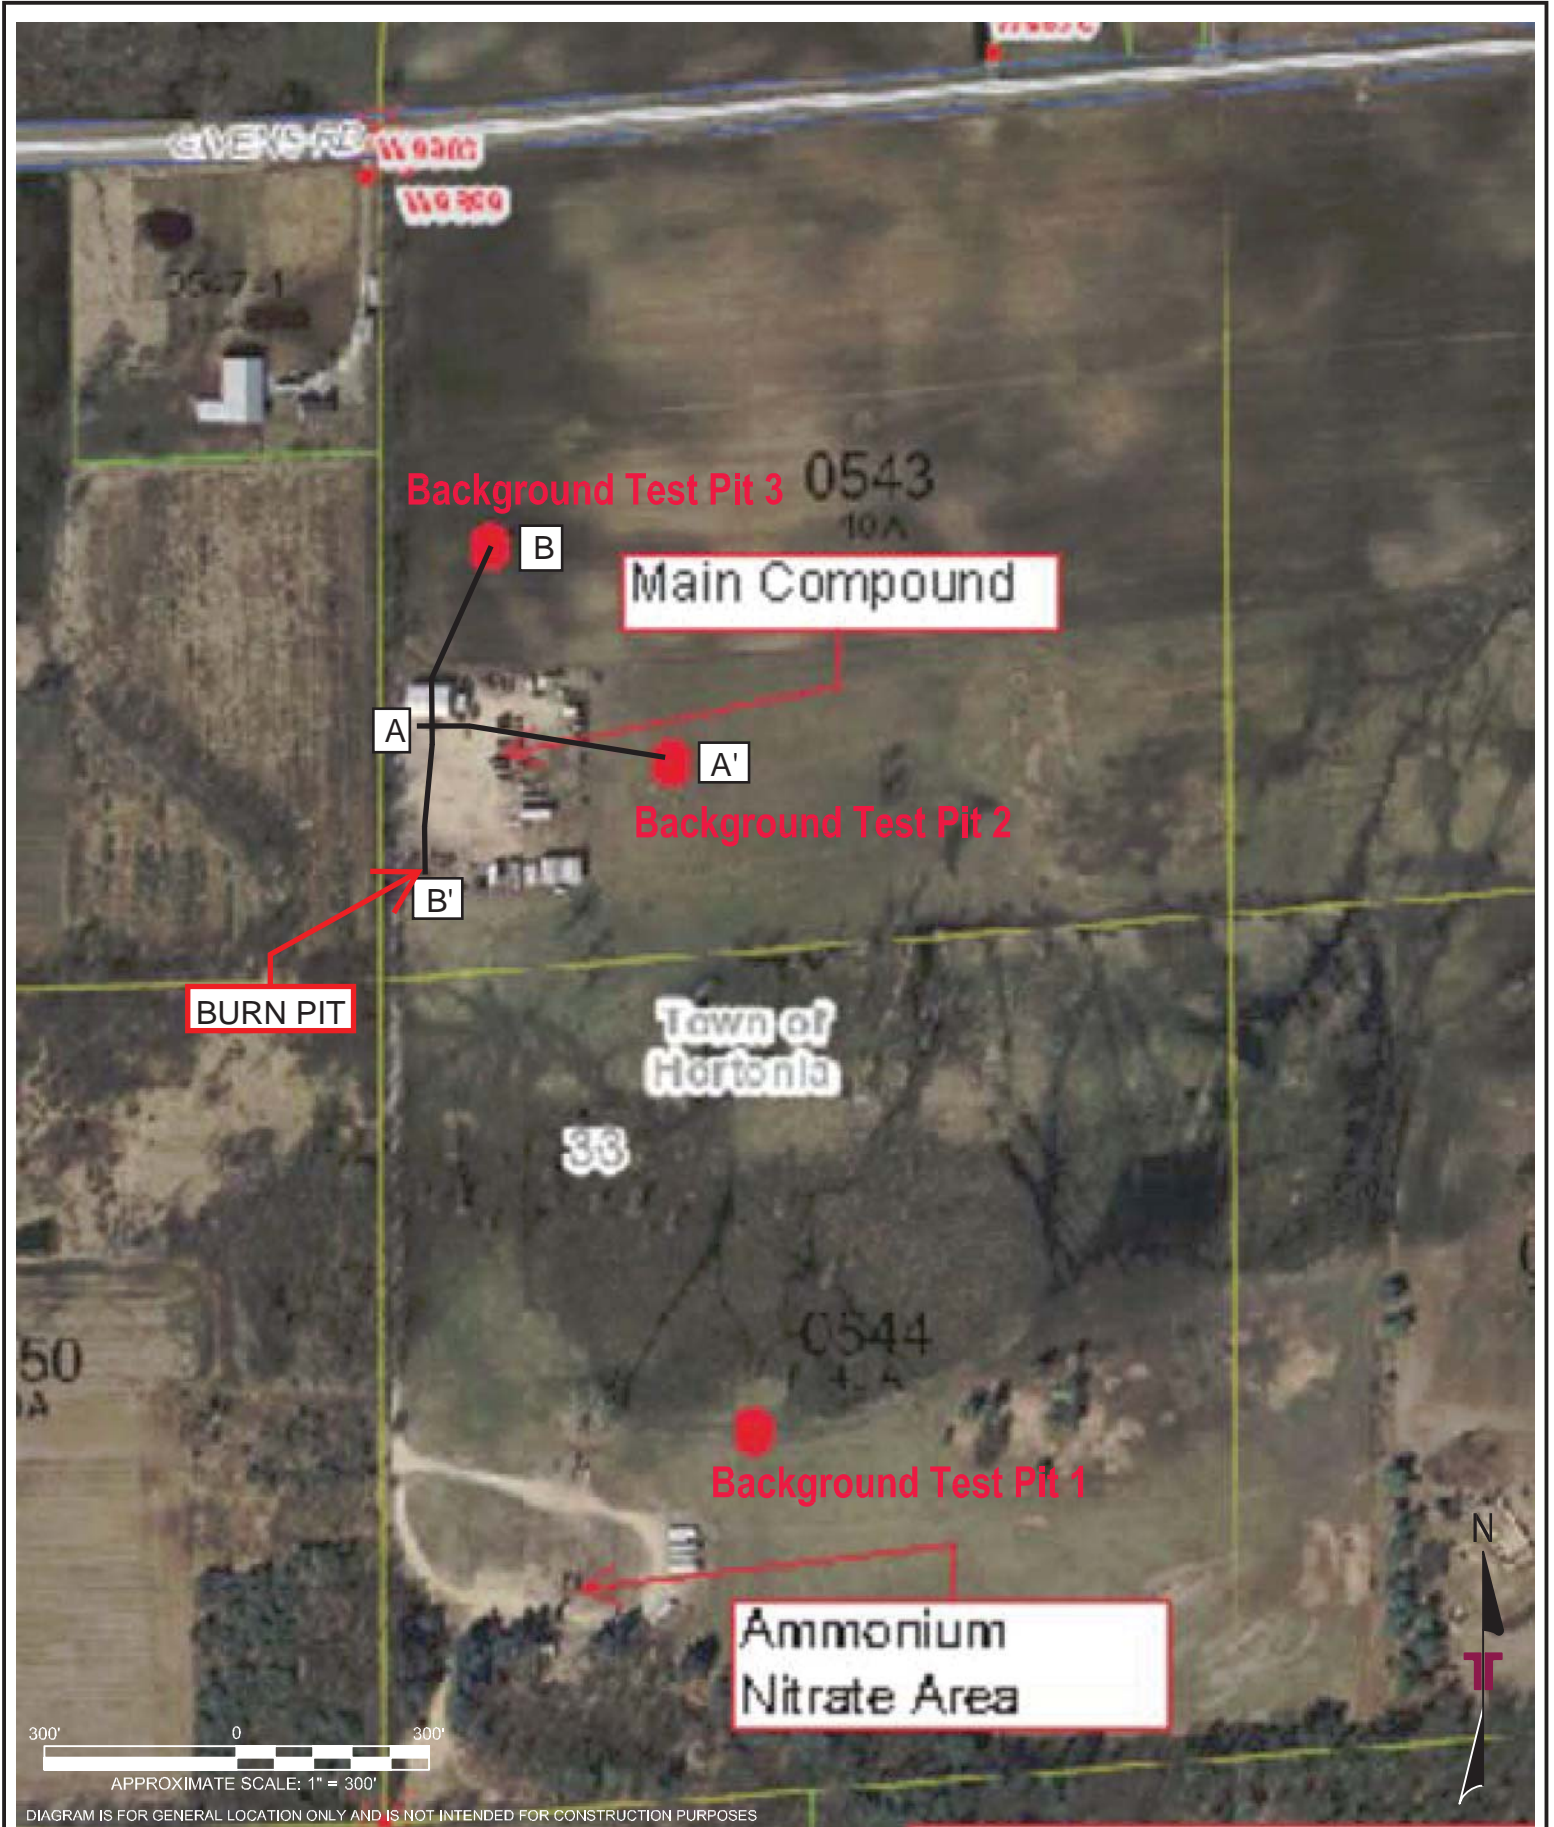
TP-4 and TP-6 are associated with BRRTS #09-45-558040 Ahlgrimm Explosives Co Inc - East Door

TP-7, TP-8, and TP-9 are associated with BRRTS #02-45-558038 Ahlgrimm Explosives Co Inc - Drill Bit Grinding Area
