Endpoint Solutions

Subject: **Preliminary Soil Sampling Results from Underground Pipe Release Area
U.S. Oil Milwaukee South Terminal
9135 North 107th Street – Milwaukee, Wisconsin**

The purpose of this letter report is to document the soil sampling activities performed at the U.S. Oil Milwaukee South Terminal (“Site”) in response to a release from an underground line near the manifold area in July 2011.

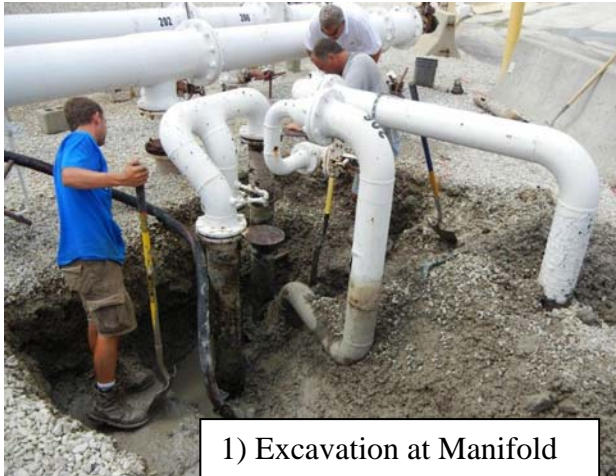
On the next page are pictures of 1) the excavation, 2) the opening in the 10-inch line (while uncapped), 3) the 1-inch line and 4) valve and the 4-inch vertical pipe – showing how it “sleeved” over the 1-inch line valve.

1) Excavation at Manifold

U.S. Venture has hired Endpoint Solutions to determine the extent of any contamination caused by the cracked pipe. Our plan is to excavate further around the manifold area to insure that no other buried fittings are compromised then have Endpoint sample the excavation base and sidewalls. If Endpoint's sampling shows the need, a full assessment of the manifold area will be performed.

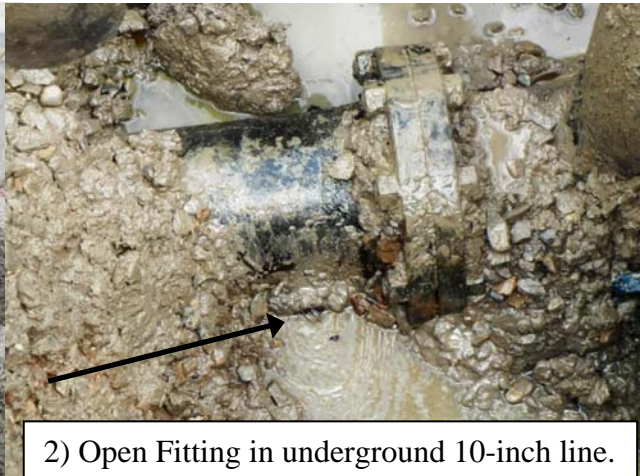
Terminal personnel took the following actions to determine if a leak existed. The suspected line was blanked off from the aboveground storage tank which feed the line and the line was drained. An excavator was brought in on June 22nd and a hole was dug around the 10-inch tank line. A small 1-inch line, coming off of the 10-inch line was found to be cracked. The 1-inch line and valve where removed and the opening into the 10-inch line was plugged.

2) Open Fitting in underground 10-inch line.

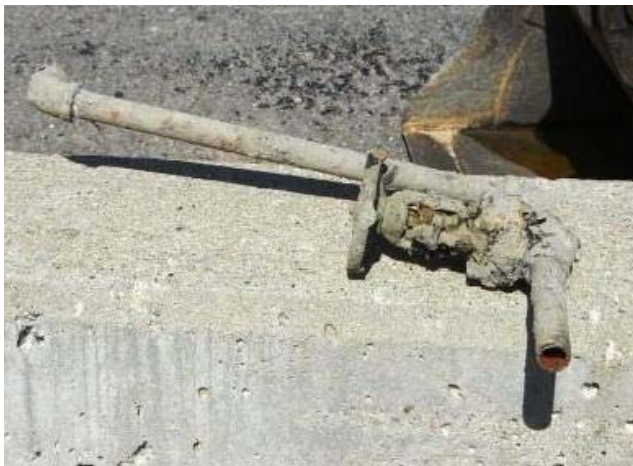
3) 1-inch pipe & valve that was connected to 10-inch line underground

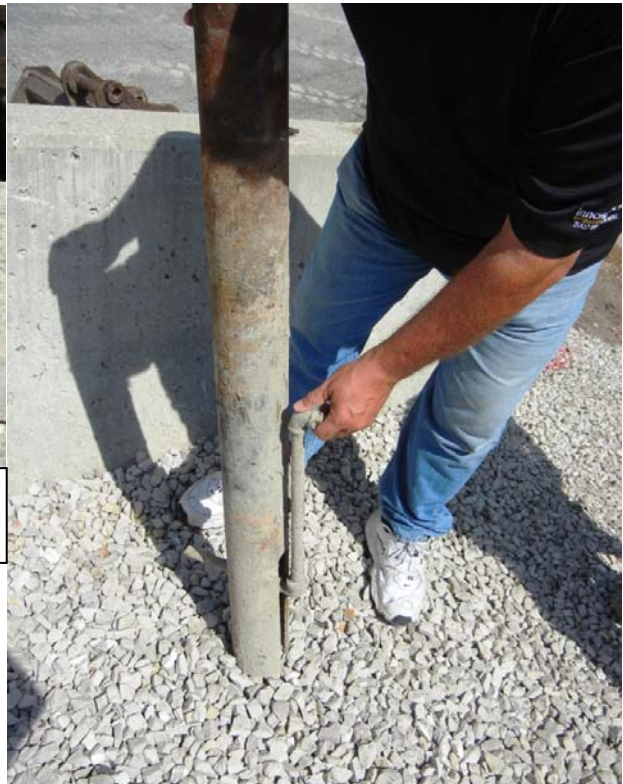
The purpose of this letter is to provide details of a lease of gasoline from an underground line at the U.S. Oil Milwaukee South Terminal. U.S. Oil suspected a problem when gasoline was found in a pipe near the manifold area at the terminal. A 4-inch diameter pipe, open at the surface, lead down vertically into the ground and provided access to a valve.

4) 4-inch pipe "sleeved" over 1-inch line valve.

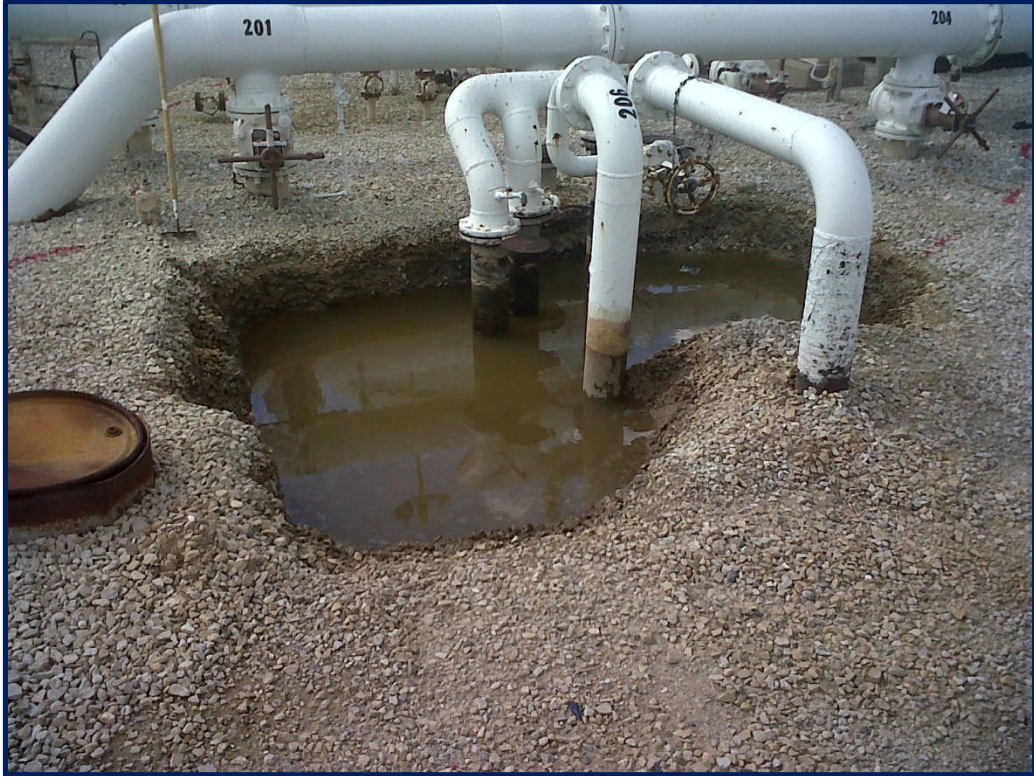
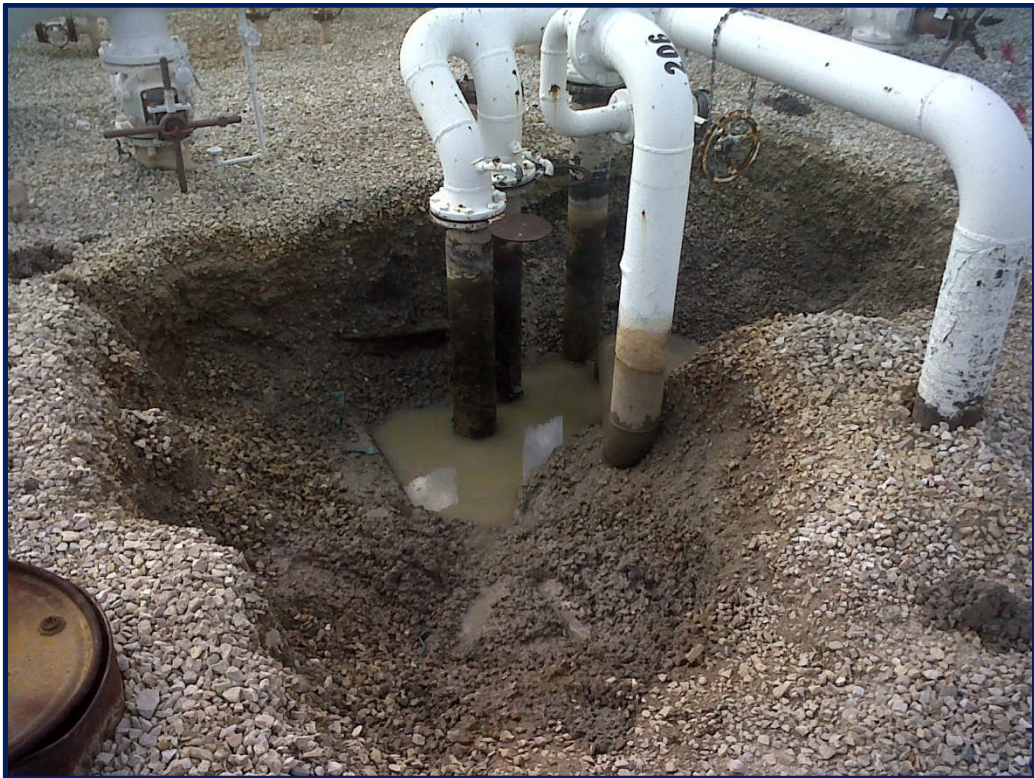
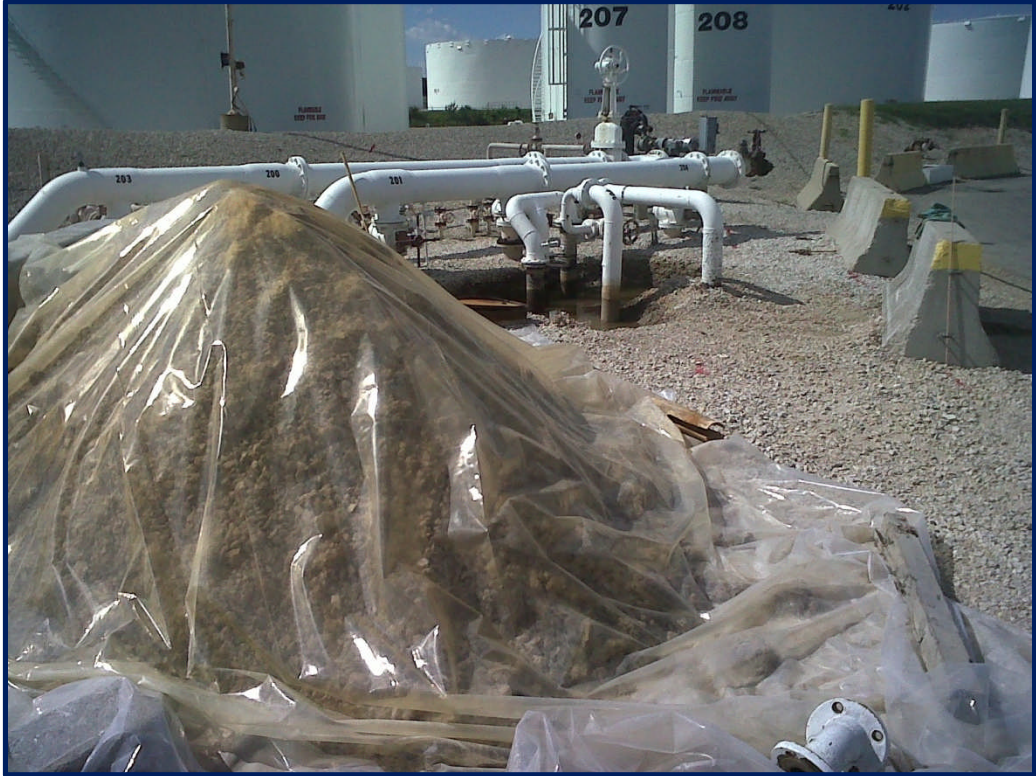
Site Photographs

U.S. Venture retained Endpoint to determine the extent of subsurface contamination caused by the pipe leak. On August 22, 2011, Endpoint collected six (6) soil samples from the walls and floor of the existing excavation in the manifold area (refer to *Site Photographs* in Exhibit C). Soil vapor readings and observations indicated that subsurface contamination was present and extended beyond the limits of the excavated area. To document soil conditions at the suspected source area and for waste characterization analysis (for disposal of excavated materials), one of the collected soil samples was submitted for analytical testing. The analytical test results of the soil samples collected are summarized on the next page. *Analytical Test Reports* are included in Exhibit D.

Field observations and analytical testing indicate that shallow subsurface petroleum contamination exceeding NR 720 Residual Contaminant Levels (RCLs) and NR 746 Direct Contact Concentrations is present in the vicinity of the piping manifold area at the Site. It is important to note that this area is within a previously documented impacted area, which was granted regulatory closure. Due to the presence of additional underground piping and other physical obstructions in the immediate area of the release, Endpoint recommends that no further excavation be performed until the extent of the subsurface contamination has been determined. Endpoint also recommends that the excavated area be backfilled.

Furthermore, we recommend that a limited subsurface investigation be conducted in the vicinity of the piping manifold area to determine the extent and nature of the subsurface impacts of this release. This investigation will consist of soil borings and the installation of groundwater monitoring wells. Following the completion of the proposed investigation, a remedial plan will be developed to address remaining subsurface contamination, if warranted or applicable.
