Technical Memorandum

To: Alex Smith, Enbridge Energy
From: Ryan Erickson
Subject: Superior Terminal Manifold 211 Maintenance Excavation Memo/
Tank 9 Release BRRTS File Addendum
Date: September 25, 2014
BRRTS Site #: 216558987 and 216552700
Barr Project #: 49161253.12

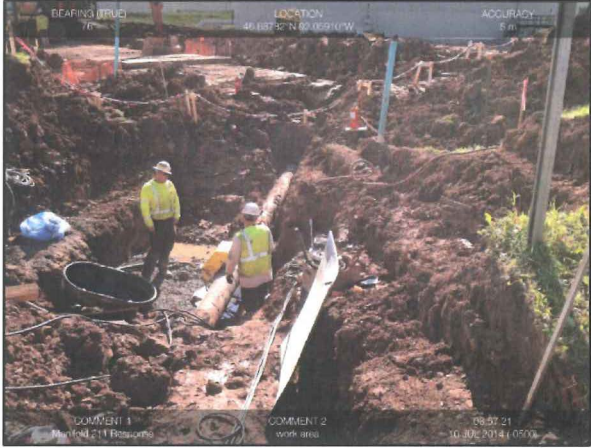
Photo 1

The final maintenance excavation was approximately 30 feet wide by 40 feet long and up to 8 feet deep (Photo 1; Figure 2; Attachment B). Excavated material consisted of fat clay and some sandy backfill material located around pipeline infrastructure. Crude oil impacted soil was identified on the eastern end of the excavation at approximately 3 to 4 feet below ground surface (bgs) near the location of the removed infrastructure, and the 2008 Tank 9 Pressure Relief Line Release (BRRTS# 216558987). The identified impacted soil had a headspace detection of up to 598.8 ppm, dark staining, a petroleum odor

Photo 1: Manifold 211 maintenance excavation. Photo taken facing east on July 10, 2014.

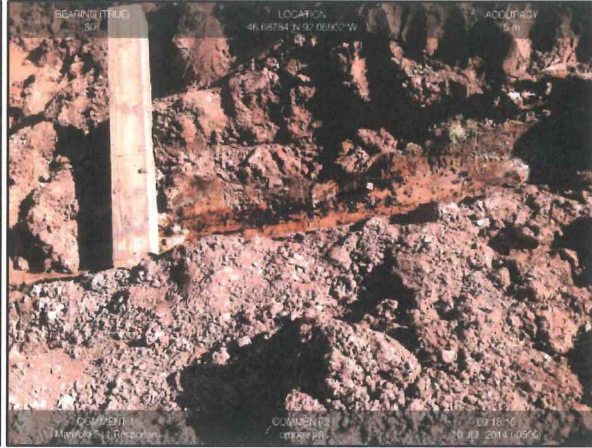
Photo 2

and residual free product (Photo 2). Additional excavation of the contaminated material was limited by the presence of station infrastructure. Analytical sample *Manifold 211-S-01* was collected from where the contaminated soil that was left in place and *Manifold 211-B-01* was collected from a deeper location to identify whether contaminants were present at depth.

Photo 2: A small volume of free-product observed in the Manifold 211 maintenance excavation. Photo taken on July 10, 2014.

Additional excavation of the soil with elevated headspace readings encountered in the zero to four foot bgs direct contact zone was not possible due to the presence of the pipeline infrastructure. Following the completion of the maintenance activity, the excavations were backfilled with clean fill and no crude oil impacted soil is exposed at the ground surface (Photo 3).

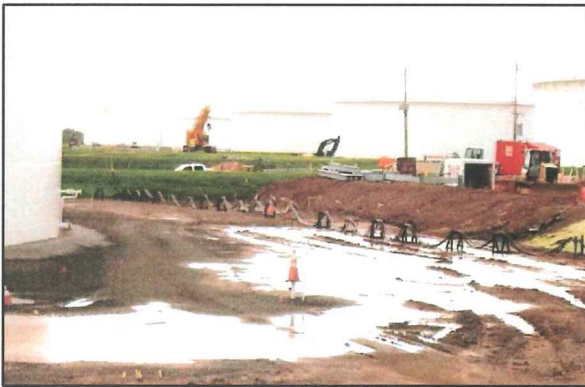
The excavation was backfilled and the berm was restored with clean fill material after maintenance activities were completed (Photo 3).

Photo 3: Restored Manifold 211 maintenance excavation site (center right side of photo). Tank 9 is shown on the left side of the photo. Photo taken facing west on September 2, 2014.

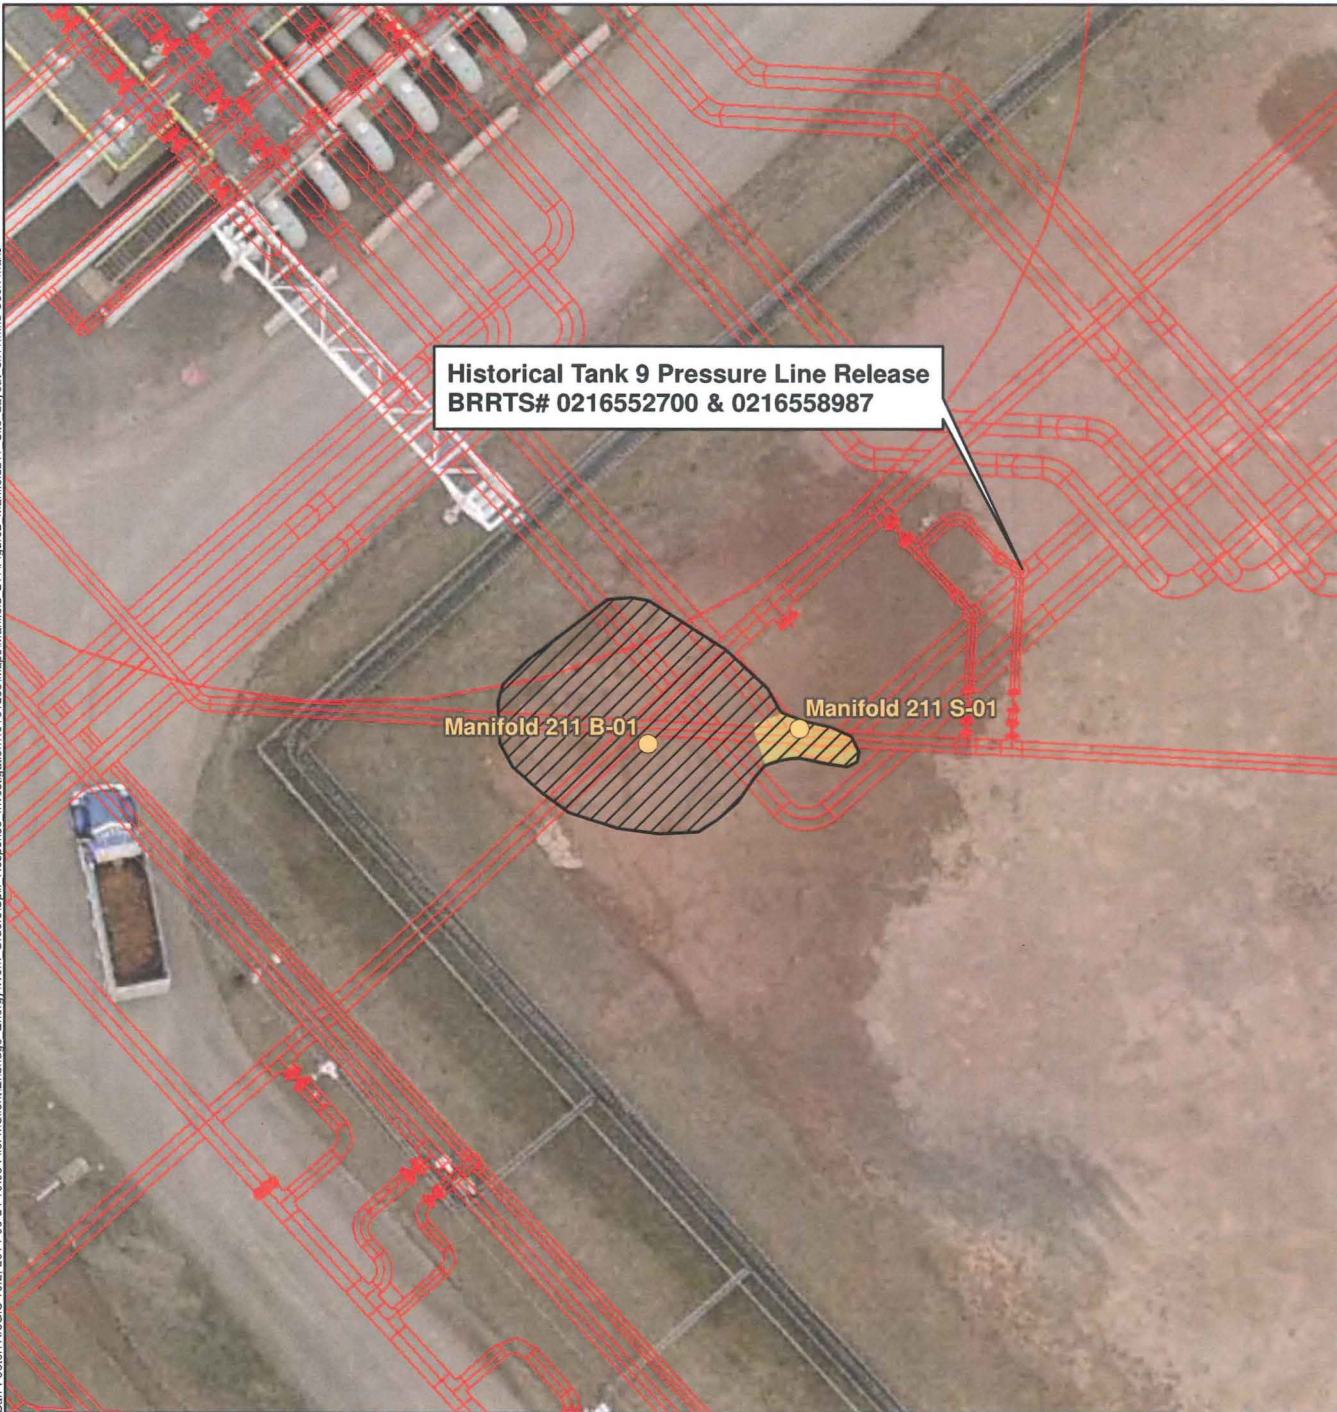
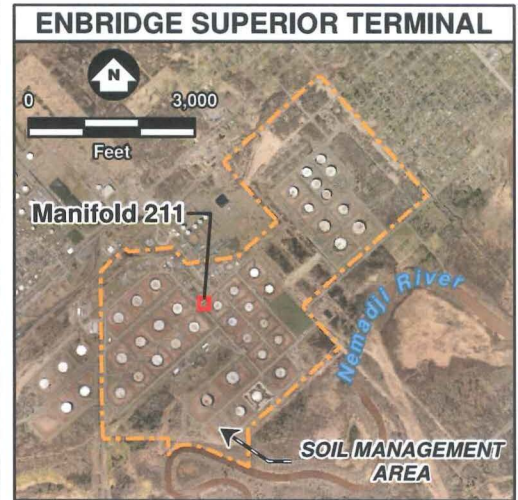
Figure 2

- Excavation Soil Sample Locations
- ▨ Excavation Extent
- Pipeline Infrastructure
- Crude Oil Impacted Soil
- - - Terminal Property Boundary

**SITE LAYOUT
MANIFOLD 211 RESPONSE
SUPERIOR TERMINAL**
Enbridge Energy, L.P.
Superior, Wisconsin

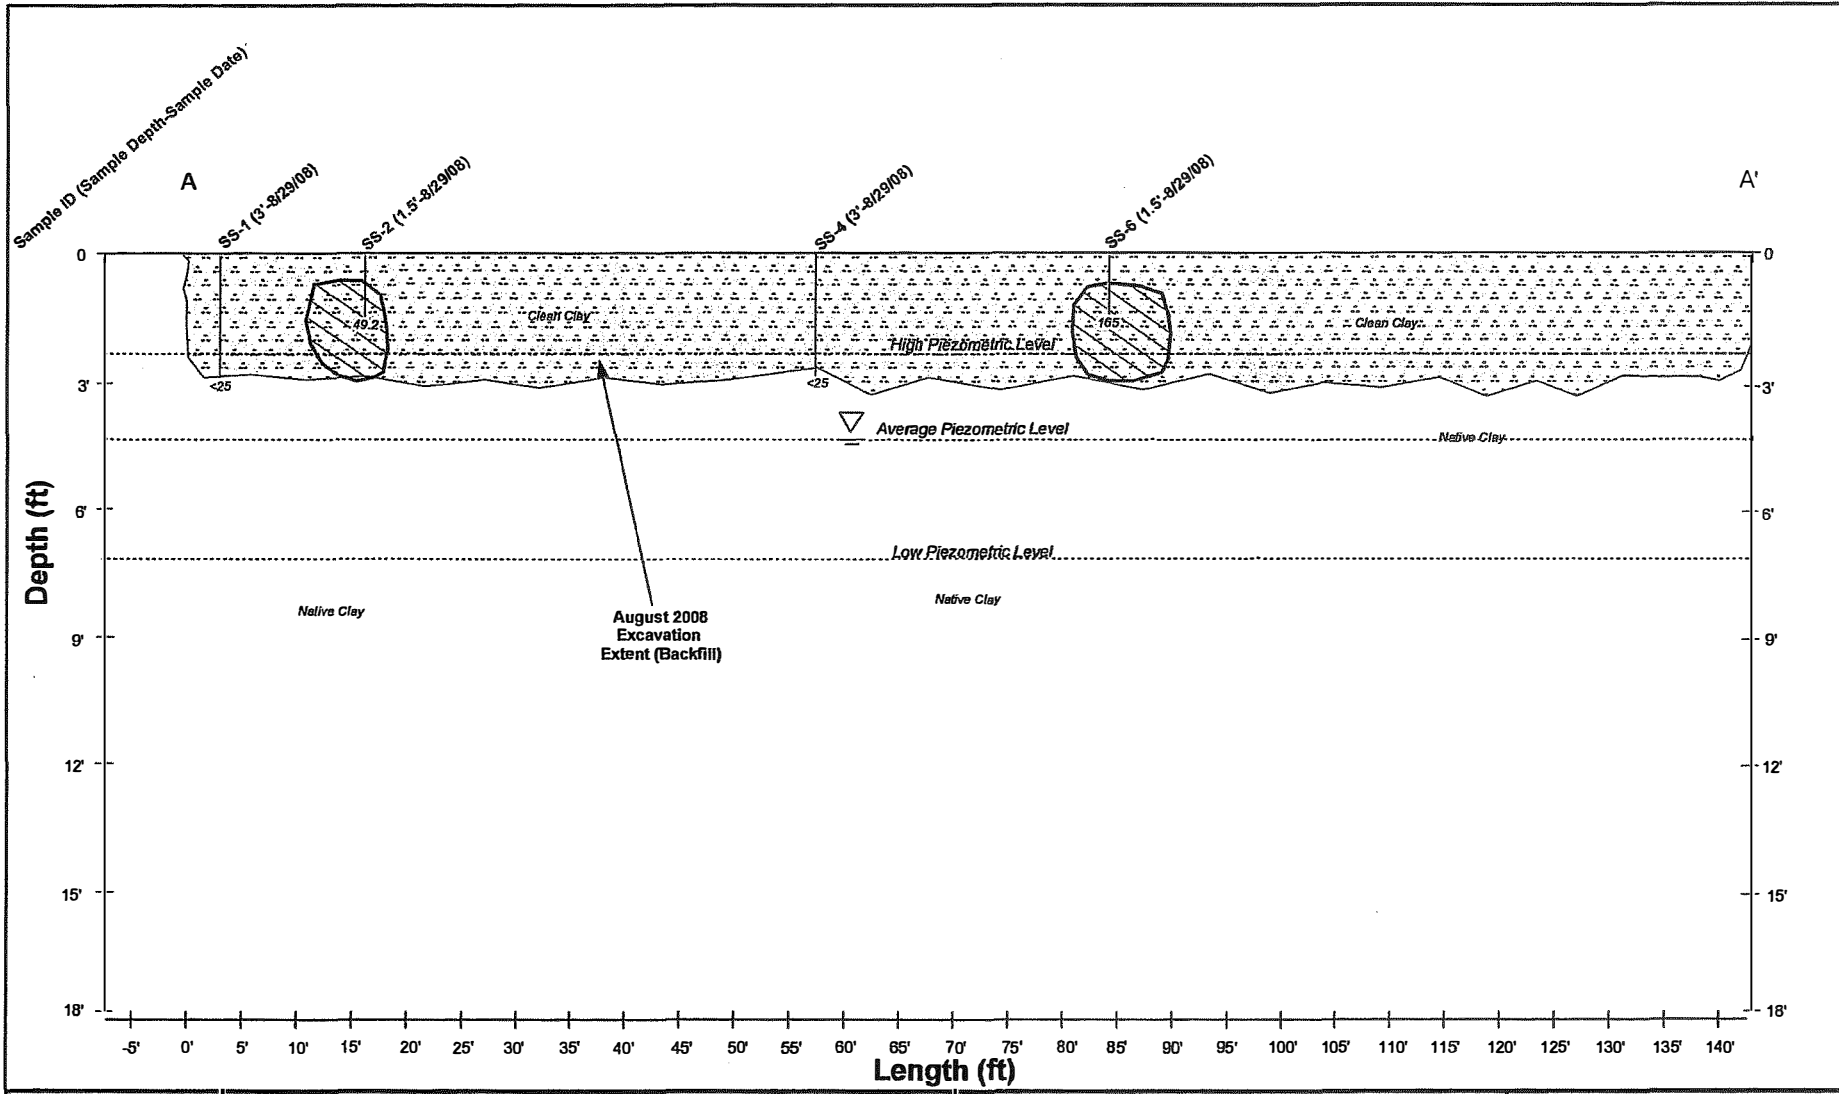
Enbridge Energy, Limited Partnership
Tank 9 Relief Line
Figure 4: Geologic Cross-Section A - A' Map

Legend	
150	Soil Sample Depth & Benzene Content (ppb)
	Approximate Water Table Elevation
	2008 Excavation Extent
	NR 720 Exceeding Soil
