Technical Memorandum

To: Nick Larabel, Enbridge Energy
From: Ryan Erickson
Subject: Enbridge Terminal – Manifold 213 Response
WDNR BRRTS #'s: 0216577298 (Manifold Corridor); 1616560657 (Terminal Facility-wide)
Site Coordinates: 46.68829°, -92.06004° (NAD83)
Barr Project: 49161092.11 003 103
Date: September 19, 2023

This memorandum summarizes the environmental response activities performed by Barr Engineering (Barr) at the request of Enbridge Energy (Enbridge) following the discovery of historical petroleum impacts in the Manifold 213 project excavation at the Enbridge Superior Terminal (Terminal) in Superior, Wisconsin (Figure 1) in July 2023.

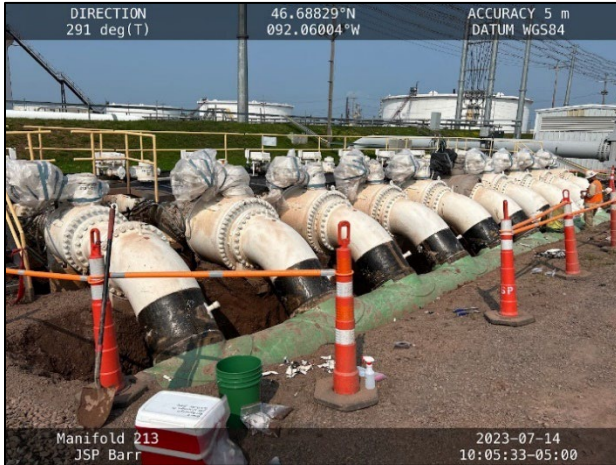
Photo 1

On July 14, 2023, Barr was on site to assess conditions in the project excavation (Photos 1 and 2; Figure 2) and collect waste characterization samples.

Barr collected eighteen field screening soil samples from the excavation sidewalls and bottom (Photos 1 and 2; Attachment B). The soil samples were tested for the presence of organic vapors using a 10.6eV photoionization detector (PID) and inspected for the presence of other potential indicators of petroleum impacts such as odor, discoloration and sheen. Field screening results are summarized below:

Photo 1: Manifold 213 excavation. Photo taken facing west on July 14, 2023.

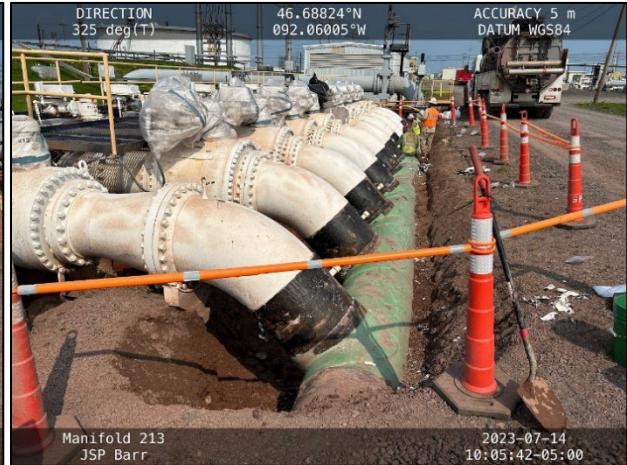
Photo 2

Photo 2: Manifold 213 excavation. Photo taken facing northwest on July 14, 2023.

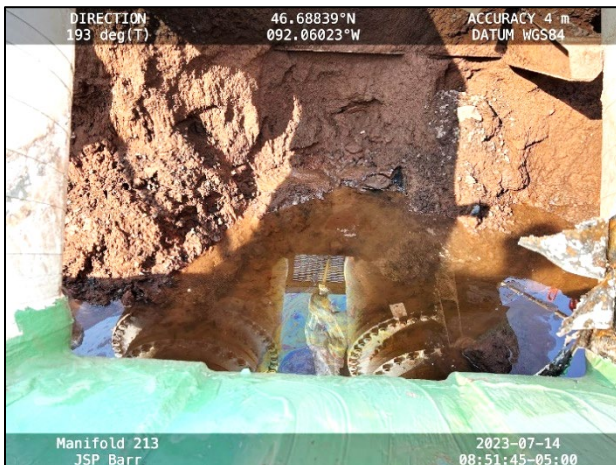
Photo 3

amounts of groundwater were observed in the excavation at approximately 3 feet below ground surface (bgs; Photo 3) and were removed with the soil during hydrovac excavation activities.

- No evidence of petroleum impacted soil (odor, sheen, headspace > 10 parts per million (ppm)) was identified in the northwest half of the excavation.
- Soil with petroleum impacts, as described below, was identified in the southeast half of the excavation. Residual impacts were mostly present below 1.5 feet bgs, near the buried pipeline.
- Four of eighteen field screening samples collected from the final southeastern excavation extents had headspace readings above 10 ppm (B-3 @ 3ft bgs = 12.8ppm; S-9 @ 1.5ft bgs = 10.6ppm; S-10 @ 1.5ft bgs = 127.1ppm; S-11 @ 2.5ft bgs = 360.4ppm) and a petroleum odor and sheen was identified in three of the samples.
- A petroleum sheen was also observed on excavation water (Photos 3 and 4) in the southeastern end of the excavation.

Photo 3: Petroleum sheen on excavation water in Manifold 213 excavation. Photo taken on July 14, 2023.

Upon completion of the project activities, the excavation was backfilled with clean fill.

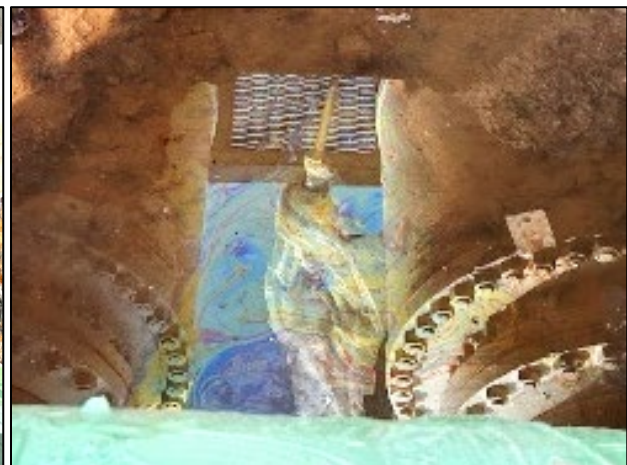
Photo 4

Photo 4: Close-up photo of petroleum sheen on excavation water in Manifold 213 excavation. Photo taken on July 14, 2023.

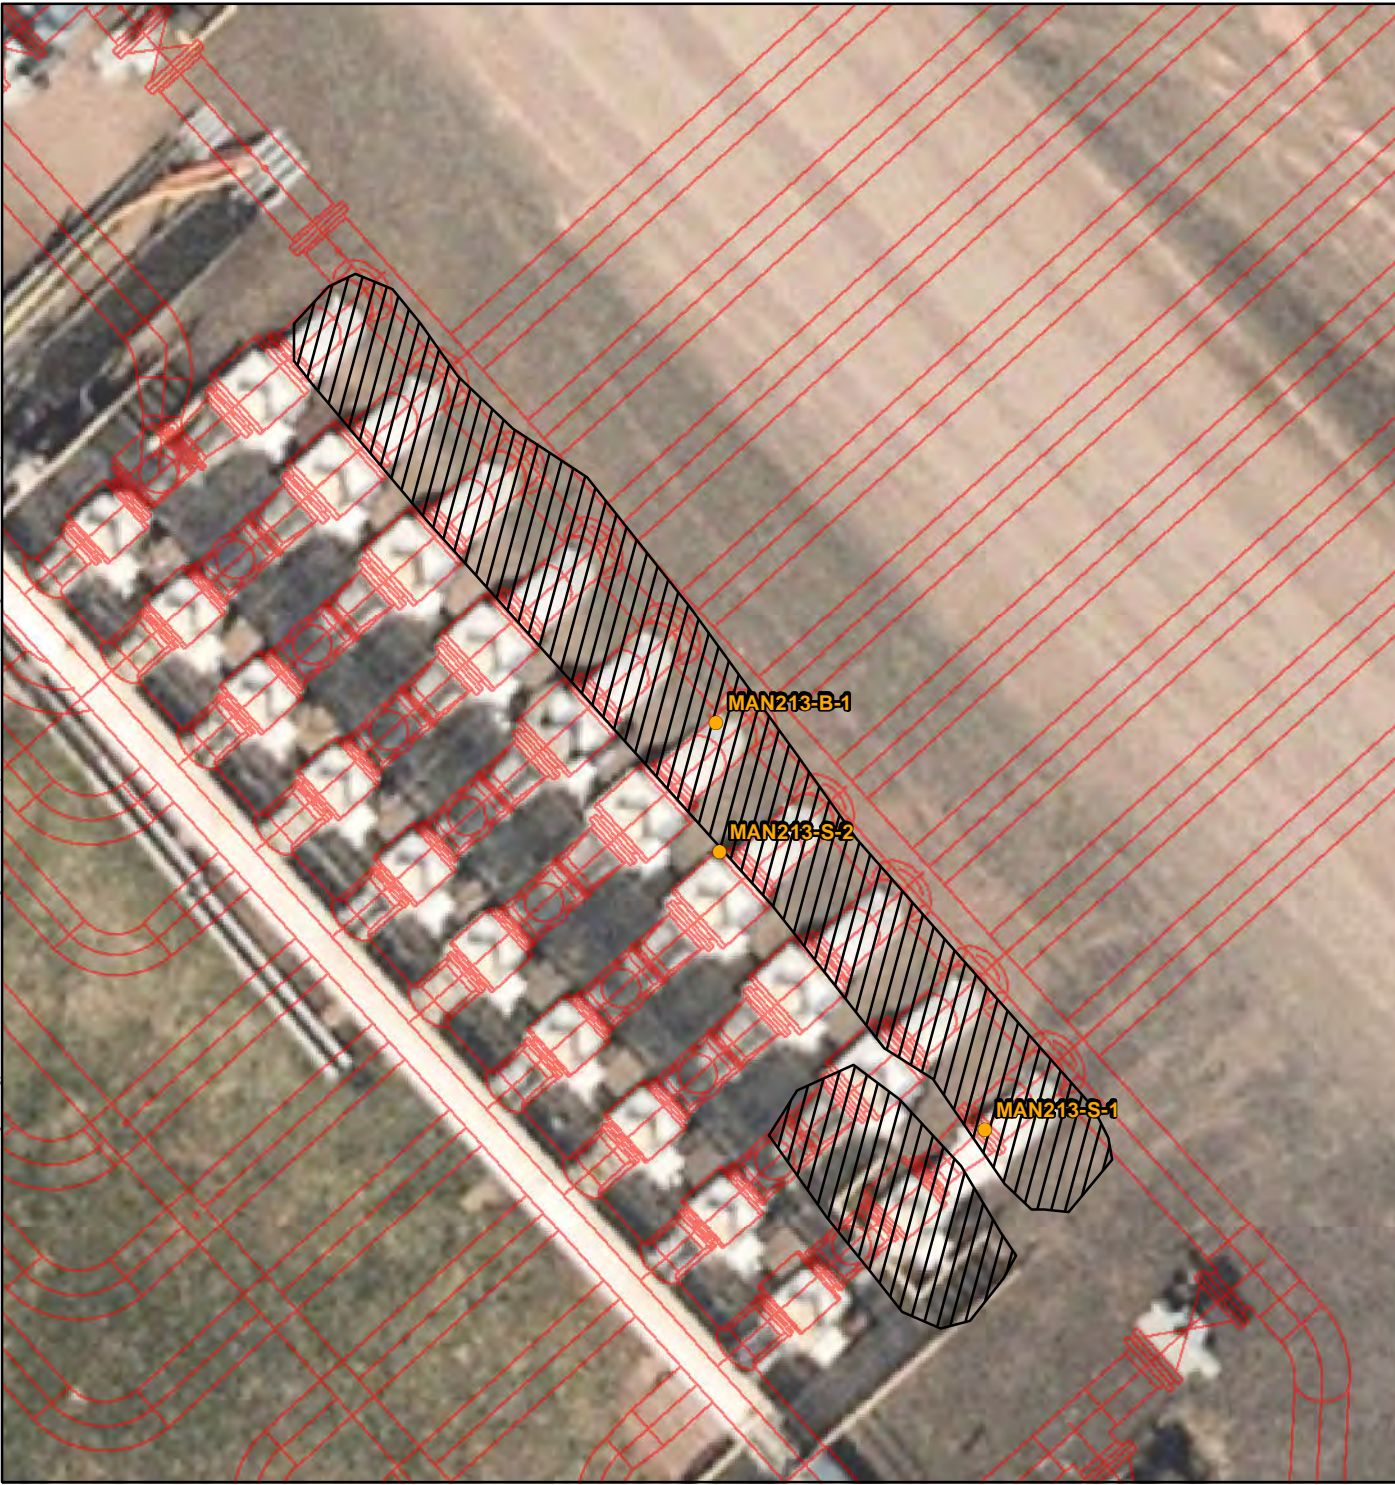
Figure 2
SITE LAYOUT
MANIFOLD 213 EXCAVATION
SUPERIOR TERMINAL
 Enbridge Energy, L.P.
 Superior, Wisconsin

Barr field screened and sampled the excavation sidewalls to document environmental conditions per the WDNR-approved *Site Investigation and Response Action Plan* (SI/RAP; 2014). The final excavation was approximately 60 feet long (northwest to southeast) by up to 20 feet wide (northeast to southwest) by up to 3 feet deep. Soil consisted mostly of clay with sand fill around some buried infrastructure. Limited

Analytical soil confirmation samples *MAN213-B-1*, *MAN213-S-1*, and *MAN213-S-2* were collected from the southern half of the excavation where impacted soil had been identified during excavation and/or in the final excavation extent coinciding the highest headspace readings (Figure 2; Attachment B). The samples were submitted to Pace Analytical Services in Duluth, MN for analysis of petroleum volatile organic compounds (PVOCs) and naphthalene. The analyte concentrations were below the laboratory method detection limits and/or the WDNR Industrial Groundwater Residual Contaminant Level (RCL) and Direct Contact RCL concentrations with the exception of *MAN213-S-1*, where a naphthalene (0.739 mg/kg) detection exceeded the Groundwater RCL (0.6582 mg/kg) but not the Direct Contact RCL (24.1 mg/kg). The sample results are summarized in Table 1 and the laboratory report is provided in Attachment C.

- Sample Locations
- ▨ Excavation Extent
- ▭ Facility-Wide BRRTS# 0216558988 - Manifold Corridor
- Pipeline Infrastructure
- - - Terminal Property Boundary
