Enbridge Historical Release Technical Memorandum Addendum

To: Alex Smith, Enbridge Energy
From: Ryan Erickson
Subject: Superior Terminal Contamination: *Line 6* Historical Impacts
Date: May 24, 2017
Barr Project #: 49161092

Updated Project Info: Line 6 Trap Excavation			
Project Name and Description	<p>Between February and April of 2017, excavation activities associated with Line 6 pipeline trap tie-in work were completed at the Enbridge Superior Terminal (Figures 1 and 2; Attachment B). Evidence of petroleum contamination (hydrocarbon odor, rainbow sheen, trace product) was periodically identified during the excavation work. Enbridge assessed the exposed pipeline infrastructure and did not identify an active release; therefore it was inferred to be historical contamination based on the field observations and the sites proximity to historical soil contamination encountered in 2012.</p> <p>This Technical Memorandum Addendum provides documentation of the Line 6 Trap environmental response activities and is being submitted as an addendum to the 2012 <i>Line 6</i> BRRTS site report.</p>		
SERTS / BRRTS # <i>(if applicable)</i>	No new number has been issued for the site.

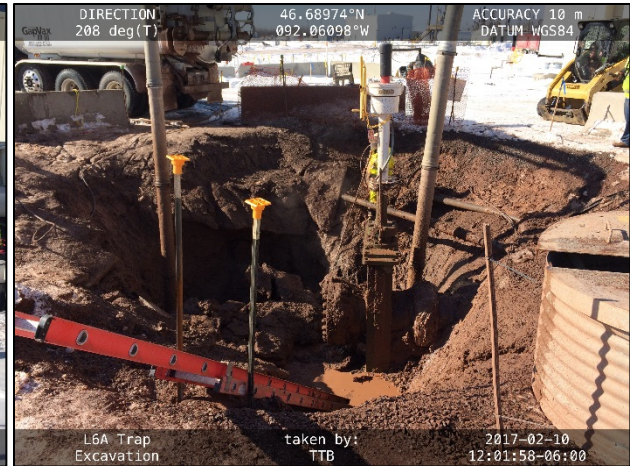
Photo 2

Photo 2: Excavation extents when hydrocarbon impacts initially encountered. The contamination identified in 2012 was focused around the valve and whistle that are visible on the right side of the photo. Product is visible on the water surface at base of the valve in the bottom center of the photo and in the zoomed in Photo 3. Photo taken facing west on February 10, 2017.

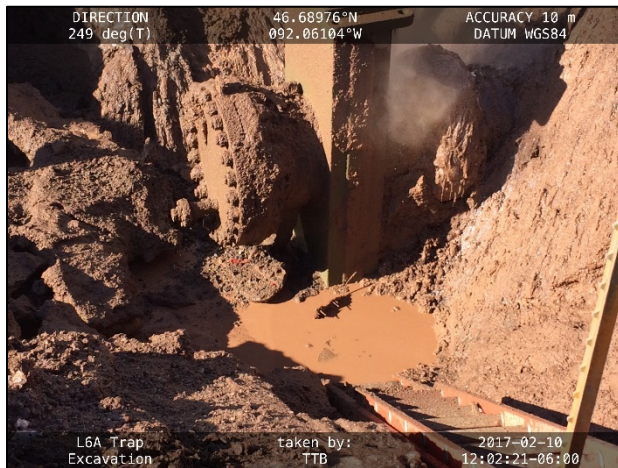
Photo 3

Photo 3: Product on the water surface at the base of the valve. Photo taken facing west on February 10, 2017.

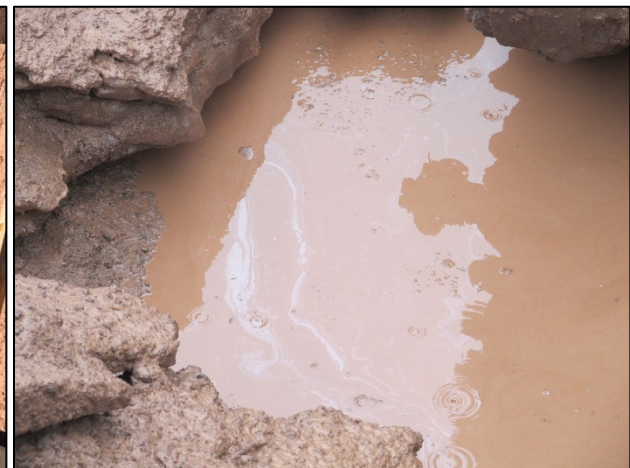
Photo 4

Photo 4: Hydrocarbon sheen on water within the excavation. Photo taken on February 10, 2017.

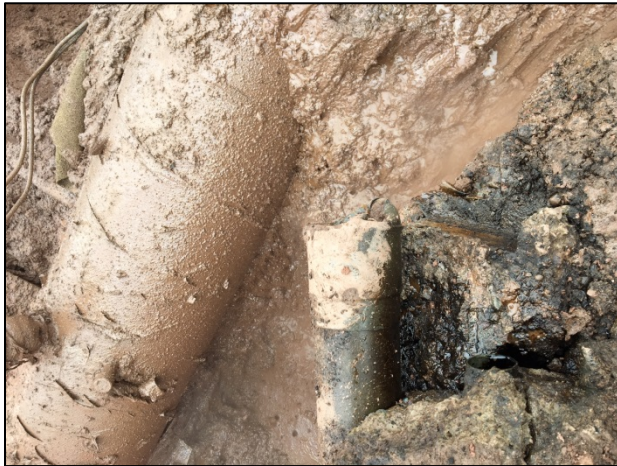
Photo 5

Photo 5: Historical abandoned and cut piping within the excavation (center of photo). Line 6 is visible on the left side of the photo. Photo taken on March 27, 2017.

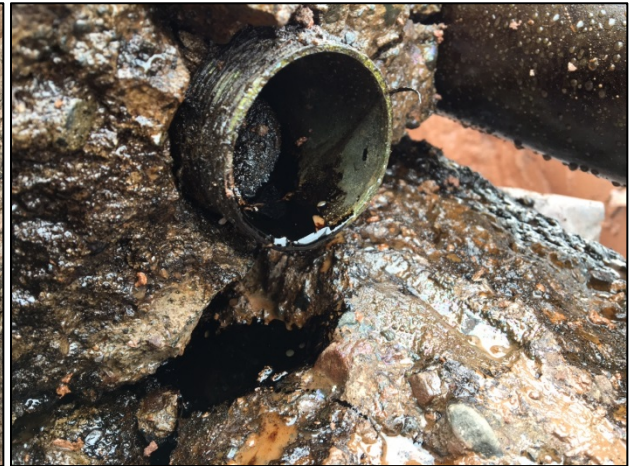
Photo 6

Photo 6: Historical abandoned small diameter piping within the excavation with product present. Photo taken on March 27, 2017.

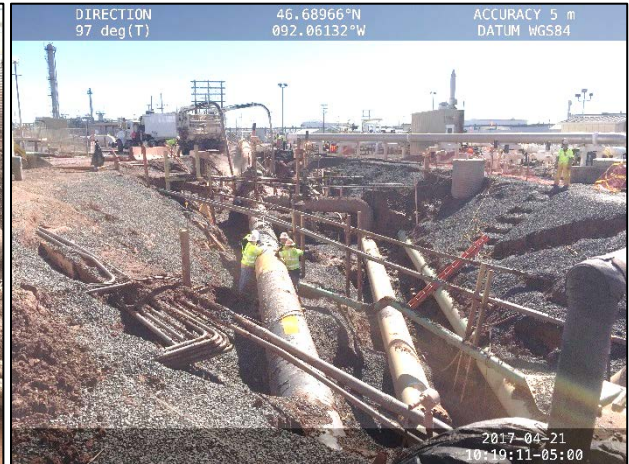
Photo 8

Photo 8: Final extents of the hydrotest excavation. Line 6 is on the left side of the excavation. Photo taken facing east on April 21, 2017.

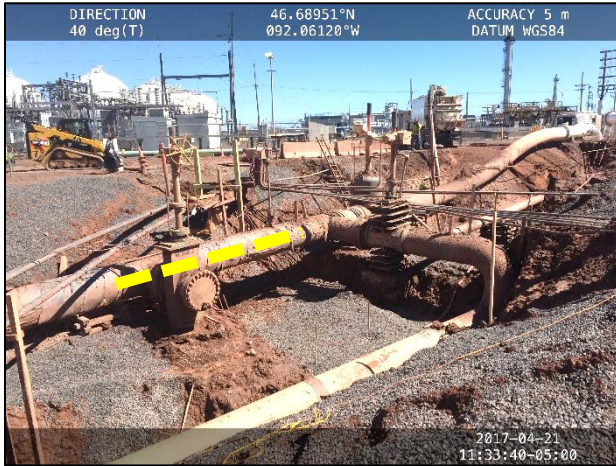
Photo 9

Photo 9: Area in which the majority of the contractor-observed contamination was identified. The contamination was focused along Line 6 in the same area where impacts were identified in 2012. The approximate area of contamination is marked by the dashed yellow line and a close up image of the area is presented in Photo 10. Photo taken facing northeast on April 21, 2017.

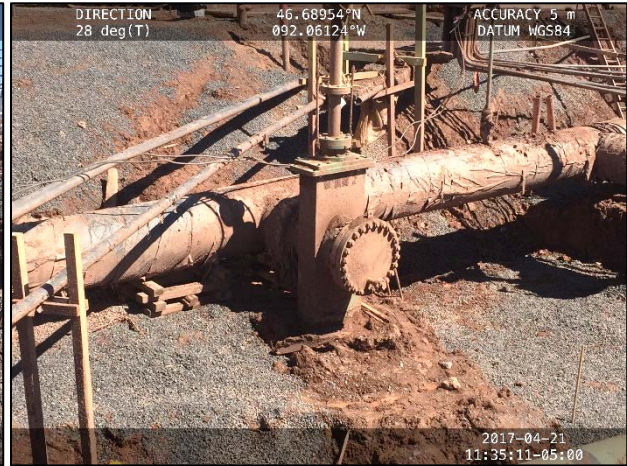
Photo 10

Photo 10: Area where historical contamination was encountered in 2012 and 2017. Photo taken facing northeast on April 21, 2017.

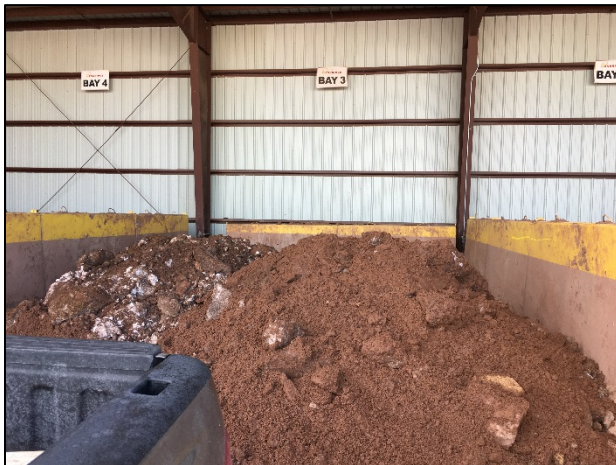
Photo 11: Excavated soil from the Line 6 pipeline trap tie-in stockpiled in the Superior Terminal SMA. Photo taken on February 13, 2017.
