## Technical Memorandum

**To:** Nick Larabel, Enbridge Energy  
**From:** Ryan Erickson  
**Subject:** Superior Terminal Line 6A Valve Excavation  
**WDNR BRRTS#:** 02-16-558991 (Line 6); 02-16-560657 (Facility-wide)  
**Date:** November 23, 2020  
**Project:** 49161092

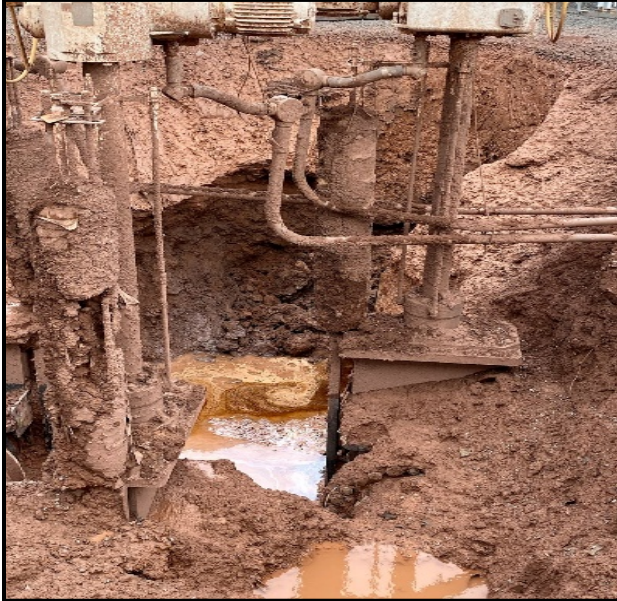
**Photo 1**

**Photo 1:** The Terminal infrastructure excavation near the Line 6A valve. Historical crude oil was observed on the surface of the excavation water. Photo taken by the site inspector on September 3, 2020.

Evidence of historical crude oil contamination (e.g., stained soil, sheen, historical crude oil) was encountered near the L6A valve on September 3, 2020 (Photos 1 and 2). Enbridge removed the contaminated material, segregated it for disposal, and prevented the migration of contaminated material into the larger project excavation that did not have identified contamination.

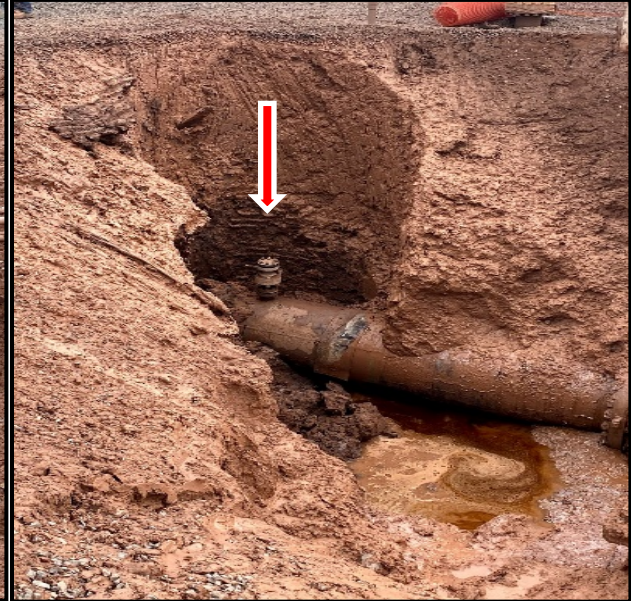
**Photo 2**

**Photo 2:** The Terminal infrastructure excavation near the removed Line 6A valve (red arrow). Historical crude oil was observed on the surface of the excavation water. Photo taken by the site inspector on September 3, 2020.

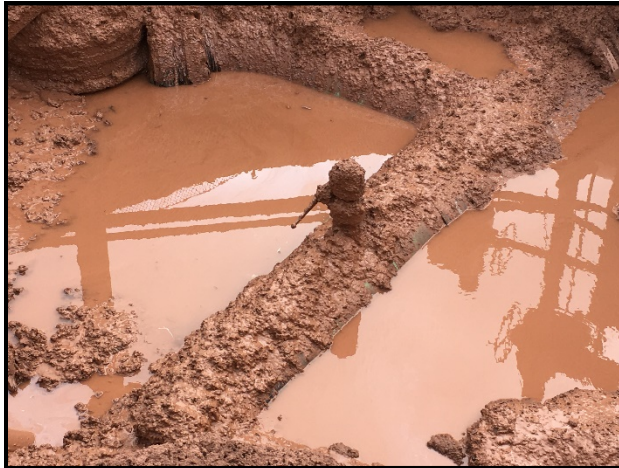
**Photo 3**

**Photo 3:** The former Line 6A Valve location. Contamination was not observed. Photo taken facing east on September 14, 2020.

On September 14, 2020, Barr visually observed conditions in the excavation but did not collect soil samples for field screening or laboratory analysis from the excavation due to ongoing project work (Photos 3 and 4). No evidence of residual crude oil contamination was observed by Barr. The project inspector reported that evidence of contamination had only been identified near the removed Line 6A valve and that no evidence of contaminated soil or water was observed after the initial discovery and remediation in the larger excavation that extended to the south, southwest, and southeast.

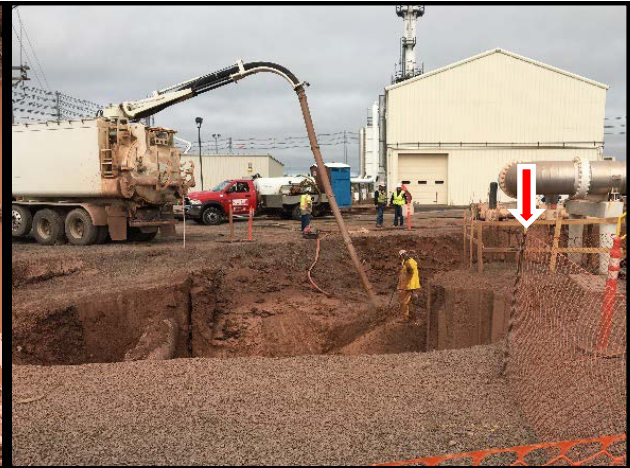
**Photo 4**

**Photo 4:** The southern end of the infrastructure improvement excavation. The red arrow points to the approximate location of the removed Line 6A valve on the far end side of the excavation. The Line 6 Pumphouse is in the top right corner. Photo taken facing north on September 14, 2020.

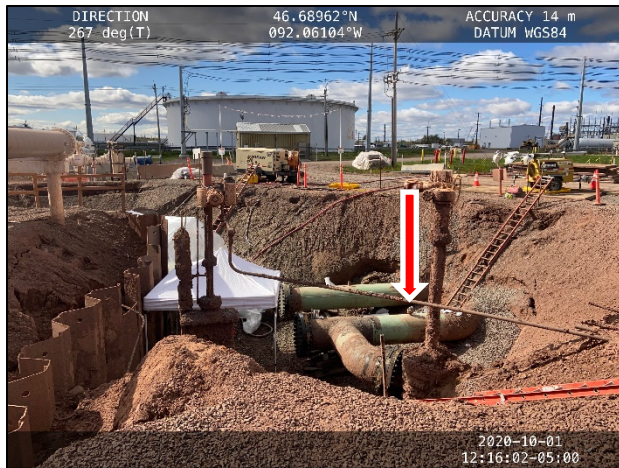
**Photo 5**

**Photo 5:** The final infrastructure improvement excavation. The red arrow points to the former location of the Line 6A valve. Photo taken facing west on October 1, 2020.

On October 1, 2020, Barr documented soil conditions in the final excavation sidewalls and bottom (Photos 5 and 6; Figure 2; Attachment A). The excavation was approximately 50 feet long (north to south) by 40 feet wide (east to west) and up to 14 feet deep. Soil observed in this location consisted of reddish-brown clay and sand and gravel construction fill.
