Re: Tank 5 Historical Crude Oil Impacts
Stairway Platform Excavation Report
Enbridge Energy Superior Terminal
Superior, Wisconsin

02-16-558993 ENBRIDGE ENERGY - TANK 5

TANK 5 SOIL EXCAVATION
Enbridge Superior Terminal
Superior, Wisconsin

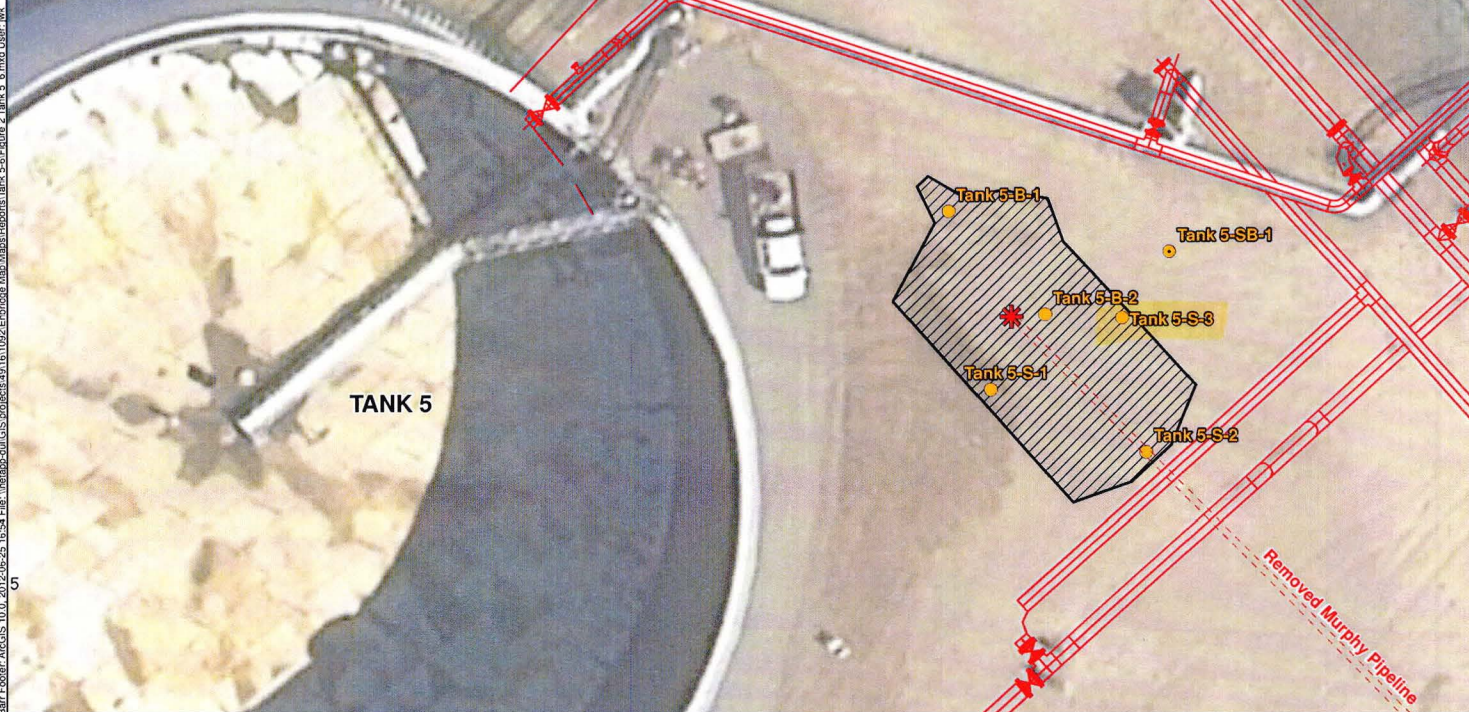
- Approximate Release Location
- Excavation Soil Sample Locations
- Geoprobe Boring Locations
- Terminal Property Boundary
- Terminal Pipeline Infrastructure
- Excavation Extent

DC Exceedance

*under new MTR values
Benzene Ind. DC is 7.41 ppm,
So no exceedance*
