RE: Documentation of the excavation of petroleum contaminated soil from the right-of-way at ten locations along STH 96 (Wisconsin Ave.), Appleton.

Figure 2 - Site Detail Map
 D & K Asian Food Market, 122 W. Wisconsin Ave.
 Appleton, Wisconsin

Environmental History
 D & K Asian Food Market, 122 W. Wisconsin Ave.

Photo and Plan View of Site, Showing Boring Locations
D & K Asian Food Market, 122 W. Wisconsin Ave.

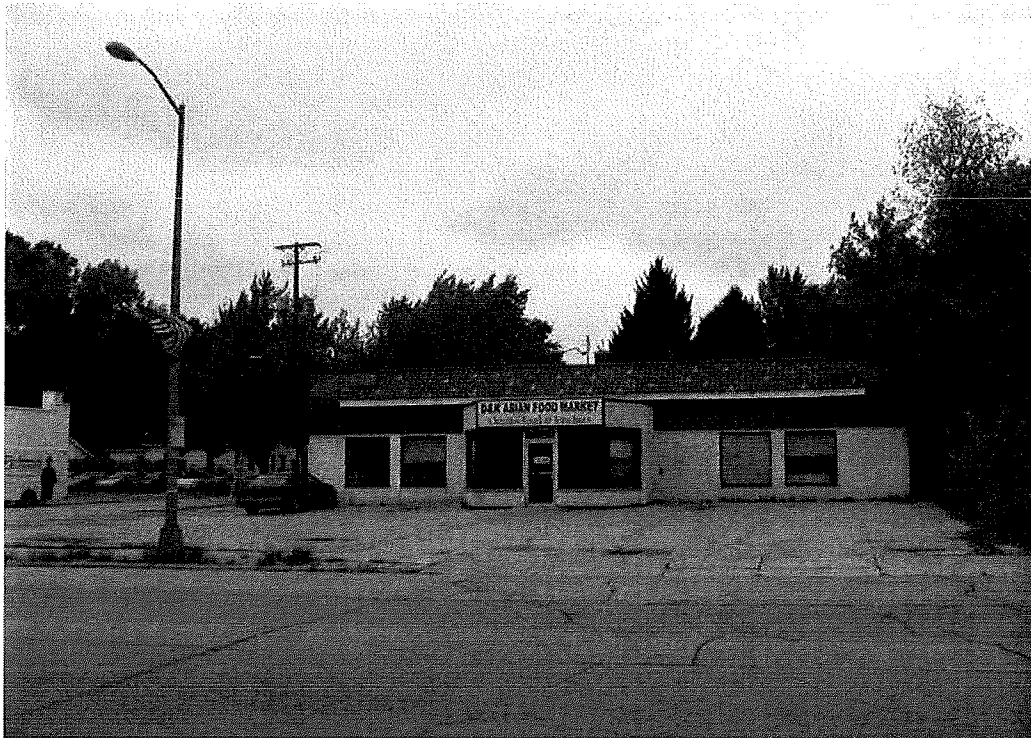
A Phase I Hazardous Materials Assessment Report identified the site as a former gasoline service station. Sanborn maps identified five underground storage tanks located at the southeast corner of the building. **The five tanks contained leaded gasoline.** Contamination was discovered as a result of the Phase II site investigation performed in the road right of way. (See Figure 2 - Site Detail Map, enclosed.) The release was reported to the WDNR.

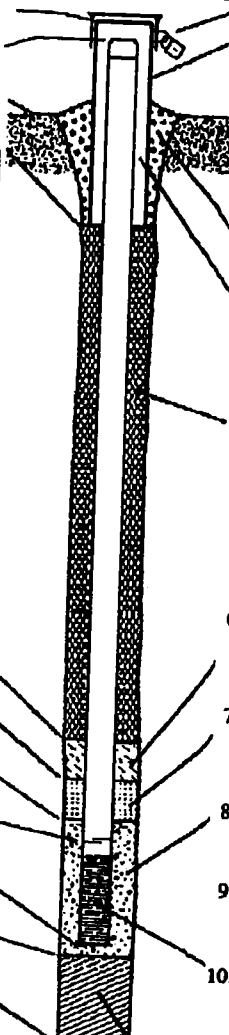
- 1. Cap and lock? Yes No
- 2. Protective cover pipe:
 - a. Inside diameter: 9.0 in.
 - b. Length: 1.0 ft.
 - c. Material: Steel 04
Other
 - d. Additional protection? Yes No
If yes, describe: _____

- 3. Surface seal: Bentonite 30
Concrete 01
Other
- 4. Material between well casing and protective pipe: Bentonite 30
Other
- 5. Annular space seal:
 - a. Granular/Chipped Bentonite 33

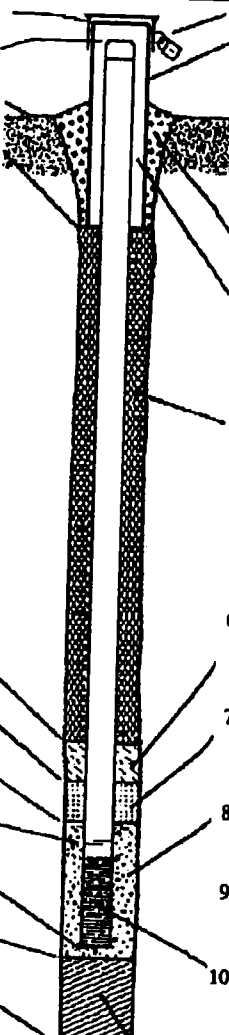
- 1. Cap and lock? Yes No
- 2. Protective cover pipe:
 - a. Inside diameter: 9.0 in.
 - b. Length: 1.0 ft.
 - c. Material: Steel 04
Other
 - d. Additional protection? Yes No
If yes, describe: _____

- 3. Surface seal: Bentonite 30
Concrete 01
Other
- 4. Material between well casing and protective pipe: Bentonite 30
Other
- 5. Annular space seal:
 - a. Granular/Chipped Bentonite 33

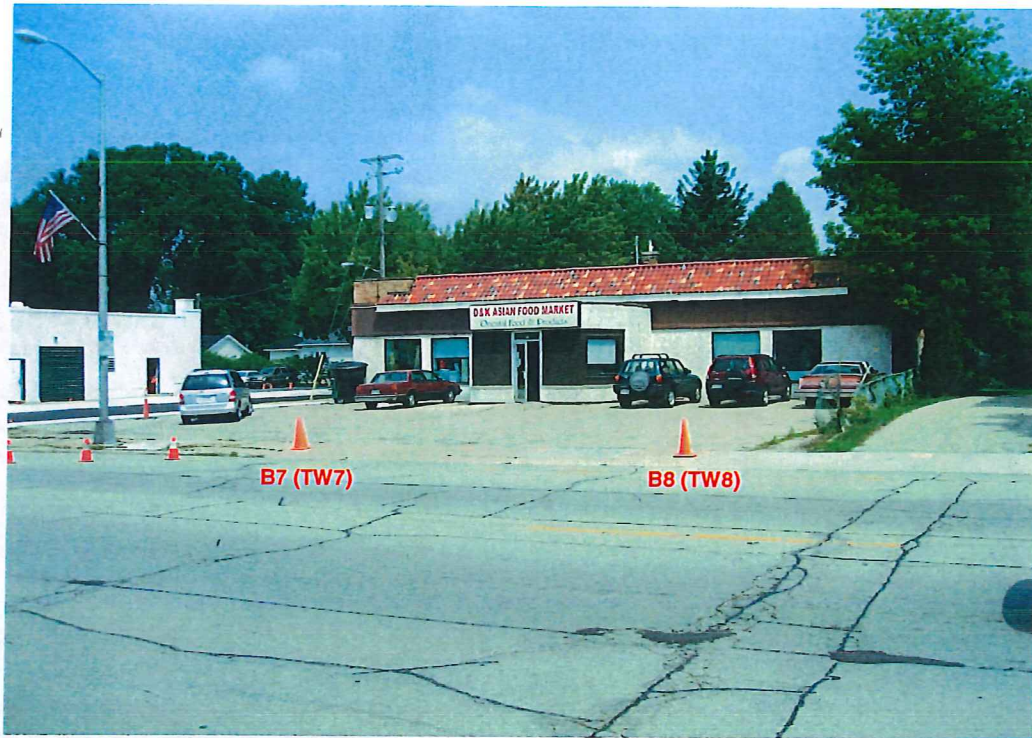
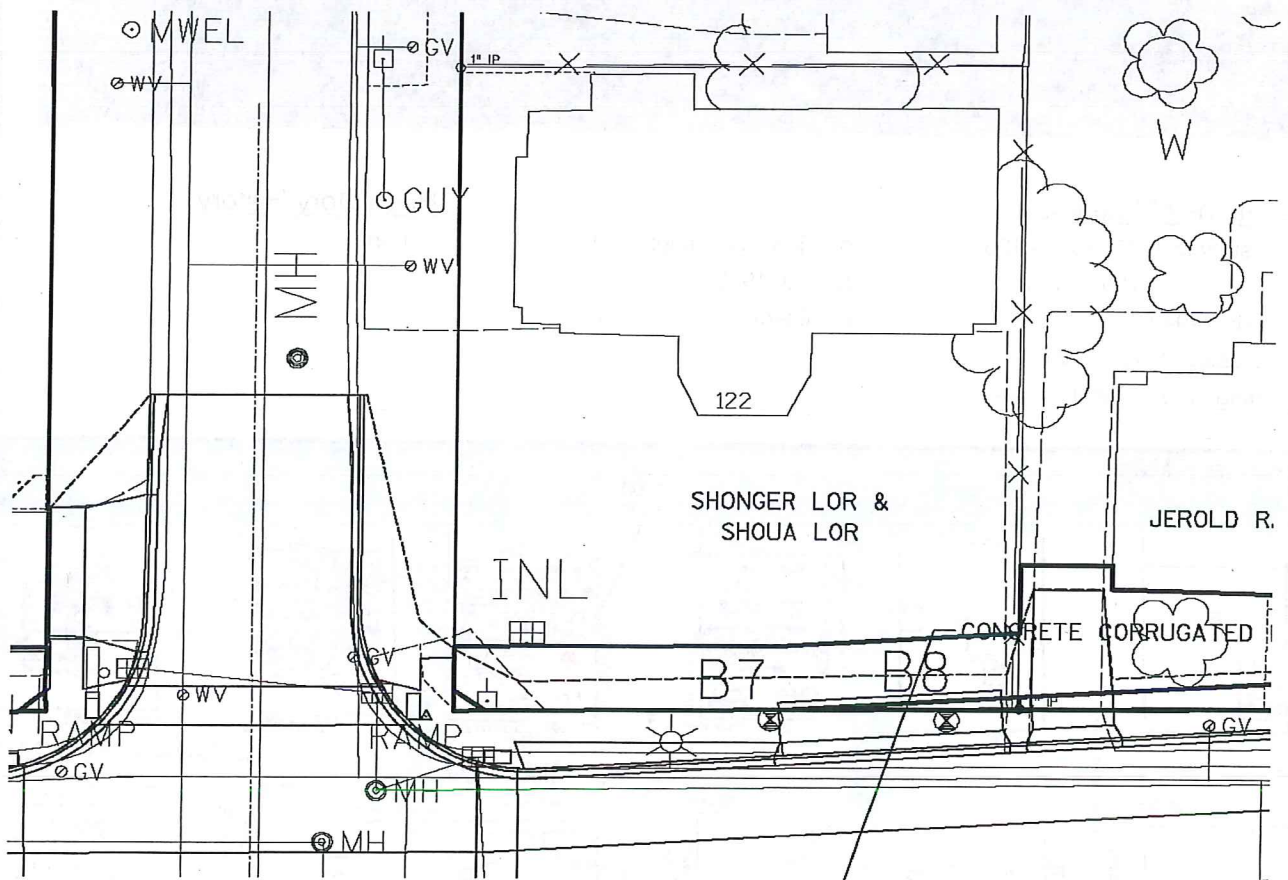
Headspace screening results from the two soil borings were 0.0 ppm (isobutylene equivalents). (See soil boring logs for headspace data, Appendix 2.) Field headspace results did not show evidence of contamination in the borings. No staining or odors were evident.

Toluene is present in the groundwater in the project right-of-way above preventive action limits. There is a possibility that contamination may be encountered by project activities. OMNI recommends that a hydrogeologist be available on standby when project excavation takes place in the area. If field evidence of contaminated soils is observed, the hydrogeologist can then mobilize to the site to field screen soils and segregate any contaminated soils for proper disposal.
