**UNDERGROUND STORAGE TANK/
SUBSURFACE SITE ASSESSMENT**

**PHILLIPS PLATING CORPORATION
984 LAKE AVENUE
PHILLIPS, WI**

REI PROJECT #6134B

December 2012

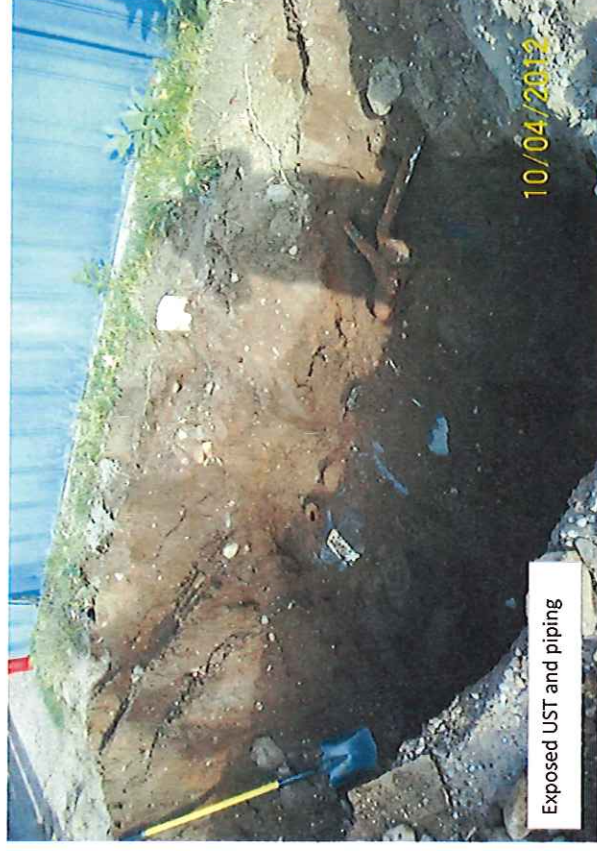
The Tank System Site Assessment (TSSA) was completed on October 4, 2012. David Larsen, Certified Site Assessor #252441, of REI Engineering, Inc. (REI) was on site to observe the removal of the UST and to complete site assessment requirements. SGS Environmental Contractors, LLC, Merrill, WI performed the excavation activities and the UST purge, cut, and clean activities. The UST appeared to be in good condition. There were no obvious holes in the tank.

Exposed UST and piping
