BRRTS #: 06-41-559788
ACTIVITY NAME: Kampus Foods (Former)
PROPERTY ADDRESS: 1400 W Wells St
MUNICIPALITY: Milwaukee
PARCEL ID #: 3900109000

SUBJECT: *Certificate of Completion* for Kampus Foods
1400 W. Wells St., Milwaukee, Wisconsin
BRRTS # 06-41-559788 FID # 341225830

CERTIFICATE OF COMPLETION OF RESPONSE ACTIONS UNDER SECTION 292.15(2)(a), WIS. STATS.

LOCATION MAP (VAPOR MITIGATION SYSTEM)
 KAMPUS FOODS (FORMER)
 1400 W. WELLS STREET, MILWAUKEE, WISCONSIN

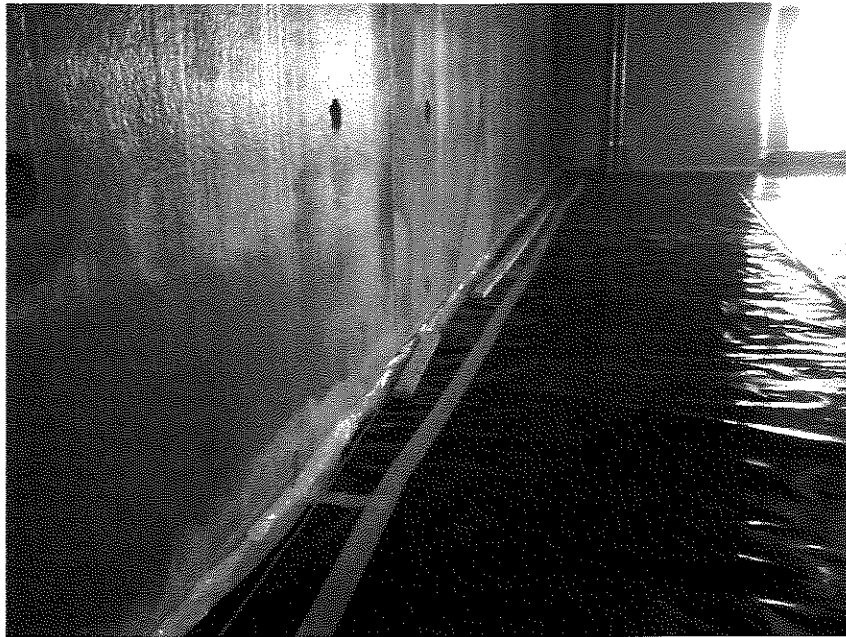
Photo 1: 15-mil vapor barrier in process of being installed in north-central portion in north half of building with taped seams and perimeter (view to east; March 7, 2014).

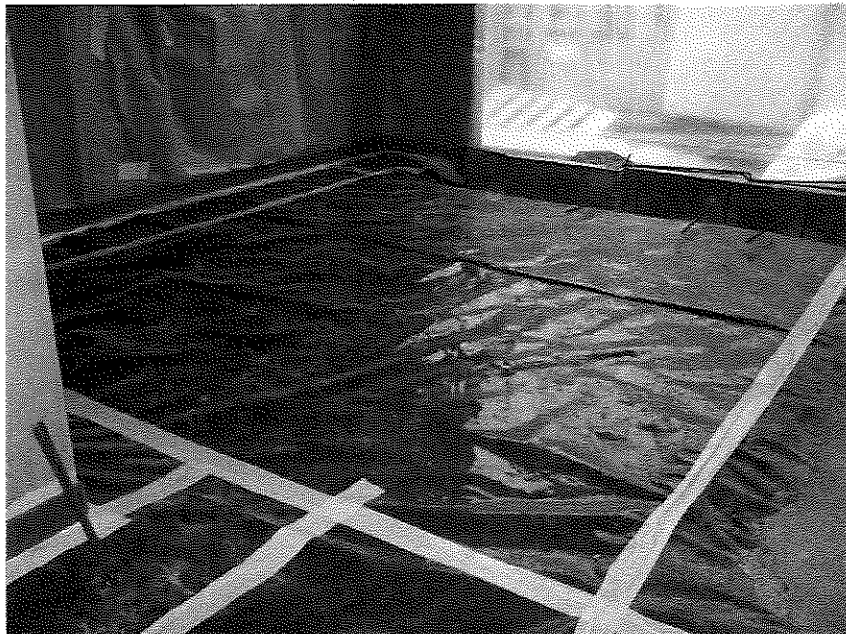
Photo 2: 15-mil vapor barrier in process of being installed in northeast portion in north half of building with taped seams and perimeter (view to east-northeast; March 12, 2014).

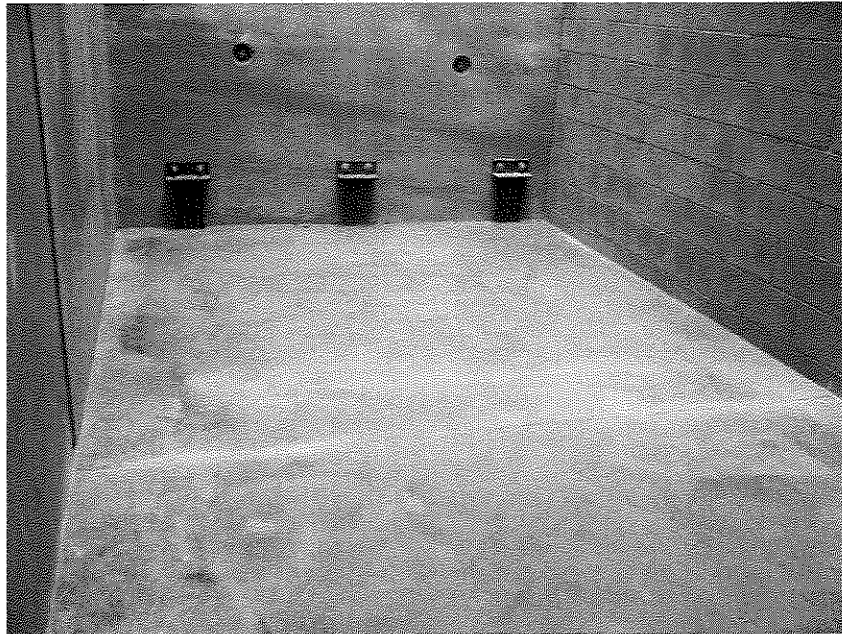
Photo 4: Concrete floor slab installed over vapor barrier in north stairwell in north half of building (view to west; March 7, 2014).

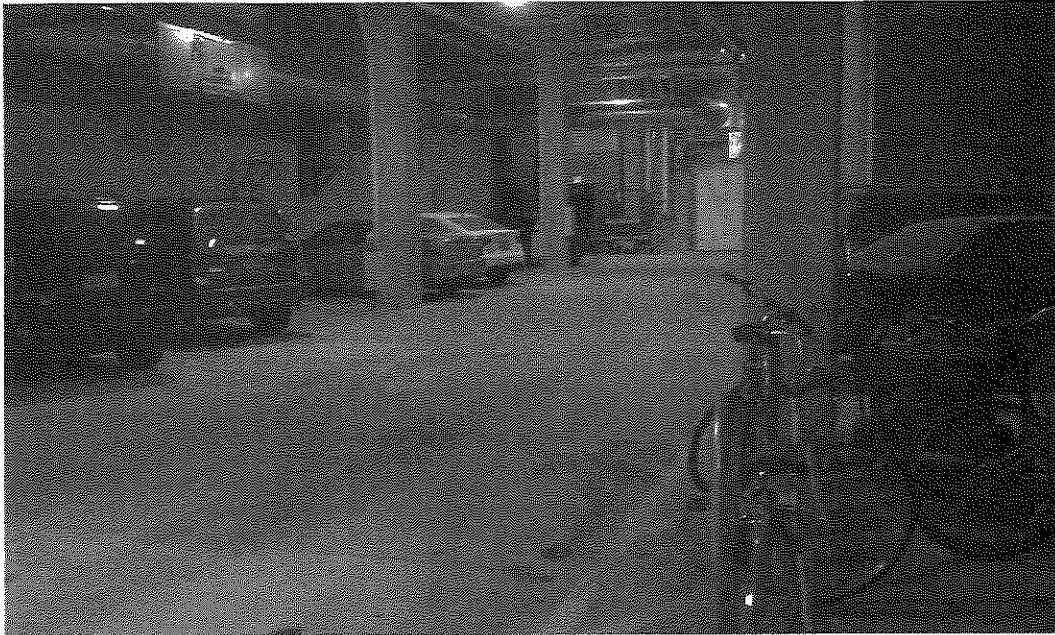
Photo 5: Concrete floor slab installed over vapor barrier in north half of building for parking garage (view to west-southwest; January 15, 2015).

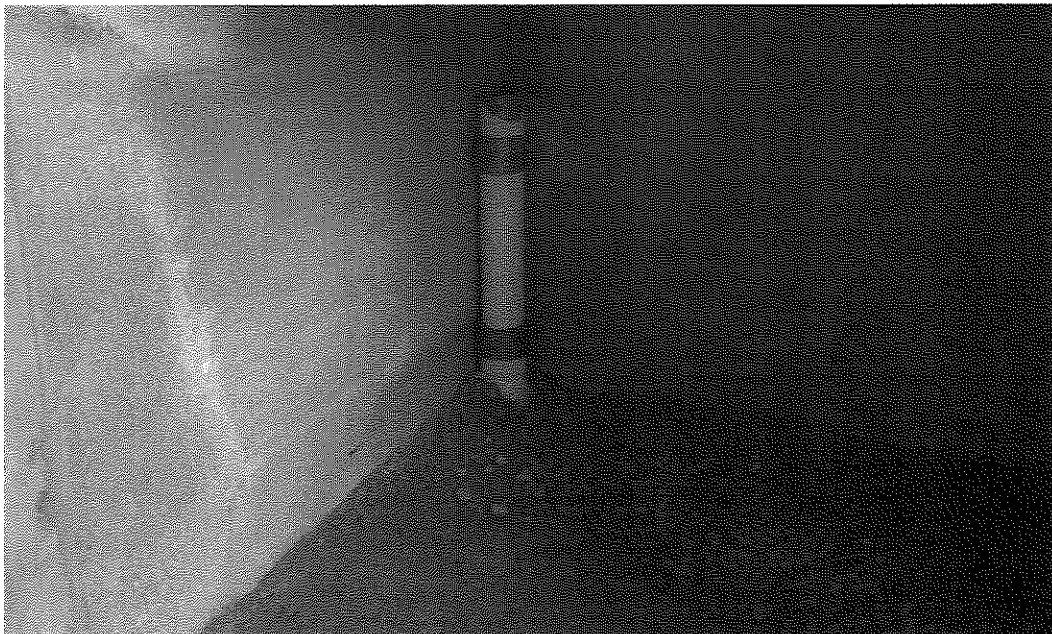
Photo 8: 4" PVC pipe stub for subslab vent system exhaust point at west wall in the south half of the building (view to northwest; June 30, 2014).

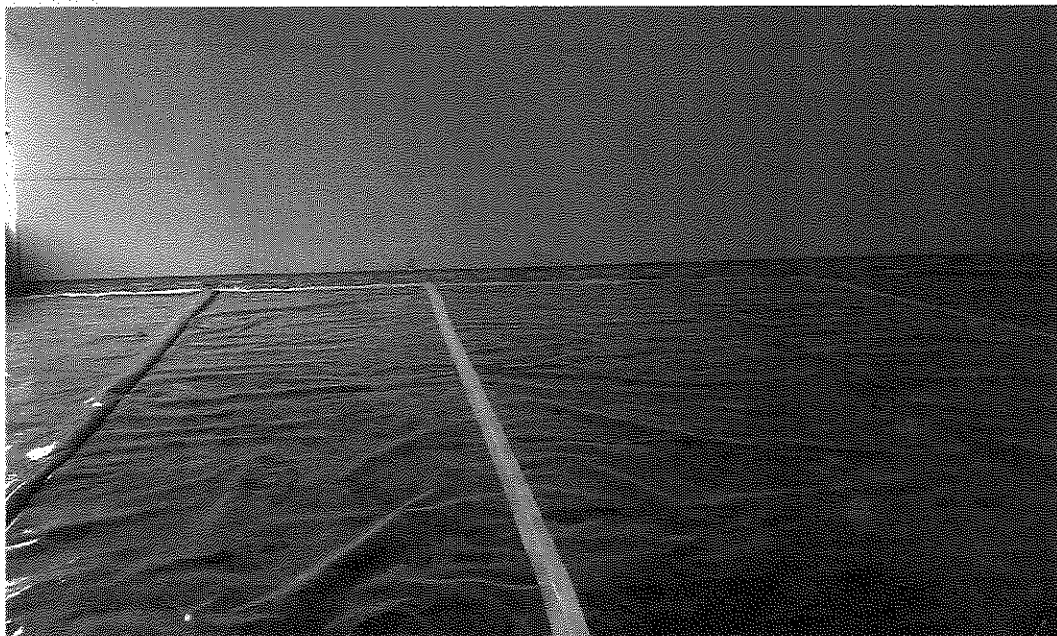
Photo 10: 15-mil vapor barrier in process of being installed in central portion of south half of building with taped seams (view to west; October 2, 2014).

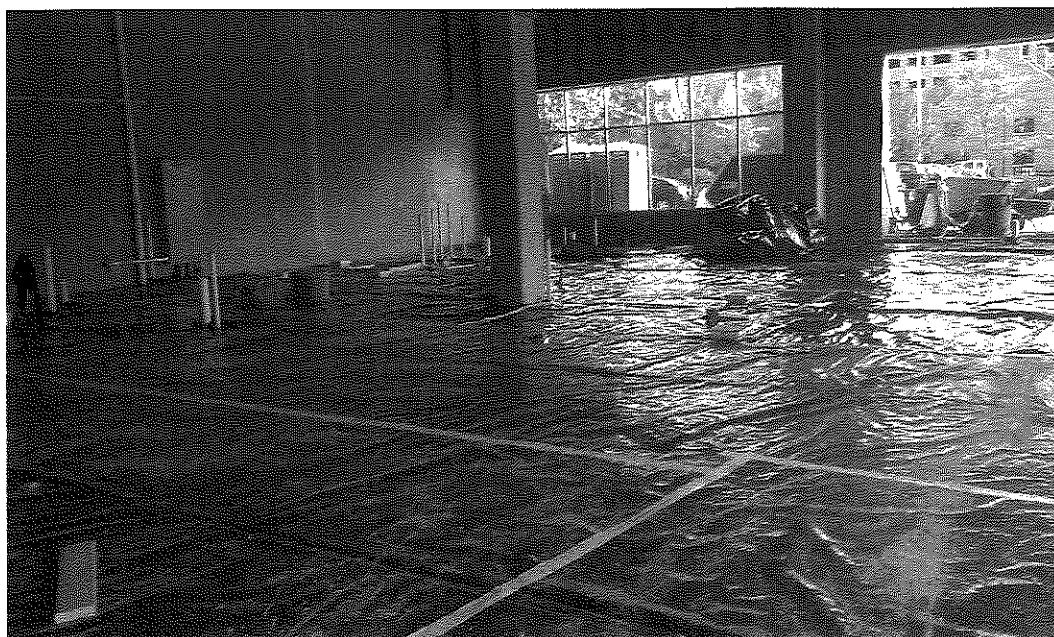
Photo 11: 15-mil vapor barrier in process of being installed at east end in south half of building with taped seams and perimeter (view to northeast; October 3, 2014).

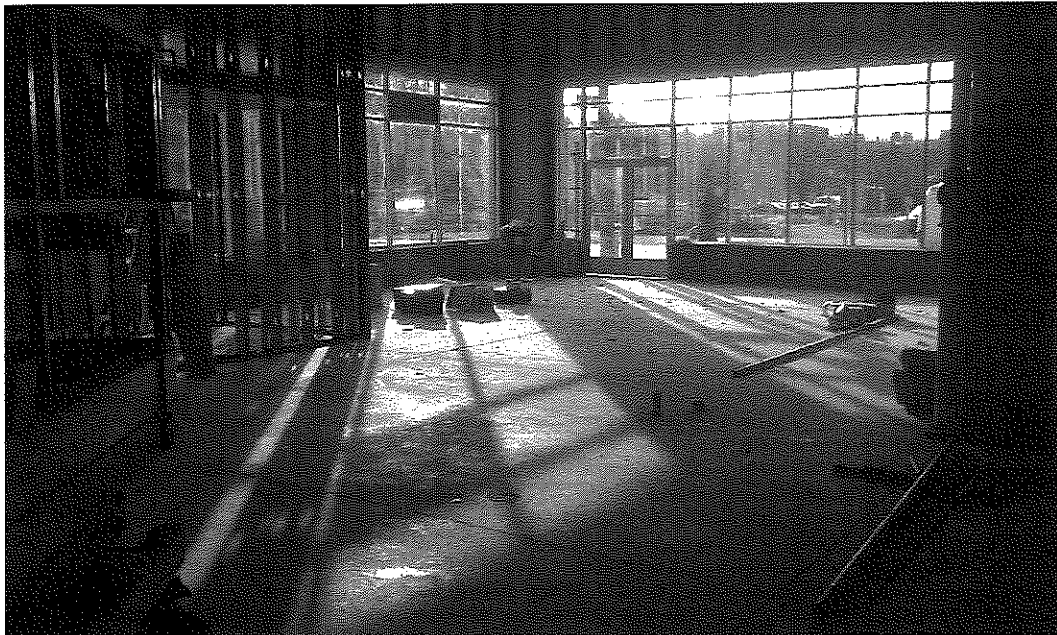
Photo 13: Concrete floor slab installed over vapor barrier in south half of building for retail areas on first floor (view to southeast; December 2, 2014).

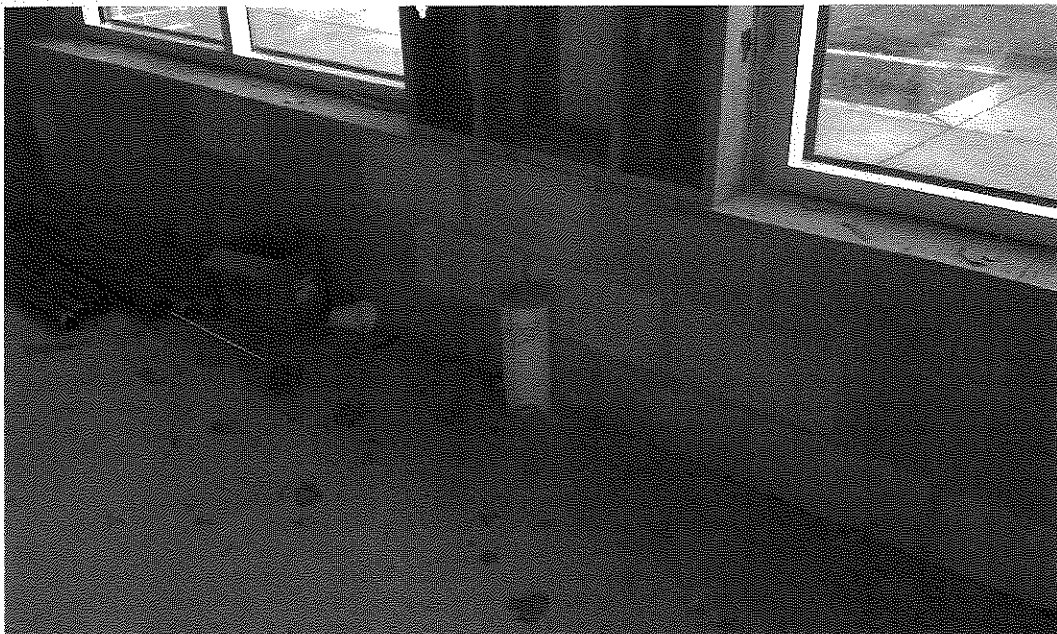
Photo 14: 4" PVC pipe stub for subslab vent system exhaust point at east wall in the south half of the building (view to northeast; December 2, 2014).

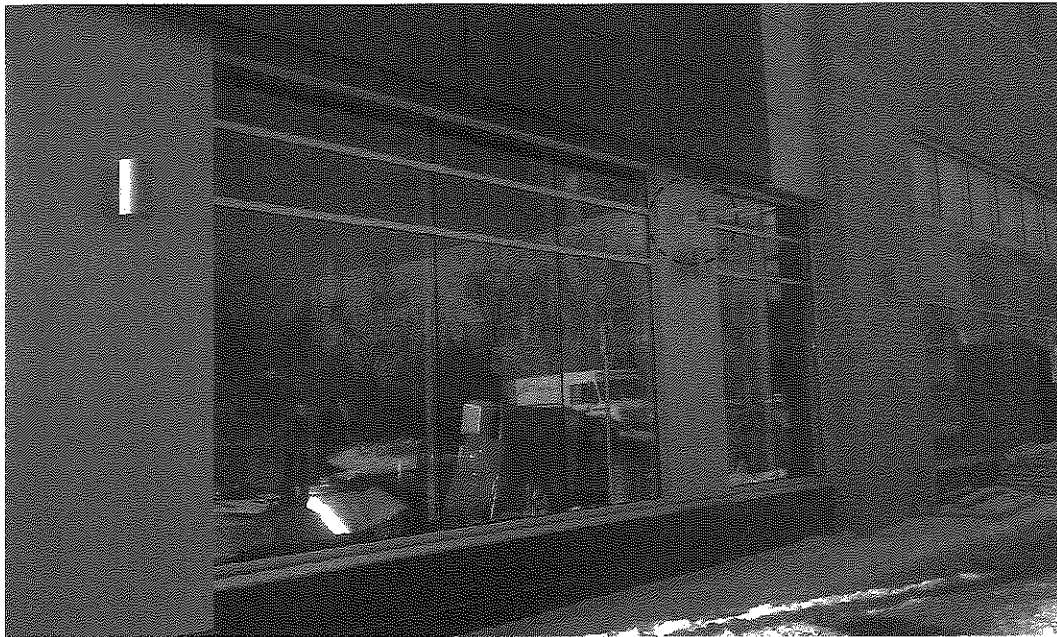
Photo 17: 4" PVC subslab vent system exhaust point at east wall in the south half of the building (view to northwest; January 15, 2015).

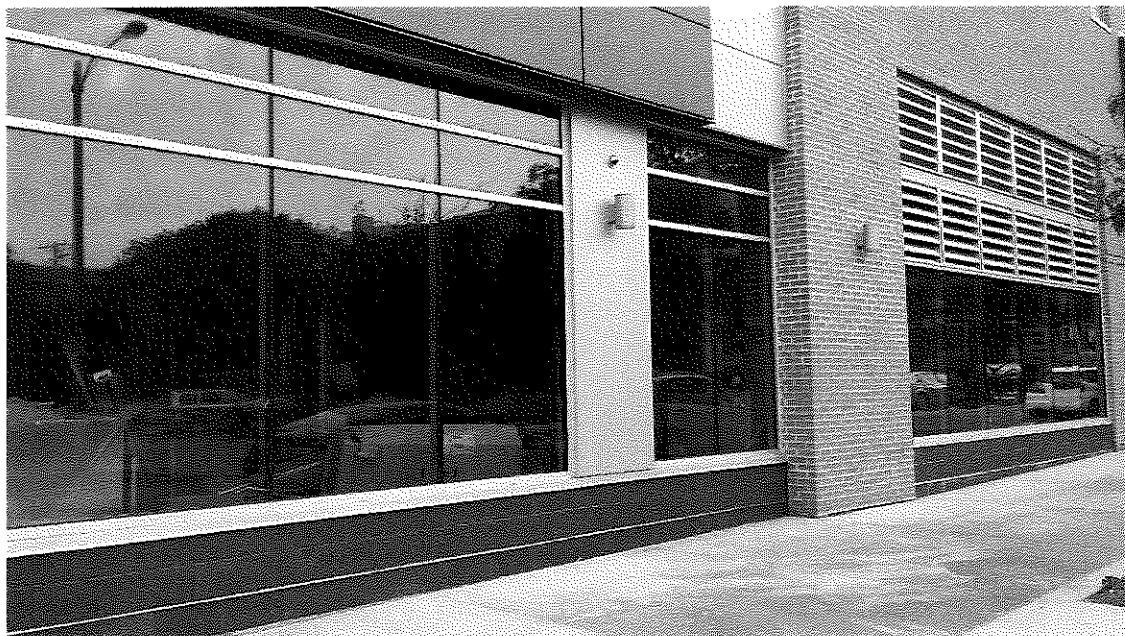
Photo 18: 4" PVC subslab vent system exhaust point at east wall in the south half of the building after vent cover installed (view to northeast; June 12, 2015).

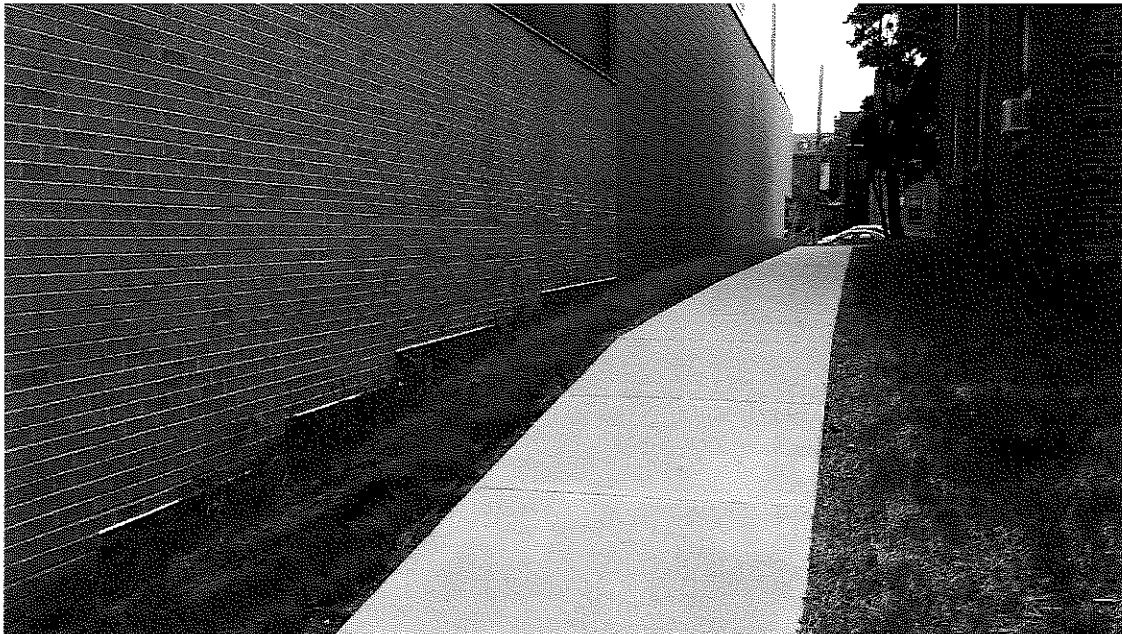
Photo 20: Exterior of north side of building with concrete sidewalk and grass on neighboring property to the right (view to west; June 12, 2015).

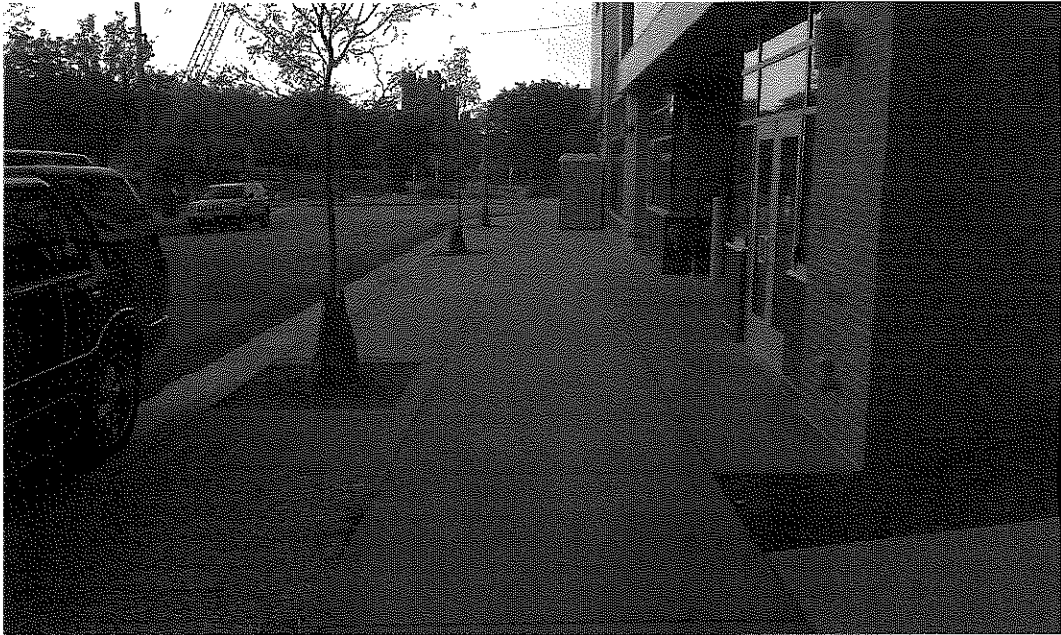
Photo 21: Exterior of east side of building with concrete sidewalks and N. 14th Street to the left (view to south; September 29, 2014).

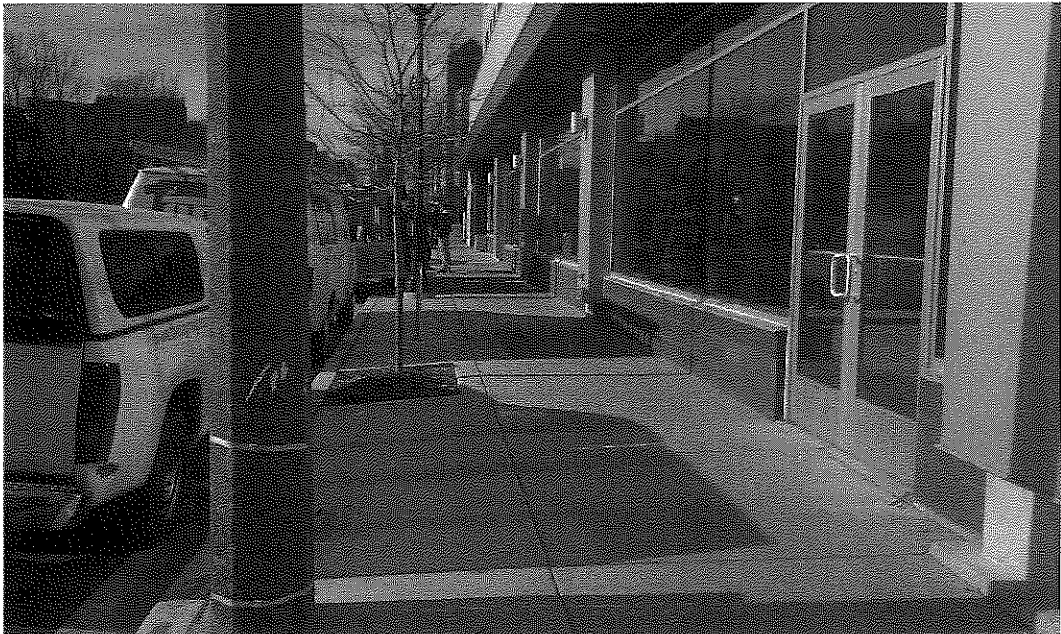
Photo 22: Exterior of south side of building with concrete sidewalks and W. Wells Street to the left (view to west; December 2, 2014).

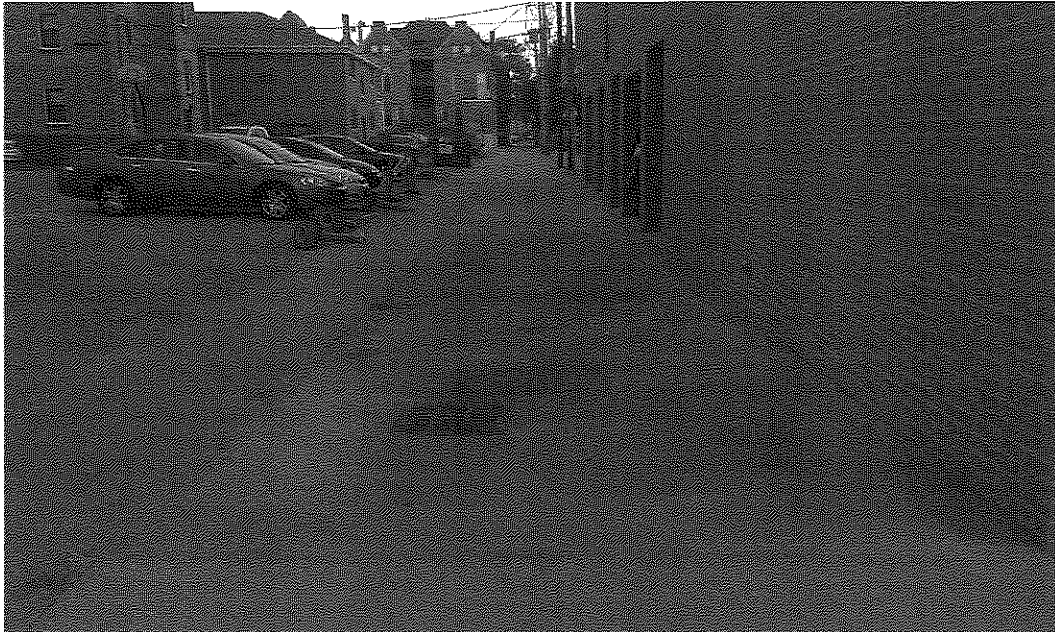
Photo 23: Exterior of west side of building with paved alley and neighboring parking lot to left (view to north; September 29, 2014).

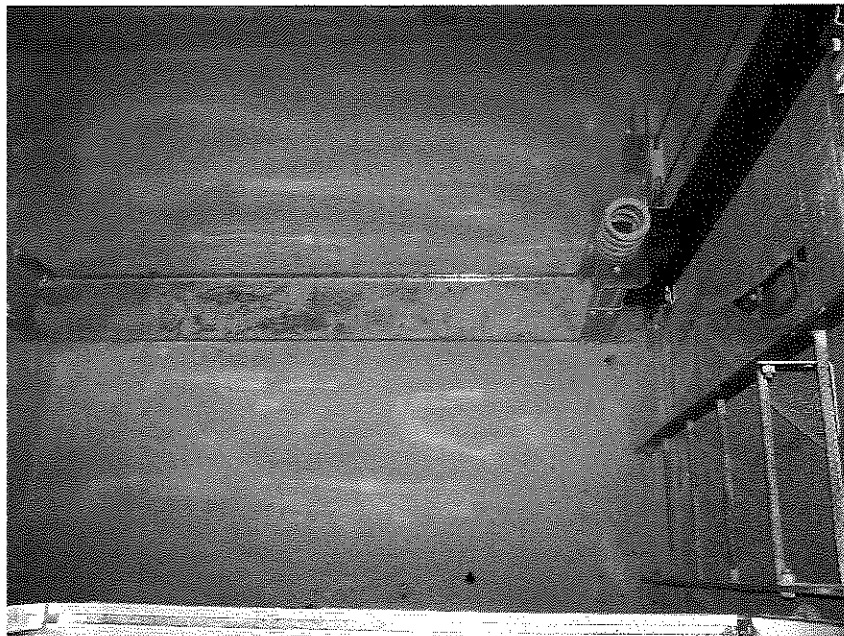
Photo 24: Vapor proofing material (Perm-A-Barrier Liquid) installed on base (and walls) of west elevator pit in the northeast portion of the building (facing north; February 6, 2015).

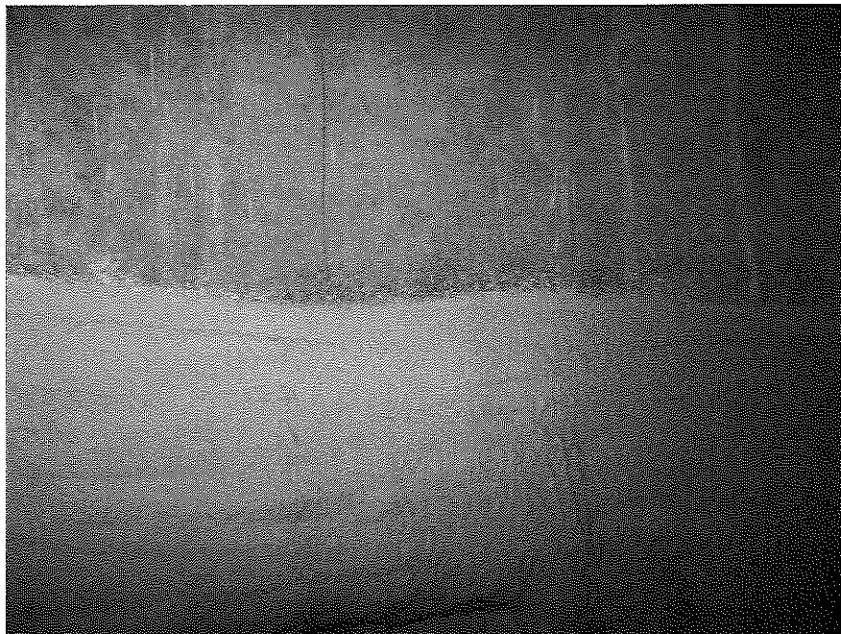
Photo 26: Close-up view of vapor proofing material (Perm-A-Barrier Liquid) as installed in elevator pits in the northeast portion of the building (February 6, 2015).
