Site Investigation Status Report

Former Quality Cleaners
1226-1228 11th Avenue
Grafton, Wisconsin

BRRTS #02-46-560212
FID #246166470

May 2023

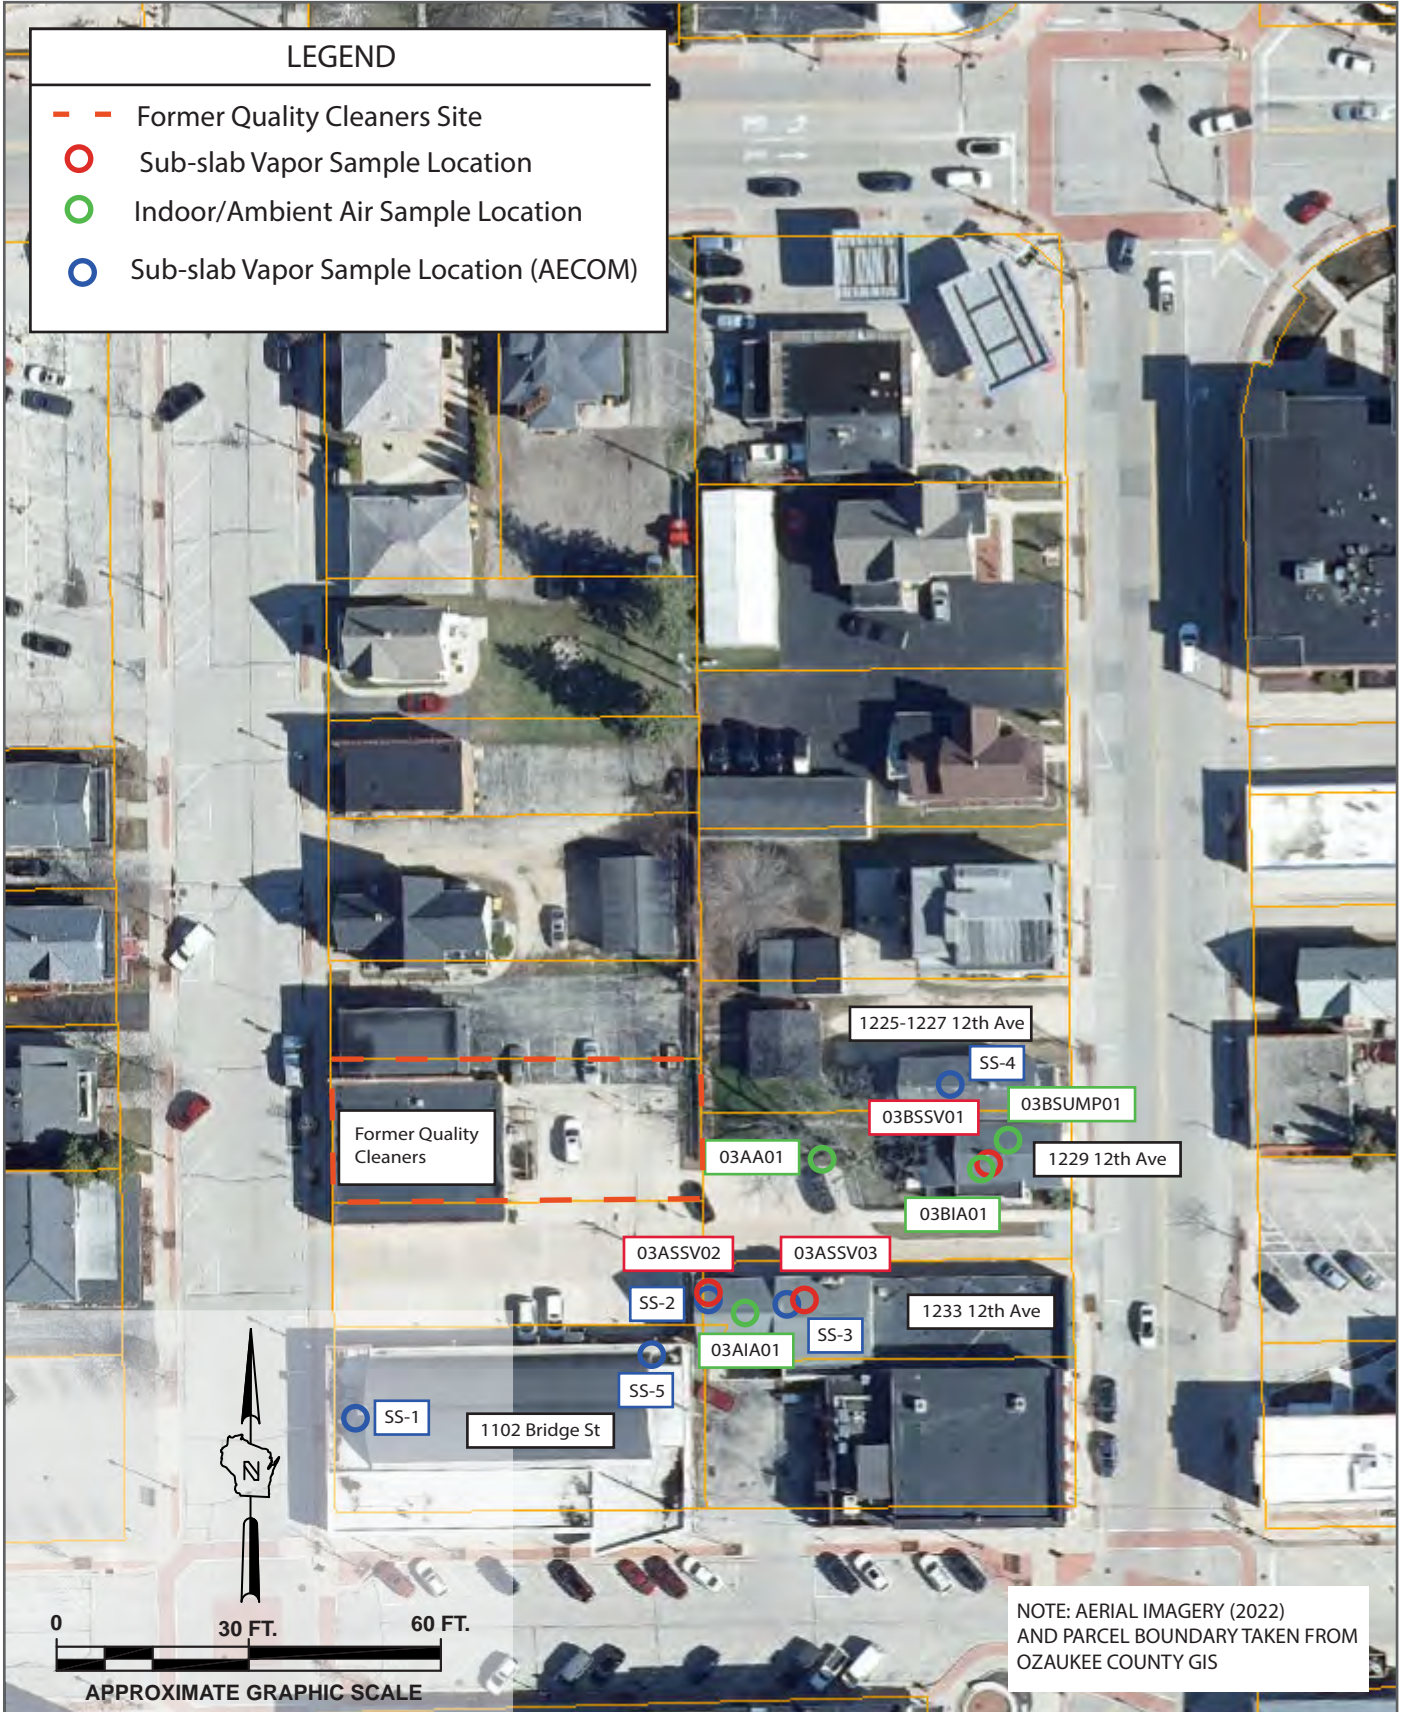
NOTE: AERIAL IMAGERY (2022) AND PARCEL BOUNDARY TAKEN FROM OZAUKEE COUNTY GIS

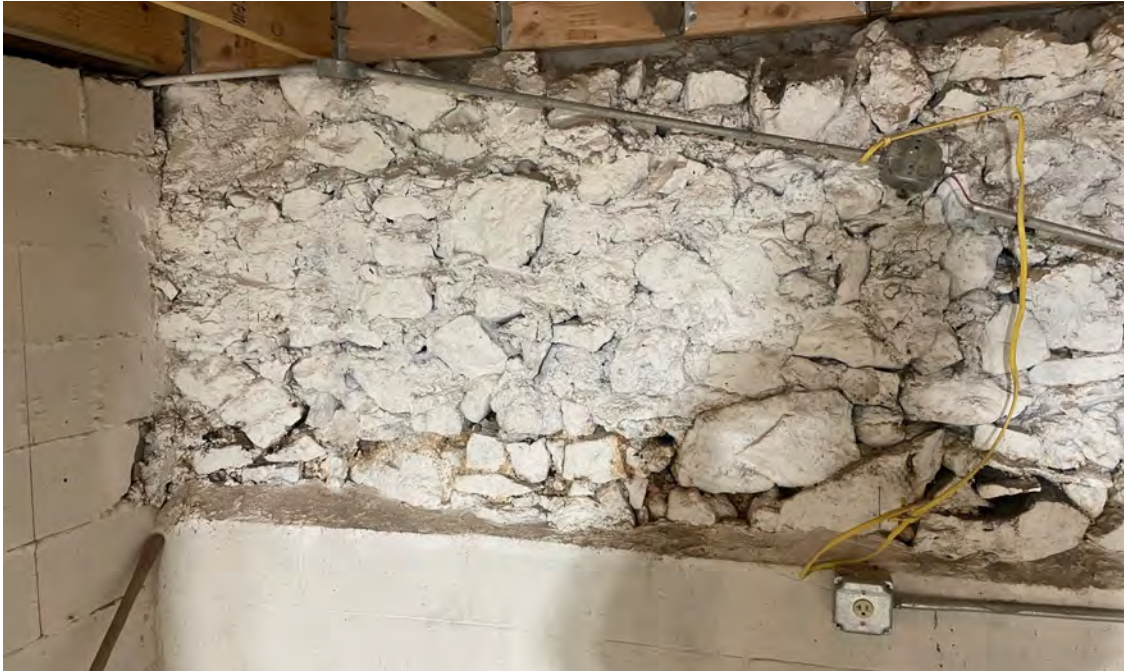
Photo 1: View of eastern portion of north basement wall in 1229 12th Avenue building, View to north. 3/8/2023.

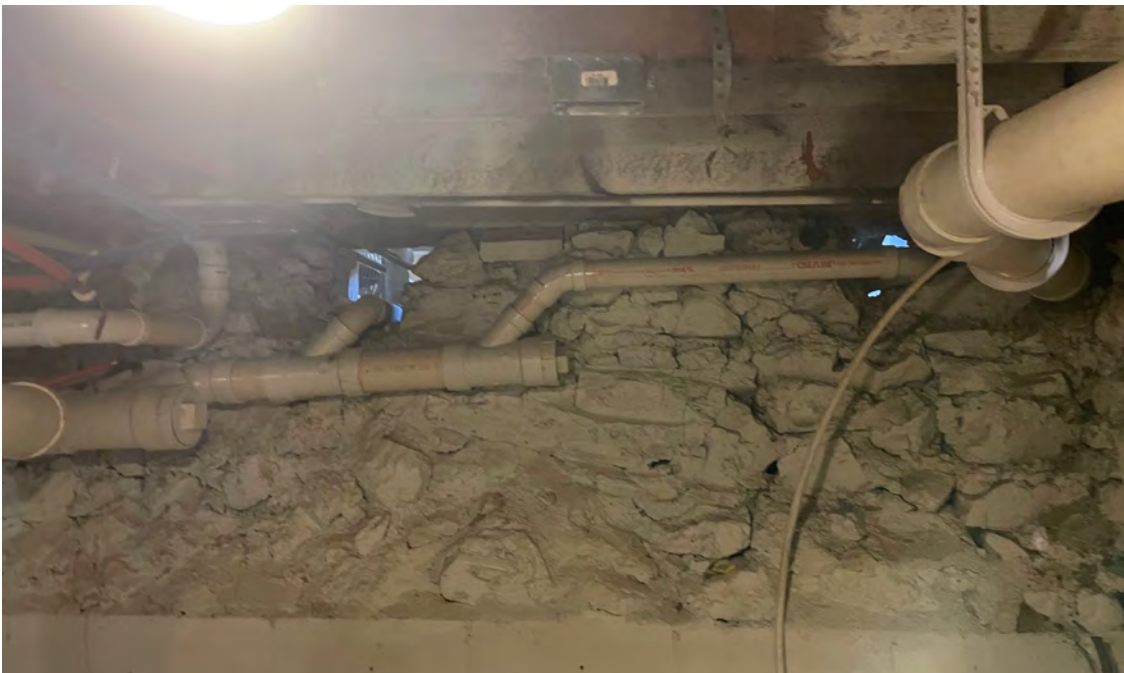
Photo 2: View of west basement wall in 1229 12th Avenue building. View to west. 3/8/2023.

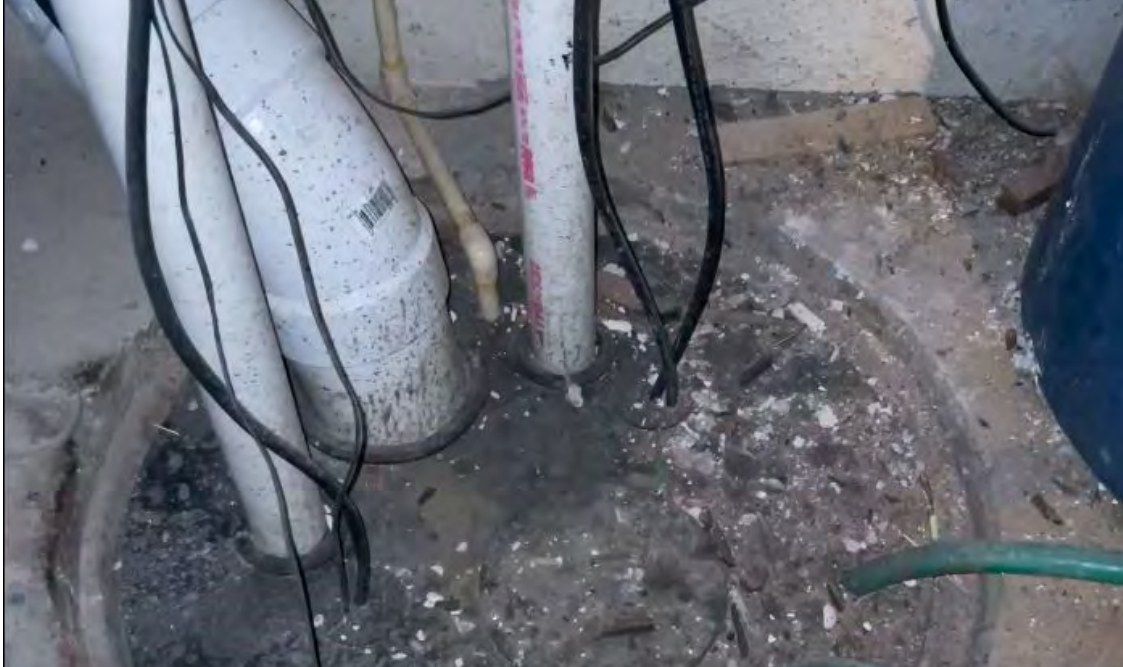
Photo 4: View of sump in basement of 1229 12th Avenue building. 3/8/2023.

For the 1229 12th Avenue building, the existing mitigation system is connected to a sump located within the basement level. The sump has a sealed cover and multiple penetrations including the mitigation system pipe, sump discharge pipes, and penetrations for condensate drains from a furnace located in the basement (according to the owner this furnace is only used for A/C, not heating) and two dehumidifiers. With the mitigation system fan active, we used a smoke stick and observed two communication points between the sump interior and basement air around the pipe penetrations (points where smoke was being drawn down into the sump). There is a sealed access port through the sump cover secured with screws. We have attached a .MOV file showing the cover – for some reason my phone turned the photo with flash into a movie.

Based on pre-sampling site observations, Sigma recommended that the proposed sampling plan be modified to include collection of an air sample from within the sealed headspace of the basement sump within the 1229 12th Avenue building. The sump headspace sample would be collected in lieu of a duplicate indoor air sample. Mr. Joseph Martinez of the WDNR provided concurrence with the recommended sampling plan modification in electronic correspondence dated March 9, 2023. A copy of the correspondence is included as **Appendix C**.

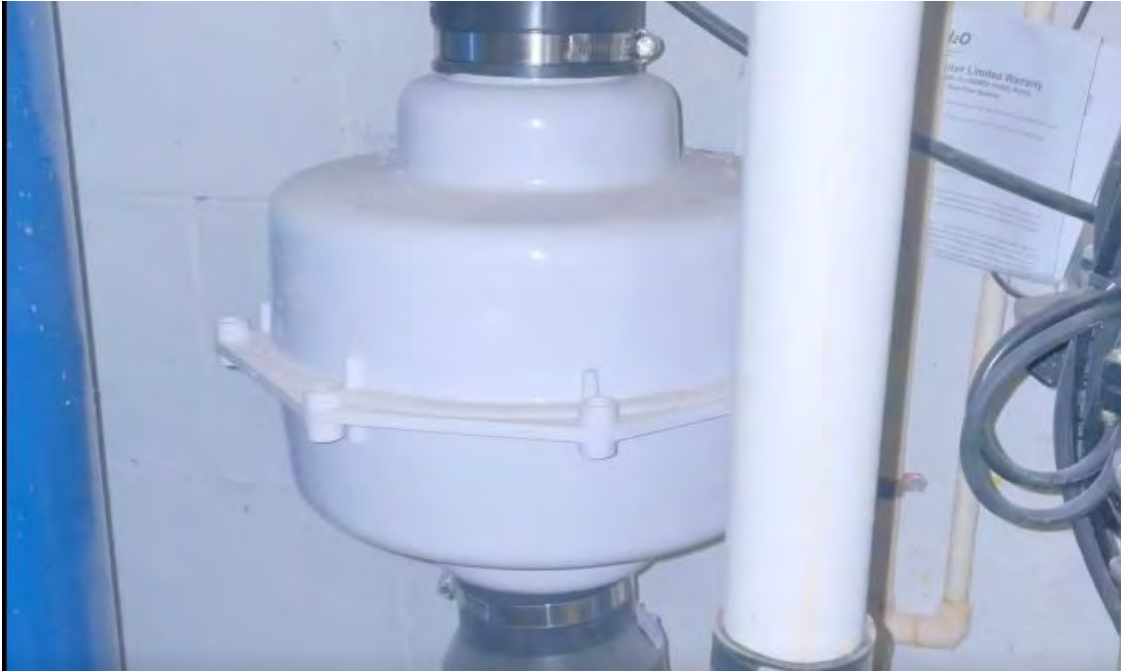
1229 12th Avenue: The building was in the process of interior renovation during the pre-sampling site visit and renovations would be on-going during the anticipated sub-slab and indoor air sampling period. The active sub-slab vapor mitigation system was connected to a sump located within the partial basement level. The sump had a sealed plastic cover; however, a smoke test identified communication points around penetrations associated with drain lines from a furnace and dehumidifiers present within the basement. The mitigation system fan (installed within the basement level) and discharge location (located less than 2 feet above grade at the building exterior) did not meet American Association of Radon Scientists and Technologists (AARST) standards.

Photo 5: View of mitigation system fan connected to sump in 1229 12th Avenue building. 3/8/2023.

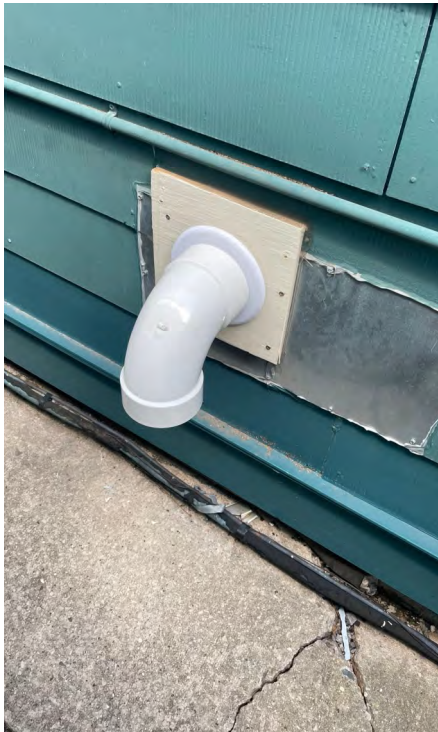
Photo 6: View of mitigation system discharge on north exterior of 1229 12th Avenue building. 3/8/2023.

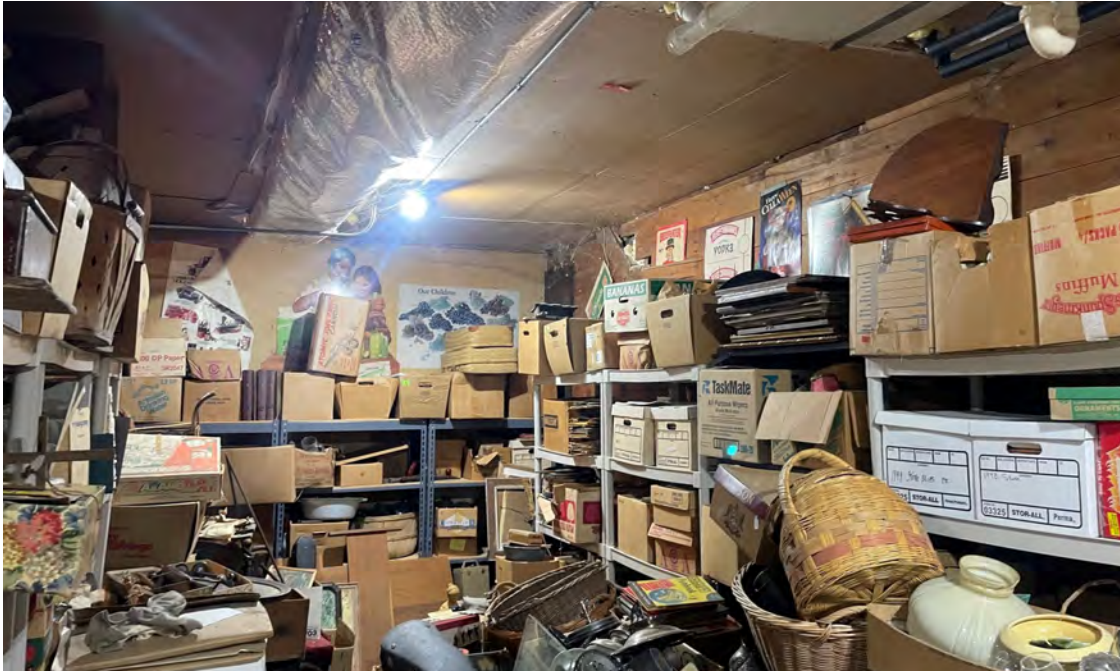
Photo 7: View of west end of ground floor (location of SS-2) of 1233 12th Avenue building. View to west. 3/8/2023

For the 1233 12th Avenue building (Seth's Antiques), the owner was able to show us the location of the previously completed sub-slab sample points (building is slab on grade). SS-2 is located in a portion of the ground floor that appears to be a later addition to the original building, is not conditioned (limited HVAC) and used for storage (a photo of this area is attached). SS-3 is located in a unfinished room housing the furnace/water heater but within the portion of the ground floor that is heated. The owner indicated that the previously collected indoor air sample was collected within the residential portion of the building (2nd floor), which extends over the portion of the building where both SS-2 and SS-3 are located.

Our recommendation would be to collect the sample in the storage area which overlies the sub-slab location of concern identified to date.

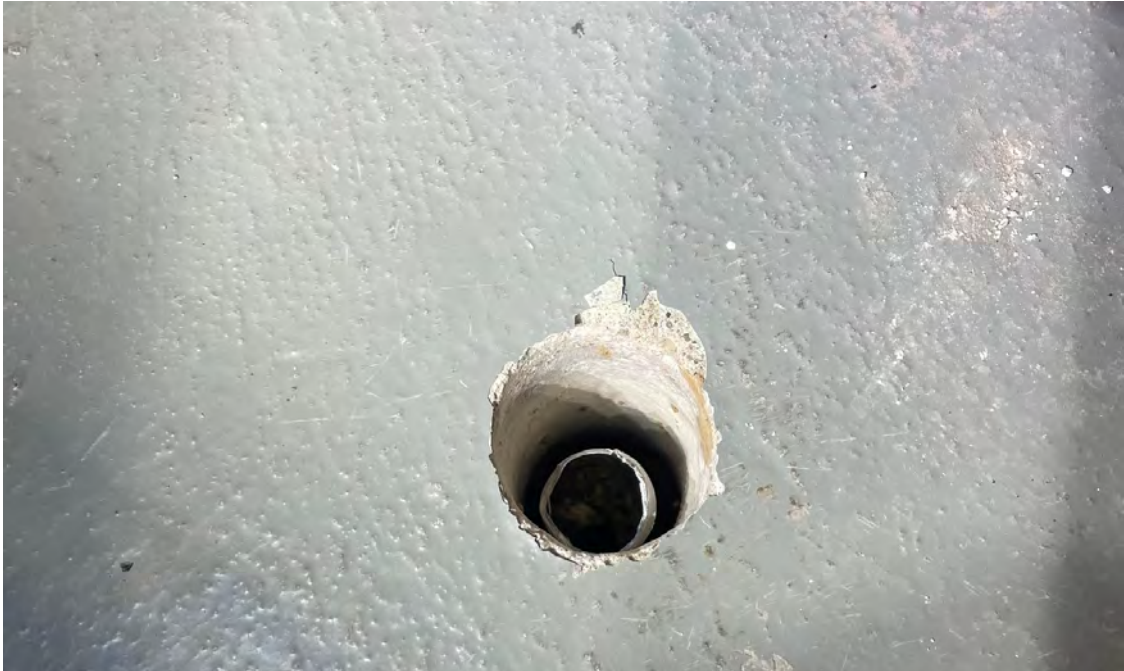
Photo 1: Sub-slab sample point SSV-01 in the basement of the 1229 12th Avenue building following installation of the aluminum tube. 3/22/2023

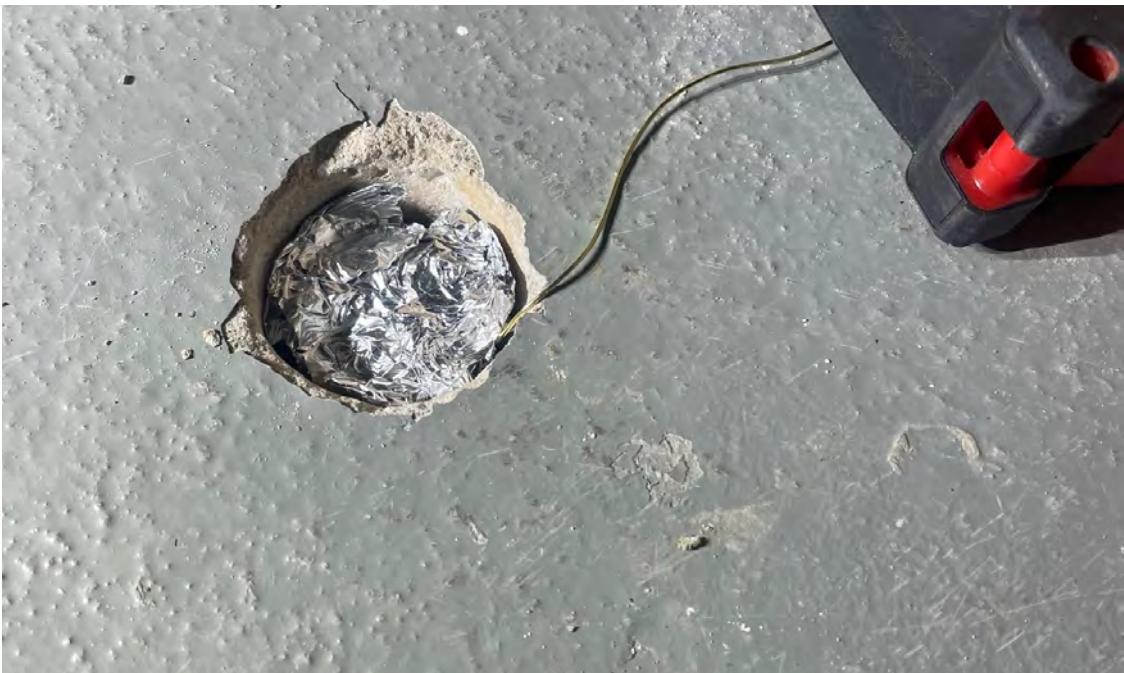
Photo 2: Sub-slab sample point SSV-01 in the basement of the 1229 12th Avenue building following installation of the passive sampler and capping with aluminum foil plug. 3/22/2023

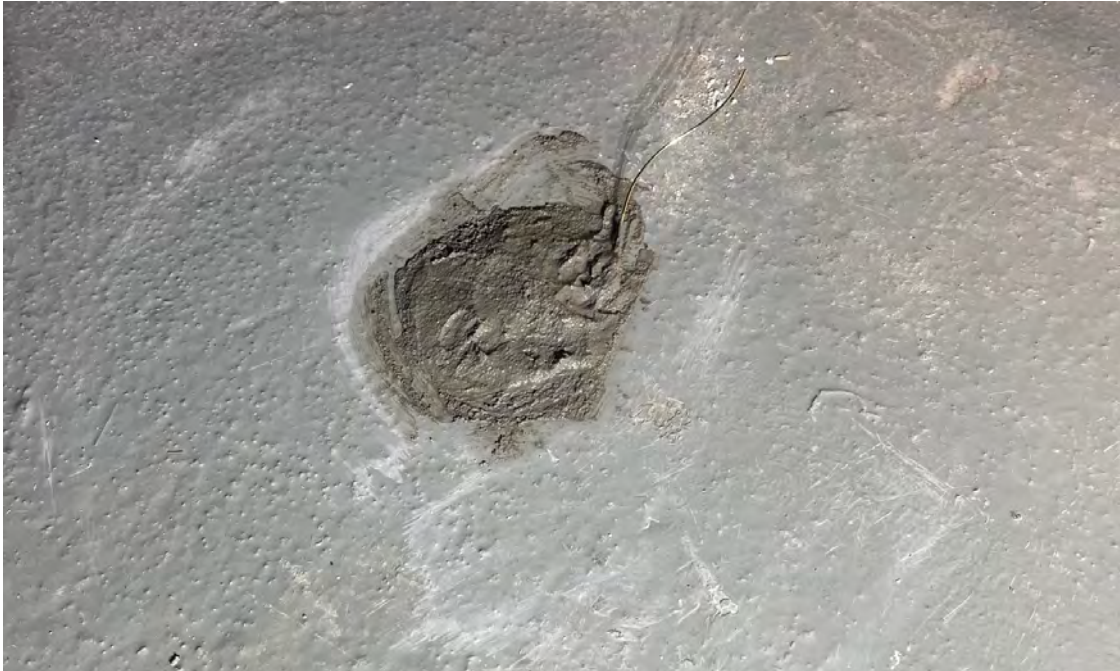
Photo 3: Sub-slab sample point SSV-01 in the basement of the 1229 12th Avenue building following installation of the temporary cement cap. 3/22/2023

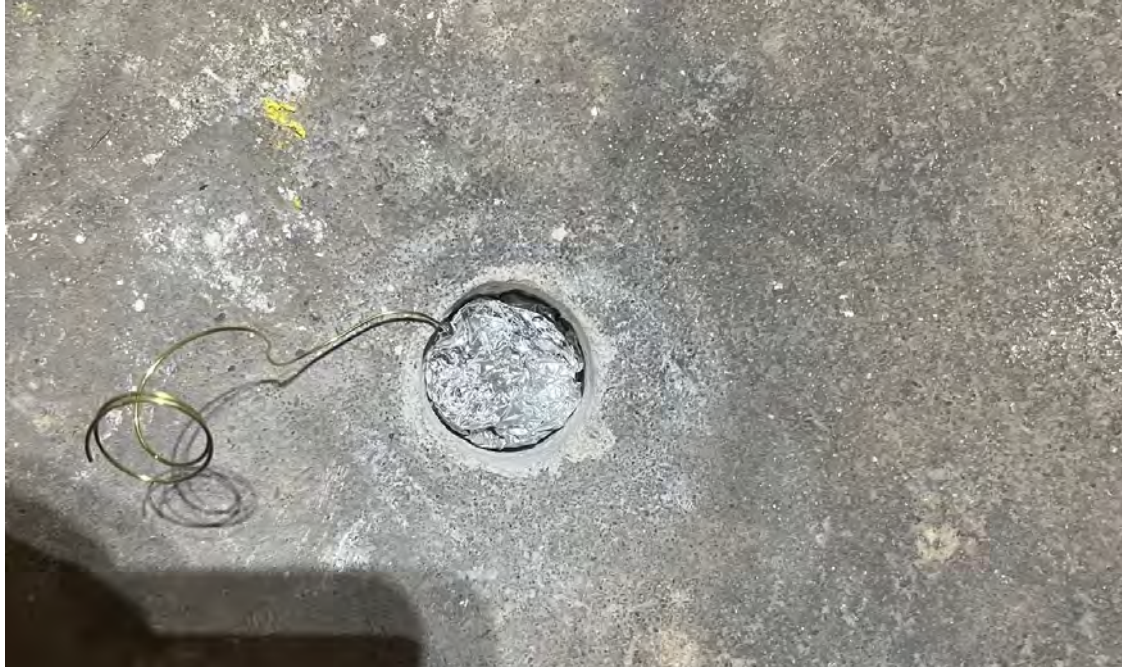
Photo 4: Sub-slab sample point SSV-02 in the 1233 12th Avenue building following installation of the passive sampler and aluminum foil plug. 3/22/2023

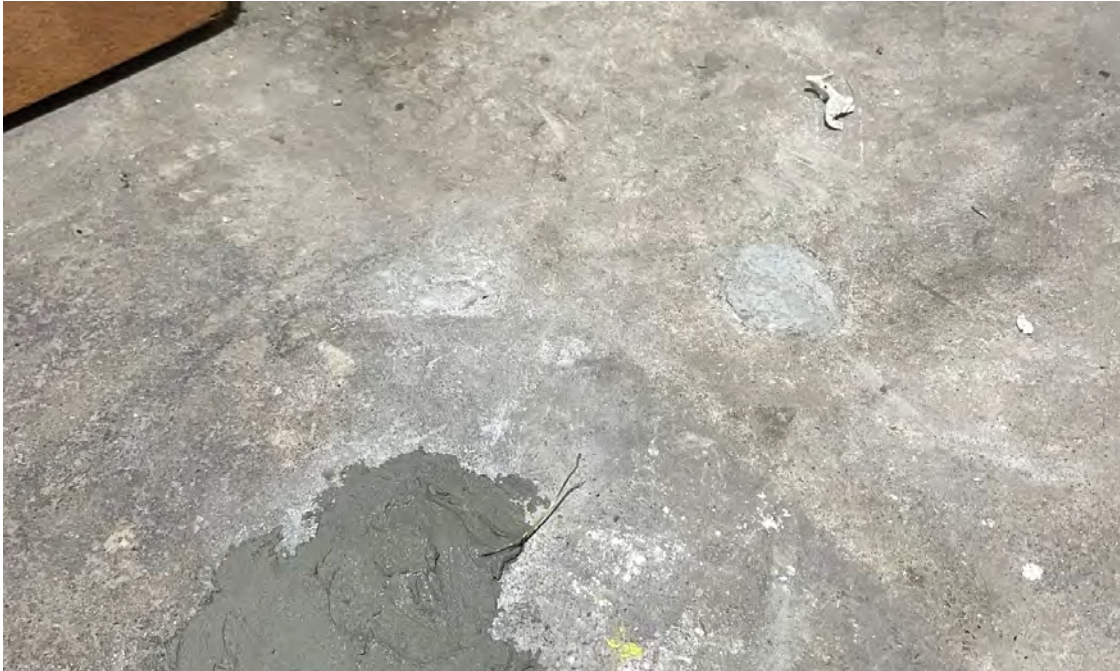
Photo 5: Sub-slab sample point SSV-02 in the 1233 12th Avenue building following installation of the temporary cement cap. Previous SS-2 sample location visible. 3/22/2023.

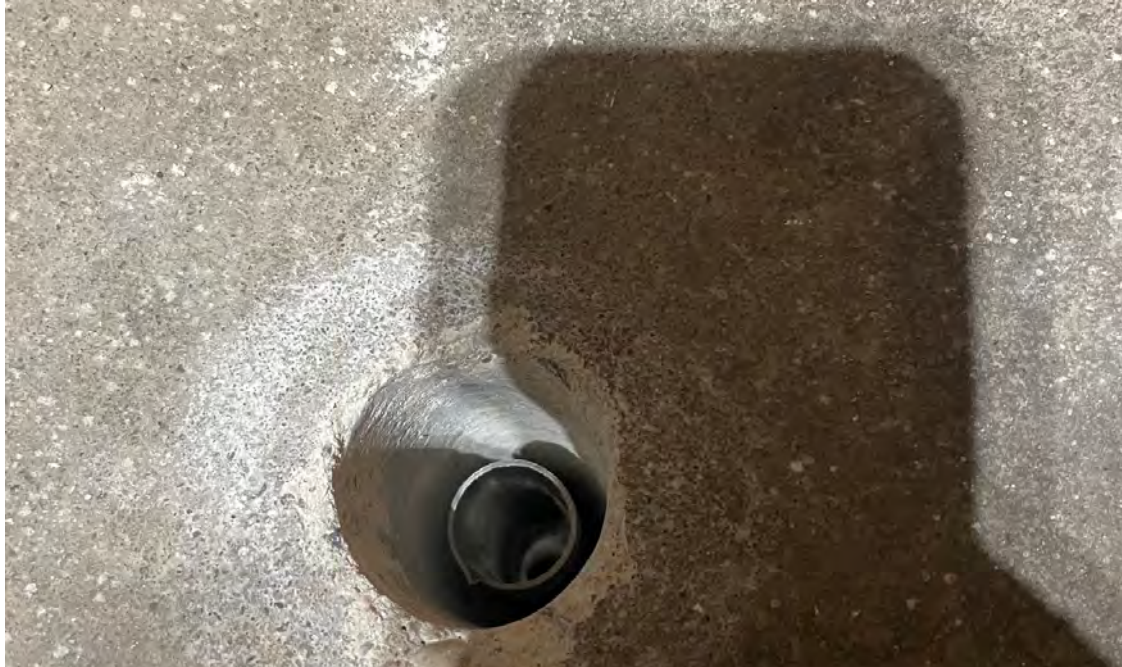
Photo 6: Sub-slab sample point SSV-03 in the 1233 12th Avenue building following installation of the aluminum tube. 3/22/2023..

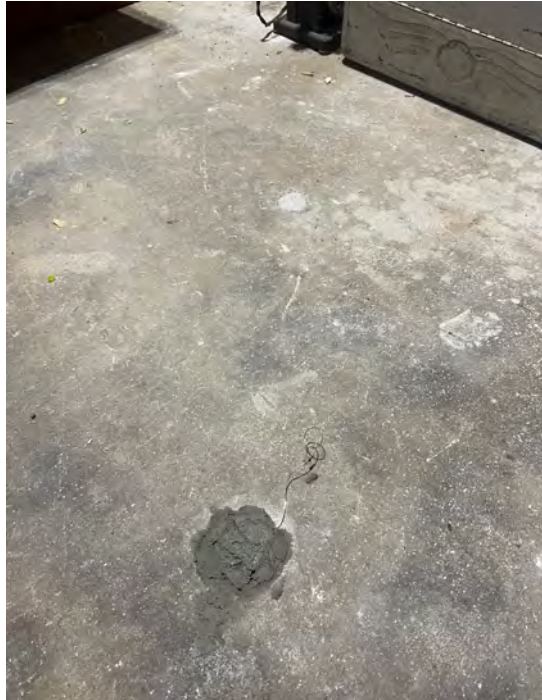
Photo 7: Sub-slab sample point SSV-03 in the 1233 12th Avenue building following installation of the temporary cement cap. Previous SS-3 sample location visible. 3/22/2023.

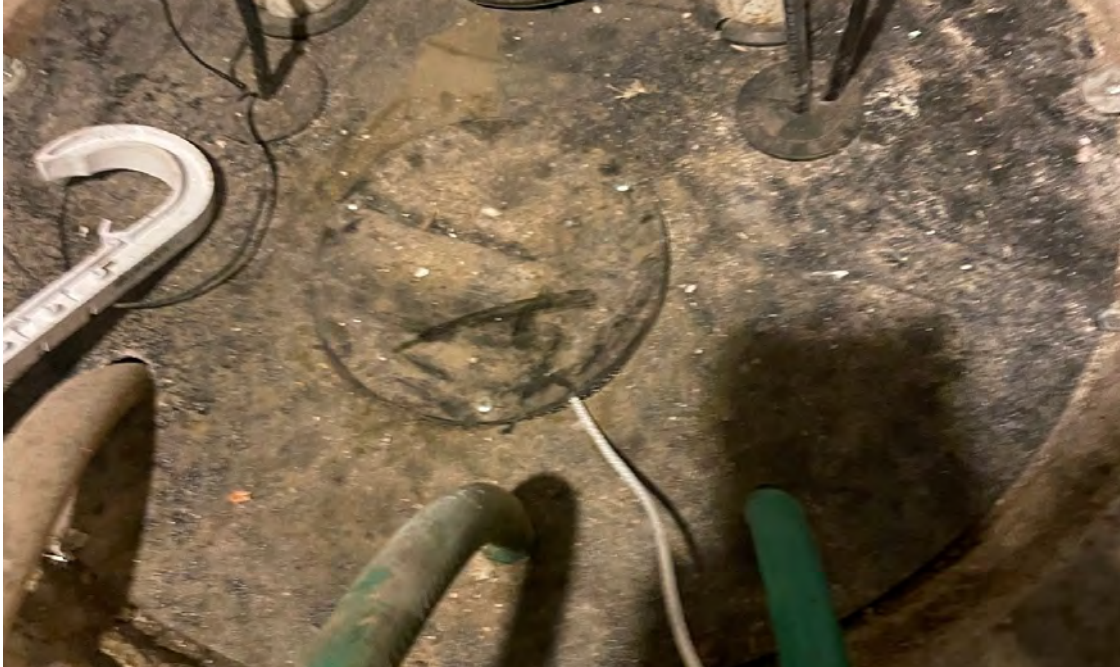
Photo 6: Passive sampler installed in headspace of basement sump in the 1229 12th Avenue building. 3/22/2023.

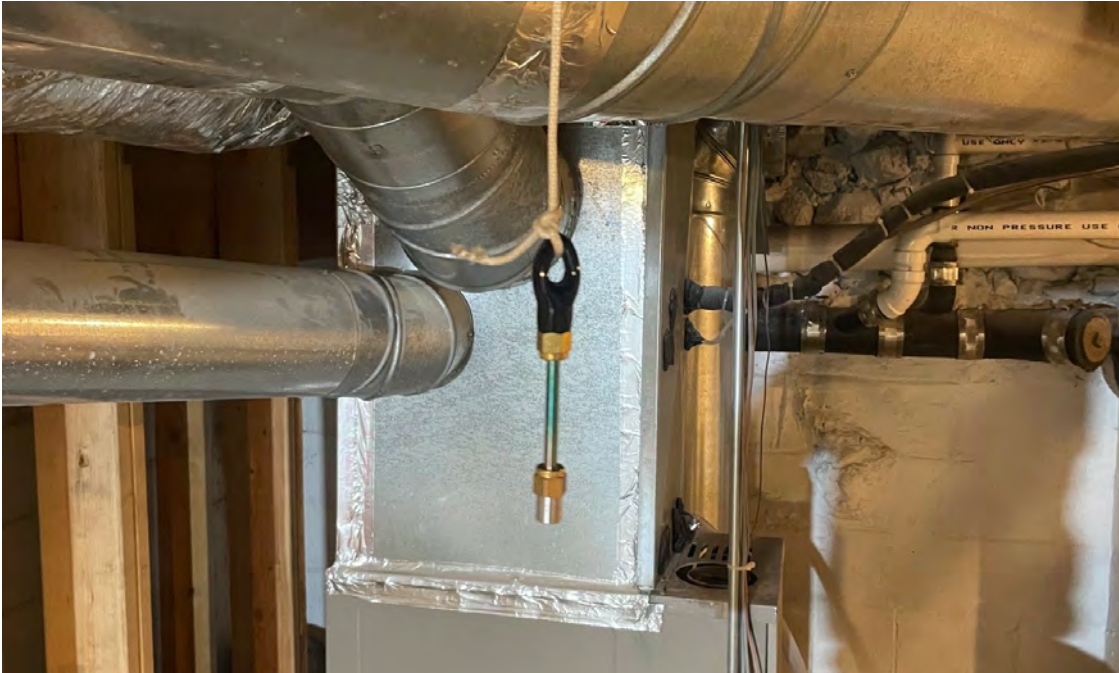
Photo 9: Indoor air sampler installed in basement of 1229 12th Avenue building. 3/22/2023.

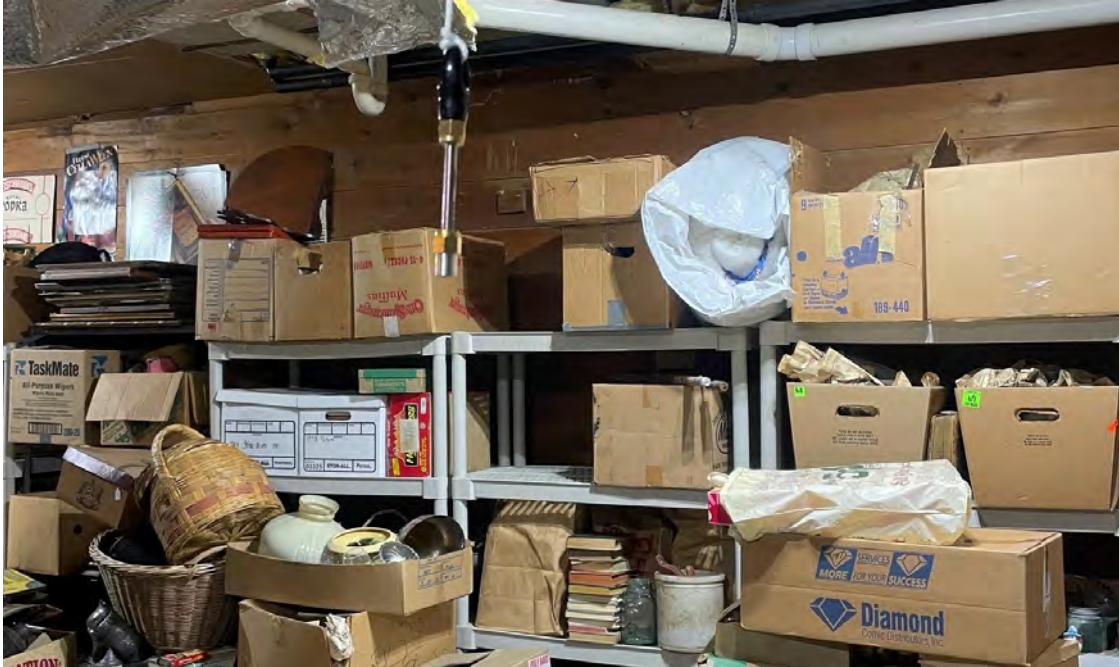
Photo 10: Indoor air sampler installed in ground floor of 1233 12th Avenue building. 3/22/2023.

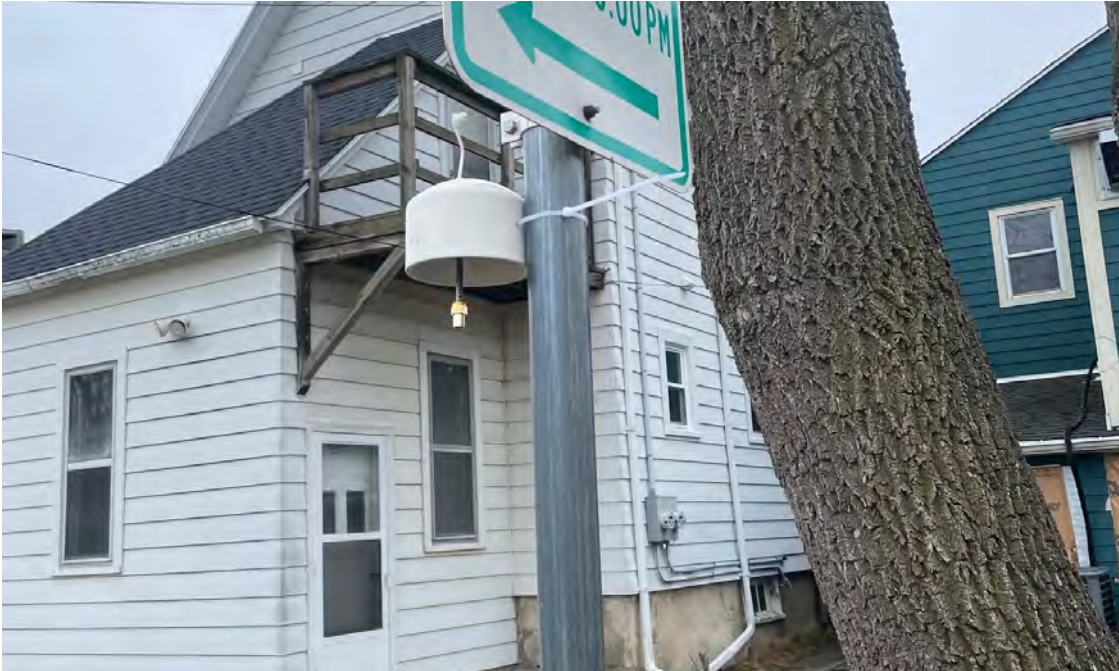
Photo 11: Ambient air sampler installed to the west of the 1229 12th Avenue building. View to northeast. 3/22/2023

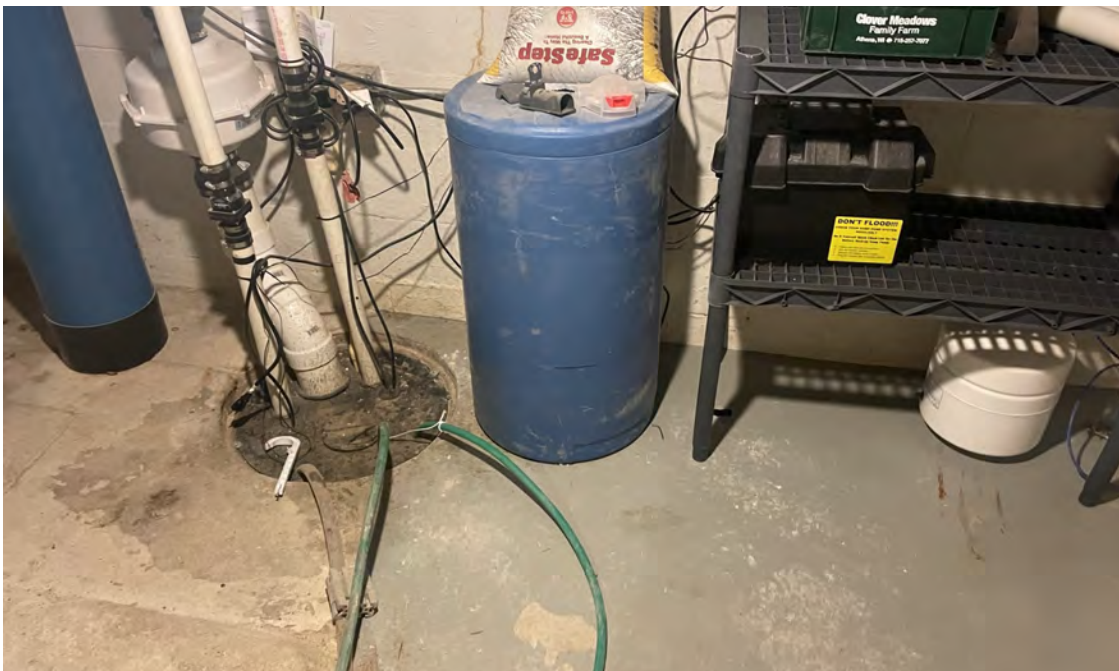
Photo 12: View of sealed sump in basement of 1229 12th Avenue building prior to retrieval of sampler from sump headspace. View to north. 3/29/2023.

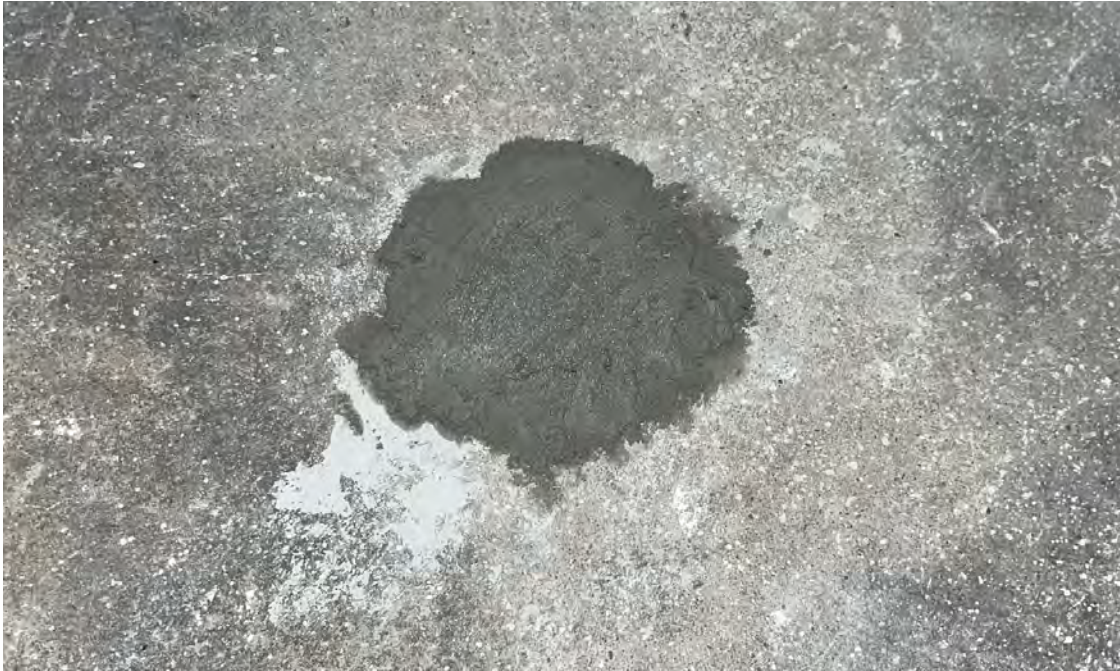
Photo 13: Filled and sealed location of SSV-02 in 1233 12th Avenue building following passive sampler retrieval. 3/29/2023.

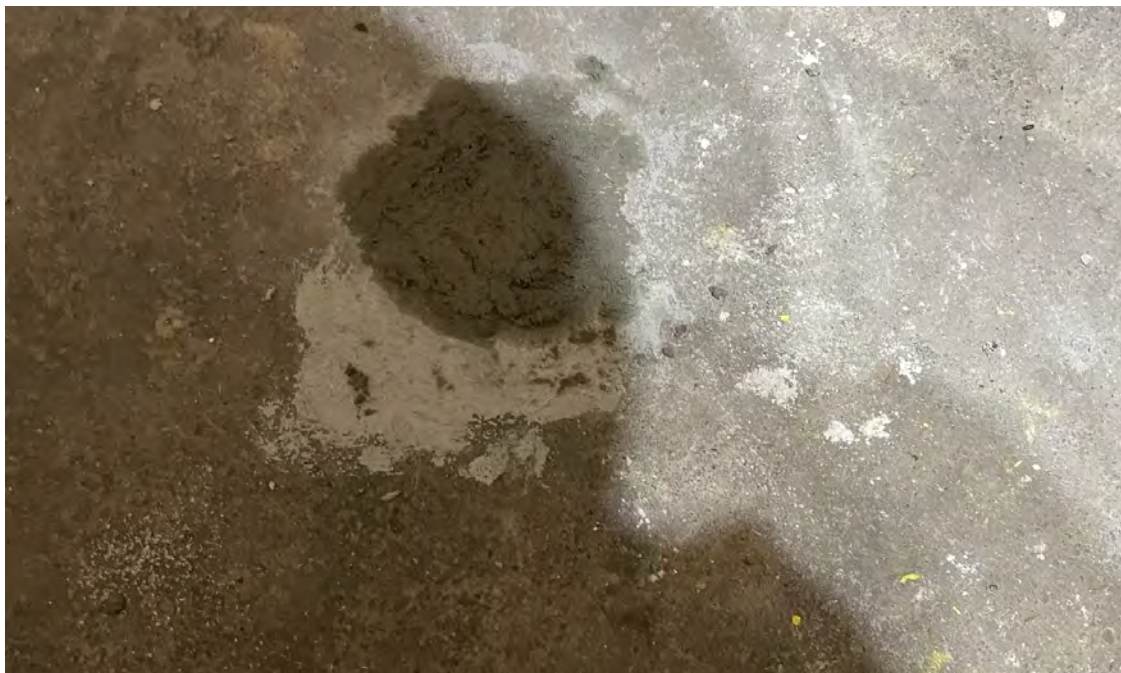
Photo 14: Filled and sealed location of SSV-03 in 1233 12th Avenue building following passive sampler retrieval. 3/29/2023.

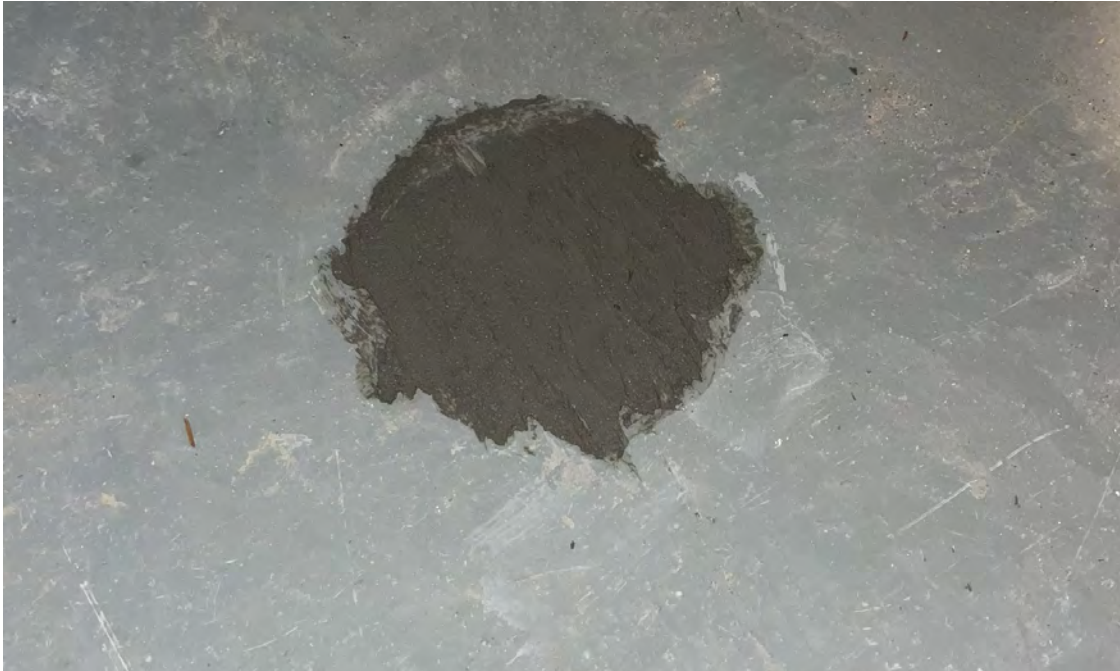
Photo 15: Filled and sealed location of SSV-01 in 122912th Avenue building following passive sampler retrieval. 3/29/2023.

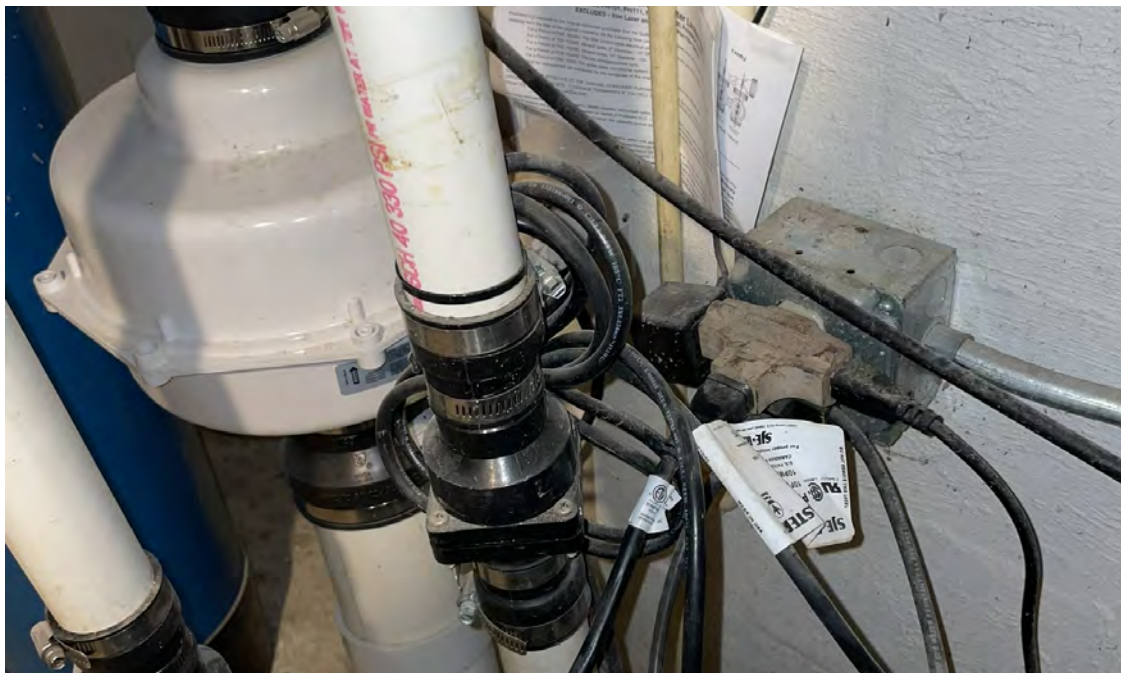
Photo 16: Reactivated vapor mitigation system in 1229 12th Avenue building. 3/29/2023.
