SUBJECT: Final Case Closure with Continuing Obligations  
Nicolet Trails Campground, 310 E. Washington Street, Gillett, WI  
DNR BRRTS Activity #: 03-43-560923

B.2.b.  
RESIDUAL SOIL CONTAMINATION  
NICOLET TRAILS  
CAMPGROUND

**B.I.b.**  
**DETAILED SITE MAP**  
**NICOLET TRAILS**  
**CAMPGROUND**

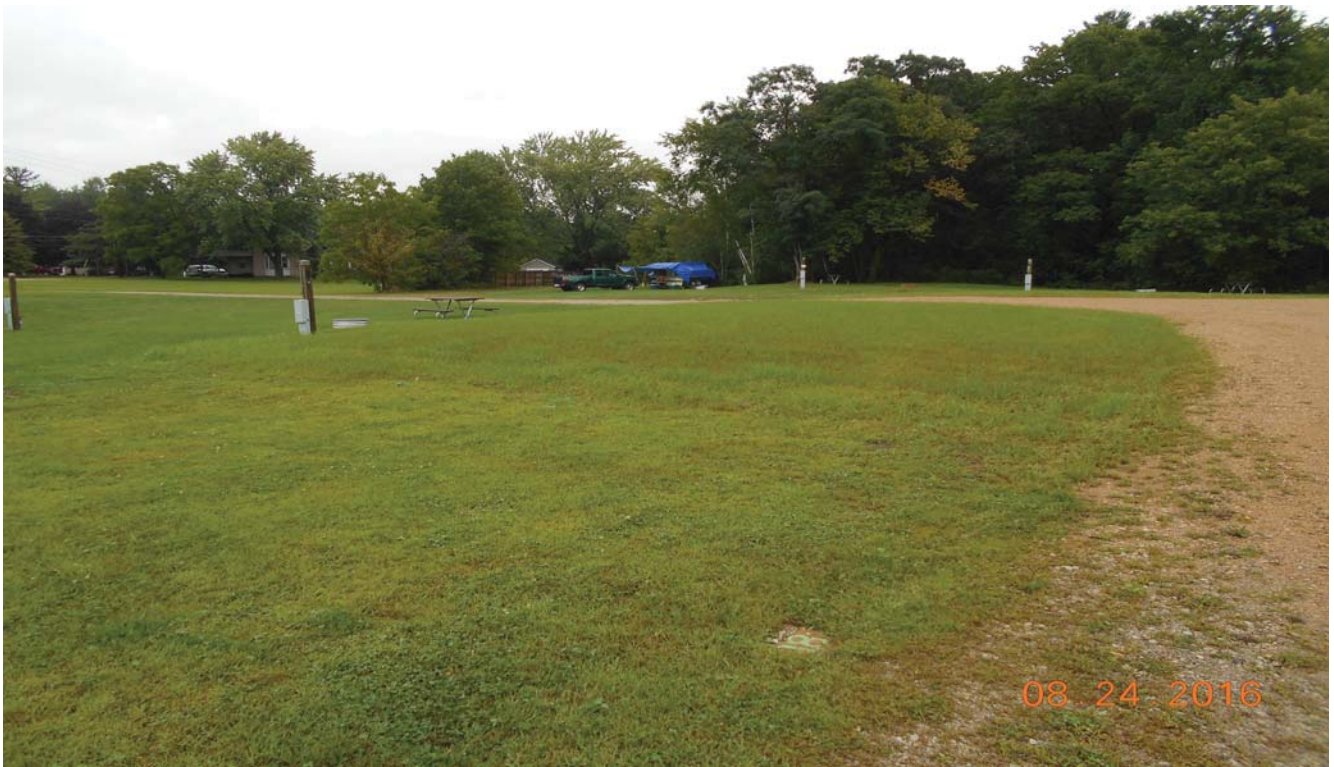
Facing east/northeast

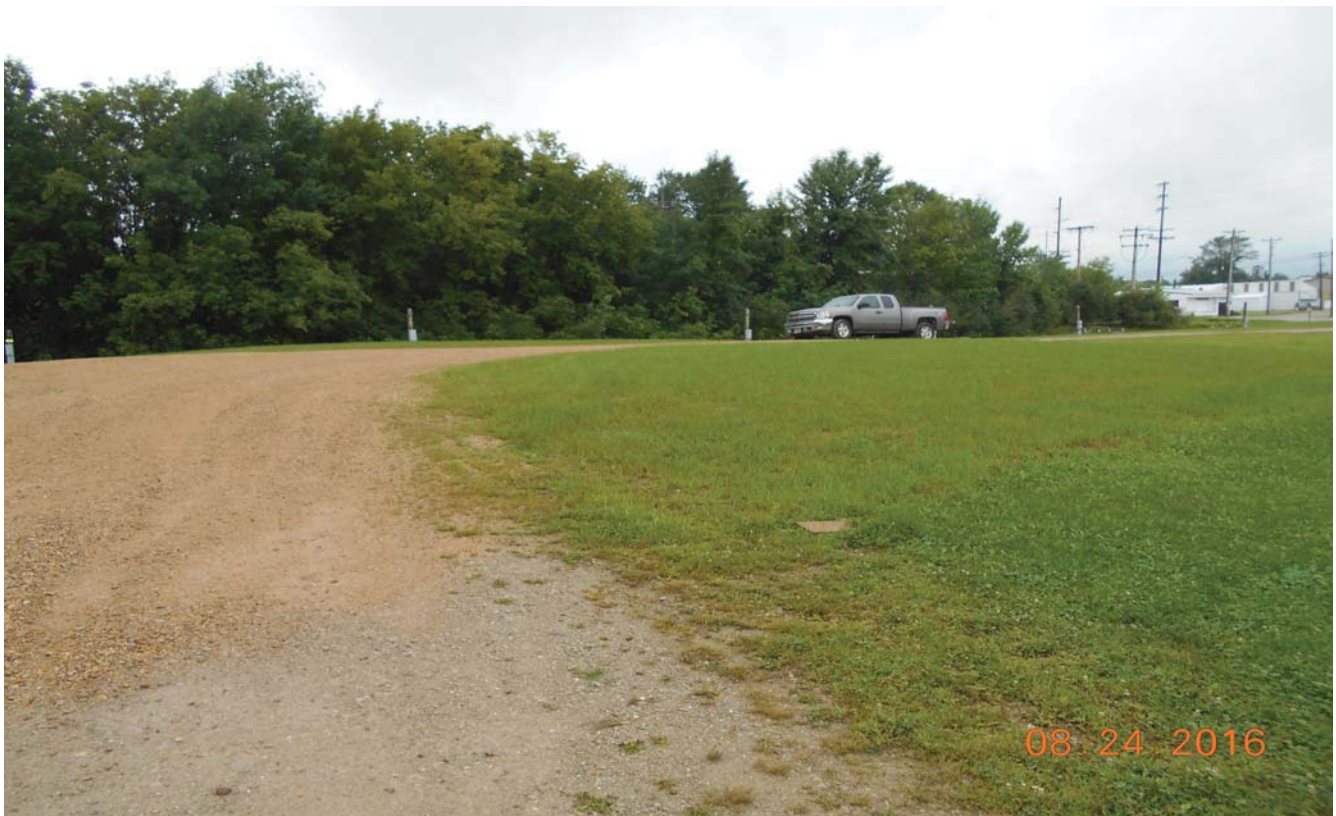
Facing South

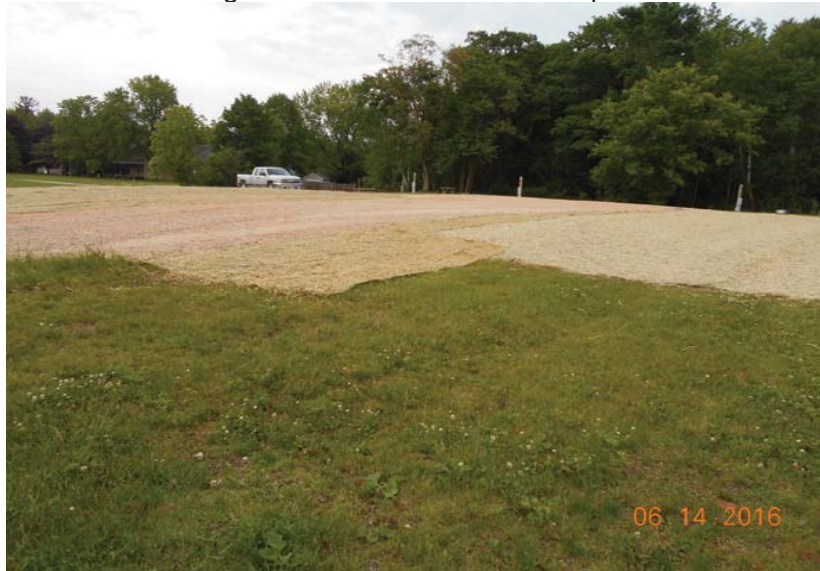
Photo #17: Facing east/northeast. Finished cap.

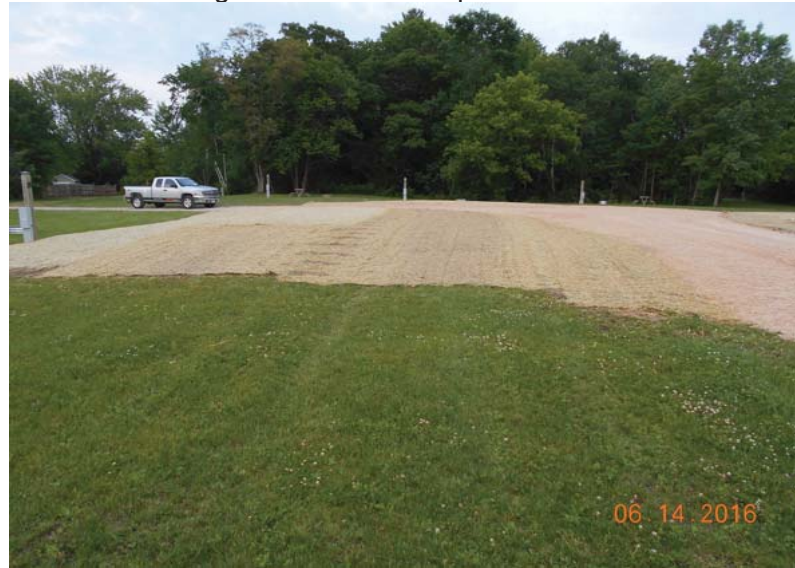
Phot #18: Facing east. Finished cap.

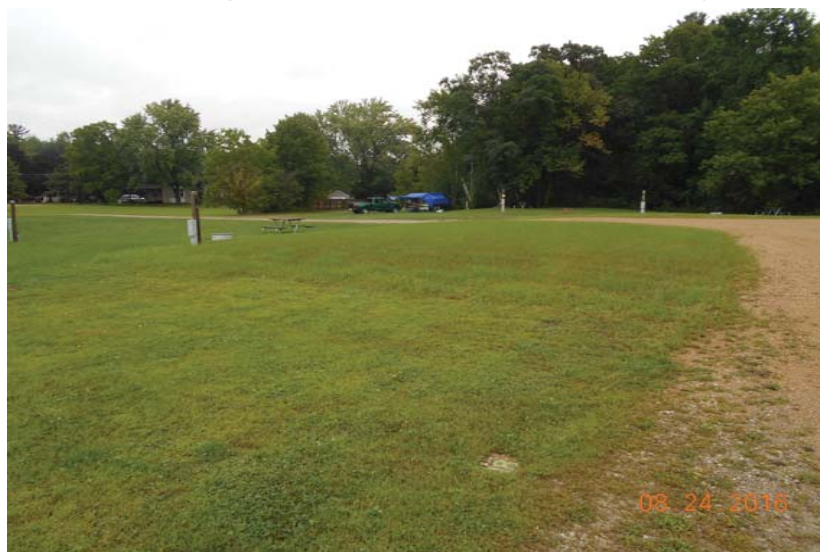
Photo #19: Facing east/northeast. Two months after project.

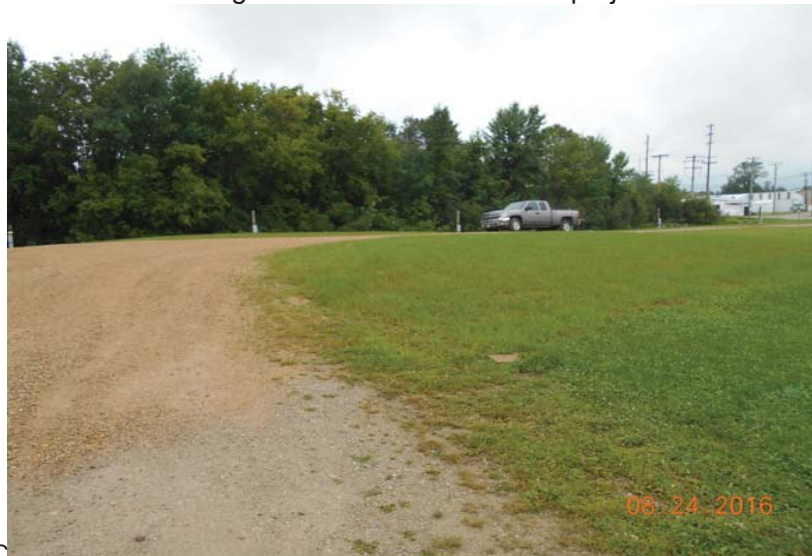
Photo #20: Facing south. Two months after project.

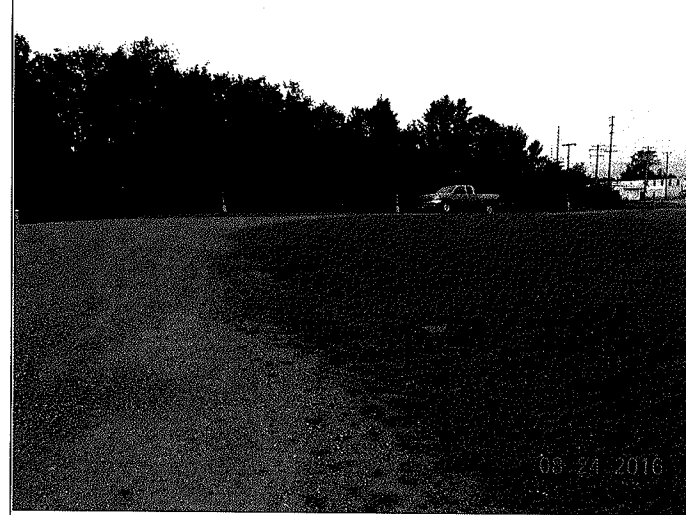
Title: Area of Cap to be Maintained (Facing South)
