The Department of Natural Resources (DNR) considers Jim's Monroe Street Cleaners closed, with continuing obligations. No further investigation or remediation is required at this time. However, you, future property owners, and occupants of the property must comply with the continuing obligations as explained in the conditions of closure in this letter. Please read over this letter closely to ensure that you comply with all conditions and other on-going requirements. Provide this letter and any attachments listed at the end of this letter to anyone who purchases, rents or leases this property from you.

Title: Location Map		<b>FEHR GRAHAM</b> ENGINEERING & ENVIRONMENTAL	
Site: Jims Monroe St Cleaners Former 2530-2536 Monroe St. Madison, WI 53711		Job # 14-1349 BRRS# 02-13-561937	
Description:	Appvd:	Date: 4/15/14	File: F: Base Map-Site Phalen-14.1349.skf
Rev: Date:		Drawn: MKH	Appvd: Figure: D.1

PHOTOGRAPHS OF VAPOR MITIGATION SYSTEMS & SOIL CAP

JIMS MONROE ST CLEANERS FORMER, MADISON, WI  
WDNR BRRTS #: 02-13-561937

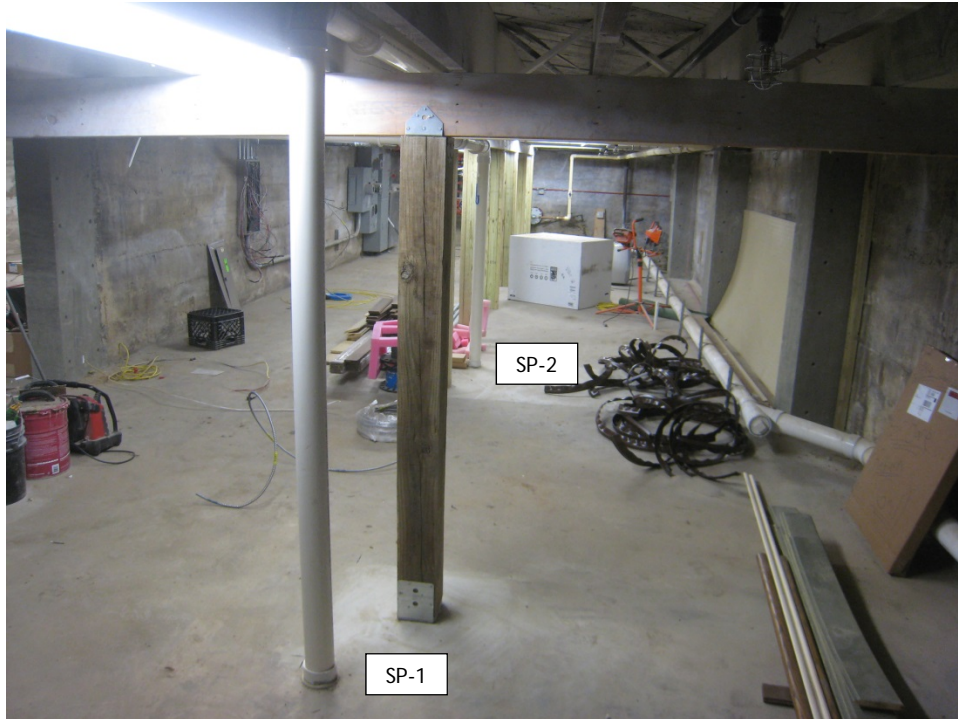
Vapor Mitigation System and Soil Cap in basement at the 2536 address. Two floor penetrations are installed at this address (West U-Tube location). Looking southeast, photo taken 2/5/15.

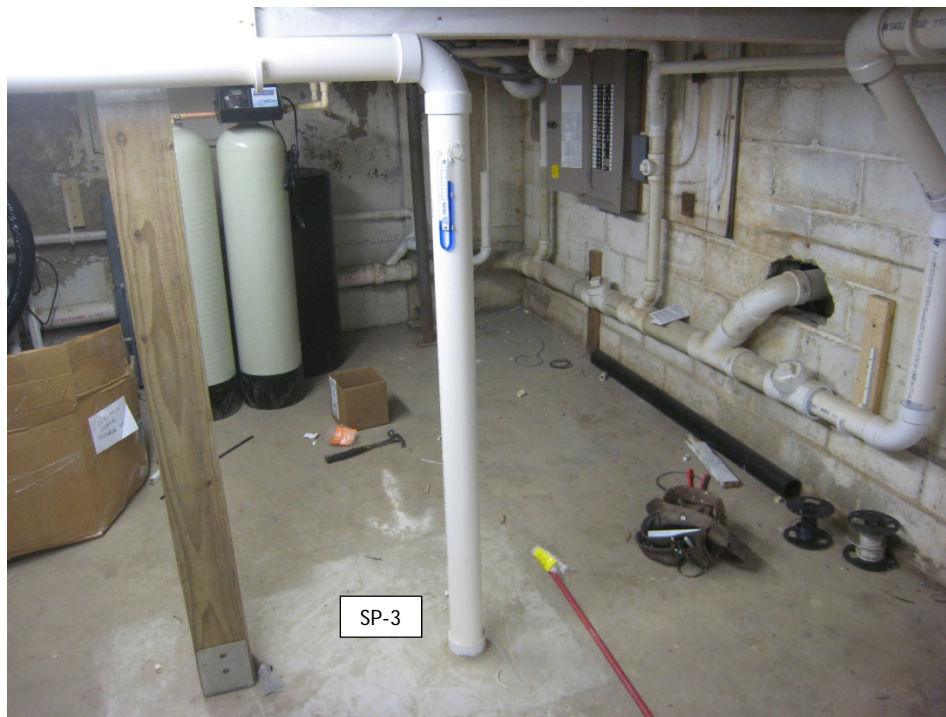
Vapor Mitigation System and Soil Cap in basement at the 2534 address. One floor penetration is installed at this address (Central U-Tube location). Looking north, photo taken 2/5/15.  
Note: The U-Tube should look as pictured in photo, with one side of the fluid higher than the other if fan is functioning properly. If fluid levels are equal, fan is not operating.

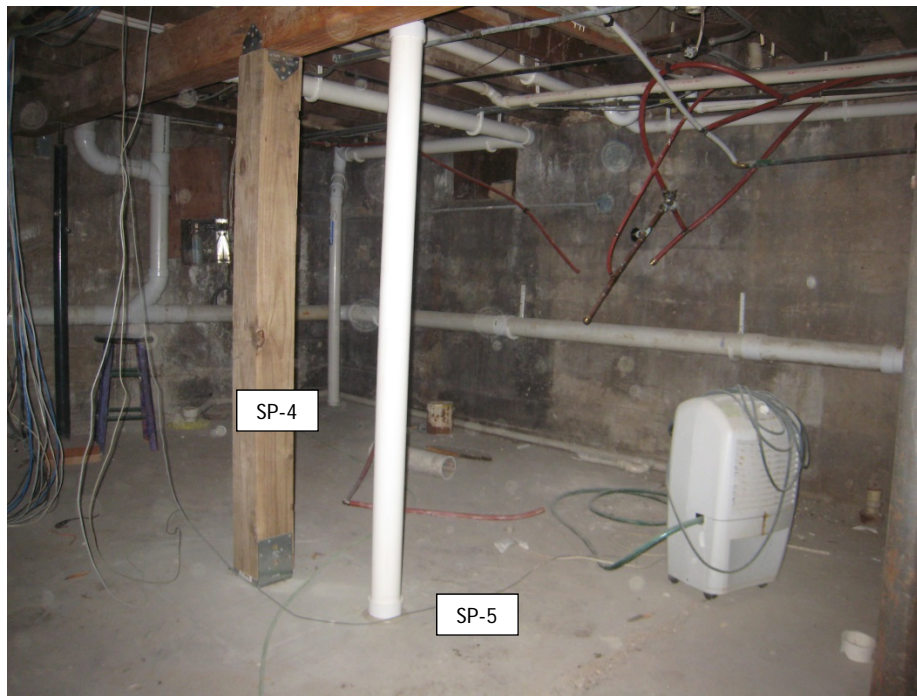
Vapor Mitigation System and Soil Cap in basement at the 2532 address. Two floor penetrations are installed at this address (East U-Tube location). Looking west, photo taken 2/5/15.

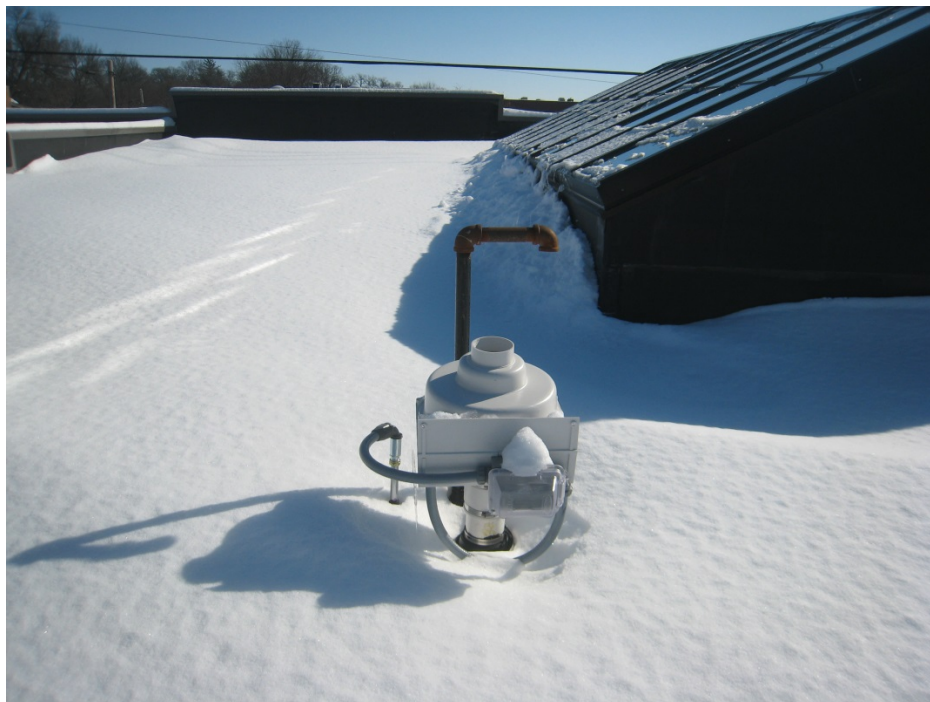
One of two high vacuum fans (RadonAway GP501) located on building roof (2536 Monroe St.). This fan exhausts subslab vapors from the 2534 and 2536 address. The other fan exhausts vapors from the 2532 address. Looking southeast, photo taken 2/5/15.
