RE: General Notice of Potential Liability and Request for Information
Vogue Cleaners Site
2578 Wauwatosa Avenue
Wauwatosa, Milwaukee County, Wisconsin 53213
Site Spill Identification Number: C51R

Figure #
 Proposed Soil Boring Locations
 Vogue Cleaners Site
 Wauwatosa, WI

U.S. ENVIRONMENTAL PROTECTION AGENCY
 POLLUTION/SITUATION REPORT
 Vogue Cleaners - Removal Polrep
 Initial and Final Removal Polrep

Subject: POLREP #1
 First and Final POLREP
 Vogue Cleaners
 C51R
 Wauwatosa, WI
 Latitude: 43.0660780 Longitude: -88.0071050

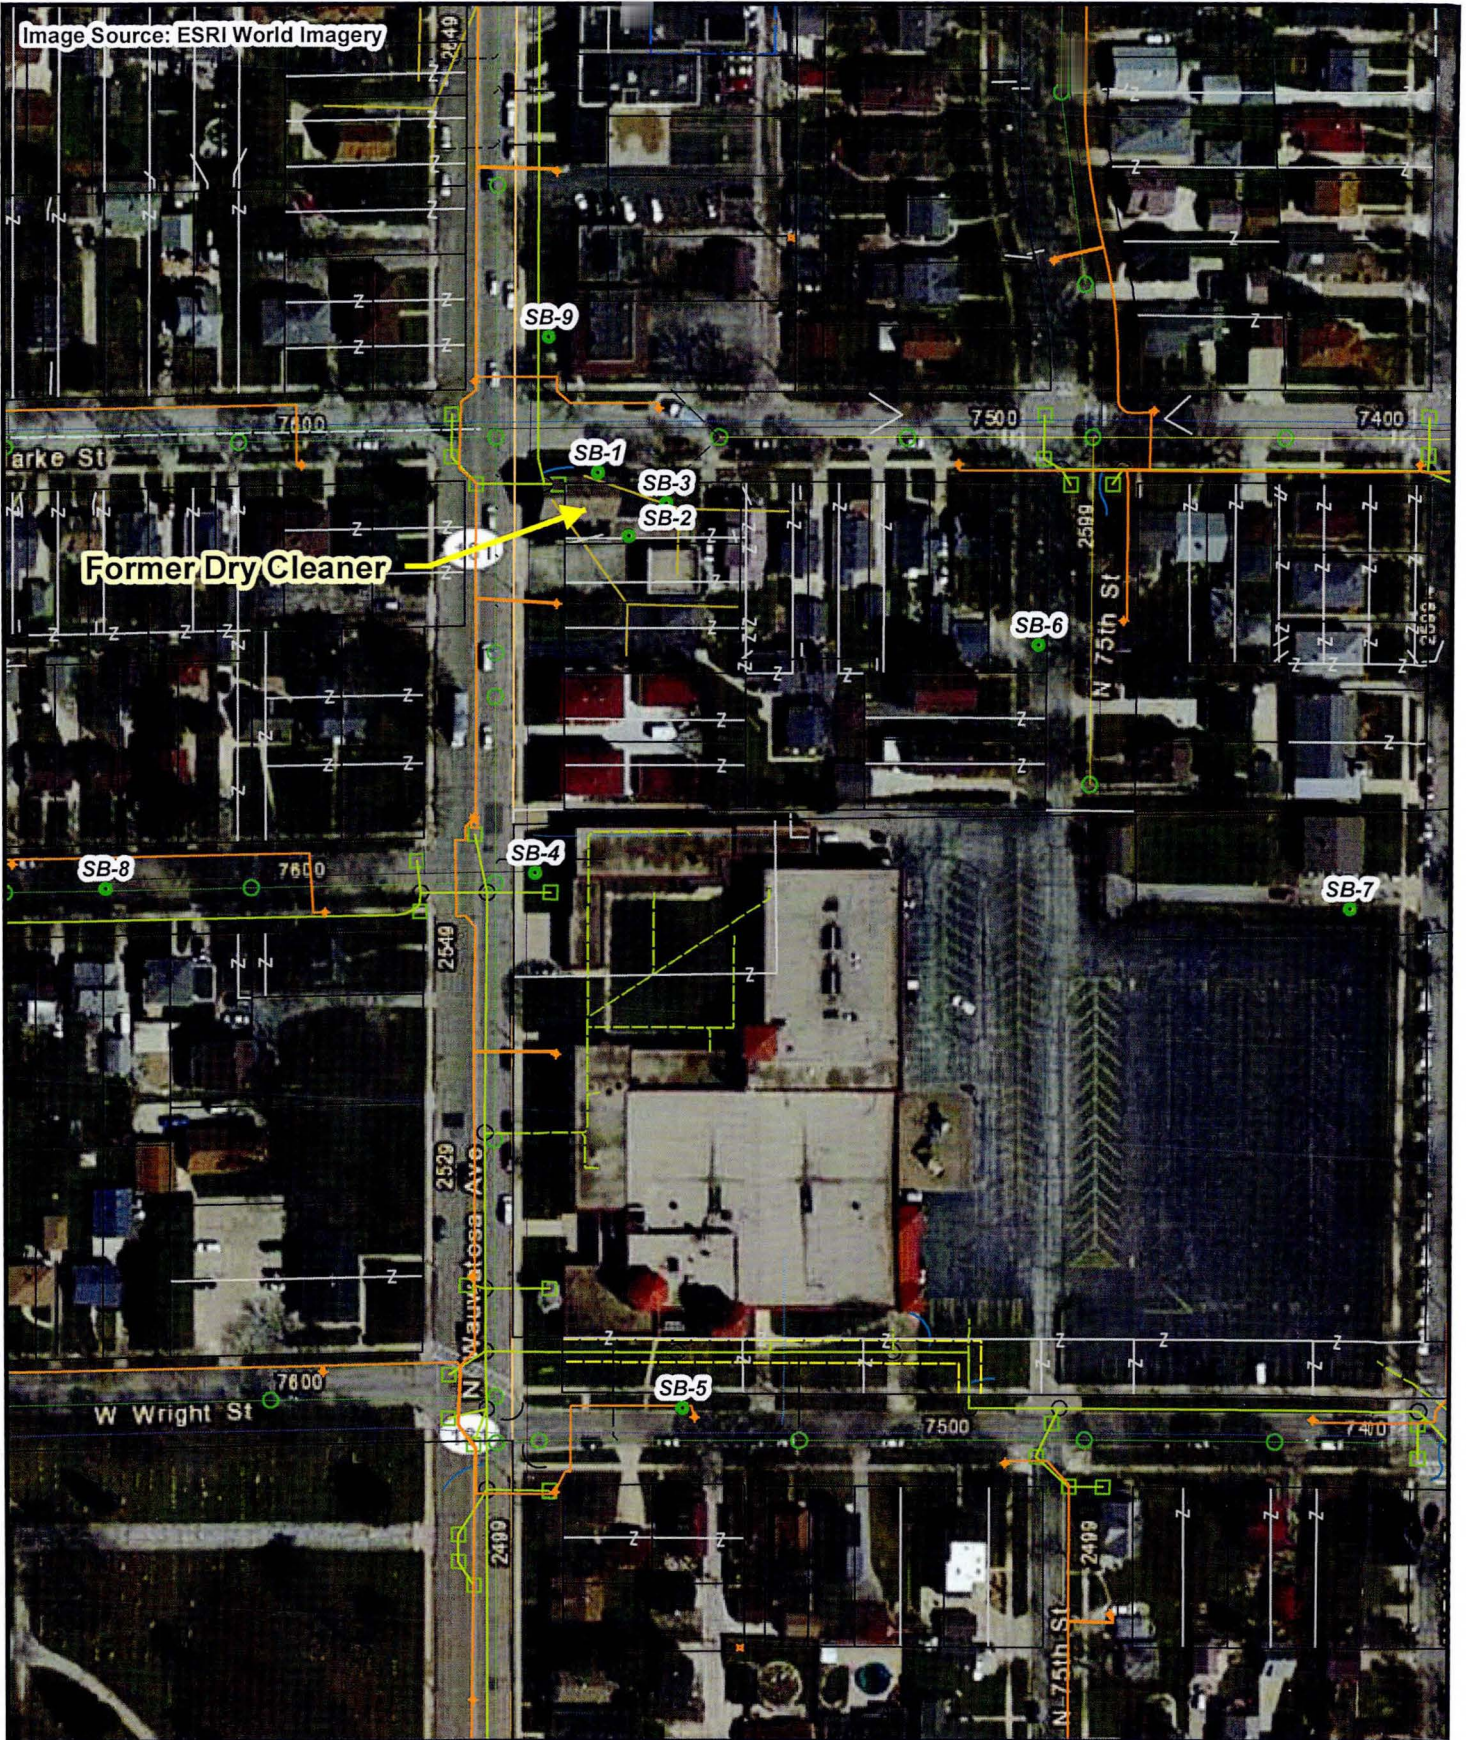
- Proposed Sampling Locations
- 0 175 Feet
