## PHASE II ENVIRONMENTAL SITE ASSESSMENT 2578 Wauwatosa Avenue Wauwatosa, Wisconsin

Parcel Ids: 331079200  
33179300

March 14, 2014  
Symbiont Project No. W121218

2578 Wauwatosa Avenue Property  
Wauwatosa, Wisconsin

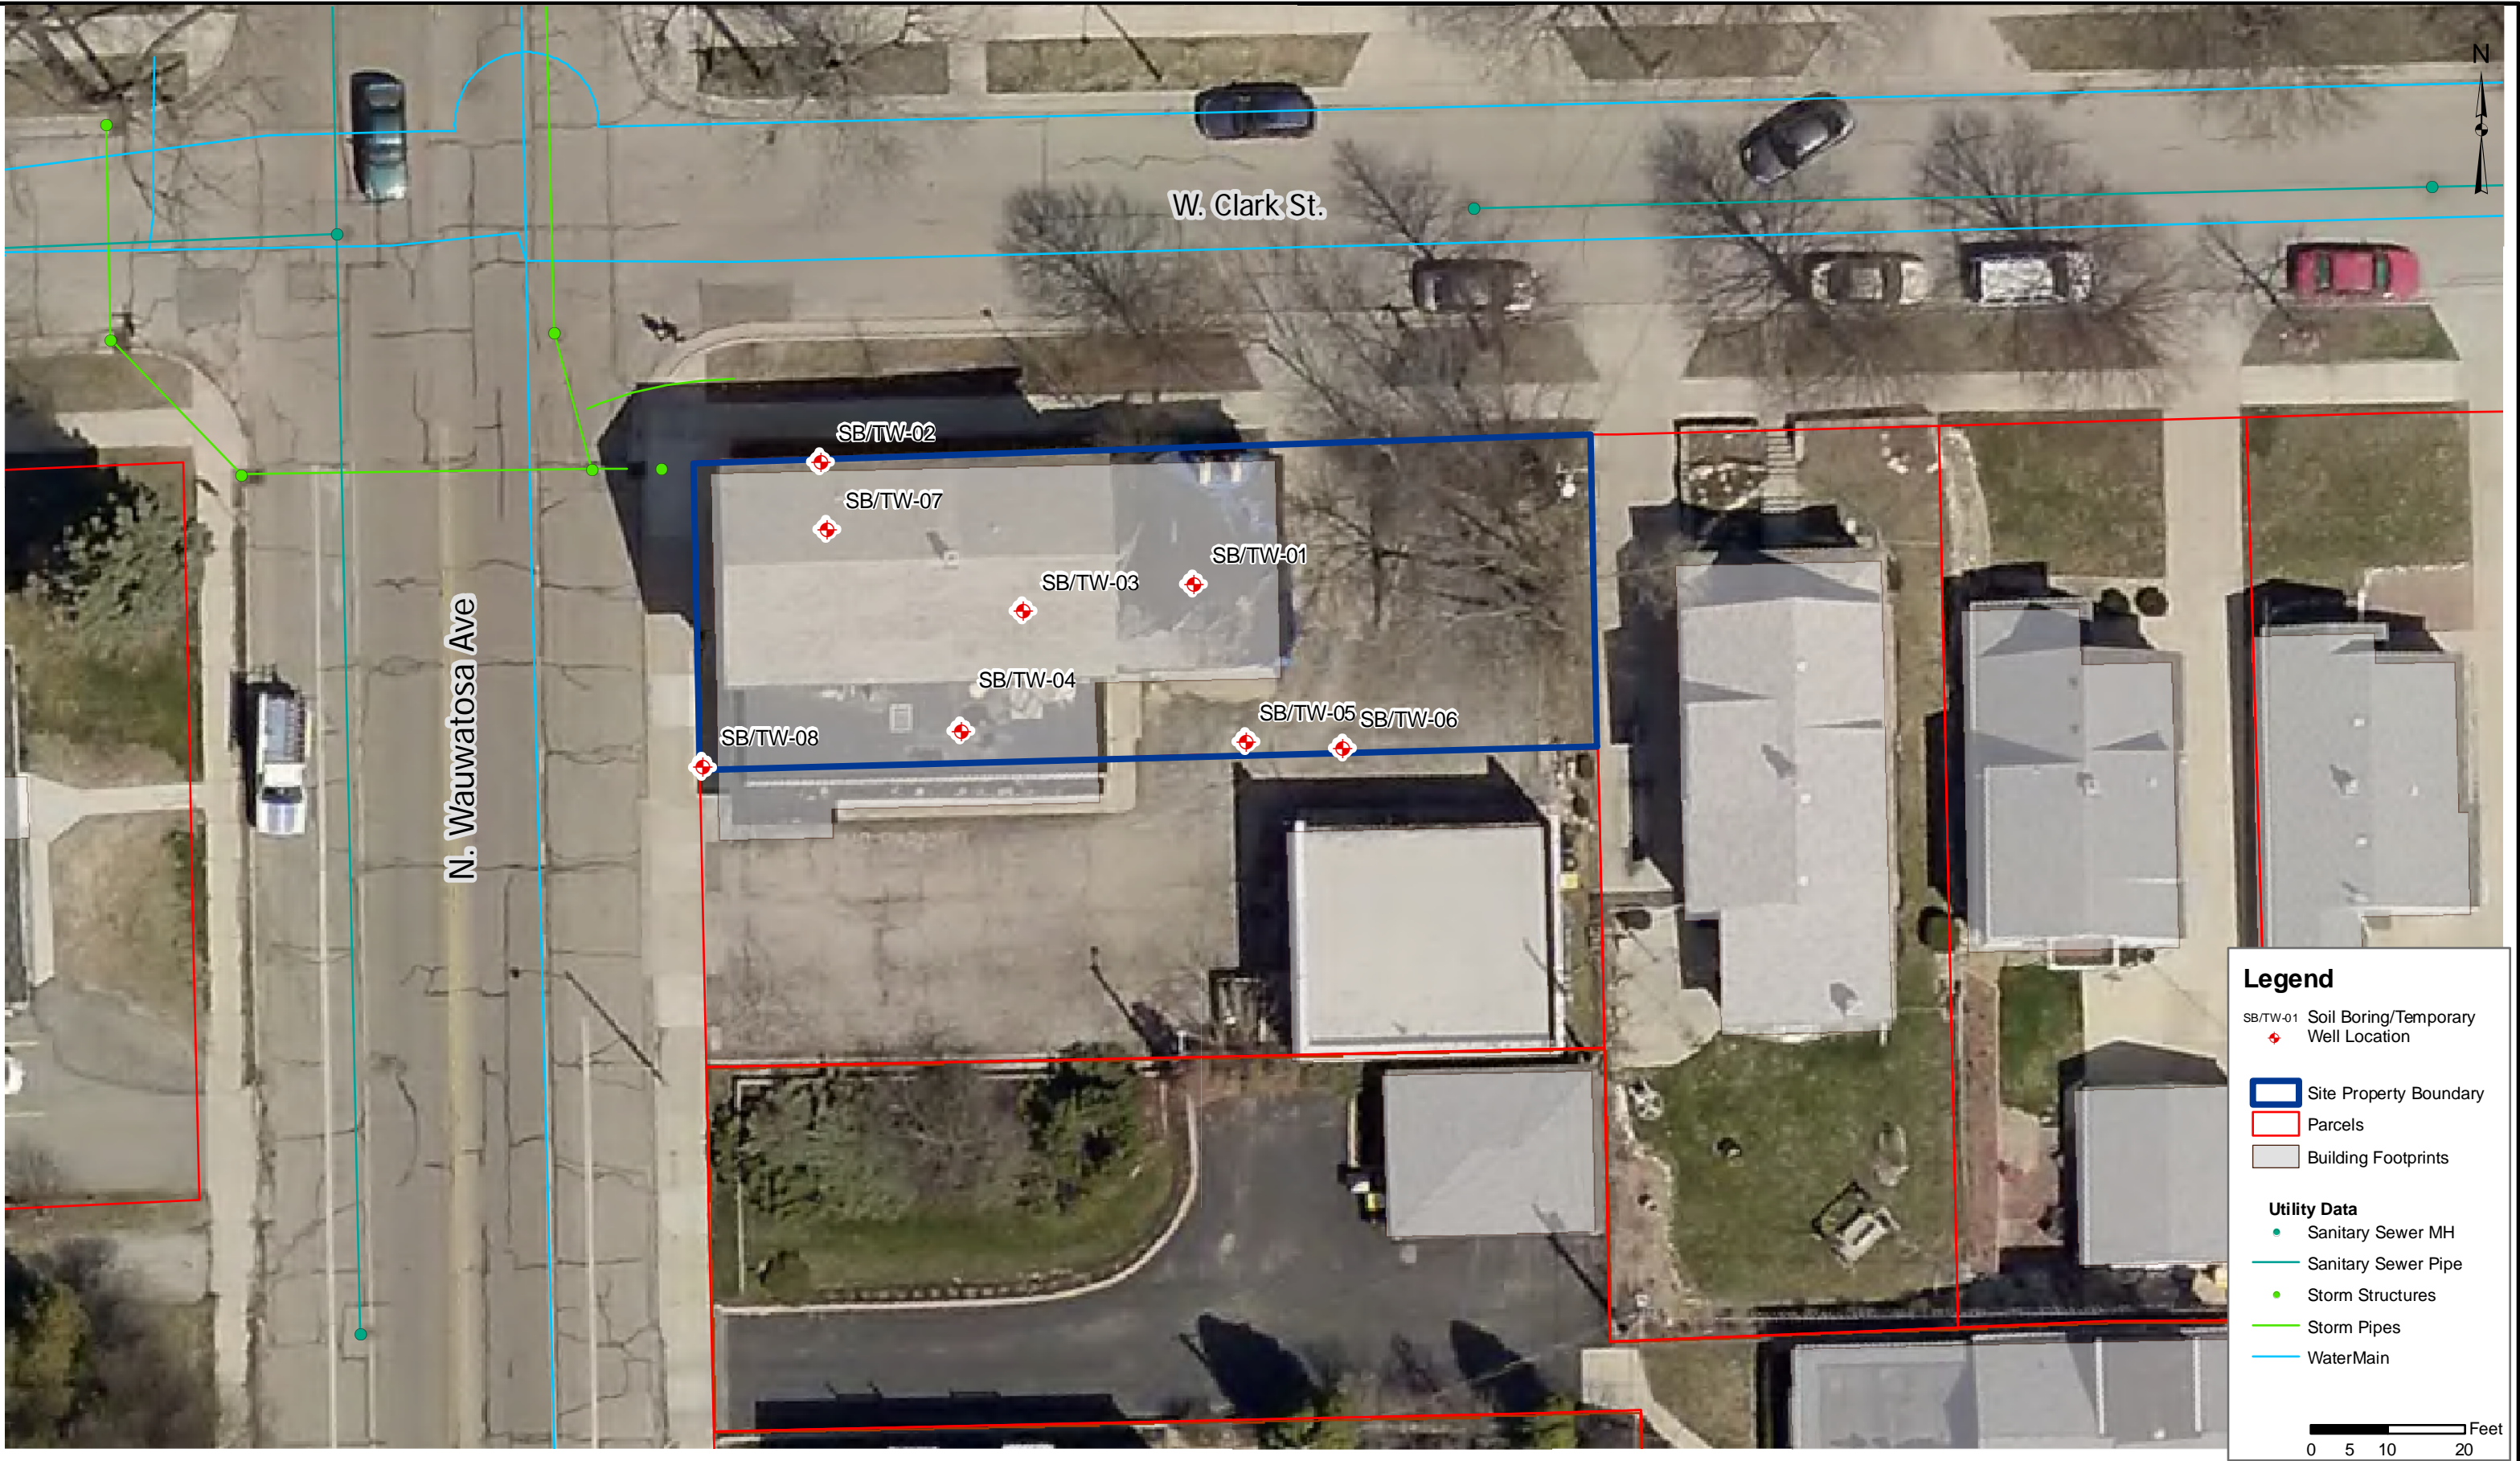
Site Basemap and Sample Locations

The general Site layout and soil/groundwater sample locations are depicted to scale on Figure 2. Sample locations include eight (8) soil borings, which were completed as temporary groundwater monitoring wells. Groundwater elevation and other survey measurements for the eight (8) temporary groundwater monitoring wells are summarized in the soil boring logs in Appendix B. Photographs taken during the Phase II ESA are presented in Appendix A. Soil boring logs for borings completed during the Phase II ESA are found in Appendix B and include lithologic descriptions, field PID readings, visual and olfactory indications of impacts, Unified Soil Conservation Service soil classifications, and temporary monitoring well construction details. Laboratory analytical results for soil and groundwater are presented in Appendix C and are summarized in Tables 1 and 2, respectively.

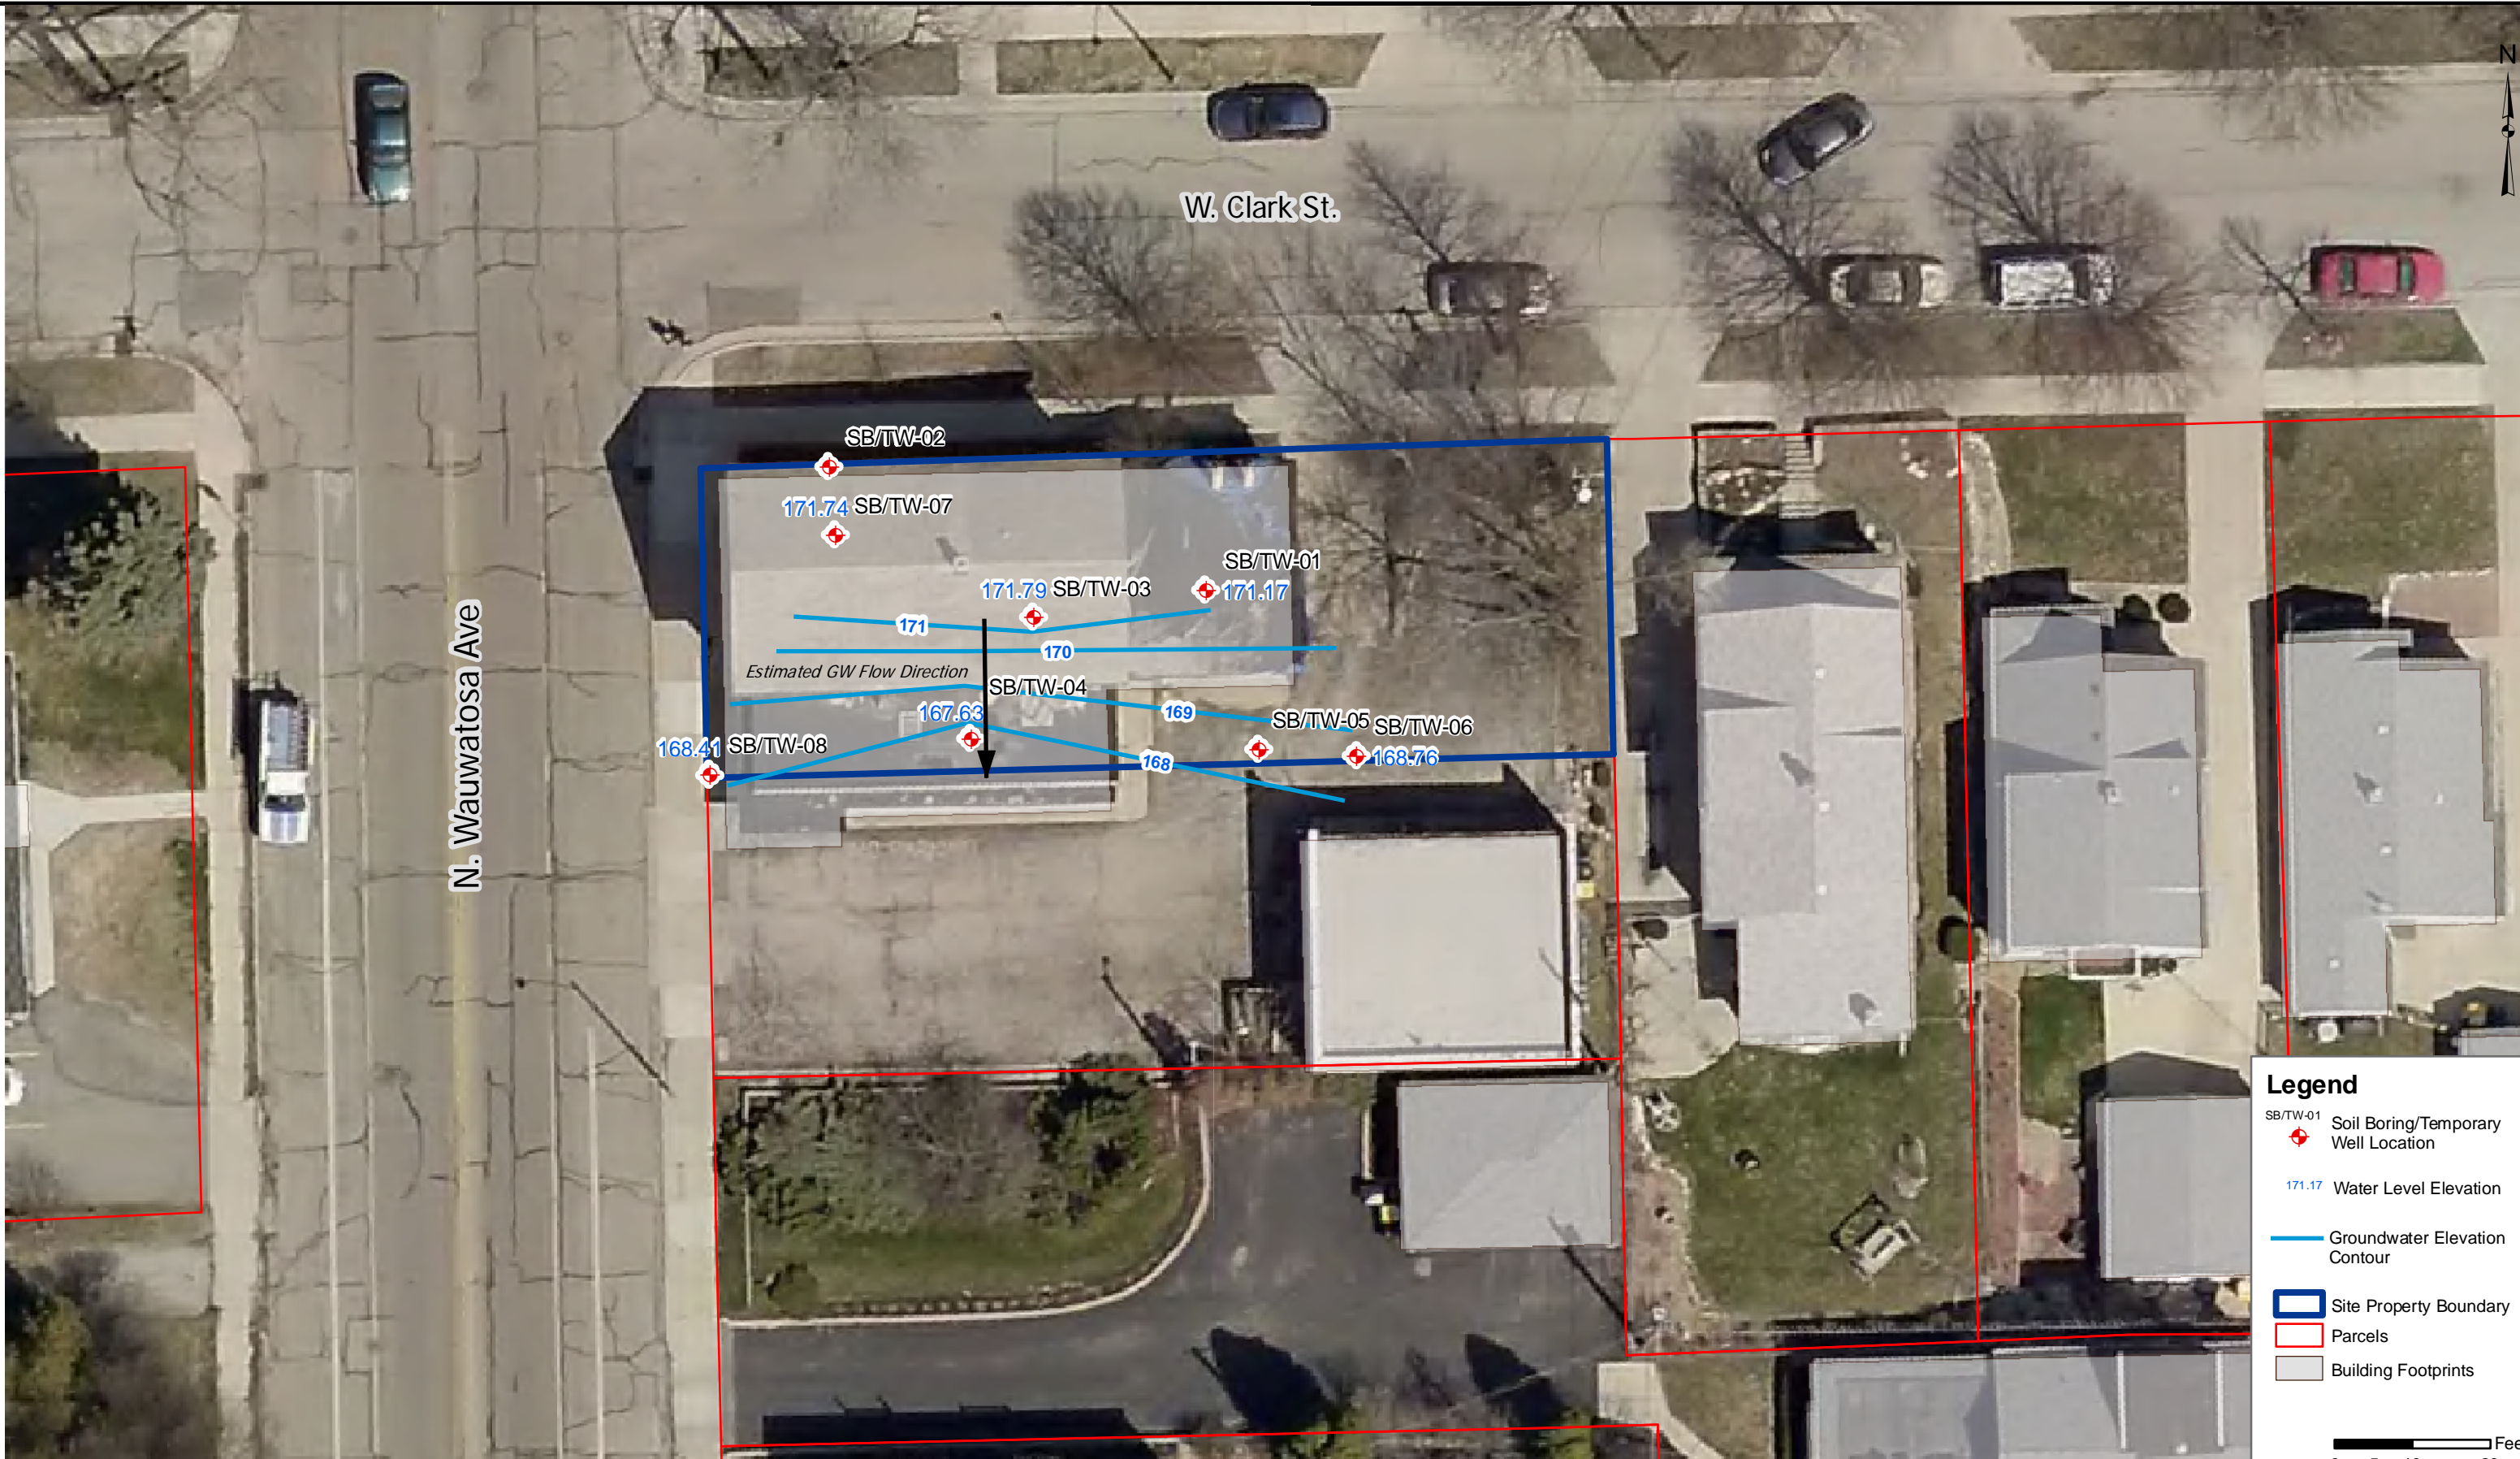
Based on field observations and groundwater measurements the general gradient of shallow groundwater across the Site on January 31, 2014 appears to be south in the general direction of the Menomonee River. Shallow groundwater elevations could be influenced by the presence of paved surfaces, buildings, foundations, and/or subsurface anomalies. Table 3 and Figure 5 summarize the survey and groundwater level measurements for the Site.

Potentiometric Surface Maps

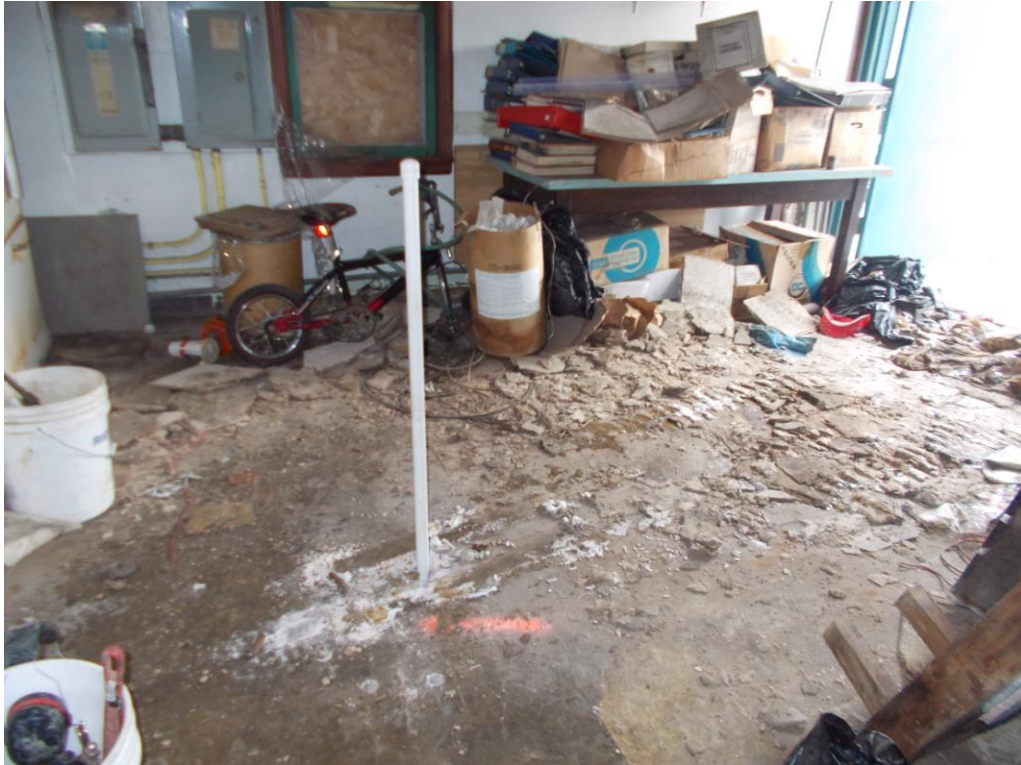
1) SB/TW-1 completed with temporary monitoring well

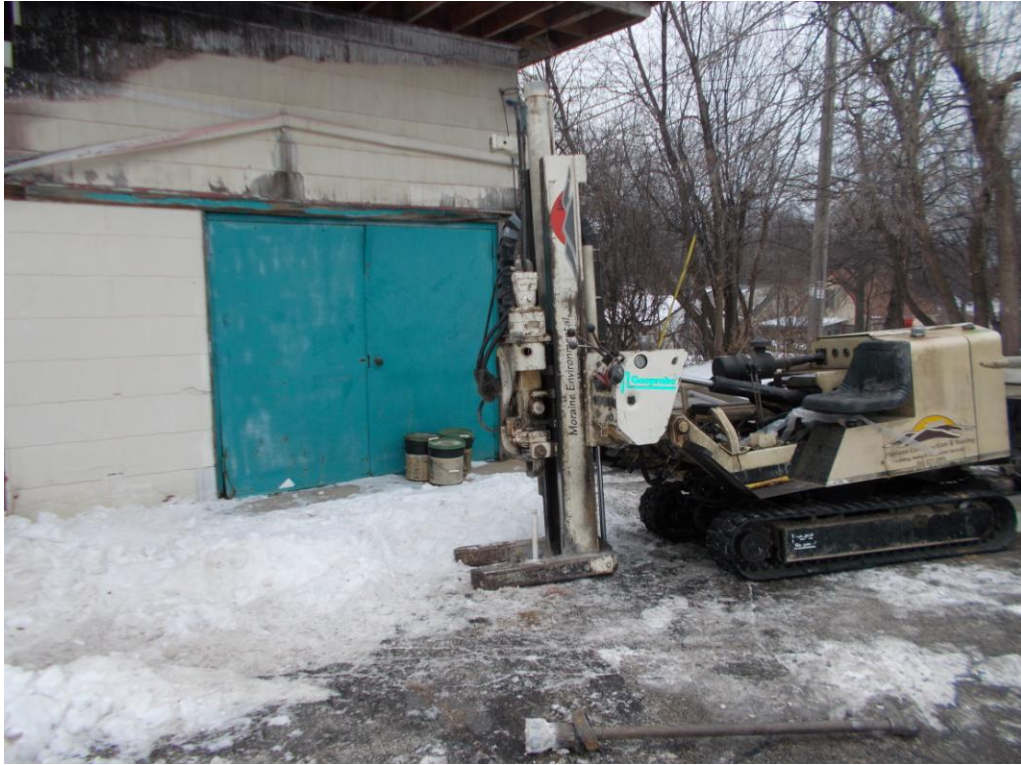
3) Location of SB/TW-5 being completed with temporary monitoring well

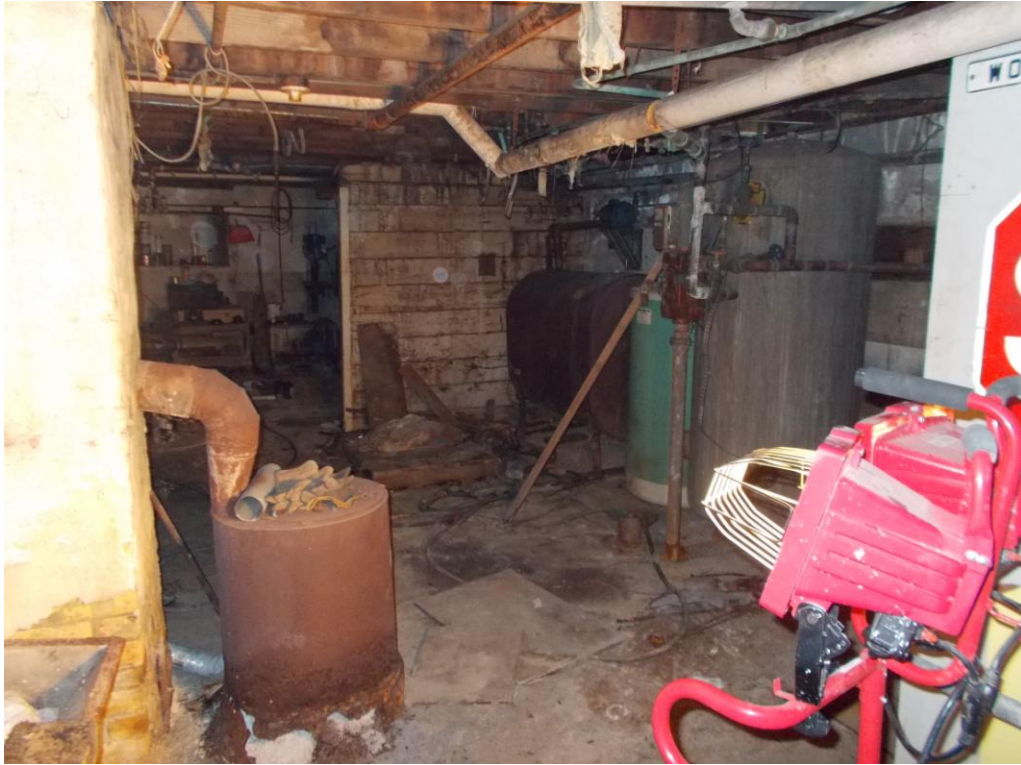
5) View of the basement and general location of SB/TW-7

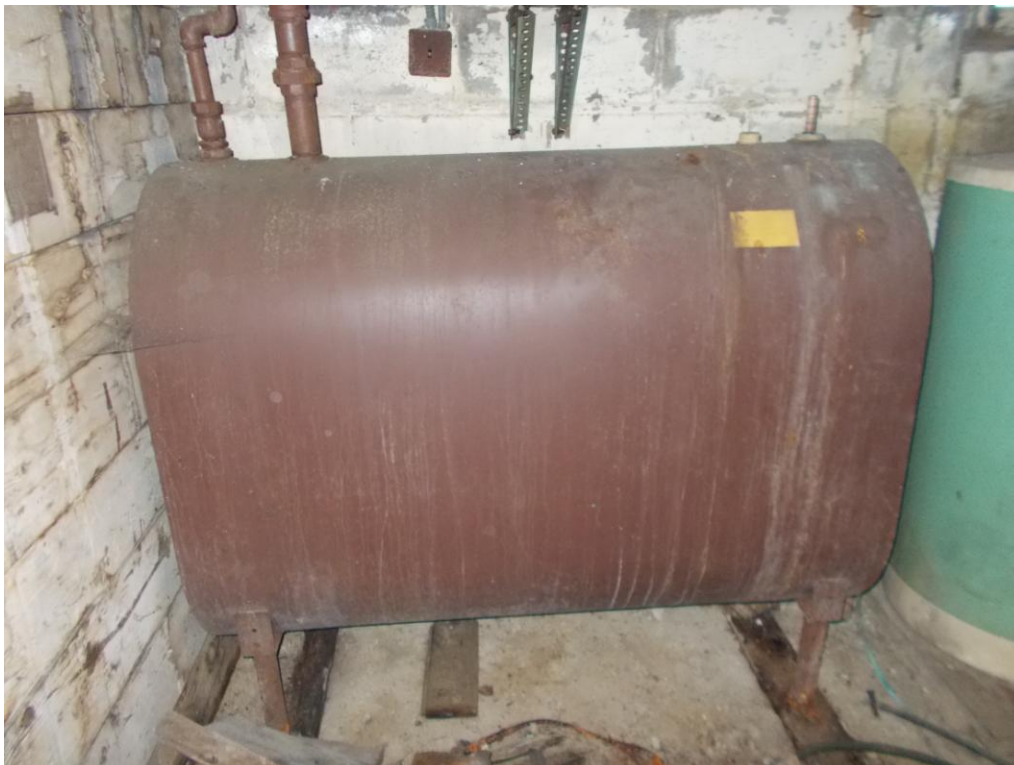
A 250-gallon fuel oil above-ground storage tank (AST) is located near the northwest corner of the basement; the concrete floor beneath and surrounding the AST is in very poor condition. The fill port and vent pipe associated with the AST were observed on the exterior of the Site building. The ground surface surrounding the building at the time of the reconnaissance was snow covered; therefore, staining or other obvious indications of a former spill/release associated with filling of the AST could not be confirmed.

7) View of the AST located in the basements

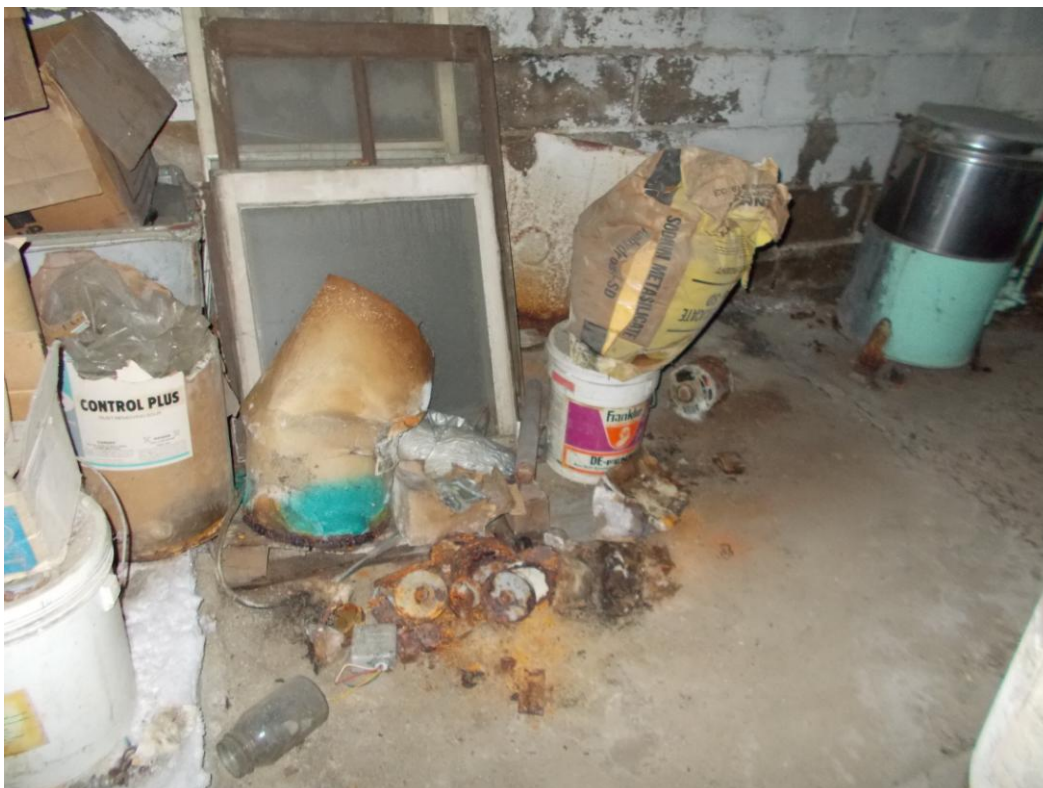
8) View of the basement and general location of SB/TW-3

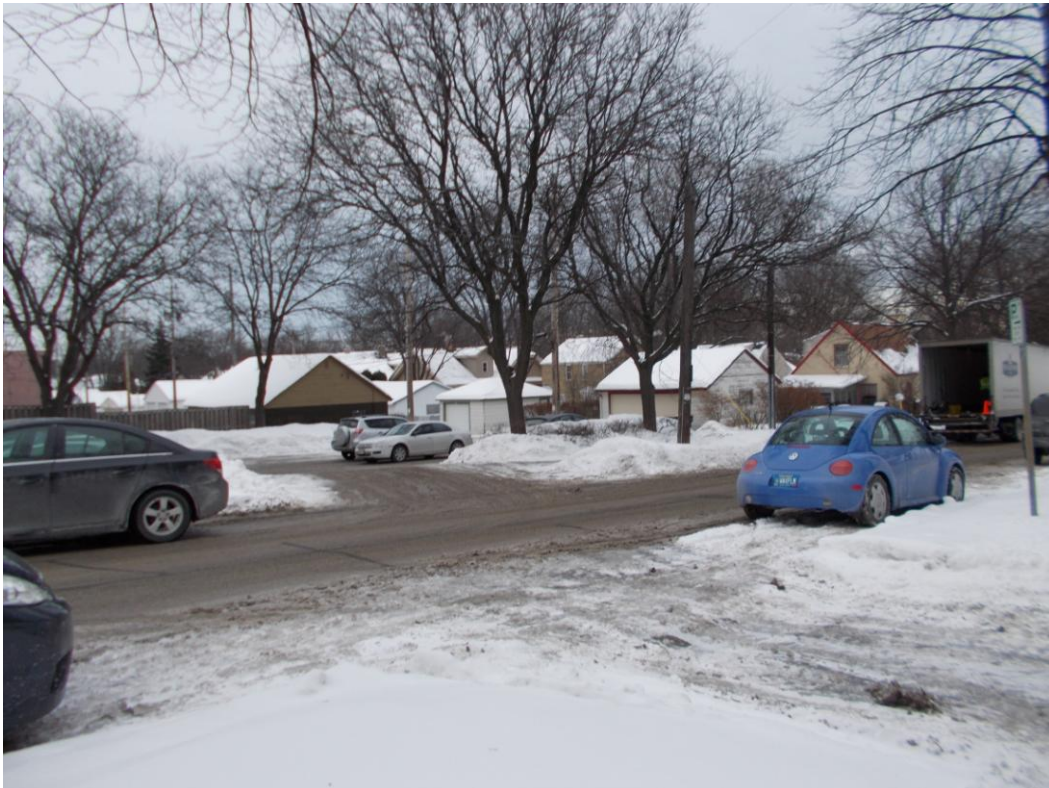
10) Manhole used for surveying bench mark
