Pre-CERCLA Screening Checklist/Decision Form

Site Name: 5750 W Fond du Lac Ave Property

Other Site Name(s): Heaven Scent Cleaners

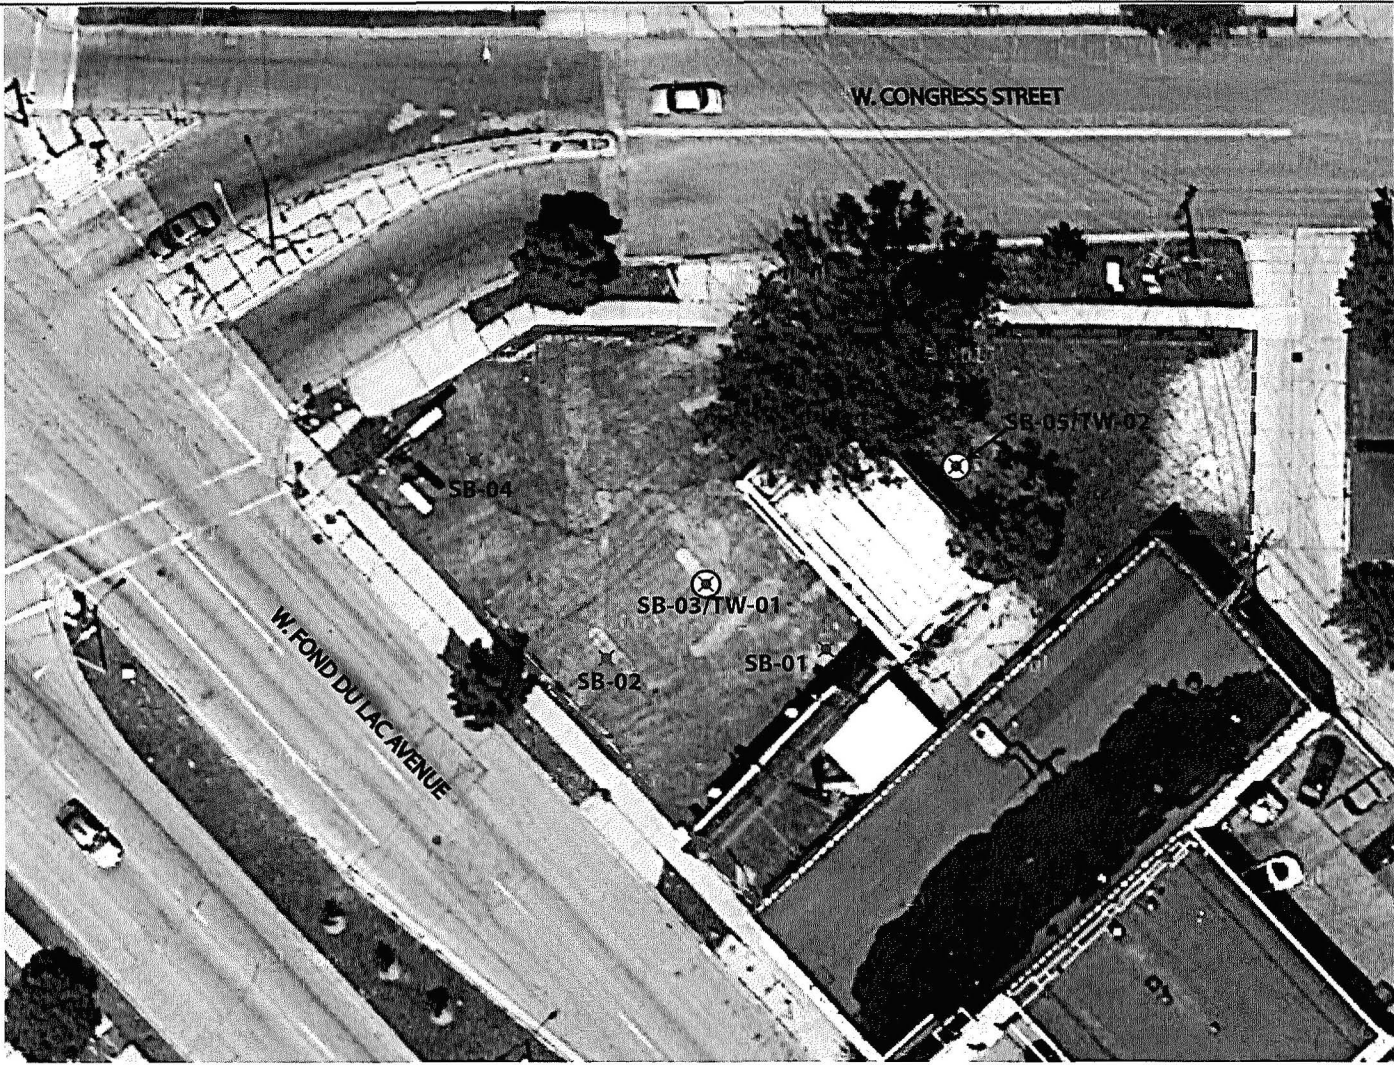
The groundwater plume has not been adequately defined in degree or extent. To date we have two groundwater samples, both were taken from temporary monitoring wells (TW-1 and TW-2). TW-2, located behind the onsite building, recorded tetrachloroethene (PCE; 3,200 ug/L), trichloroethene (TCE; 83 ug/L), cis-1,2 dichloroethene (540 ug/L), and vinyl chloride (6.8 ug/L) in exceedance of their respective NR 140 Enforcement Standards. Groundwater contamination may extend northeast beneath residential homes.

Soil on site has been investigated at five locations; at each location a shallow soil sample and a deep soil sample was taken. Soil contamination was noted in the shallow soil samples. The soil investigation found PVOCs, RCRA metals, and CVOCs. SB-03, located in front of the building, noted naphthalene at 2,140 ug/kg and 1,2,4 trimethylbenzene at 9,000 ug/kg. Arsenic was present in exceedance of the NR700 Direct Contact standard in sample SB-02 (3.03 mg/kg) and SB-04 (2.85 mg/kg); both samples were taken at 2-4 feet bgs. SB-05, located behind the building at 6-8 feet bgs, noted various CVOCs. SB-05 noted PCE (27,200 ug/kg), TCE (1,110 ug/kg), cis-1,2 dichloroethene (2,880 ug/kg), and vinyl chloride (74 ug/kg) in exceedance of their respective Wis. Admin. Code ch. NR 720 groundwater pathway residual contaminant levels. The extent of soil contamination has not been adequately defined. Additional investigation is needed behind the on-site building.

LEGEND	
⊗ Appx. Soil Boring Location	○ Temporary Well
--- Appx. Property Boundry

The extent of soil and groundwater contamination has not been adequately defined. Further investigative and potentially remedial work is necessary to protect human health and the environment. The contamination from on site may pose a risk of vapor intrusion into residential homes. The potential of vapor intrusion must be evaluated.
