Subject: Final Case Closure with Continuing Obligations
1681-1683 N Van Buren Property, Milwaukee WI
BRRTS #: 02-41-562442, FID #: 341143220

1681 North Van Buren Street
Milwaukee, Wisconsin 53202

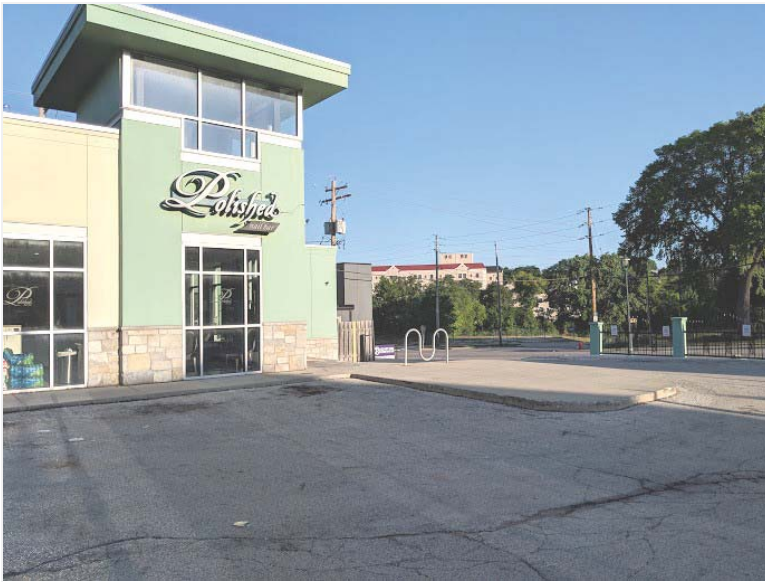
PHOTOGRAPH 1:

View of building and asphalt parking lot looking northwest

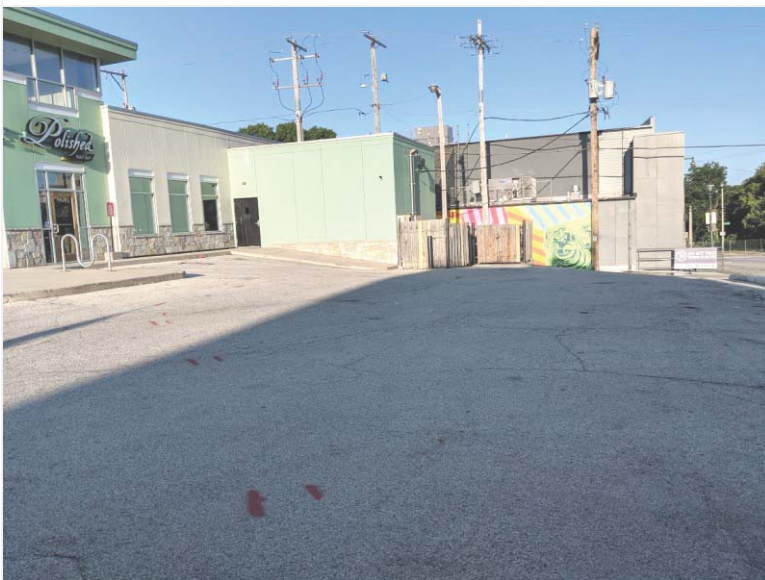
PHOTOGRAPH 2:

View of building and asphalt parking lot looking west

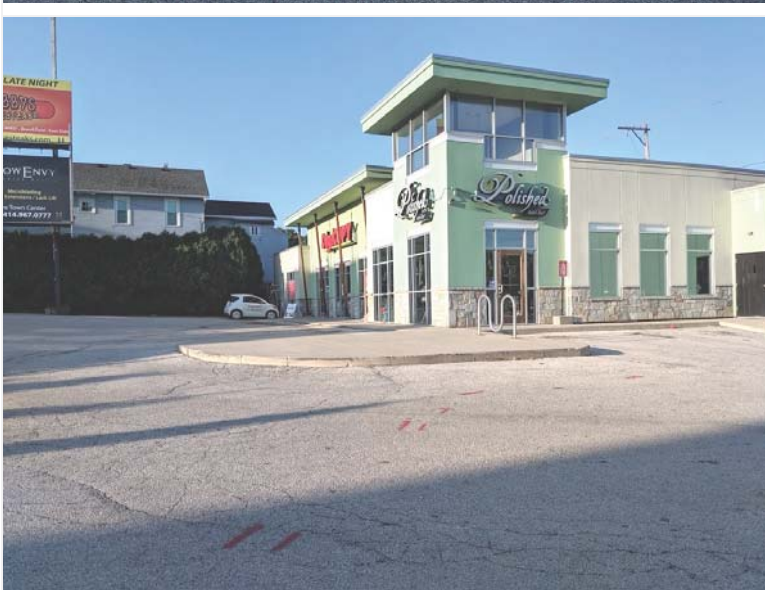
PHOTOGRAPH 3:

View of building and asphalt parking lot looking south
