Re: Municipal Well and Pump Diesel Spill

Near New Rhinelander City Well #8, North End of South Fox Ranch Road (no address)
WDNR Spills Database Number (SERTS) : 20140903NO44-1

Subject: Narrative of Activities and Documentation of Remedial Actions Completed

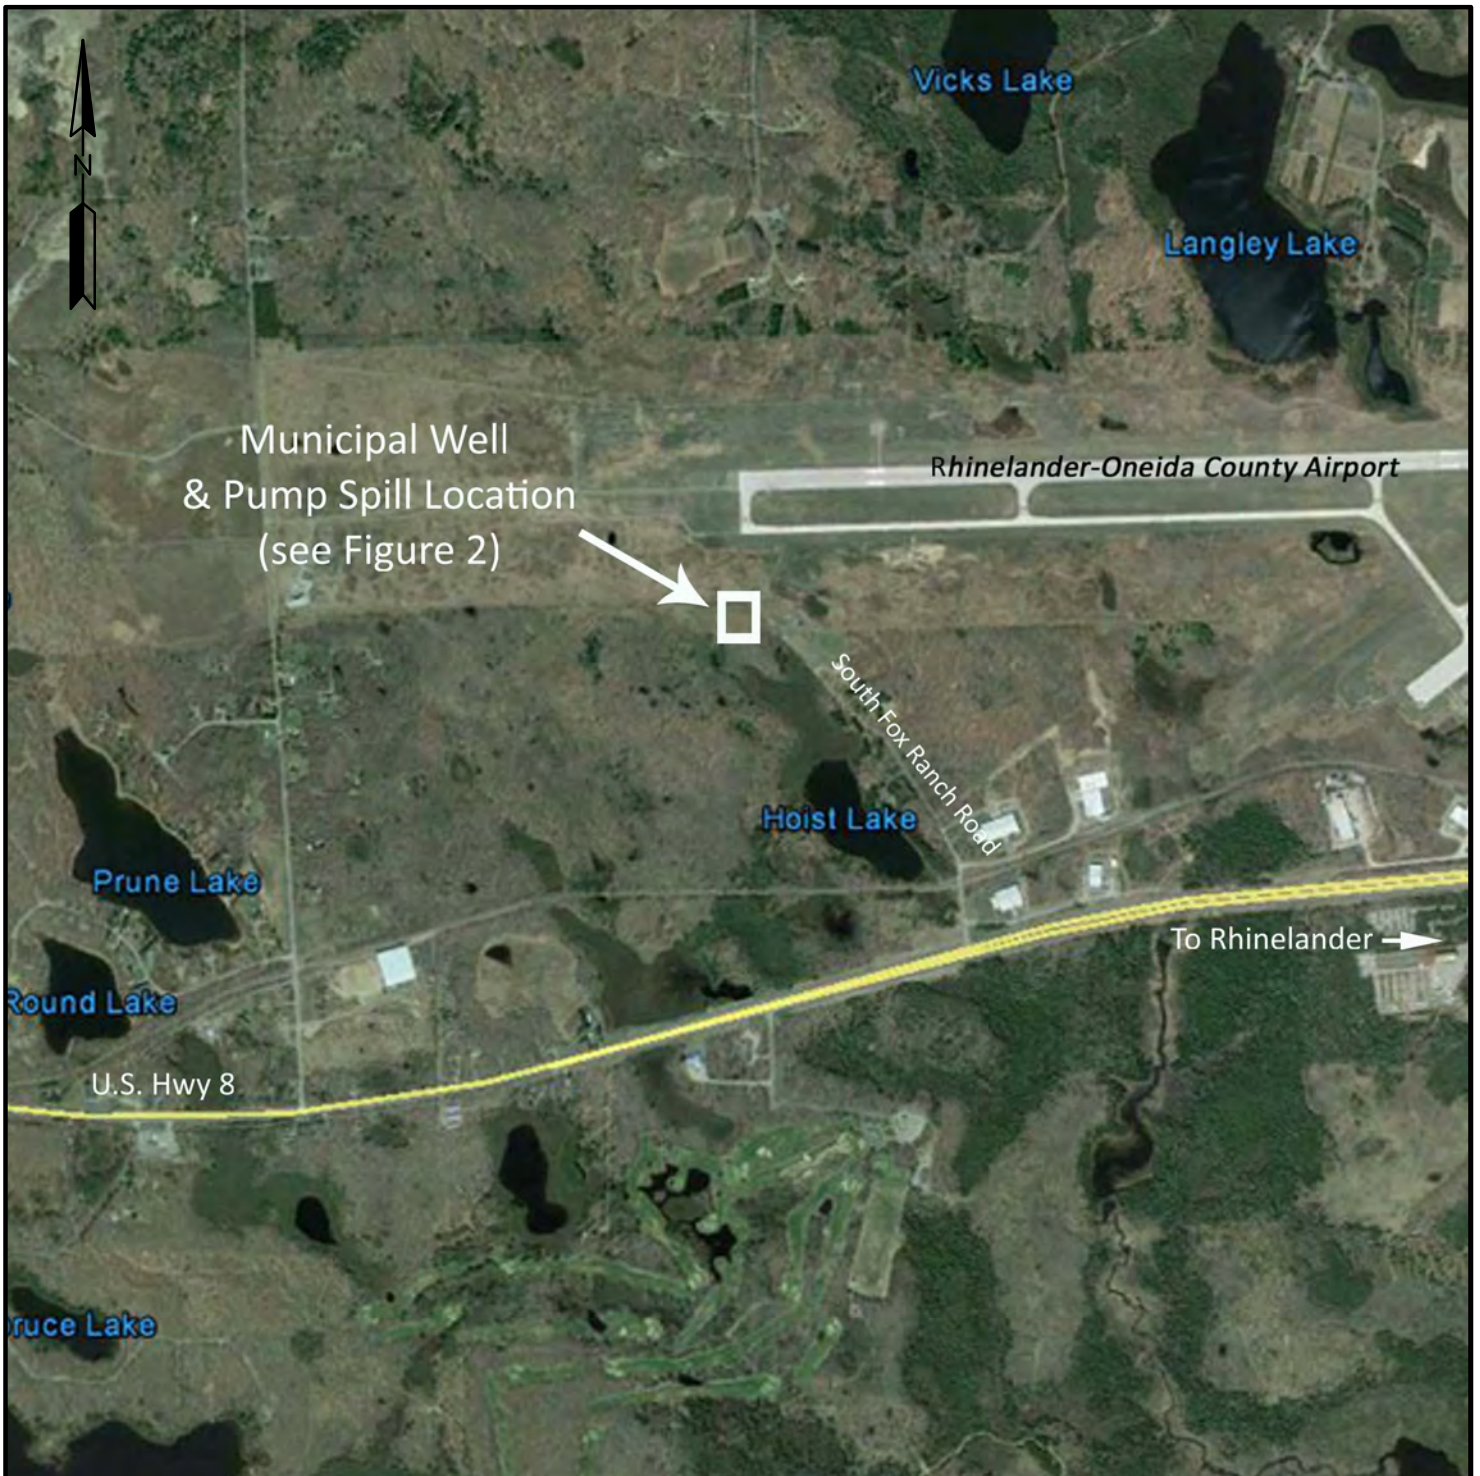
FIGURE 1

Figure 1 shows the location of the incident on a Google Earth base photo. The coordinates of the incident are 45°37'39.24"N Latitude and 89°29'12.09"W Longitude. As shown on **Figure 1**, the incident location is along the dirt road that extends off the north end of South Fox Ranch Road just south of the Rhineland/Oneida County Airport, roughly 12,400 feet west of the intersection of US 8 and STH 17 on Rhineland's west side. This is the location of the new City Well #8, and the release occurred from a diesel tank on one of the drilling company's vehicles. As of September 2, City Well #8 had been completed and was undergoing well development but was not in operation.

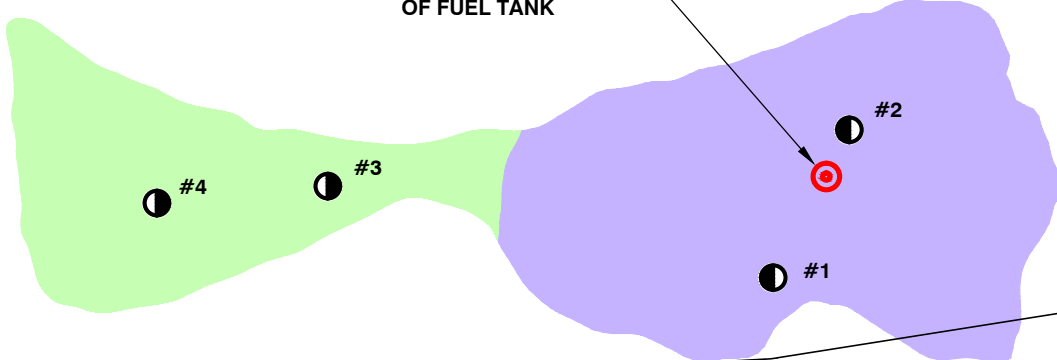
FIGURE 2

As shown on **Figure 2**, two distinct areas of the spill were noted. The area immediately beneath the tank received direct impacts of diesel fuel and was blackened soil (the Primary Spill Area on **Figure 2**). To the west, it appeared as if a light rainfall may have washed some of the fuel down a slight incline, leaving a very thin film of oil in the upper few inches of the soil (the Secondary Spill Area on **Figure 2**).

SPILL POINT AT BASE
OF FUEL TANK

Therefore, as shown in **Figure 2**, these two areas were excavated differently. In the immediate spill area, excavation proceeded to 3 feet deep, where soils appeared to be free of oil. We then proceeded to excavate another 1.5 feet to provide a (to a total depth of 4.5 feet) to provide a margin of safety.

In the secondary spill area, excavation depth was 10 inches, which field indications suggested was adequate.

Four soil samples were collected from the base of the excavation as shown on **Figure 2**. Samples were collected using standard protocols (25 grams of soil preserved in methanol) and sent to WDNR –Certified laboratory Pace Analytical Services in Green Bay for rush analysis for BTEX plus naphthalene.

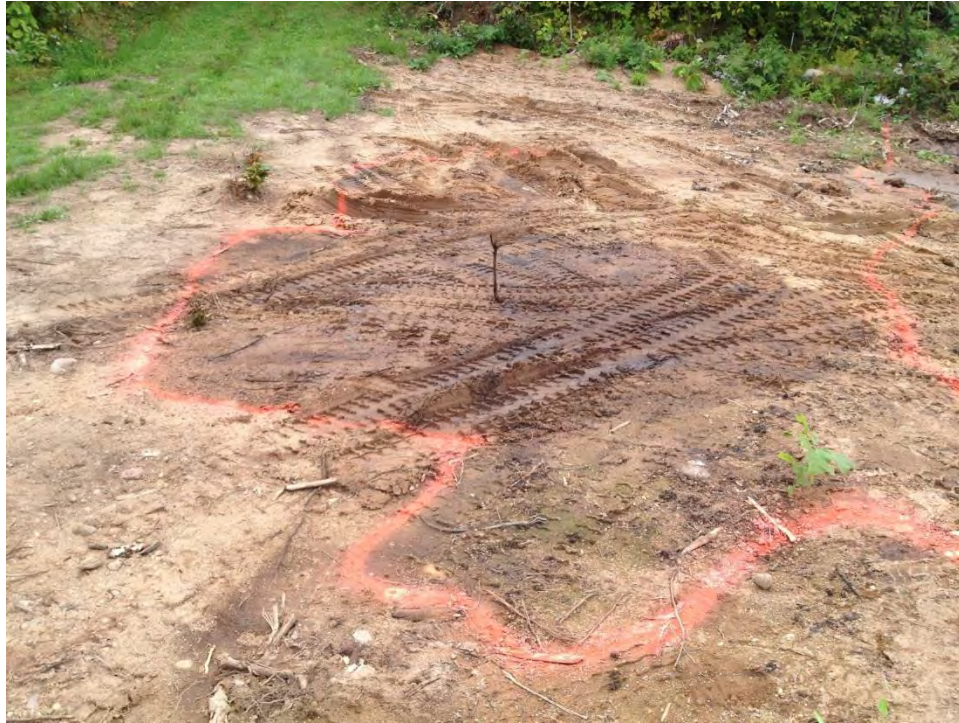
The tank seemed to be rusted and the leak was likely a failure of the tank due to age and condition of the tank. No evidence of vandalism was noted.

Photo #1 Primary Spill Area, looking west. The small root in the ground is the leak location. Approximately 3:00 PM on September 3, 2014.

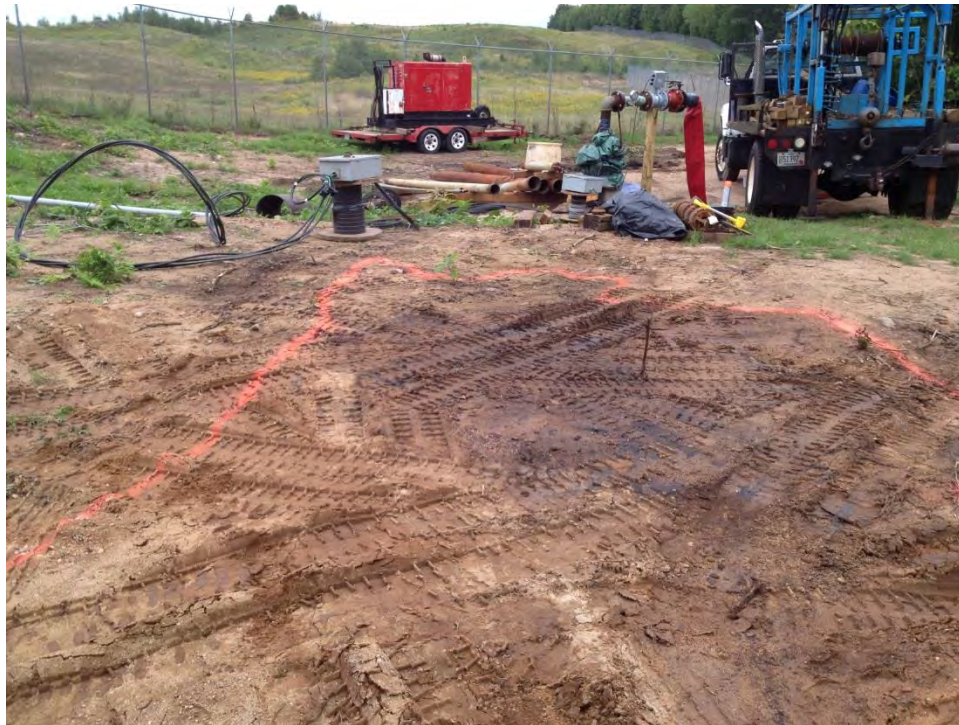
Photo #2 Primary Spill Area, looking northeast toward the Airport Fence. The new City Well is in the background.

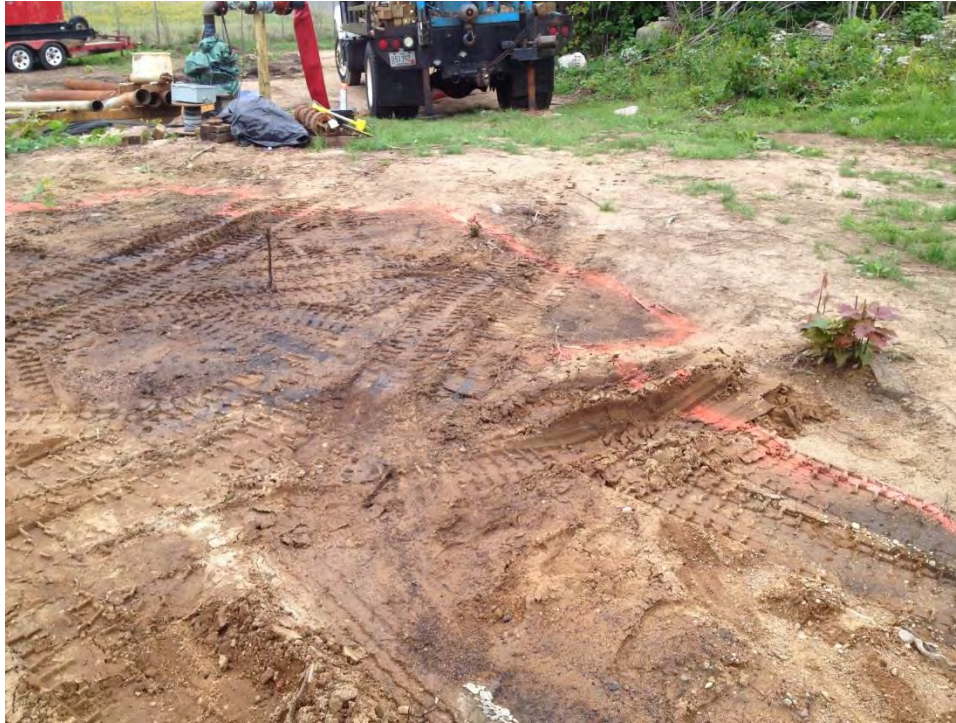
Photo #3 South edge of the primary spill area.

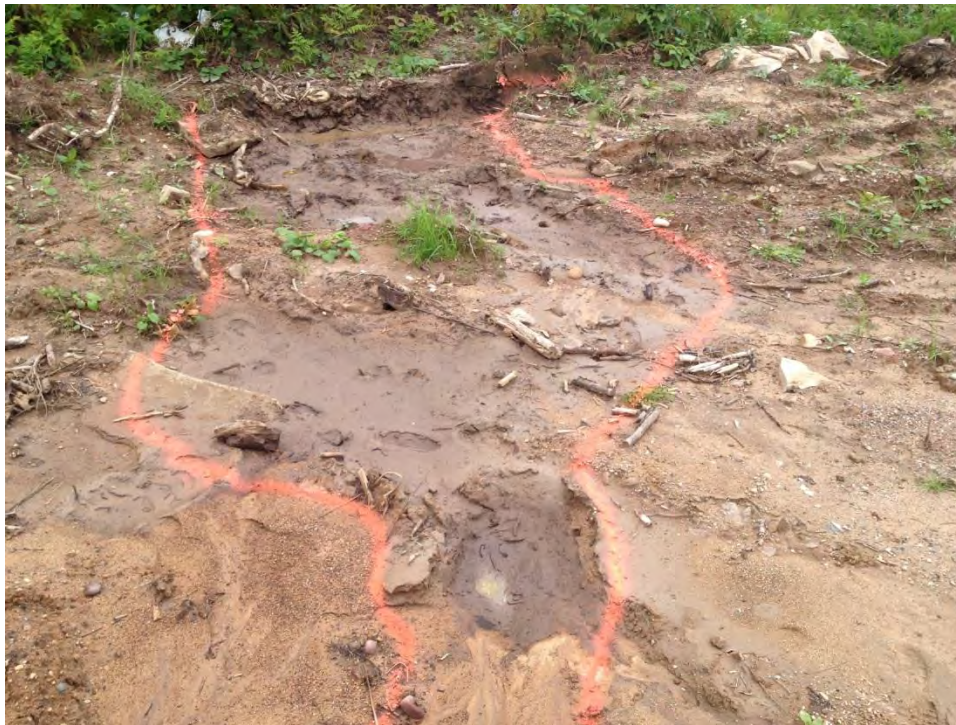
Photo #4 Secondary spill area, looking west from the primary spill area.

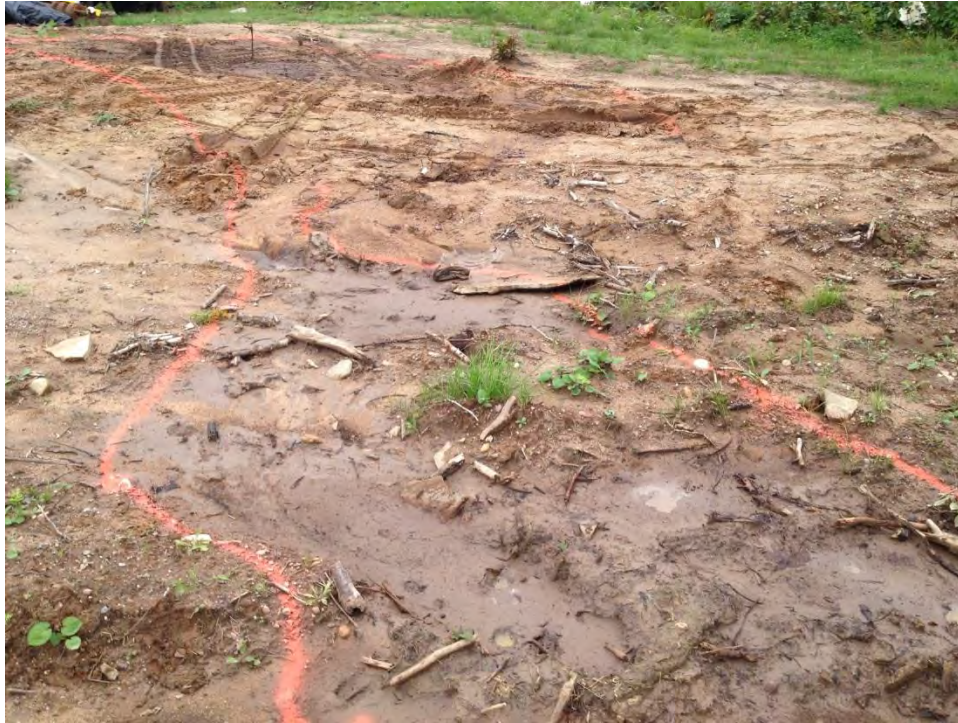
Photo #5 Secondary spill area in the foreground. Primary spill area in the background. Looking east.

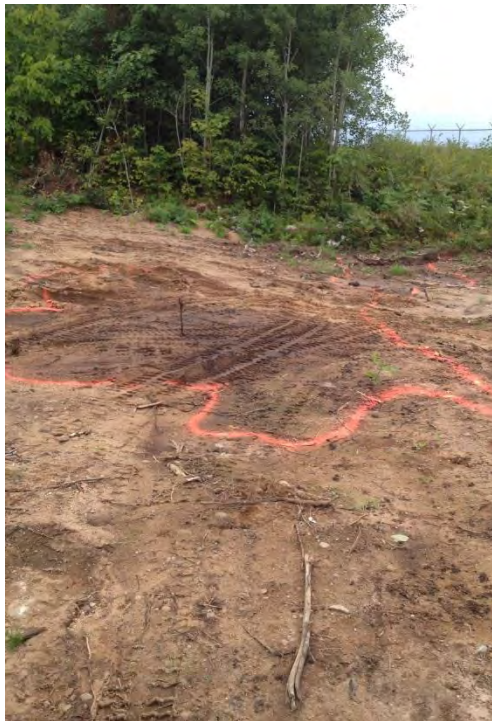
Photo #6 Primary Spill Area in the foreground and secondary spill area in the background. Looking Northwest.
