SUBJECT: Case Closure with Continuing Obligations
Pizza Place Restaurant, 225 USH 8 & 63, Turtle Lake, Wisconsin
BRRTS #03-03-562914

PIZZA PLACE RESTAURANT

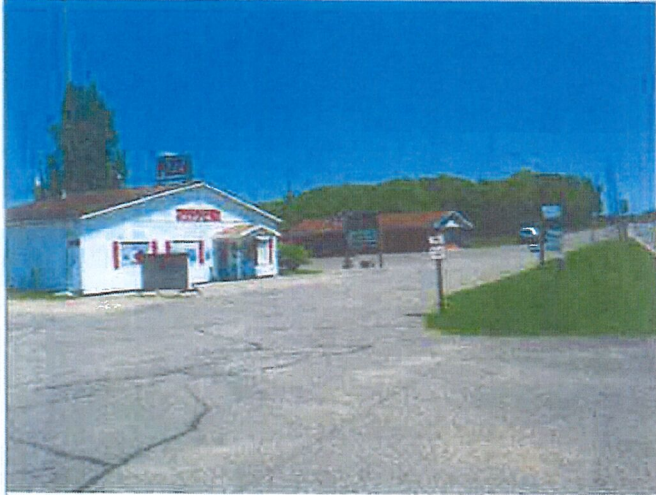
Title: Photo 1#: Area of cap to be maintained (looking north)

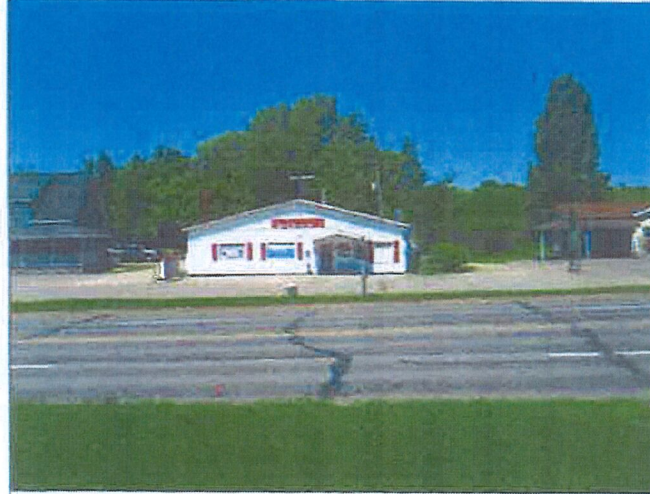
Title: Photo 2#: Area of cap to be maintained (looking northwest)

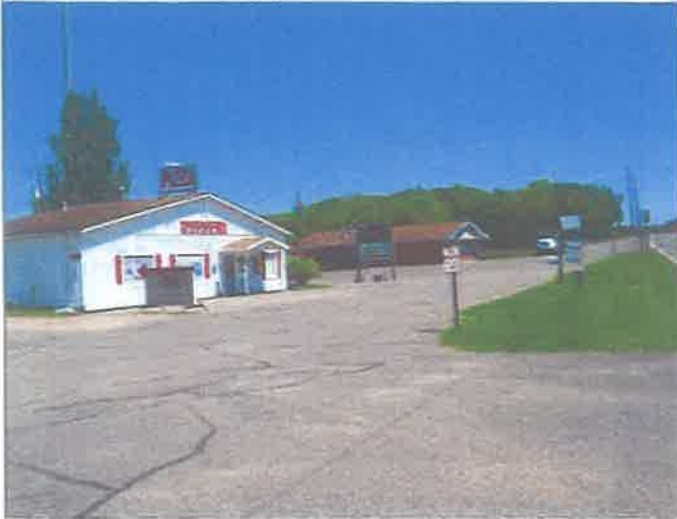
Title: Photo 1#: Area of cap to be maintained (looking north)

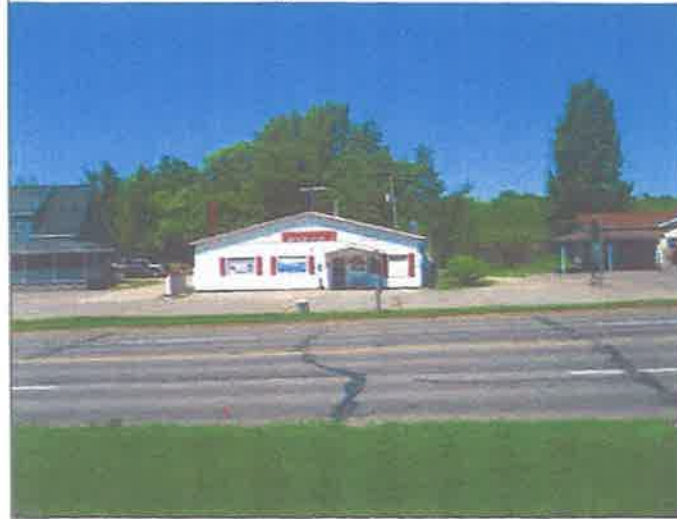
Title: Photo 2#: Area of cap to be maintained (looking northwest)
