APPENDIX A

Sediment Core Logs

**Site-Specific Residual Contamination Levels (RCLs)
for Dredged Material from Howards Bay
Proposed for Placement at the Closed Wisconsin
Point Landfill in Superior, Wisconsin**

**GLLA SEDIMENT CLEANUP IN HOWARDS BAY
Superior, Michigan**

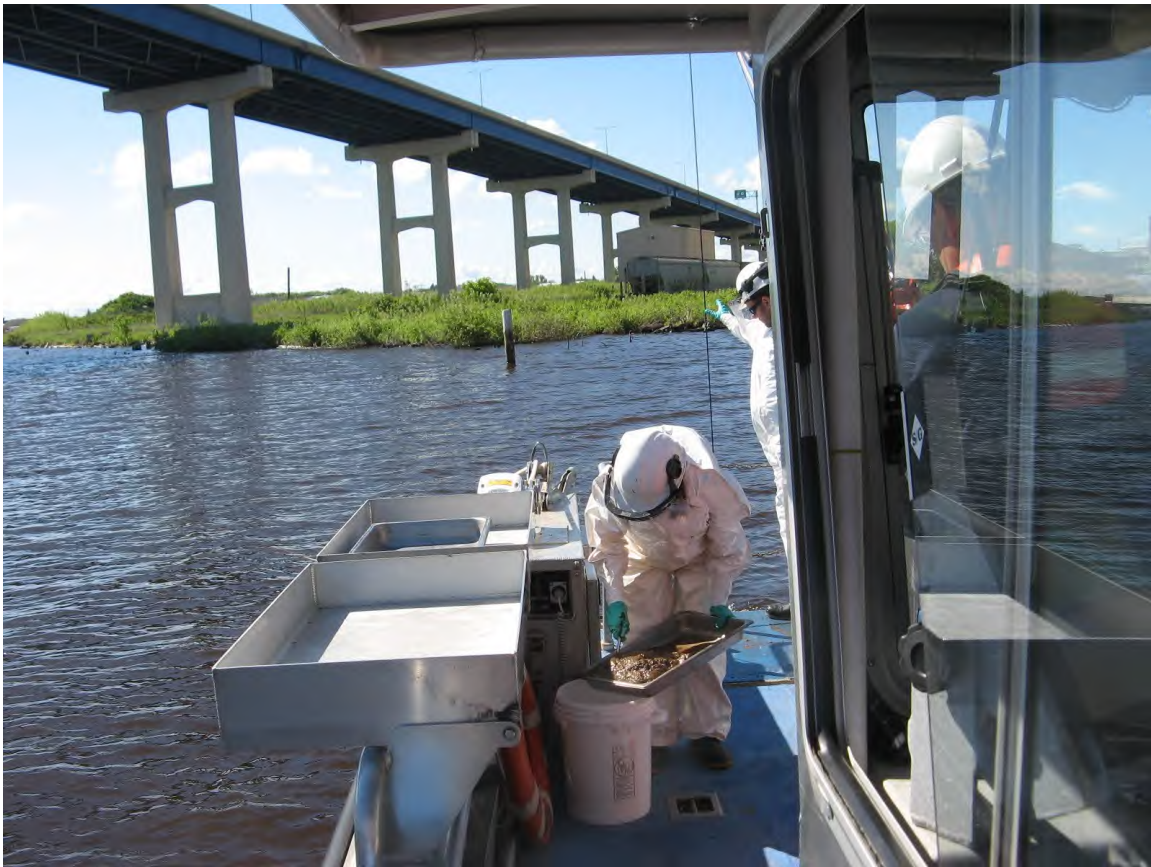
Ponar grab sample for treatability testing at HB17-01

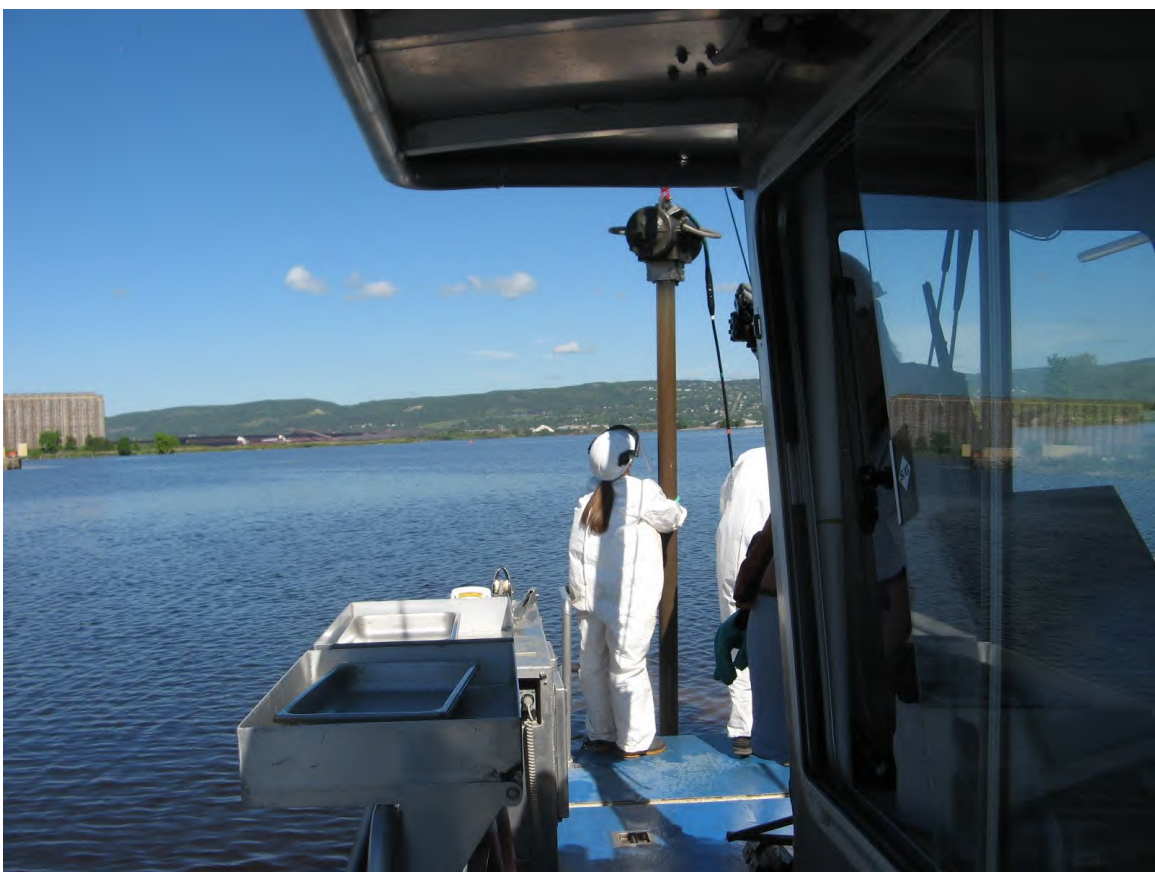
Core taken with Vibracore —Typical

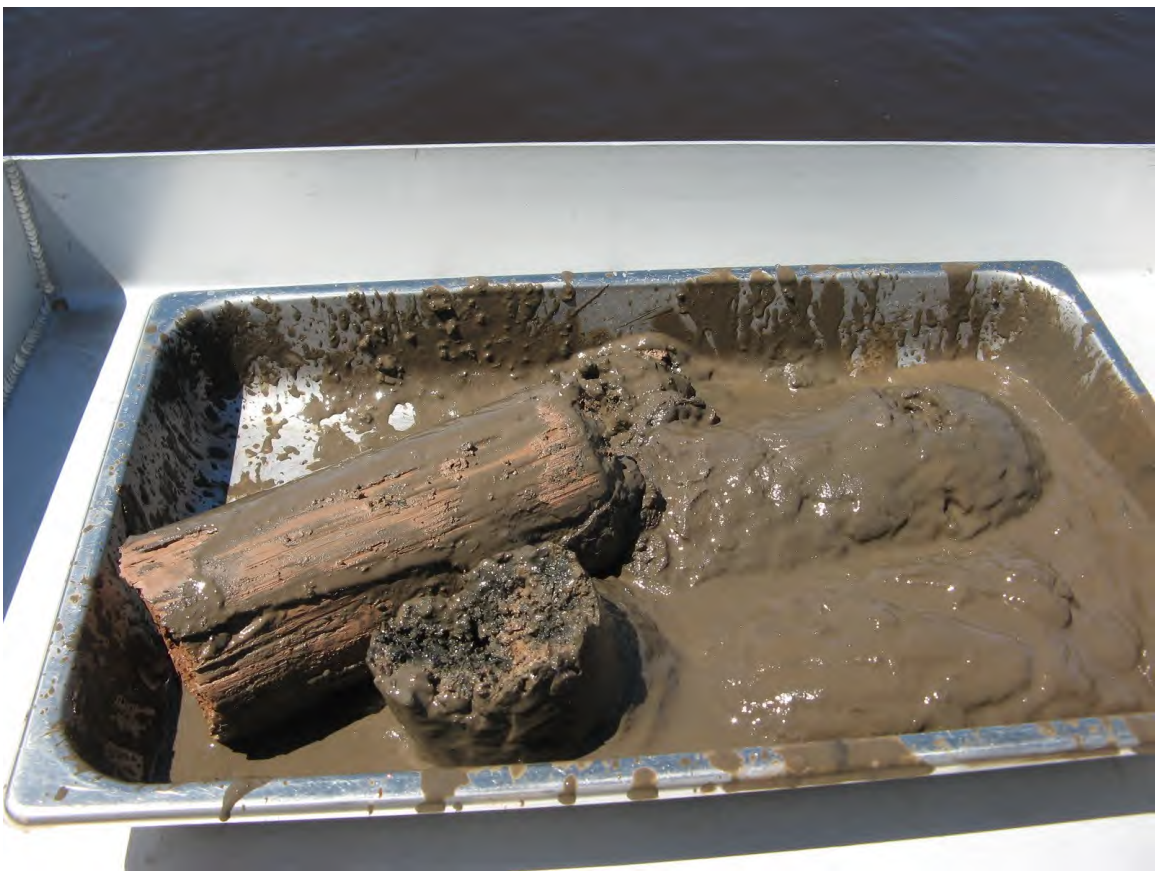
Extraction of core HB17-17 into pan. (Photo 1 of 3): Top to right. Note plug of dense red clay from core bottom (left)

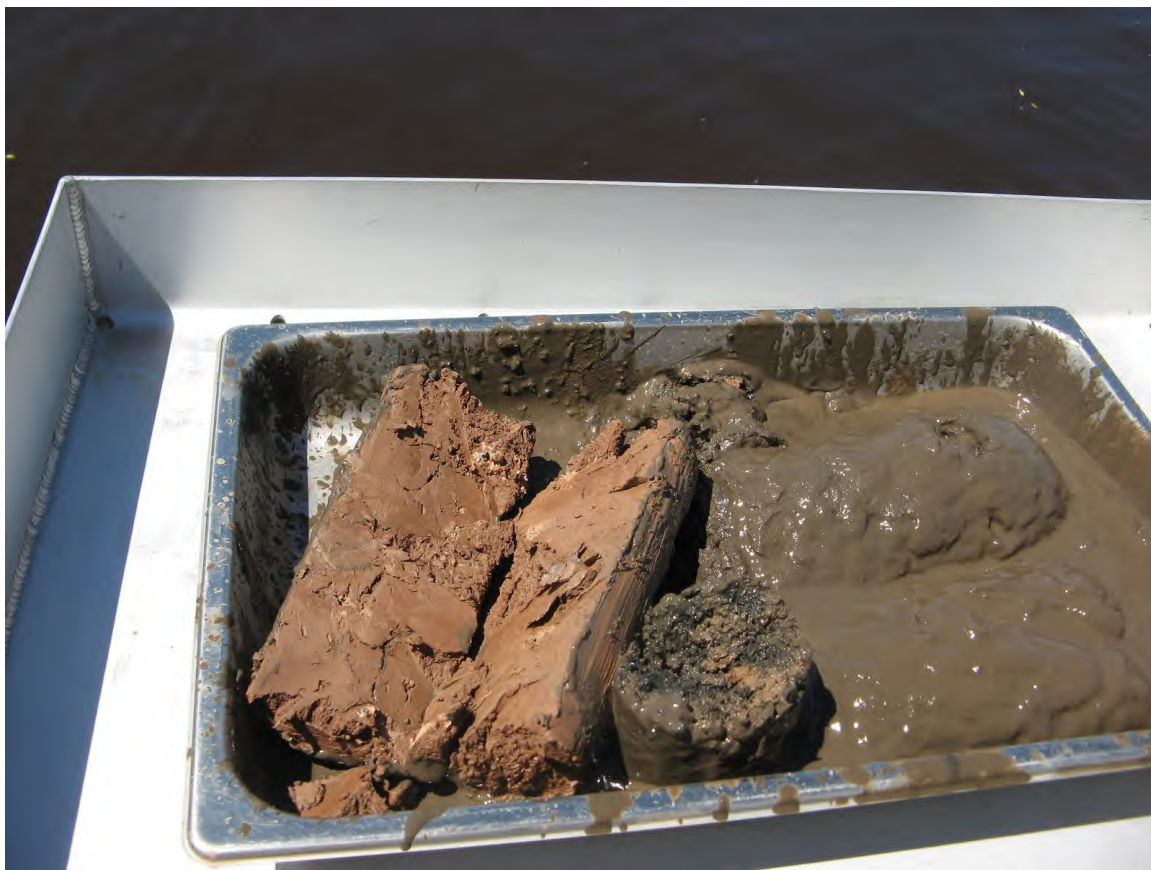
Extraction of core HB17-17 into pan. (Photo 2 of 3): Red clay plug split lengthwise.

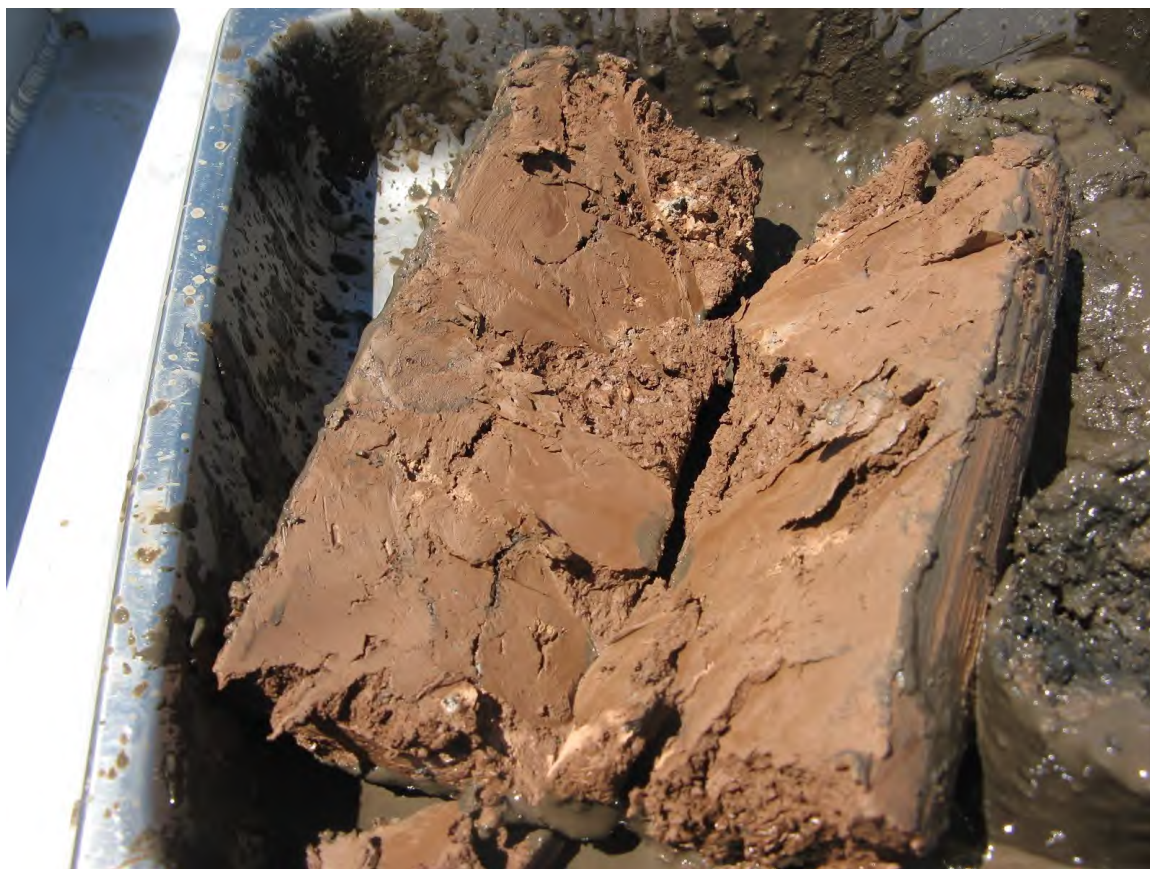
Extraction of core HB17-17 into pan. (Photo 3 of 3): Close-up of red clay plug split lengthwise.

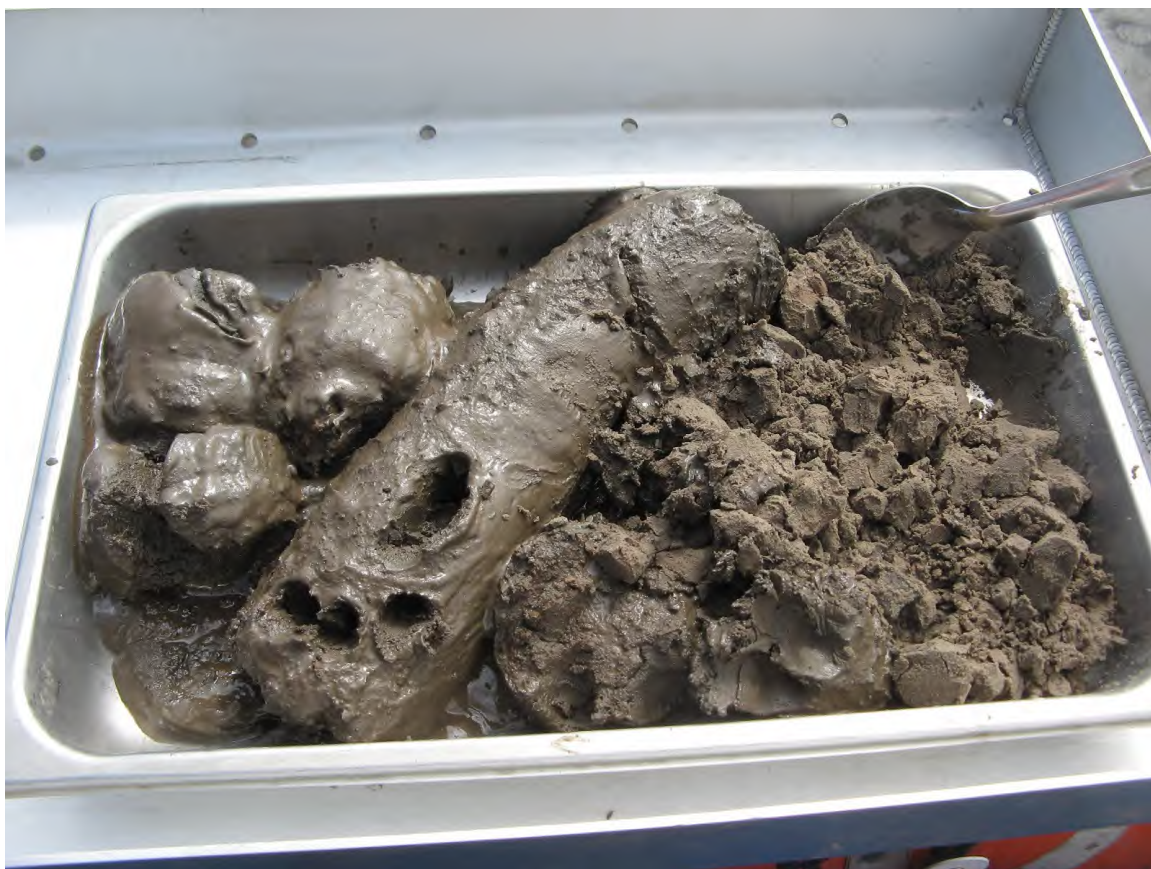
Soft silty clay over dense fine sand - Typical

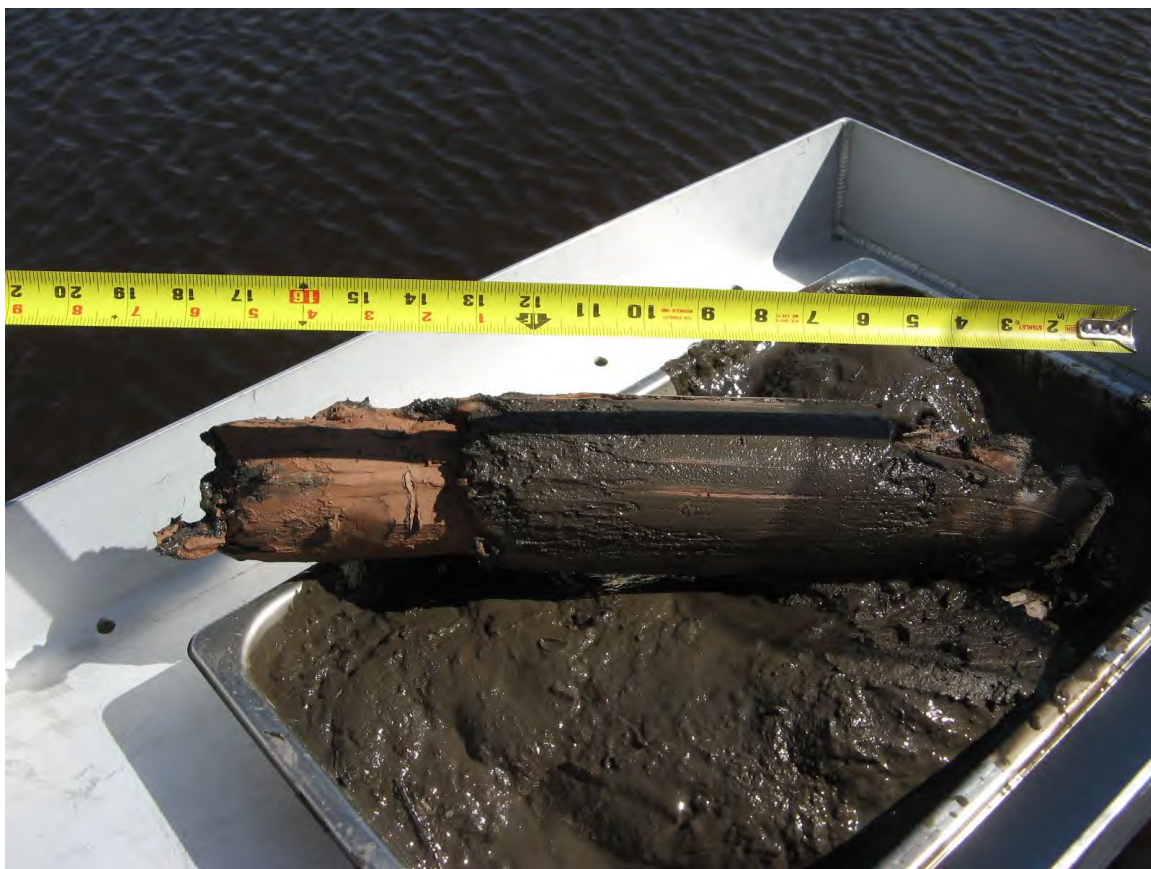
Extraction of core HB17-21, note red clay plug from bottom of core.

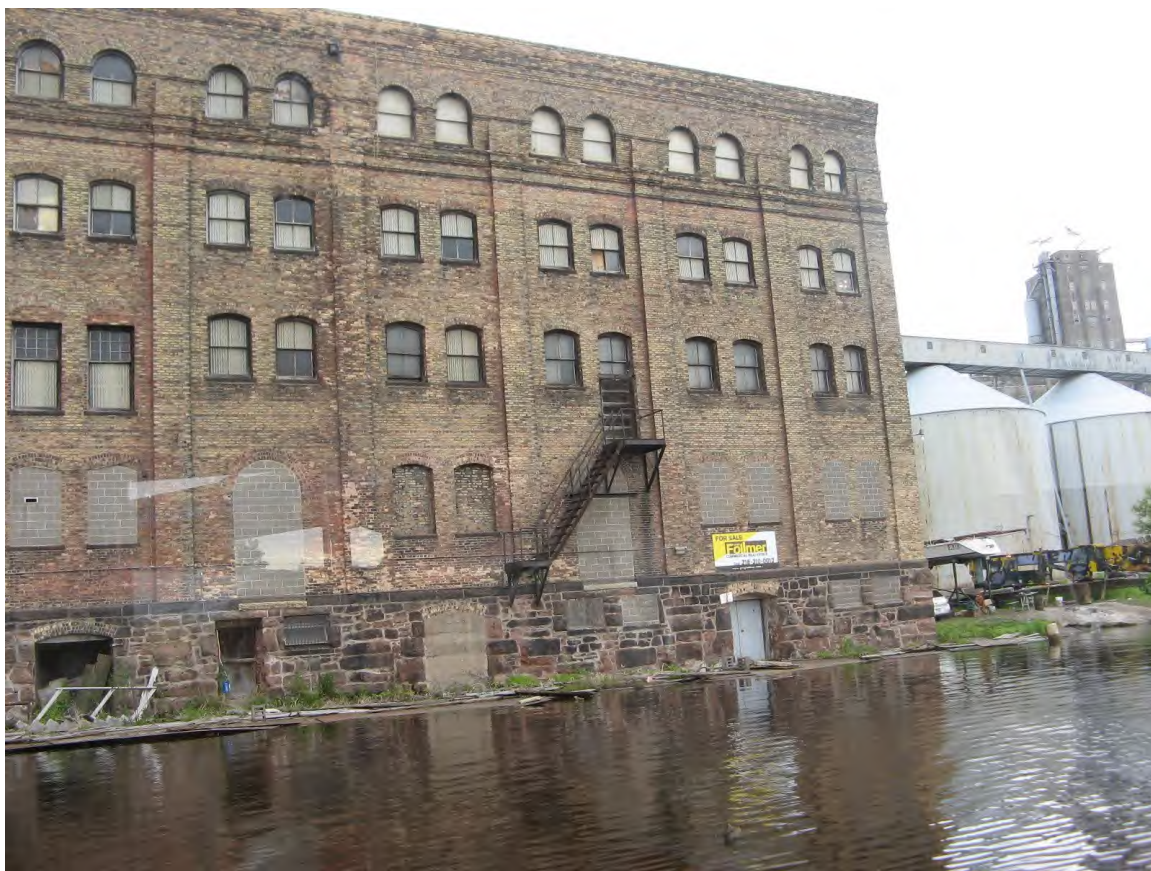
Warehouse for sale in Hughitt Slip—cracks in bricks & mortar were evident from top to bottom at right corner.

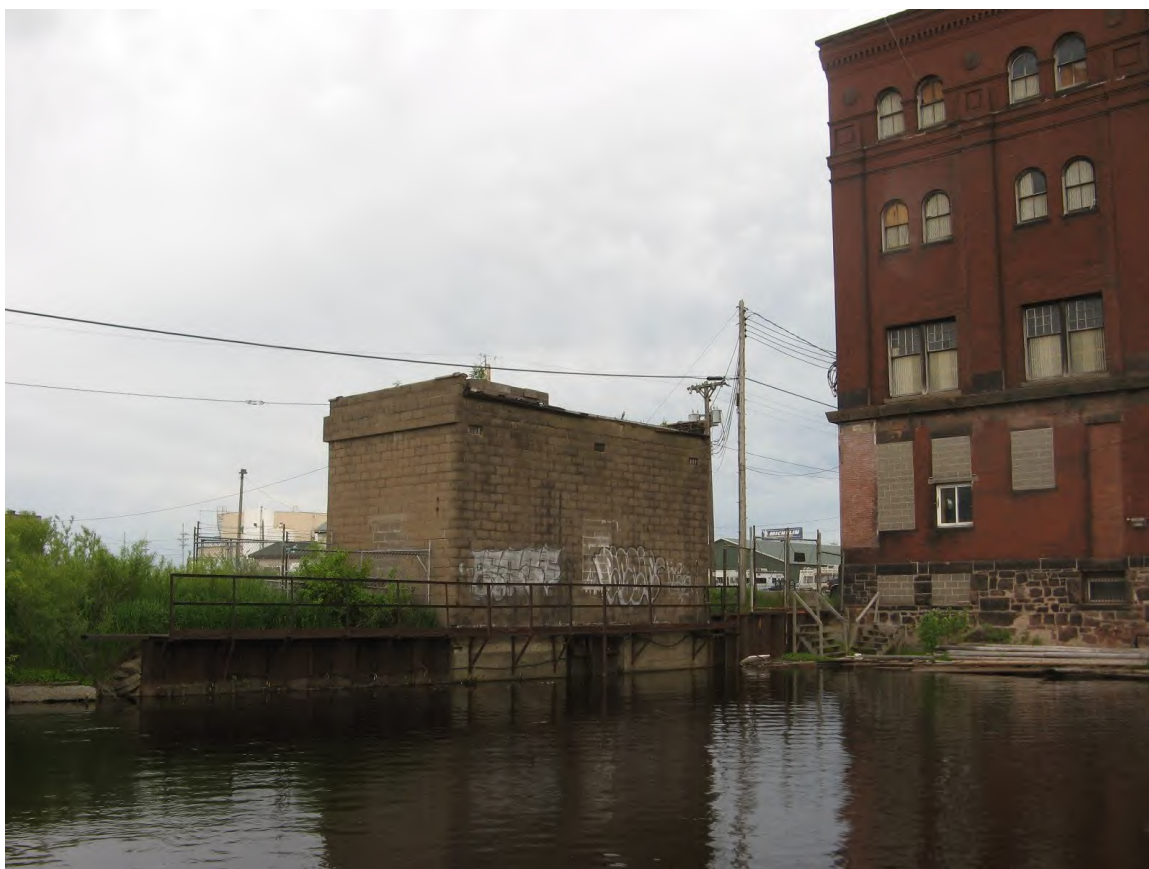
End of warehouse and possible old intake structure in Hughitt Slip

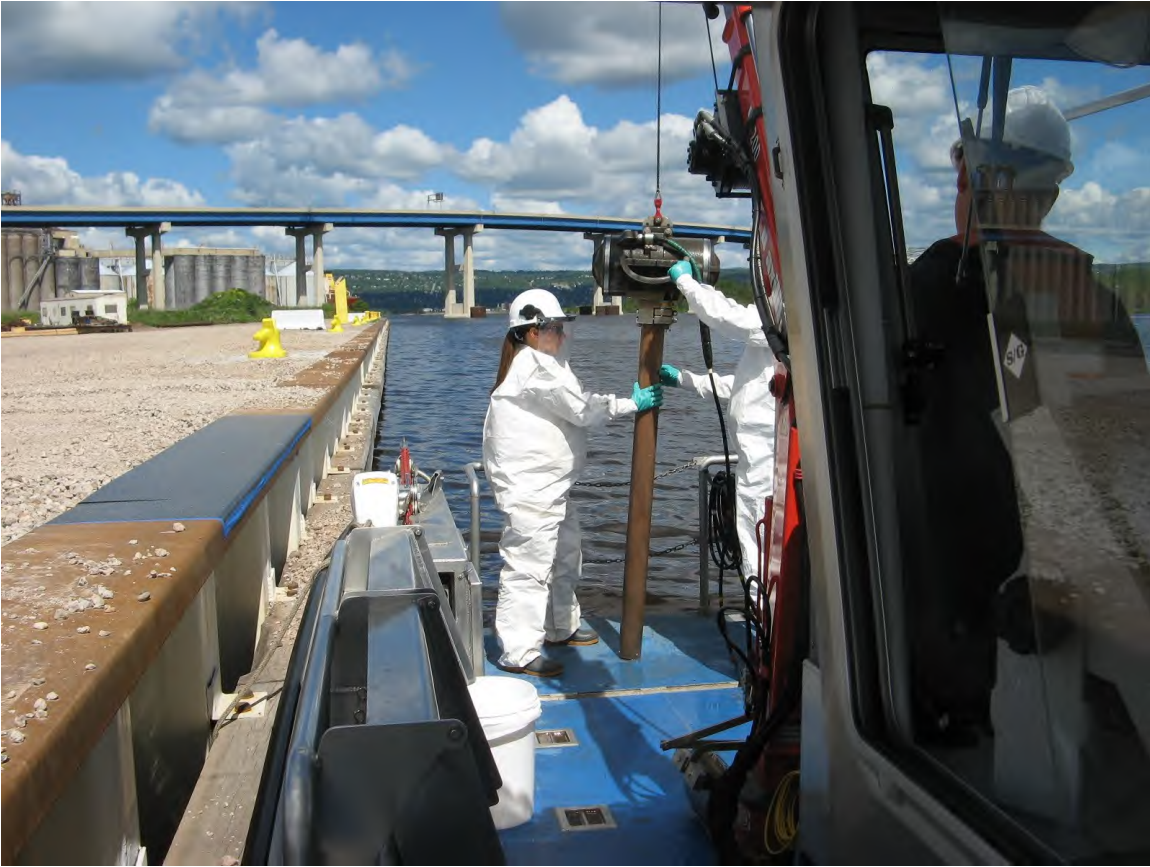
Photographs: Location HB17-07 (page 1 of 2)

Typical Core at HB17-07: Cores at this location were collected off right side of the boat using boom arm of crane. Photographed by J. Graham 06/20/2017 with Cannon Power Shot A710.

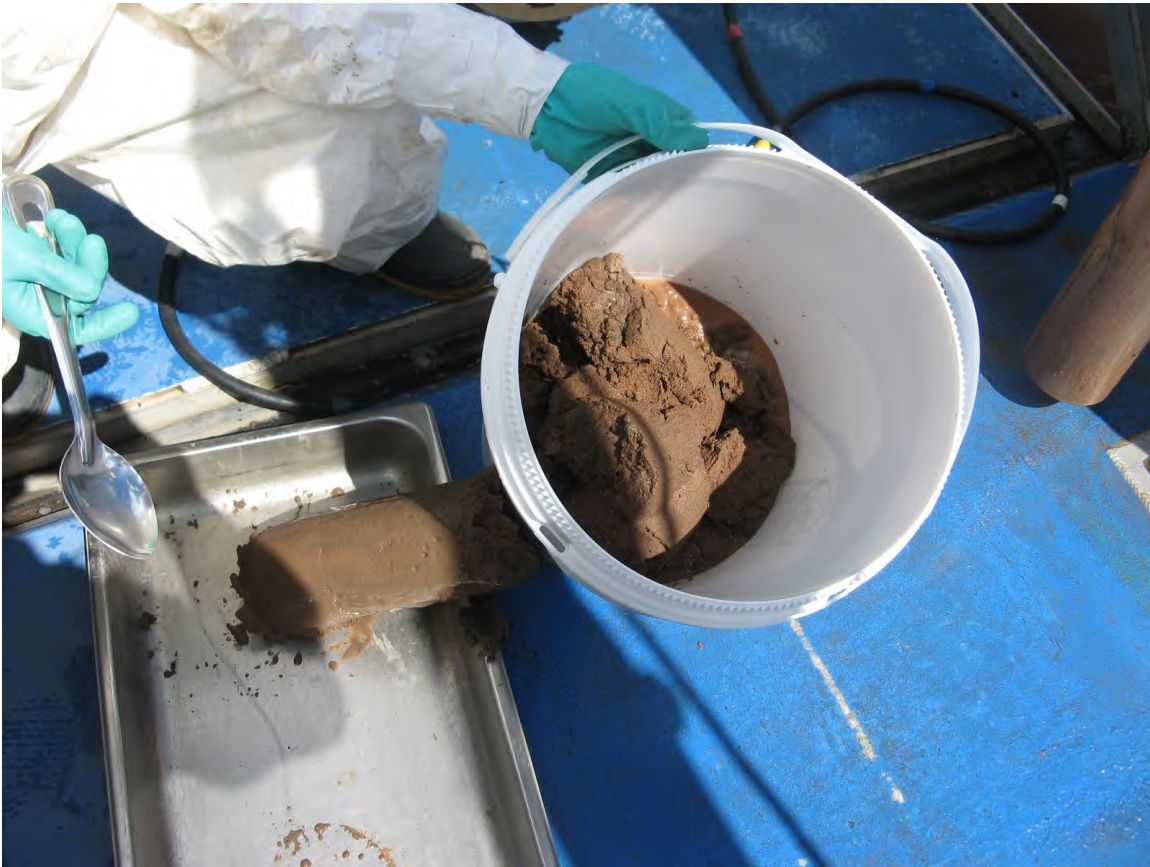
Photographs: Location HB17-07 (page 2 of 2)

Contents of Core 1 of 5 at HB17-07 for USACE treatability sample; bucket contains sand from top of core , pan at right has 12 inches of brown silty clay from bottom of the core tube. Photographed by J. Graham 06/20/2017 with Cannon Power Shot A710.

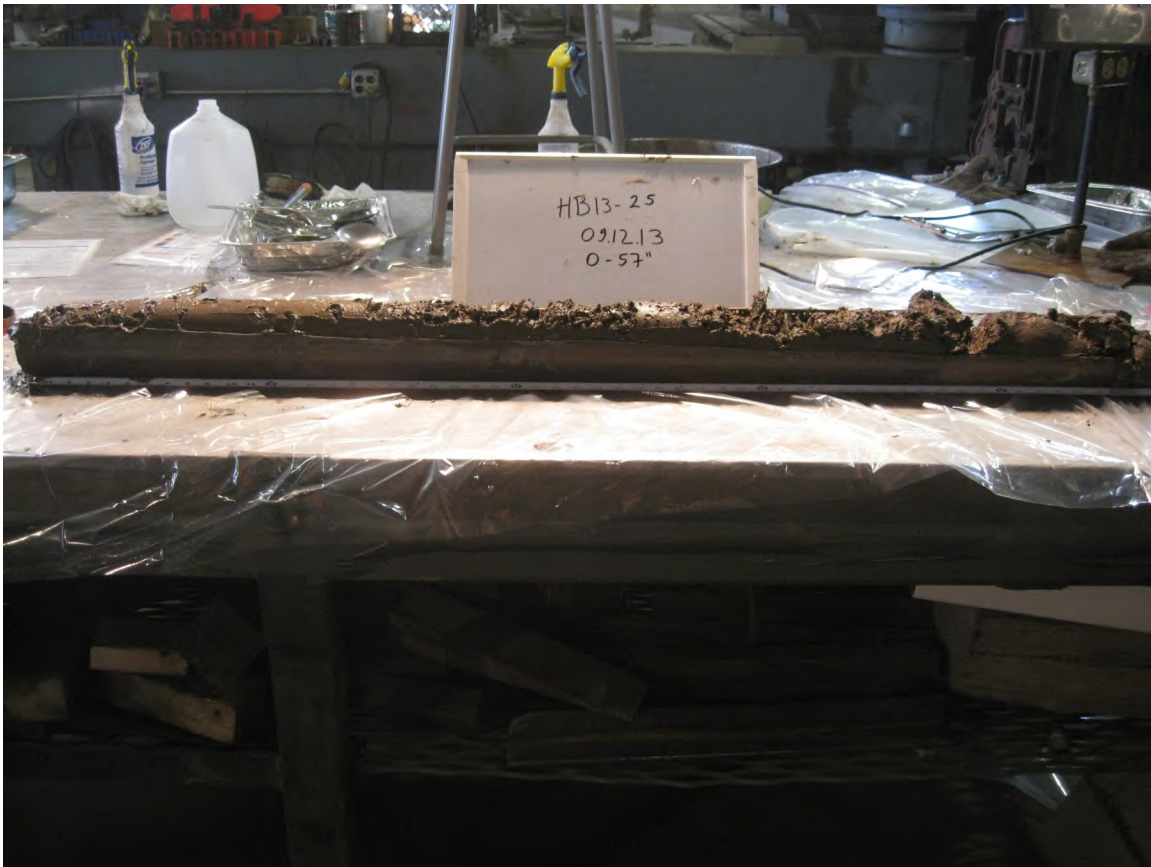
Full profile—no flash. Top is to left. Top is grey brown silt. See core log for full description. Photo by ARCADIS 09/12/2013.

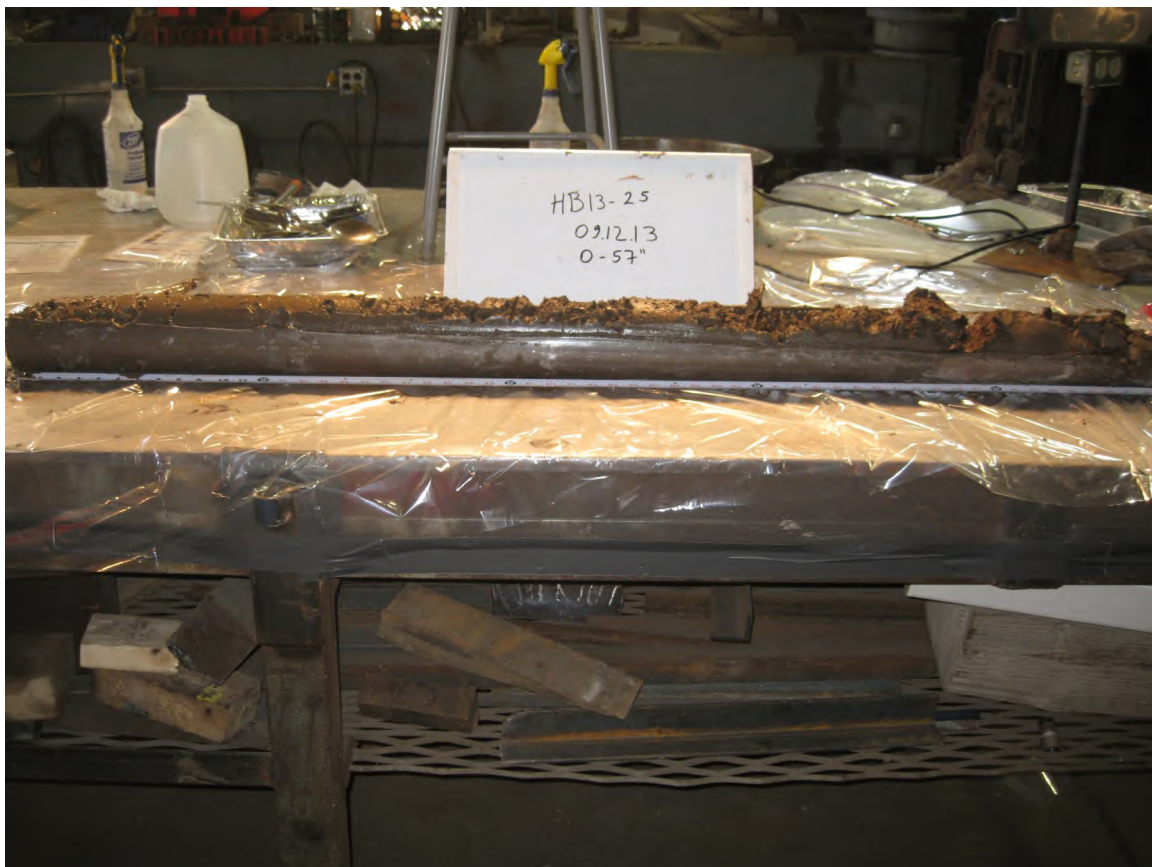
Full profile—with flash. Top is to left. Top is grey brown silt. See core log for full description. Photo by ARCADIS 09/12/2013.

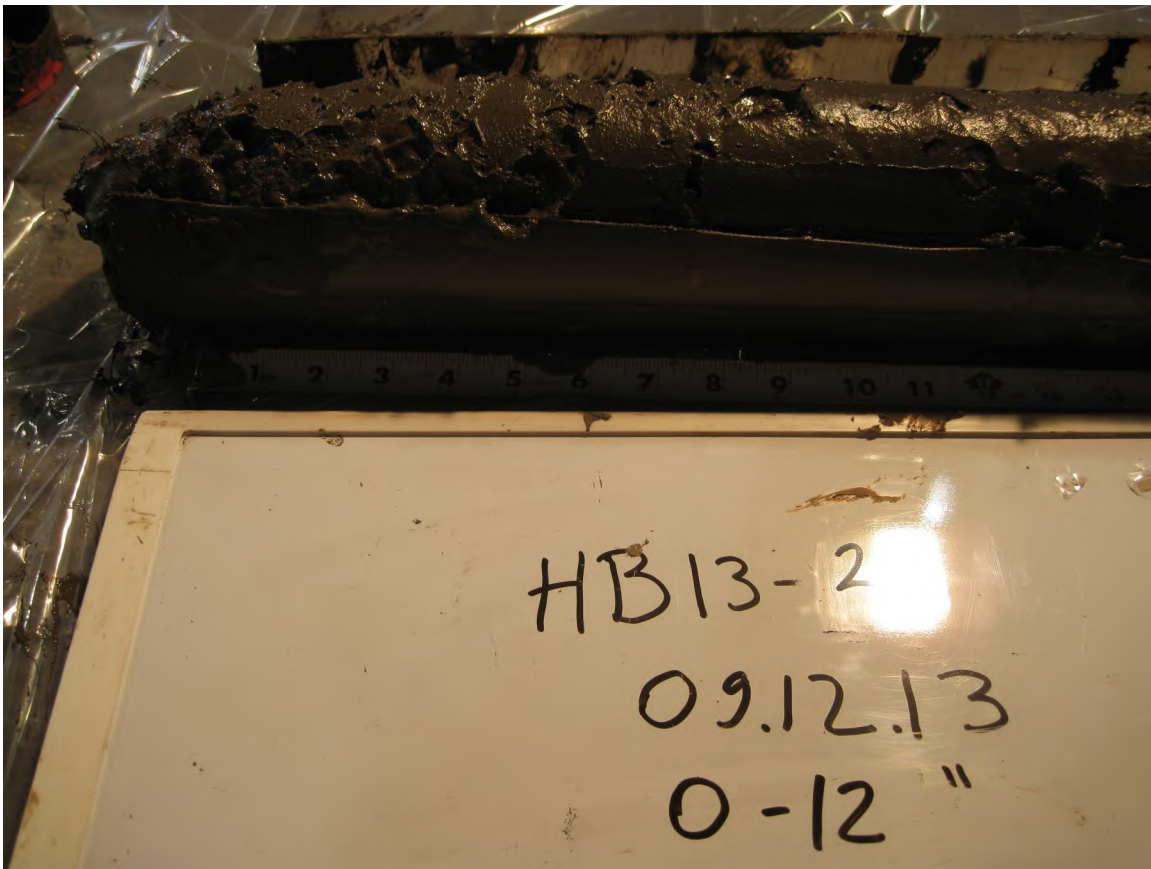
Core HB13-25: 0 to 12 inch depth interval. Grey Brown Silt. See core log for full description. Photo by ARCADIS 09/12/2013

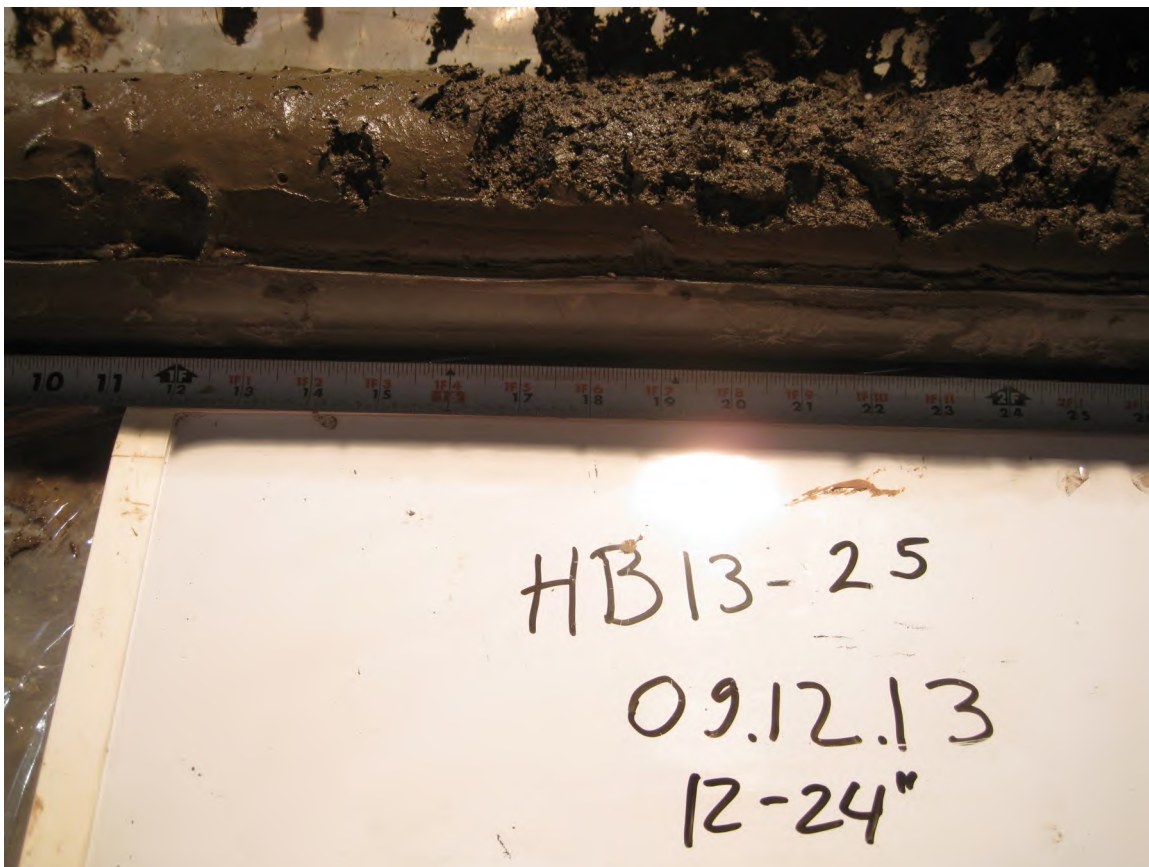
Photographs of Core HB13-25 (Page 2 of 4)

Core HB13-25: 12 to 24 inch depth interval. Grey brown silt. See core log for full description. Photo by ARCADIS 09/12/2013.

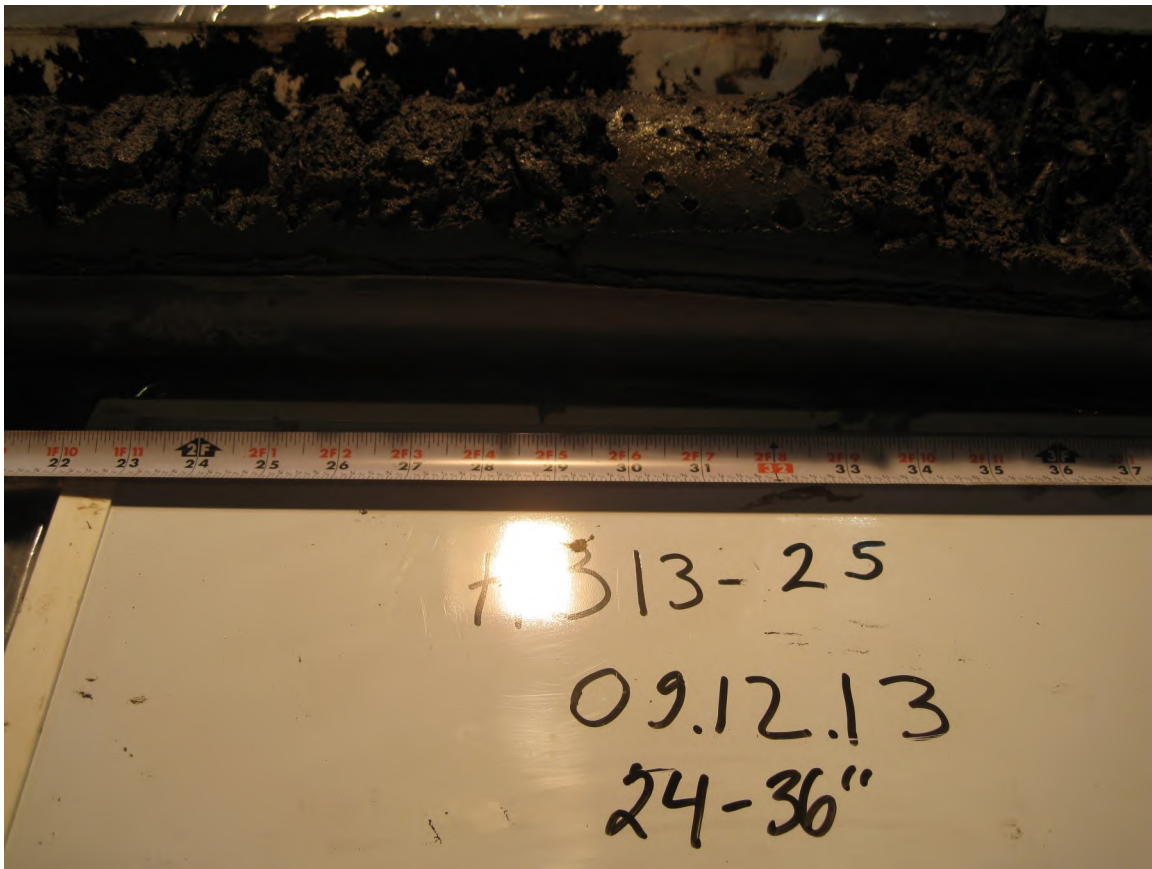
Core HB13-25: 24 to 36 inch depth interval. Grey Brown Silt. See core log for full description. Photo by ARCADIS 09/12/2013

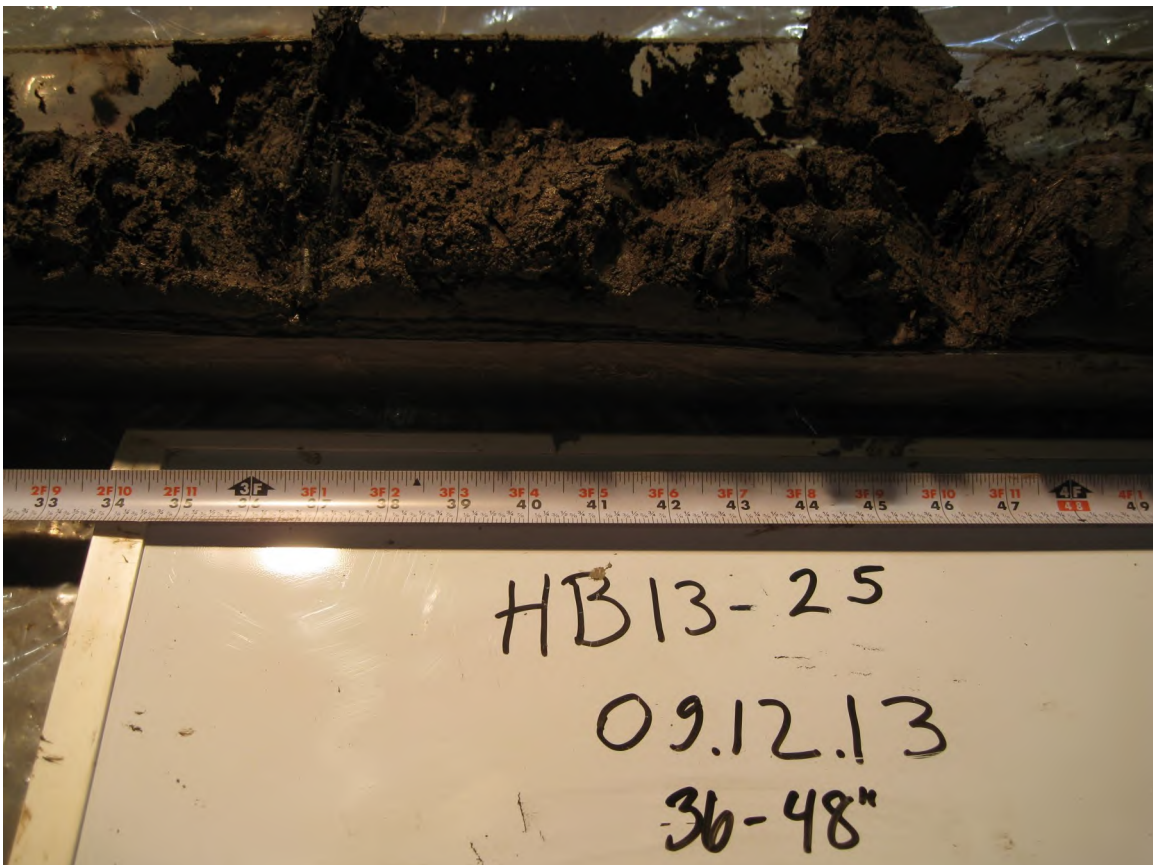
Core HB13-25: 36 to 48 inch depth interval. Brown clay with organics. See core log for full description. Photo by ARCADIS

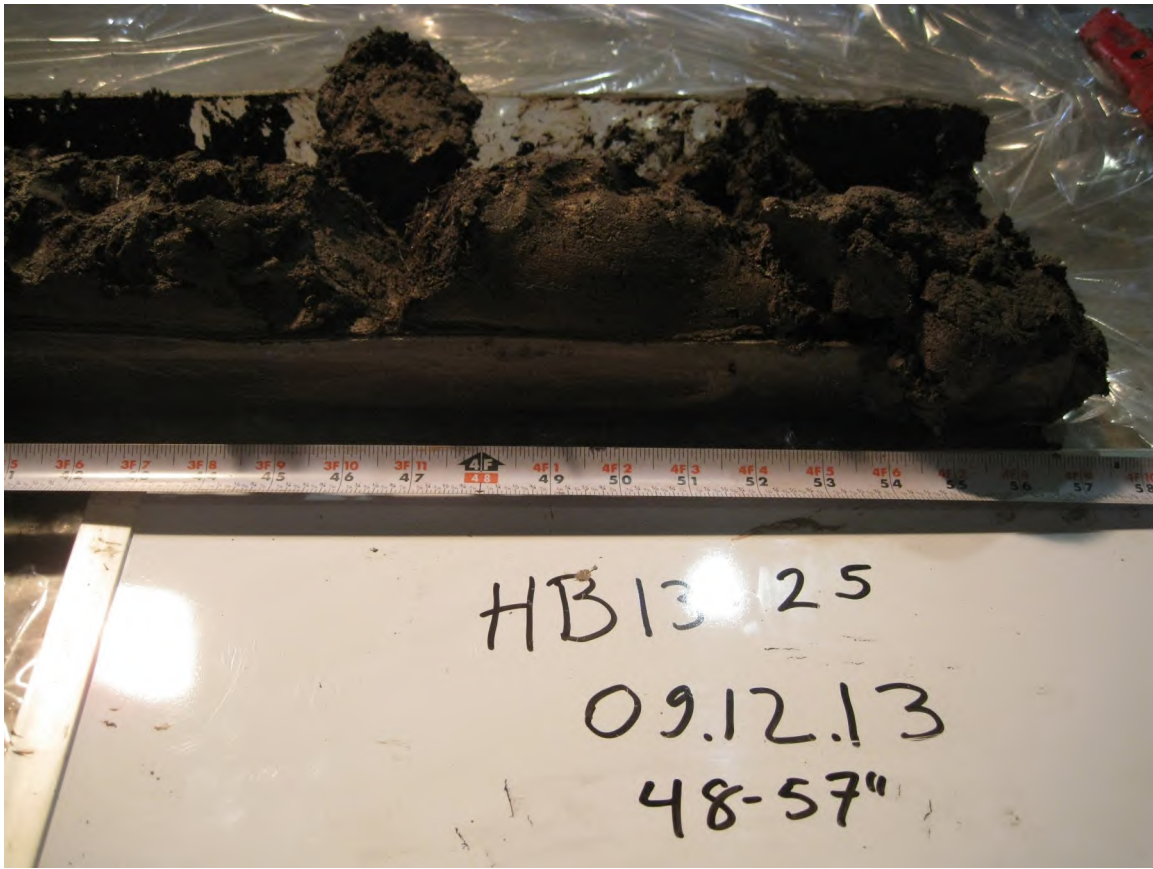
Core HB13-25: 48 to 57 inch depth interval. Brown clay. See core log for full description. Photo by ARCADIS 09/12/2013
