SUBJECT: Final Case Closure with Continuing Obligations

Mr. P's Tires (FMR), 2705 West Clybourn Street, Milwaukee, WI

DNR BRRTS Activity #: 03-41-563586

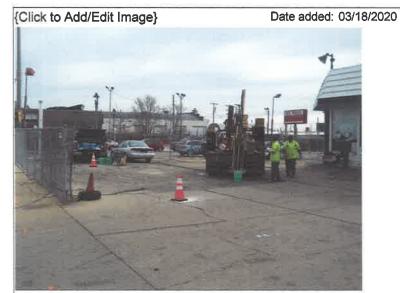
Title: Photo #1: Area of cap to be maintained looking southeast

The asphalt and concrete cap overlying the contaminated soil and as depicted in Attachment D.2 will be inspected once a year, normally in the spring after all snow and ice is gone, for deterioration, cracks and other potential problems that can cause exposure to underlying soils. The inspections will be performed by the property owner or their designated representative. The inspections will be performed to evaluate damage due to settling, exposure to the weather, wear from traffic, increasing age and other factors. Any area where soils have become or are likely to become exposed and where infiltration from the surface will not be effectively minimized will be documented.

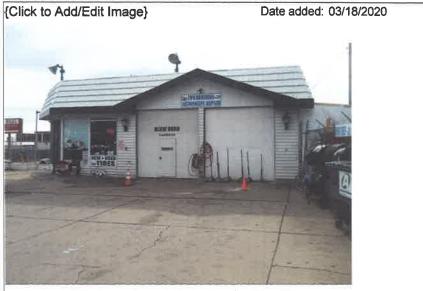
Title: Photo #2: Area of cap to be maintained looking south

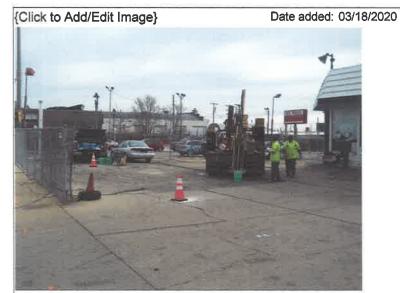
Title: Photo #1: Area of cap to be maintained looking southeast

The asphalt and concrete cap overlying the contaminated soil and as depicted in Attachment D.2 will be inspected once a year, normally in the spring after all snow and ice is gone, for deterioration, cracks and other potential problems that can cause exposure to underlying soils. The inspections will be performed by the property owner or their designated representative. The inspections will be performed to evaluate damage due to settling, exposure to the weather, wear from traffic, increasing age and other factors. Any area where soils have become or are likely to become exposed and where infiltration from the surface will not be effectively minimized will be documented.

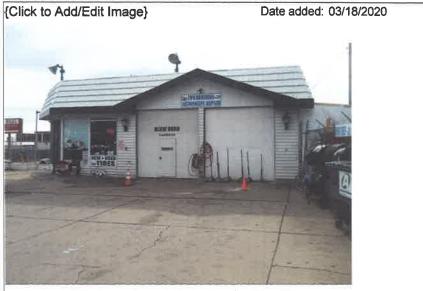
Title: Photo #2: Area of cap to be maintained looking south
