**SUBJECT:** Final Case Closure with Continuing Obligations  
Maron Property, W9468 Iron Road, Beaver Dam, WI  
DNR BRRTS Activity #: 03-14-563925  
FID #: 114109710

This former commercial manufacturing business had petroleum-related soil and groundwater contamination associated with an underground diesel storage tank that has since been removed. Response actions included investigation activities related to soil, groundwater and sub-slab vapors and a remedial soil excavation.

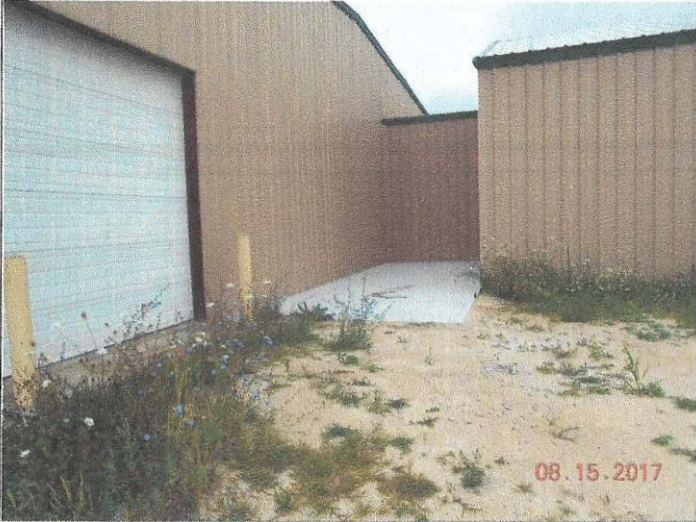
Title: Photo #1: Area of cap to be maintained (looking north/northwest)

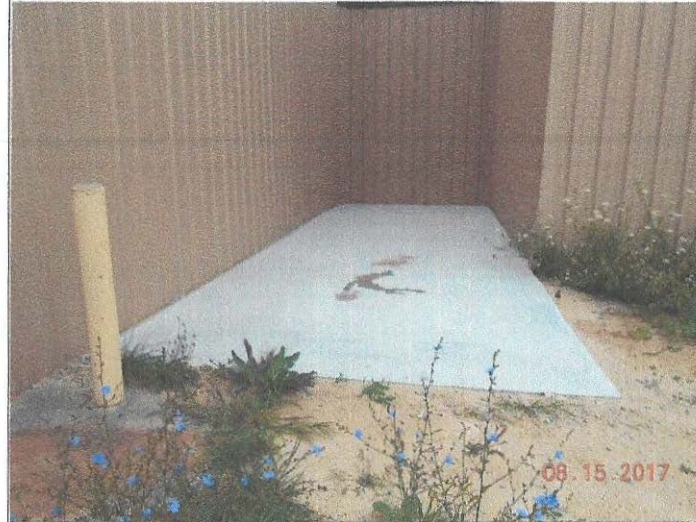
Title: Photo #2: Area of cap to be maintained (looking north/northwest)

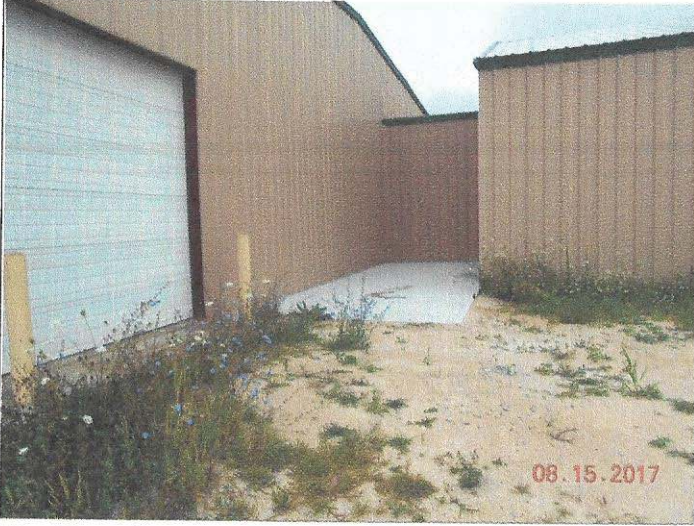
Title: Photo #1: Area of cap to be maintained (looking north/northwest)

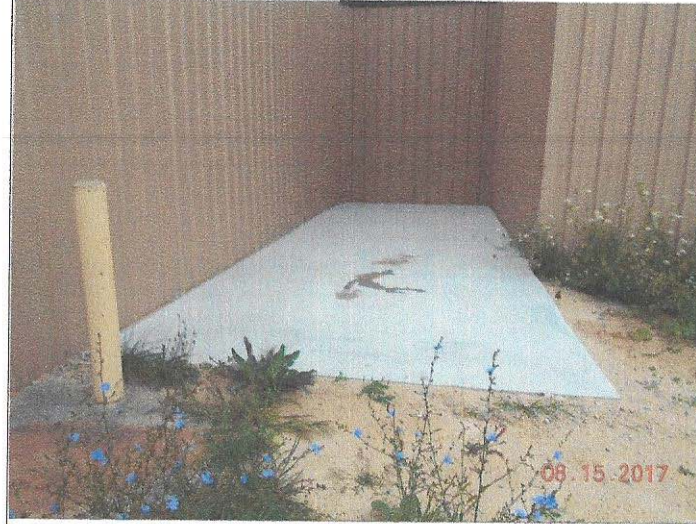
Title: Photo #2: Area of cap to be maintained (looking north/northwest)
