**From:** Stoltz, Carrie R - DNR  
**Sent:** Thursday, August 02, 2018 11:14 AM  
**To:** 'Ken Shimko'  
**Subject:** RE: Olson Goodman - MTBE in MW-9P-Closure Committee Review Info  
**Attachments:** 20180802112351938.pdf

SUBJECT: Olson & Goodman (03-61-563926) **DISCUSSION ONLY!**

**Table 4: Ground Water Level Measurements**  
 Olson Goodman Inc  
 Stetsonville, WI  
 Meridian No. 05F807

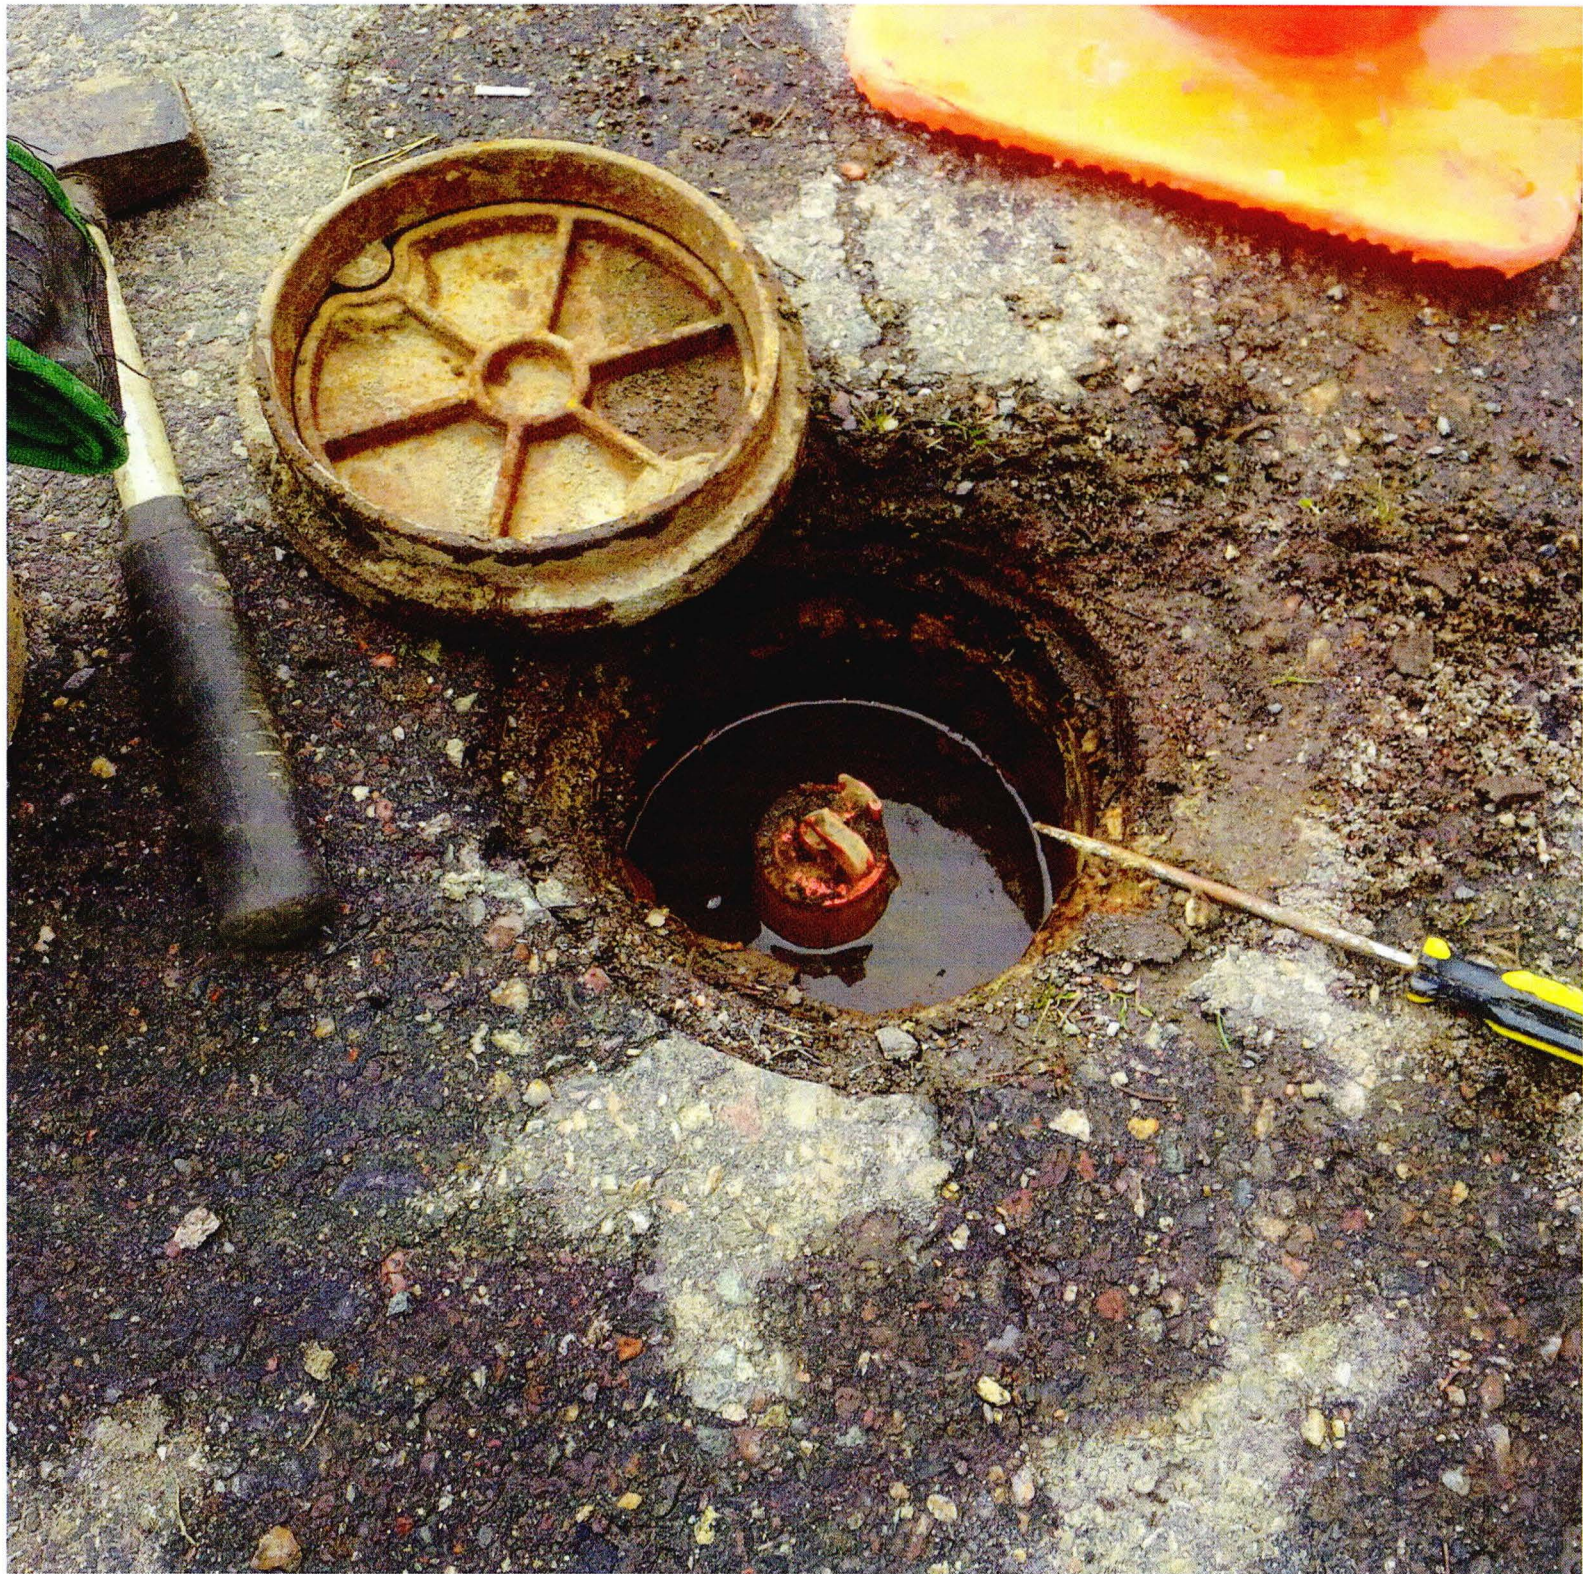
Please see attached picture of manway for MW-7P at Olson Goodman/Eds Service site in Stetsonville. As you can see, the manway has rusted and is no longer attached. The manway should be replaced.

Hi Ken, attached is the approval letter + U&C for MW -7P repair. A hard copy will be sent via USPS. Thanks, Carrie
