SUBJECT: Case Closure with Continuing Obligations
Rath Property, 1304 Saint Rose Road, Cuba City, WI 53807
BRRTS #: 03-22-563937

<u>Address (City, WI)</u>	<u>COs Applied</u>	<u>Date of Maintenance Plan(s)</u>
Rath Property, 1304 Saint Rose Road, Cuba City, WI 53807	-Residual Soil Contamination -Structural impediment	Not applicable

**RESIDUAL SOIL CONTAMINATION
RATH PROPERTY
1304 Saint Rose Road
Cuba City, Wisconsin**

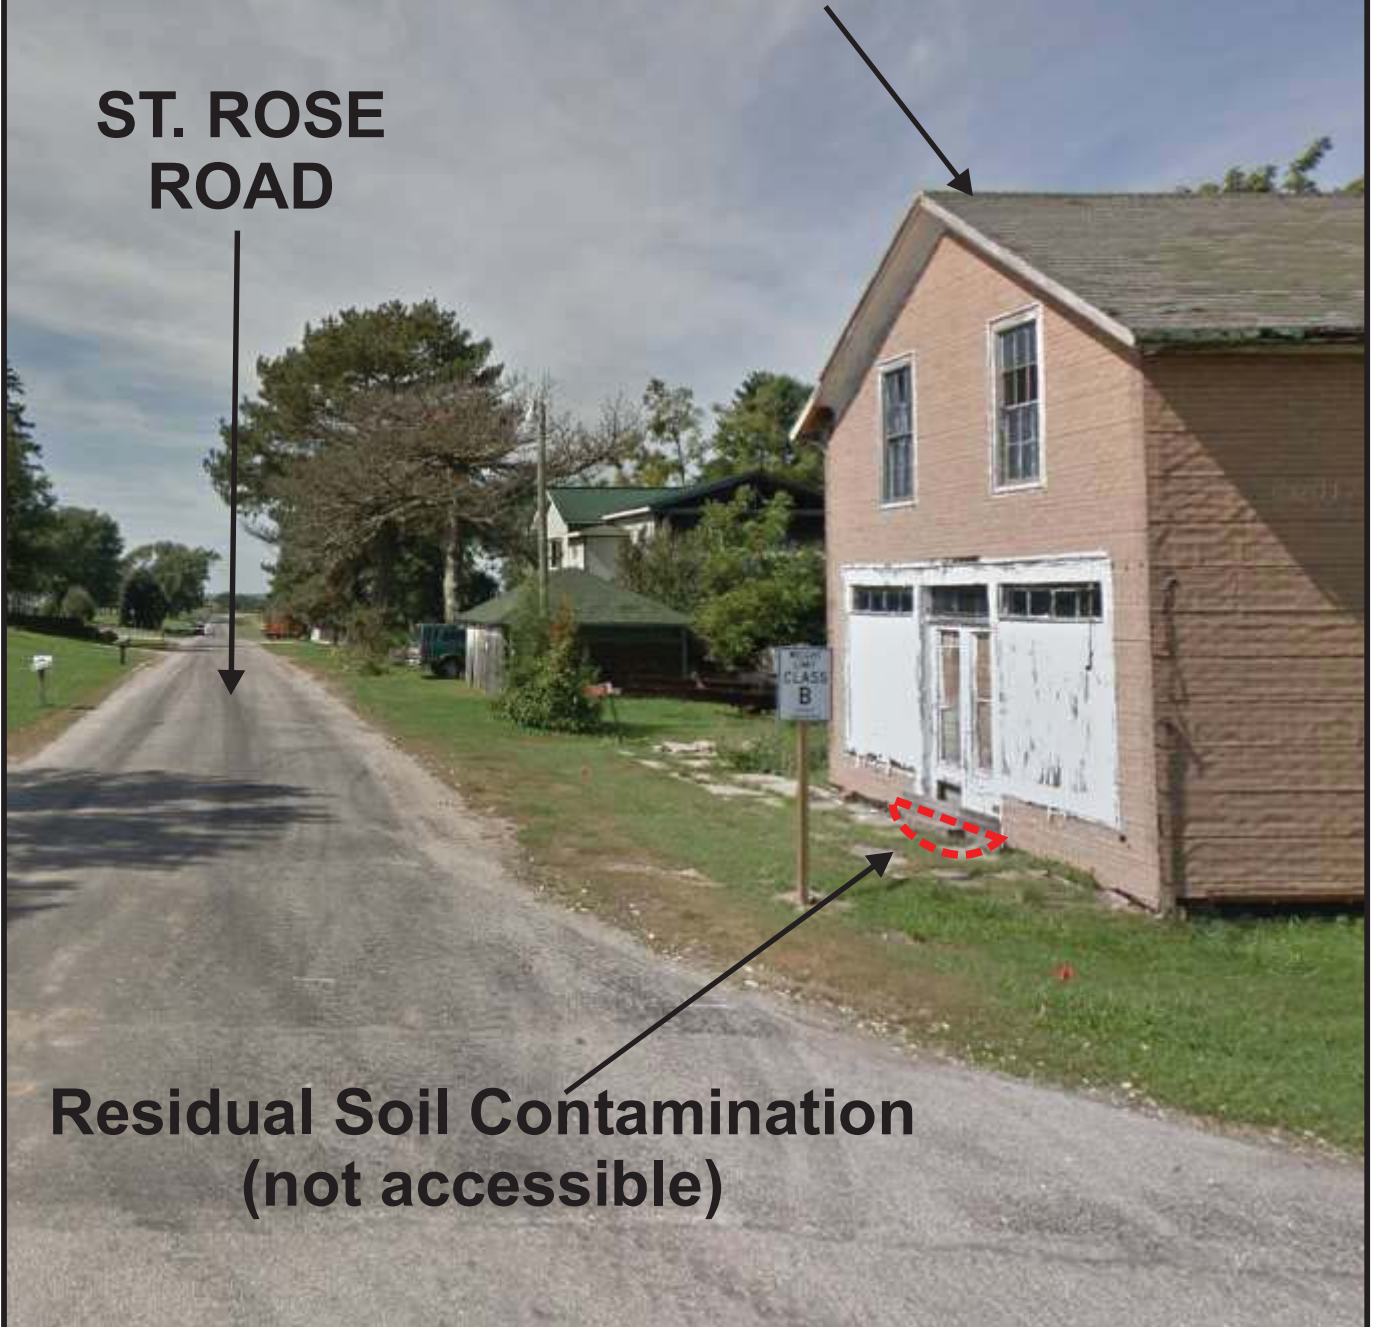
**IMPEDIMENT
(Former Store Building)**

**Residual Soil Contamination
(not accessible)**

The former general store building was an impediment to remediation of the contaminated soils at the site. The building is not a significant barrier to infiltration of water since the residual soil contamination is located along the building footing and is 8 to 10 feet below grade. Precipitation that accumulates at the site simply infiltrates along the foundation wall.
