Project: Vapor investigation at Allyn property

Sigma Project #16551

**Subject: Sub-Slab Vapor and Air Sampling
Former Algoma Dry Cleaning
111 Steel St.
Algoma, Wisconsin**

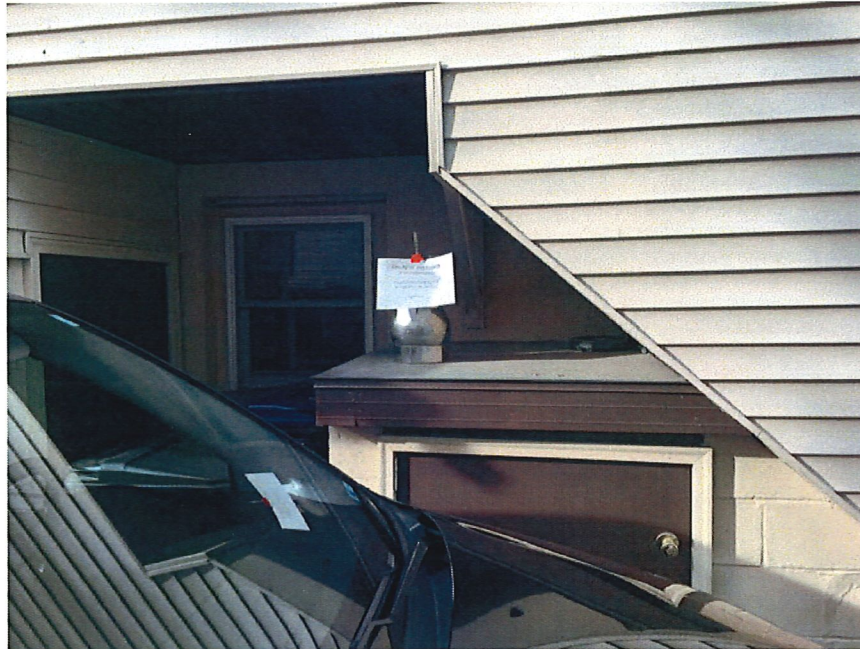
Photo 1: Outdoor air sample collection location.

- Outdoor air sample (background) V-3: Outdoor air sample collected just outside of the eastern wall of house. Outdoor air sample V-3 was collected over a 24-hour period between November 11 and 12, 2016.

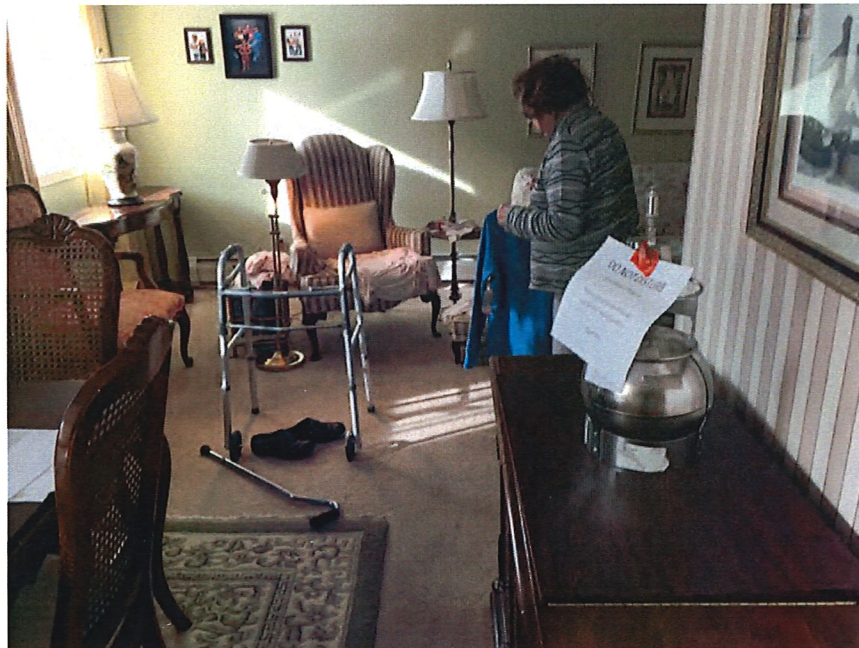
Photo 2: Indoor air sample collection location.

- Indoor air sample V-1: Indoor air sample collected within the living room of the home. Indoor air sample V-1 was collected over an approximately 24-hour period between November 11 and 12, 2016.
- Sub-slab vapor sample V-2: Sub-slab vapor sample collected from beneath the floor slab of the former dry-cleaning processing room, specifically in the location of the former "perc" unit as identified in information provided to Sigma.

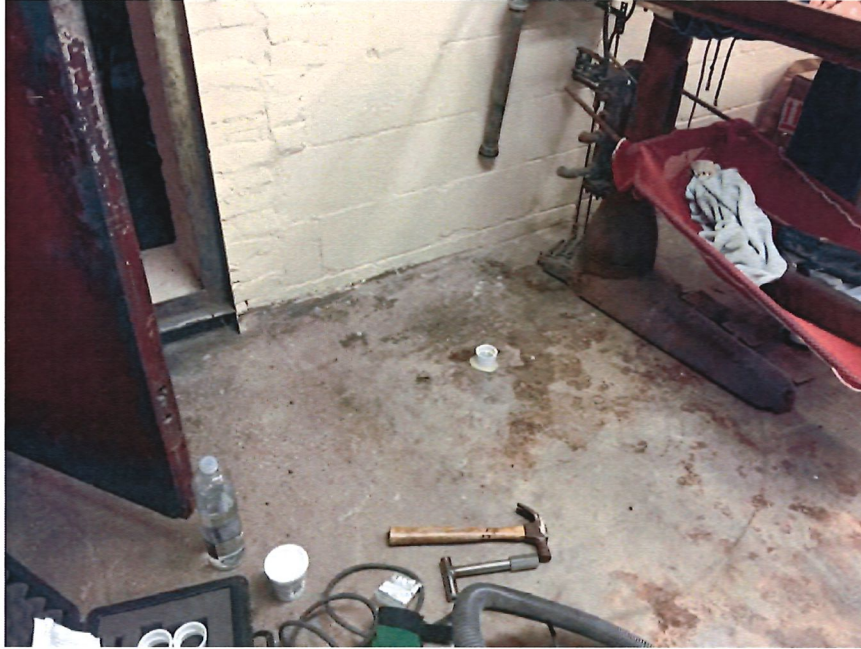
Photo 3: Sub-slab sample point location and water dam test set up.

On November 11, 2016 Sigma installed one brass Vapor Pin® within the concrete floor slab of the former dry-cleaning processing room. A 5/8-inch diameter hole was drilled through the floor slab to accommodate the vapor pin. The hole was cleaned of concrete debris. The neck of the vapor pin was fitted with a silicon sleeve to create an air-tight seal around the vapor pin. The vapor pin was gently hammered into place and then capped. Following installation of the vapor pin, Sigma performed a water dam seal test on the vapor pin / floor slab to ensure there was no leakage at the surface seal around the sampling point. The water dam test was completed using a 1-1/2 inch diameter PVC pipe coupling placed around the location of the vapor pin and sealed to the floor slab with plumber's putty. A small volume of water was poured into the water dam, surrounding the vapor pin and vapor pin / floor slab penetration point. The water level within the water dam was subsequently monitored and no change (indicating leakage) was observed over a period of 10 minutes. The vapor pin was left in place overnight for sampling the following morning.

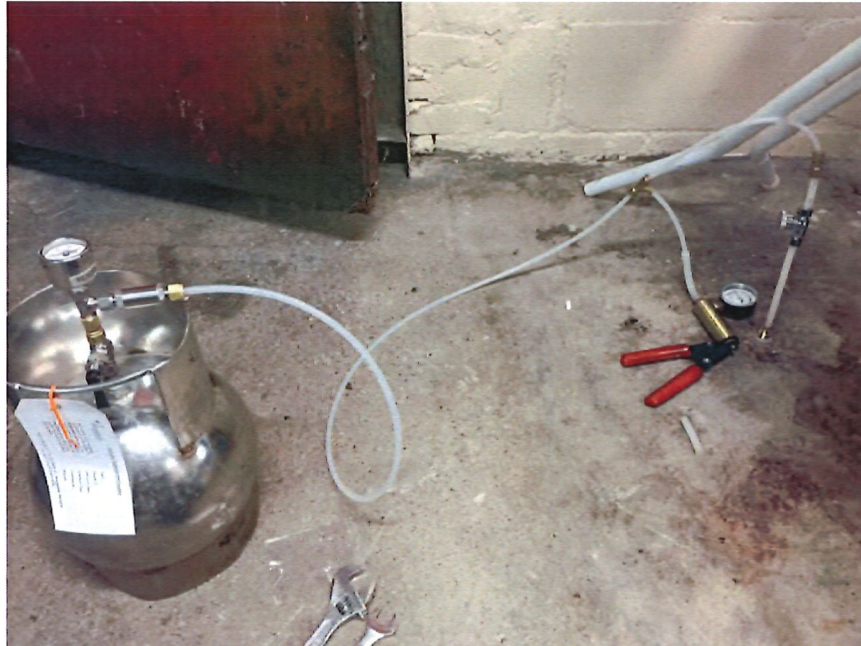
Photo 4: Sample train set up and shut-in test.

the sampling canister to the vapor pin for sample collection. Prior to sampling, a shut-in (leak) test was performed on the nylon tubing to SUMMA can connections by use of a hand vacuum pump. The connection at the vapor pin was shut with a valve, creating a closed system between the vapor pin and SUMMA canister connection point. The hand vacuum pump was used to produce a minimum vacuum pressure of 25 inches of mercury within the closed sample train. The vacuum pressure held steady for approximately 2 minutes, which indicates no leakage in the sampling train tubing or connections. Upon completion of the shut-in test, the sample train and SUMMA canister valves were opened to begin sample collection. Following sample collection, the sample train was removed and the vapor pin tip was capped with an air tight rubber nipple cap and left securely in place.

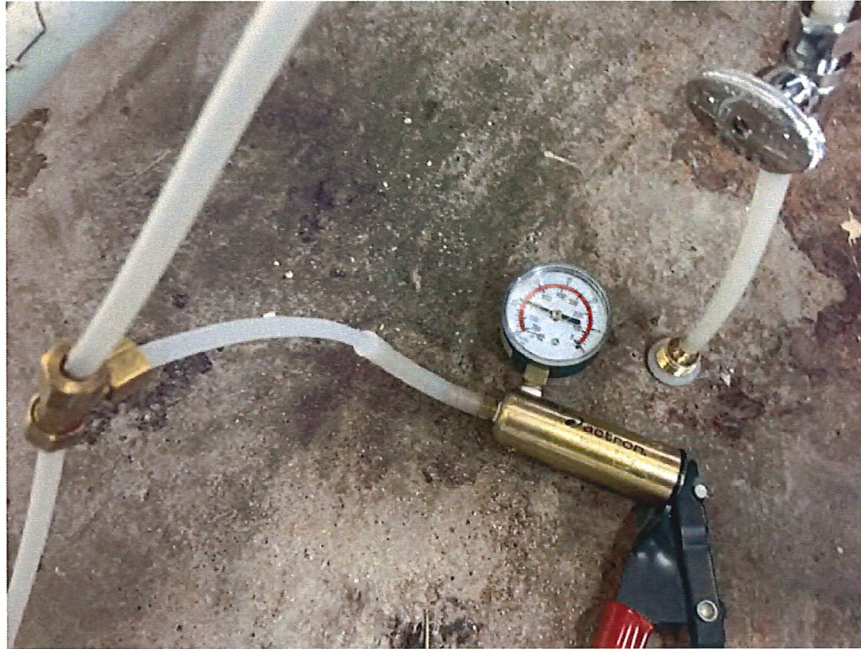
Photo 5: Shut-in test on sub-slab sample train.
