Tank System Site Assessment (TSSA)

Ultra Service, L.L.C.
1002 11th Avenue
Grafton, Wisconsin 53024

December 9th, 2015

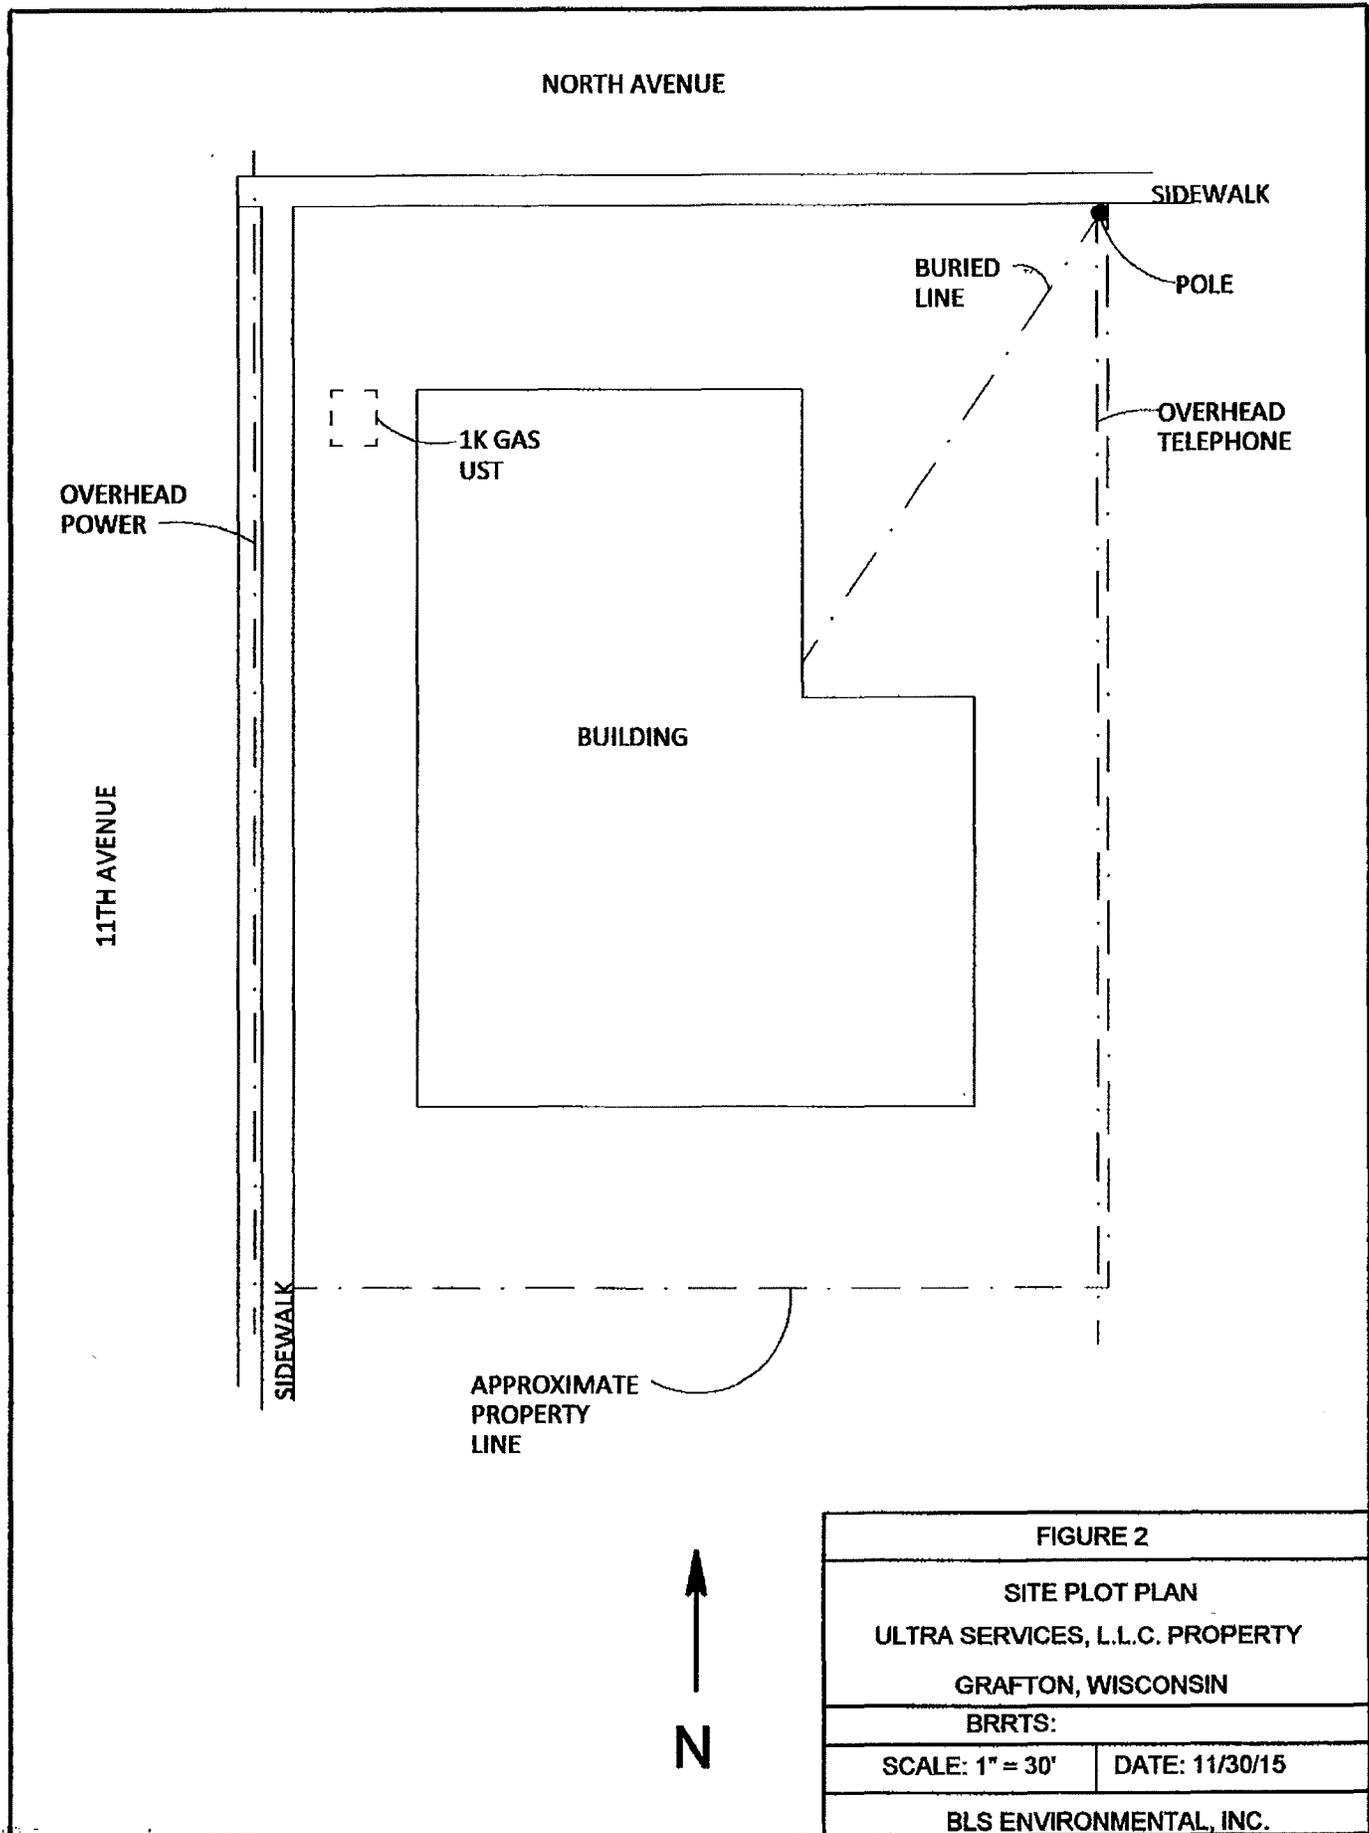
FIGURE 2	
SITE PLOT PLAN	
ULTRA SERVICES, L.L.C. PROPERTY	
GRAFTON, WISCONSIN	
BRRTS:	
SCALE: 1" = 30'	DATE: 11/30/15
BLS ENVIRONMENTAL, INC.

Figure 2 presents the location of the UST relevant to permanent structures immediately surrounding the area. As shown on Figure 2, the UST was located in the northwestern portion of the Property. The fill pipe was located above the UST, with the vent pipe located adjacent to the building just east of the UST. The conveyance piping was

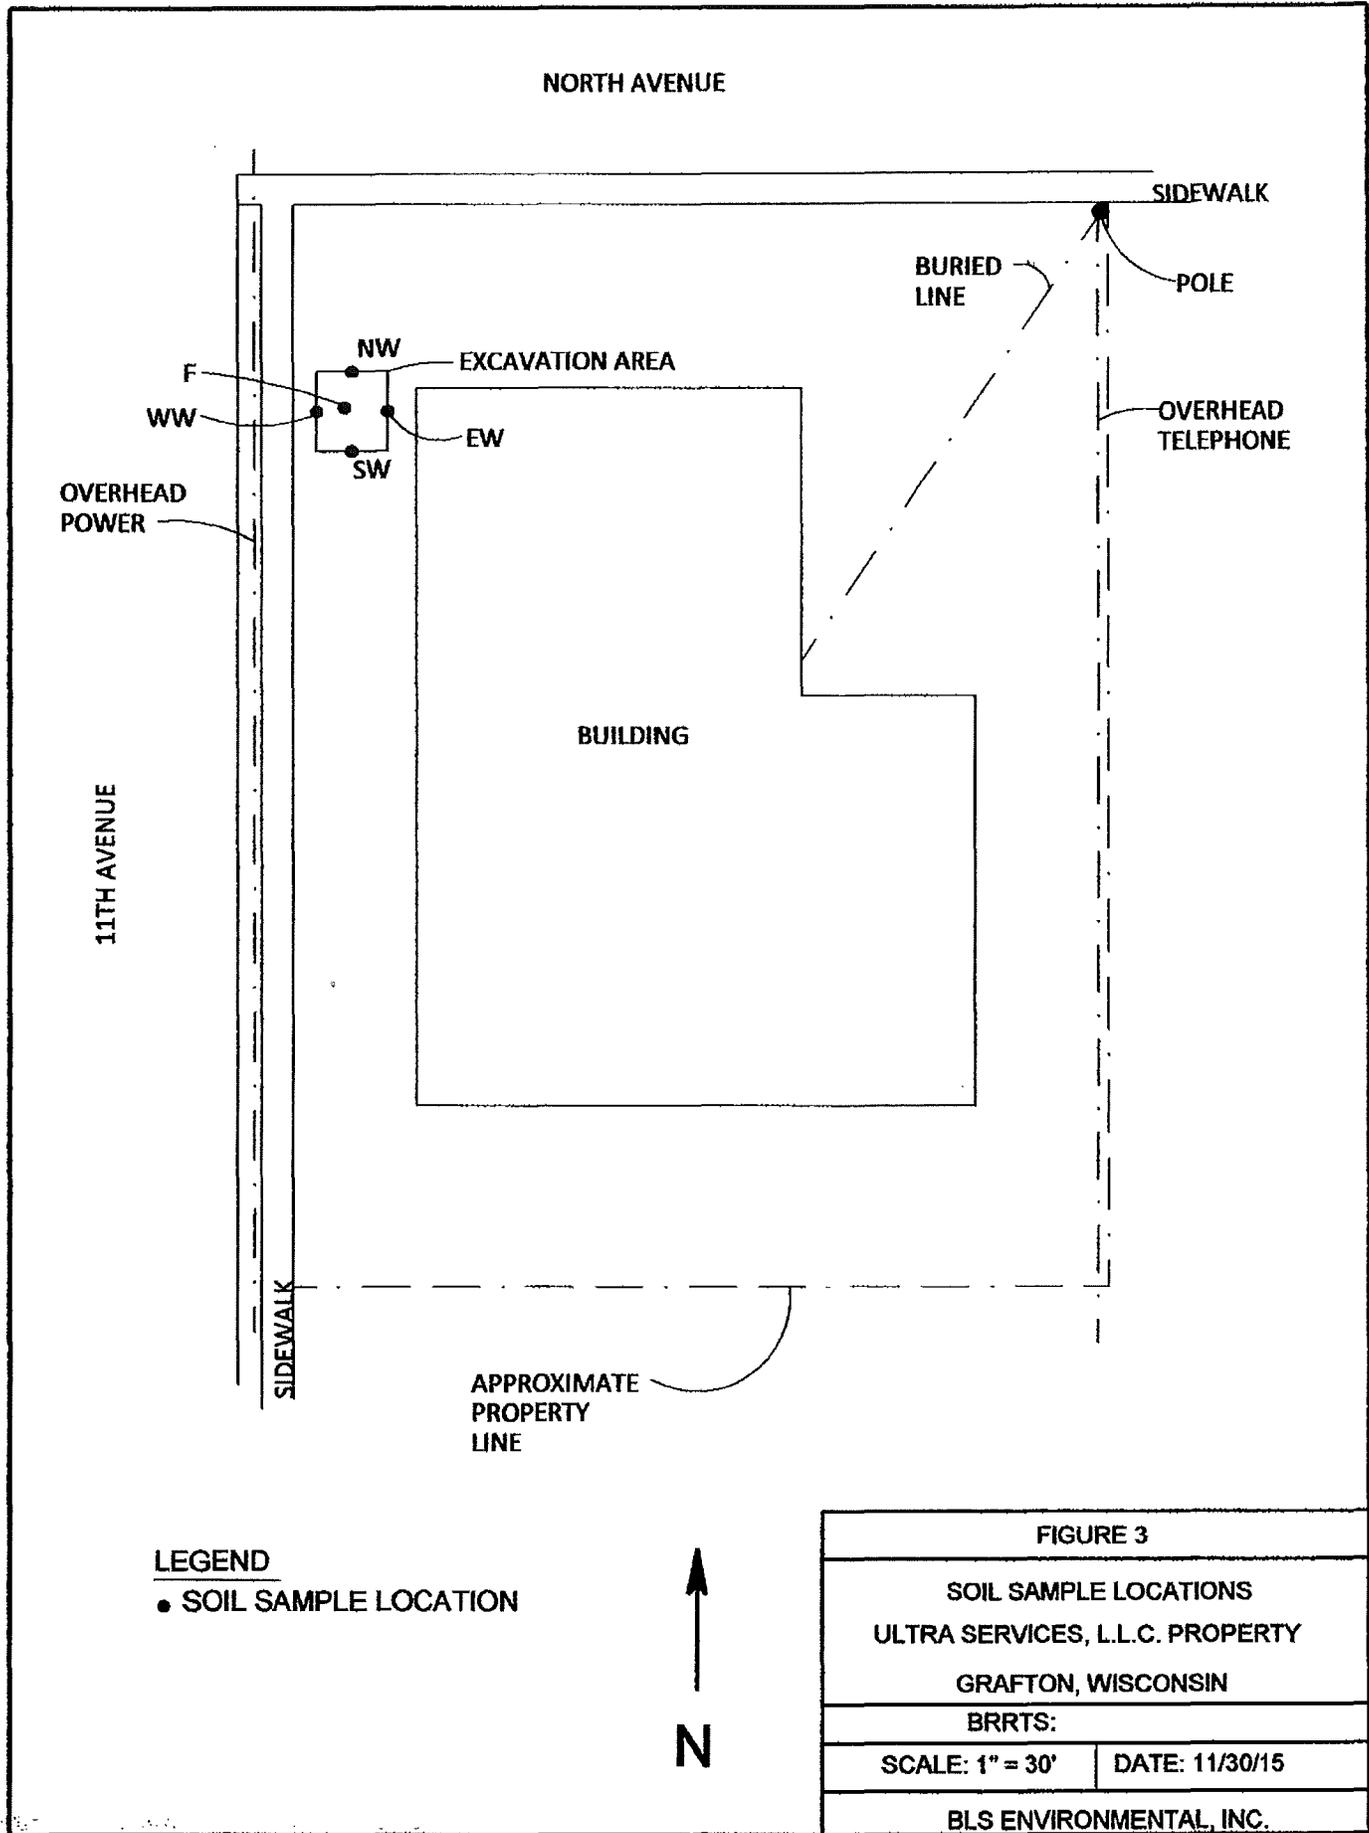
As part of the closure activities, a BLS Environmental Inc. (BLS) field geologist carefully examined the in-place and excavated soil for the presence of any release of petroleum product associated with the former UST systems. Soils located immediately adjacent to the USTs were subject to more scrutiny. In addition, permeable layers within the native soils and/or backfill materials were carefully examined. Odor and appearance of the soil samples were noted during the field screening activities. The soil sampling locations conducted during the UST closure are presented on Figure 3.

A total of five (5) soil samples were collected from beneath the invert and from the excavation sidewalls in accordance with state tank closure assessment standards. Each sample was collected from approximately 2-feet below the invert or into the sidewalls.
