Tank System Site Assessment (TSSA)

Ultra Service, L.L.C.
1002 11th Avenue
Grafton, Wisconsin 53024

December 9th, 2015

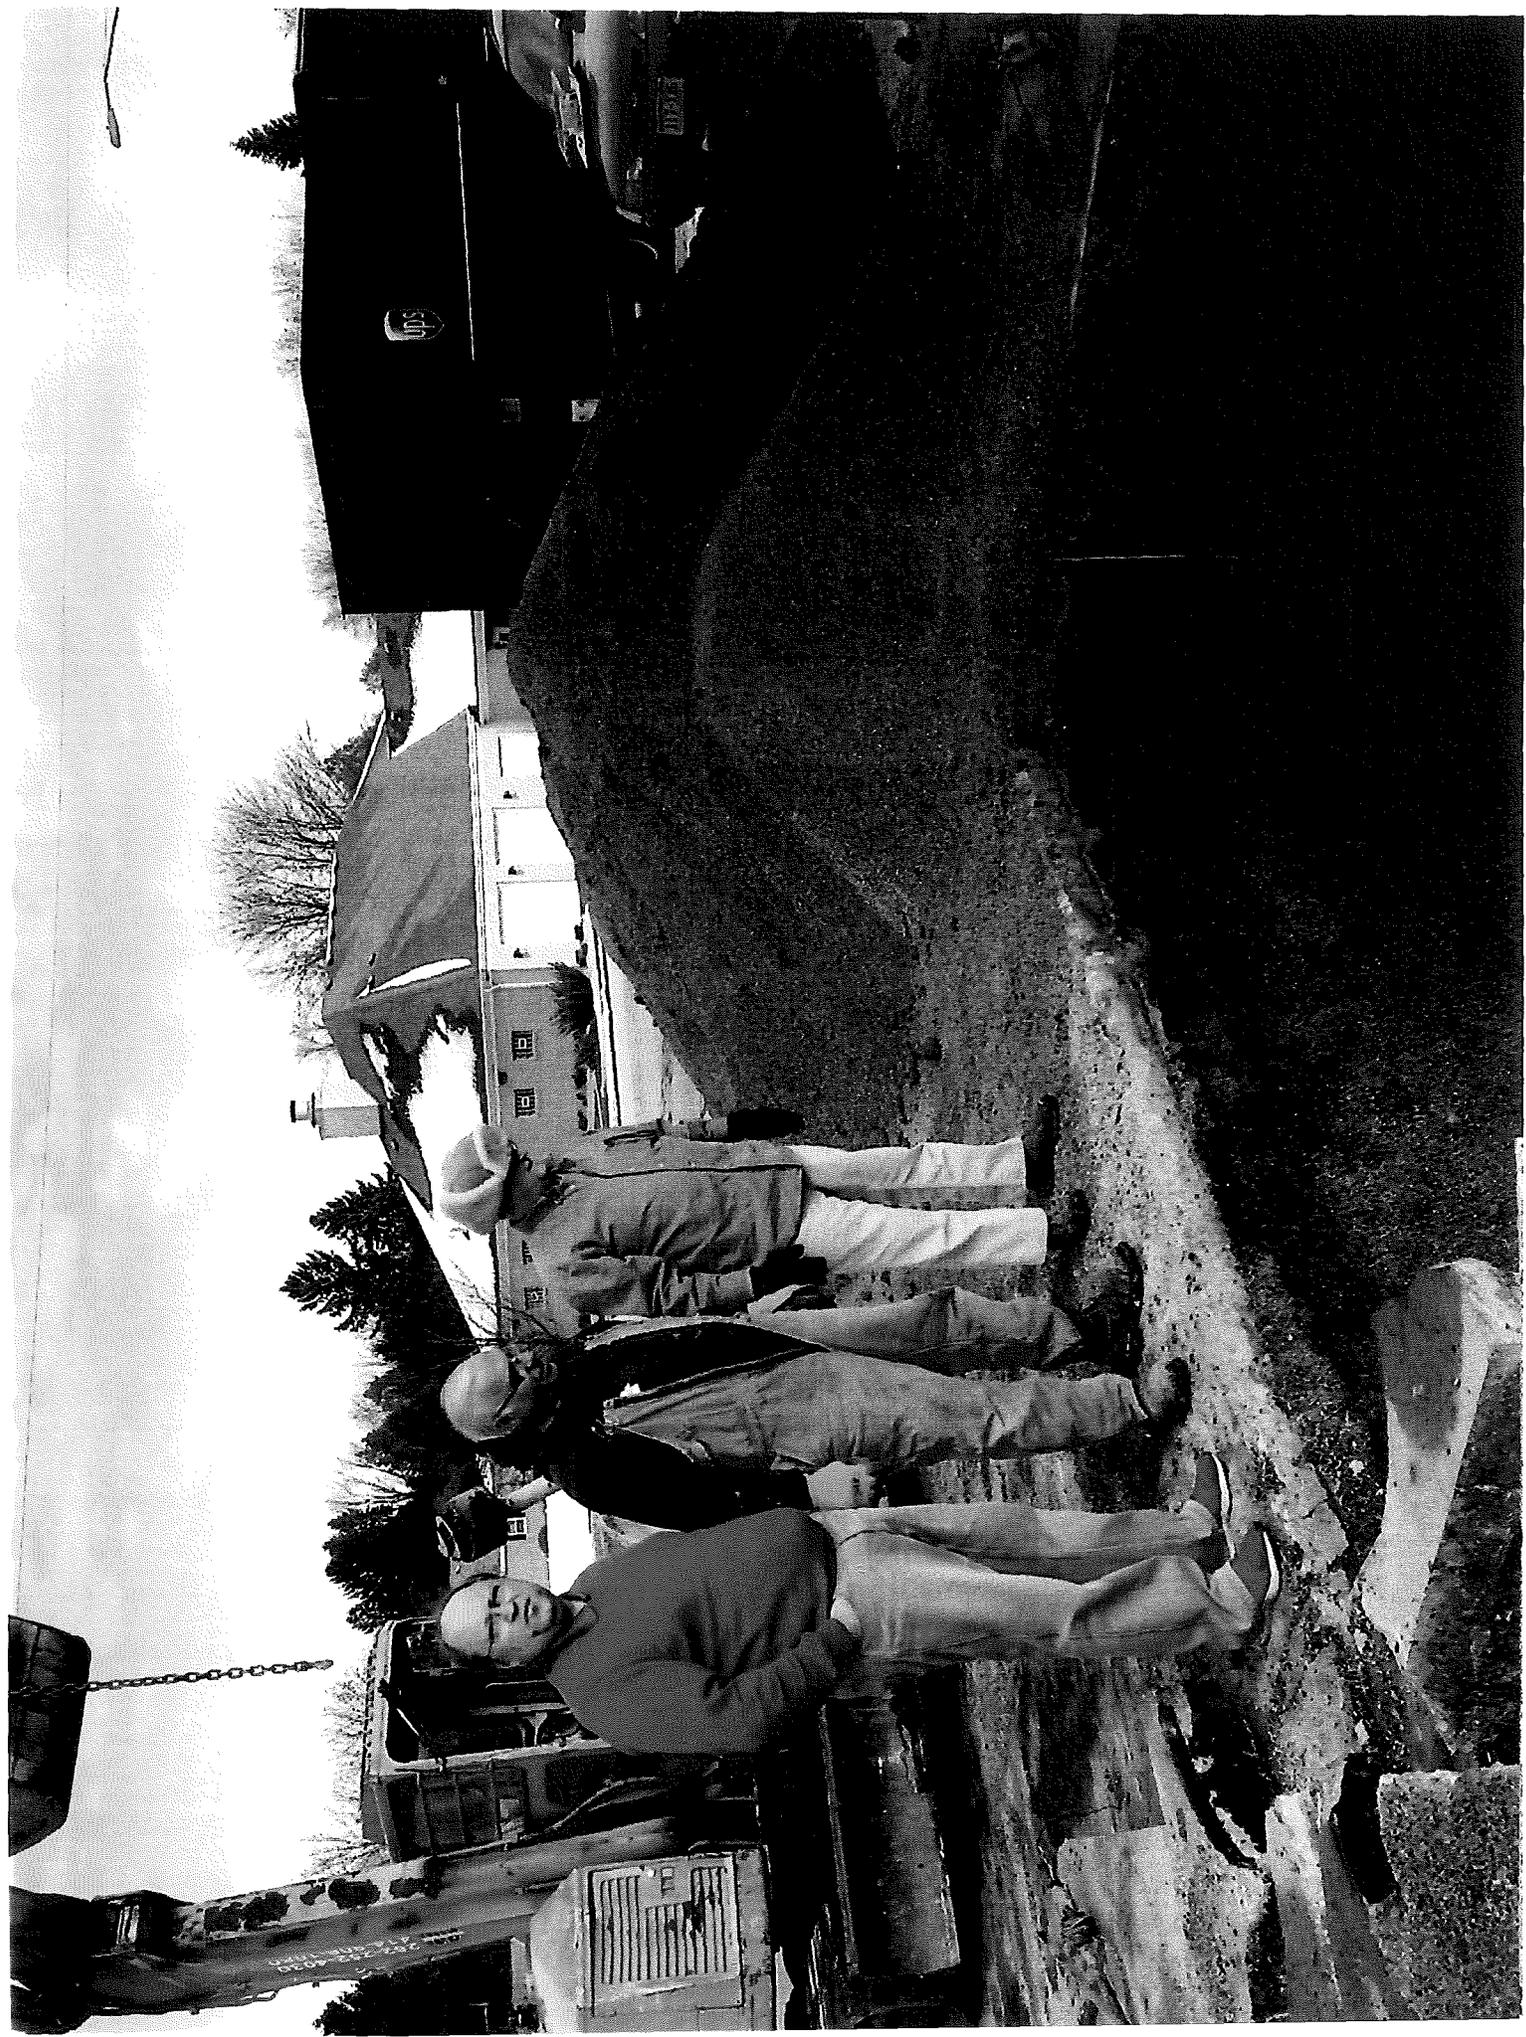
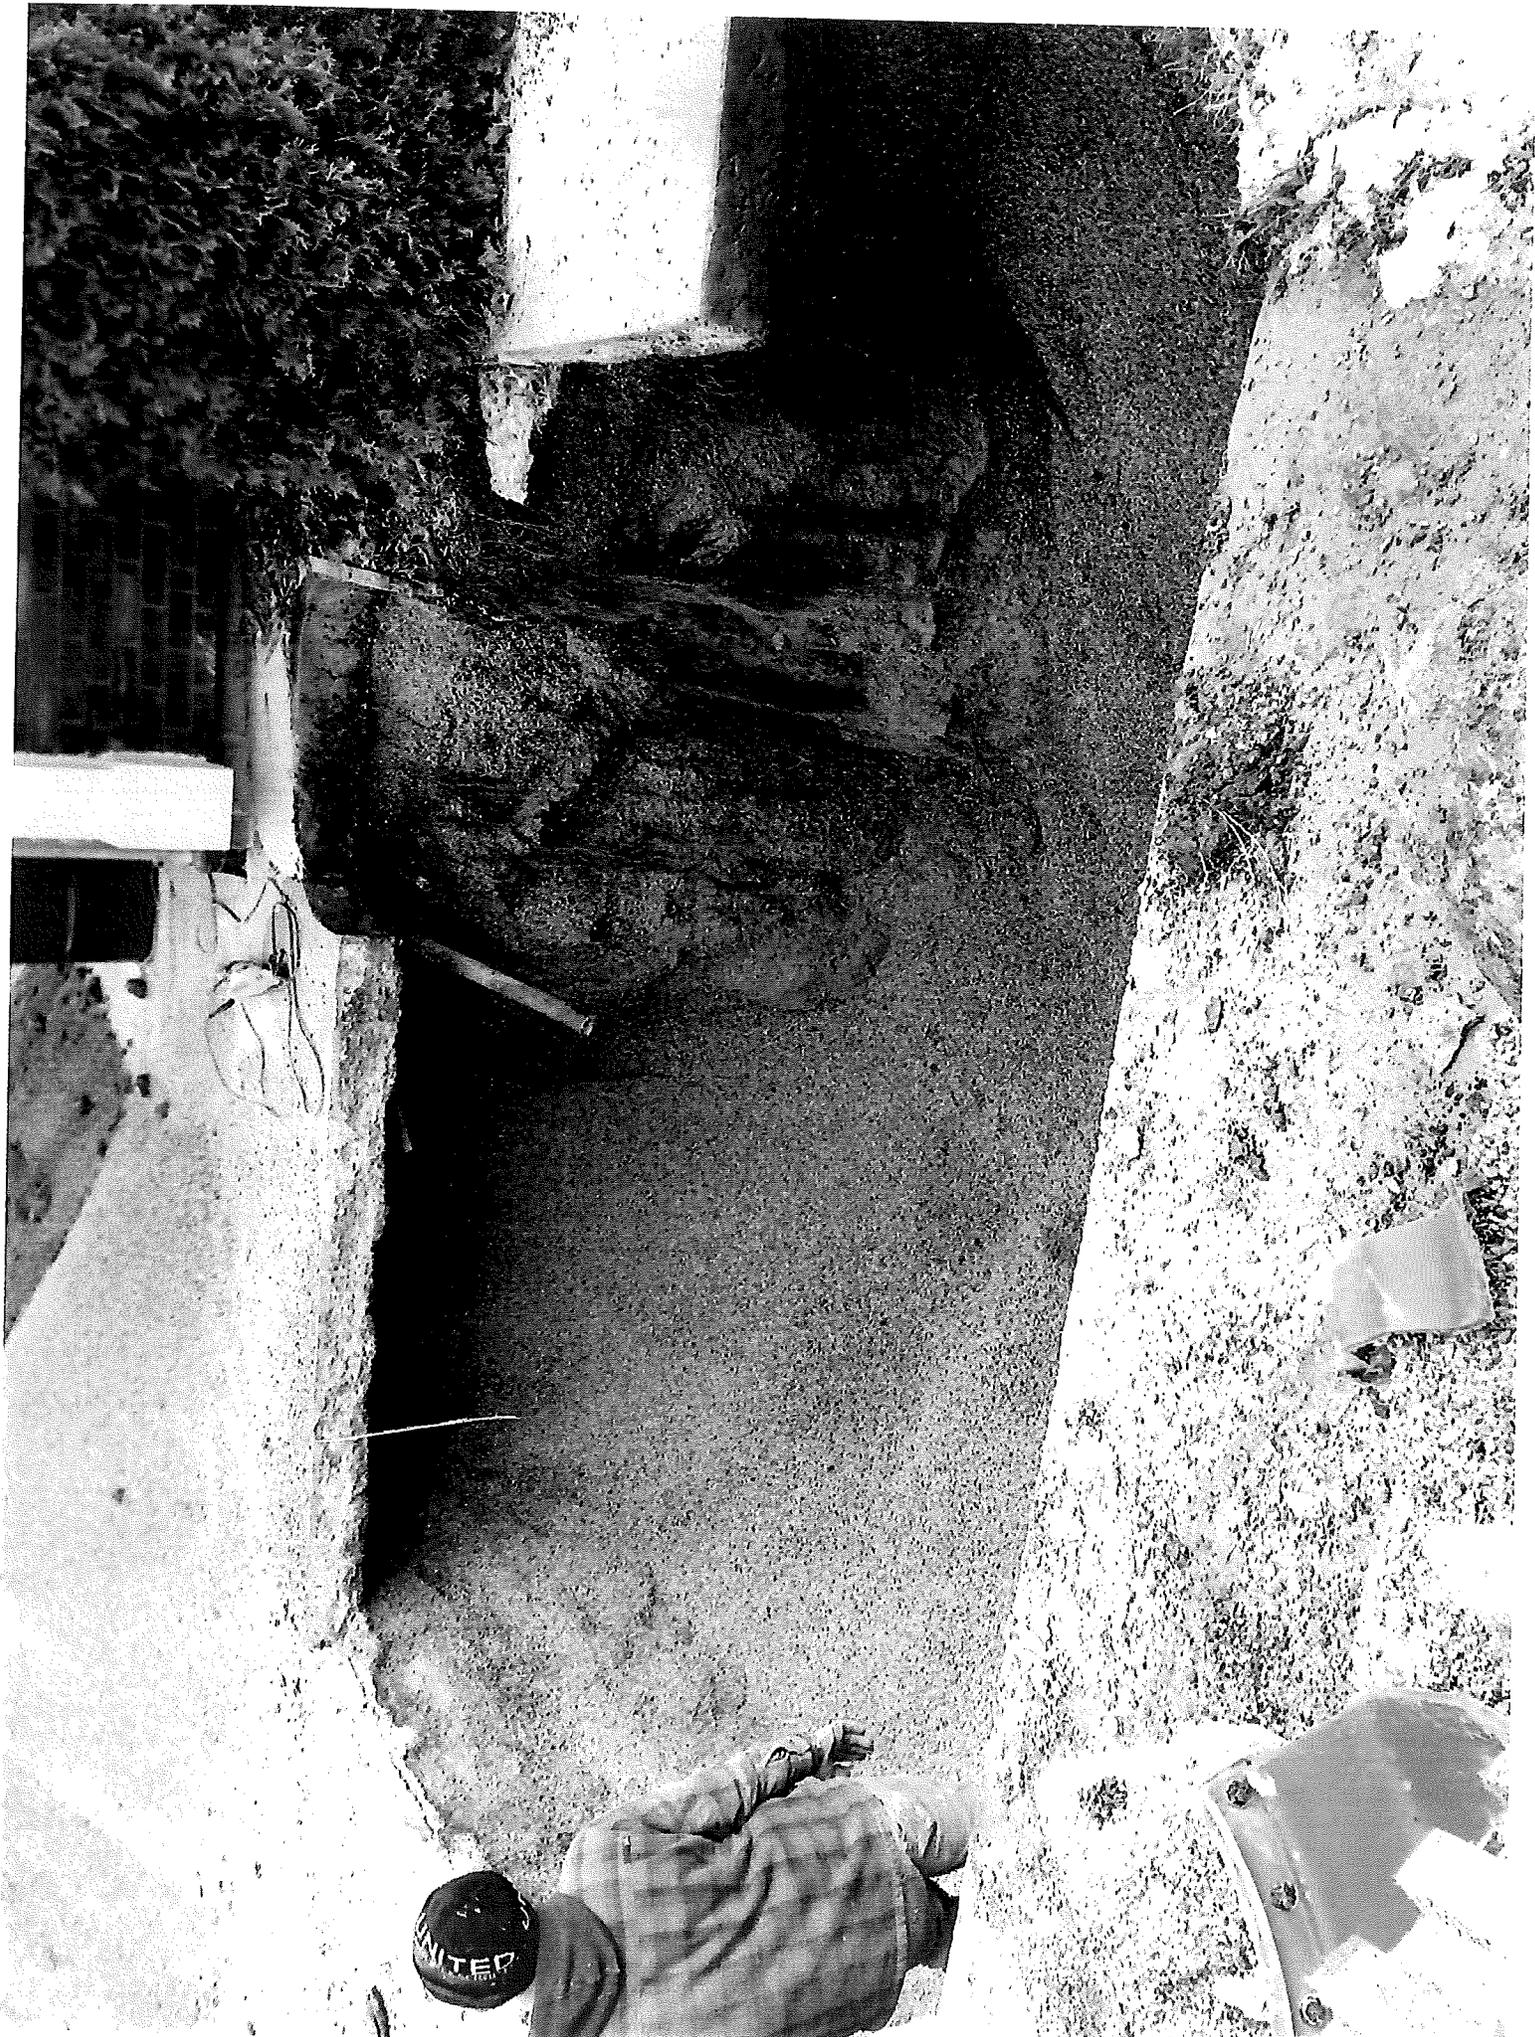
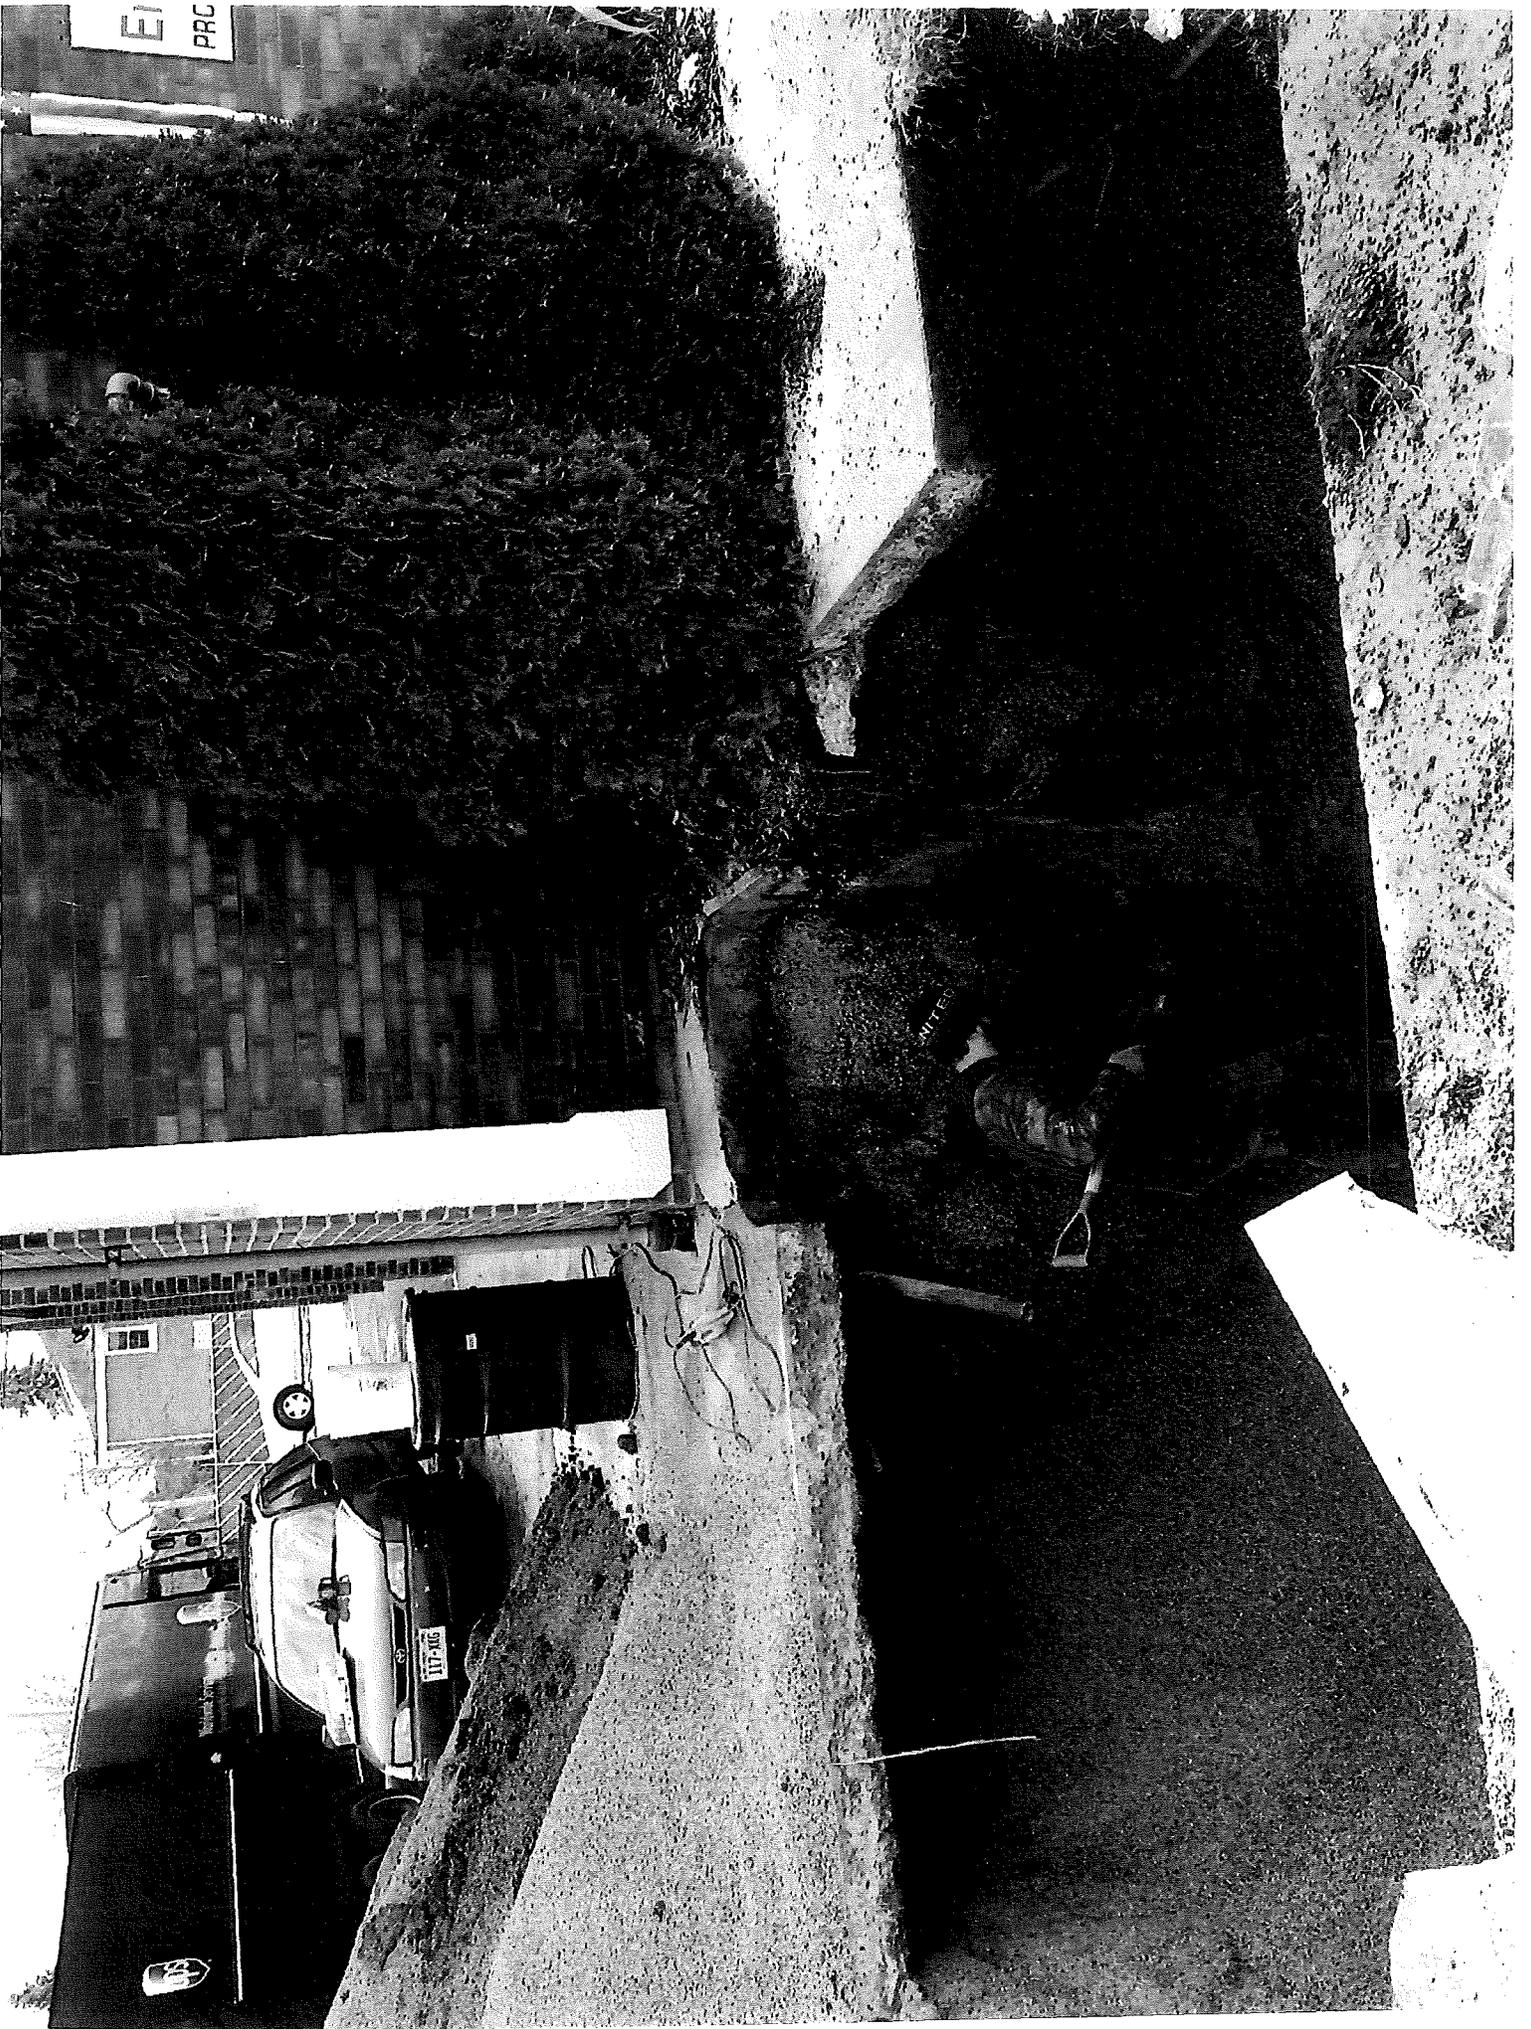
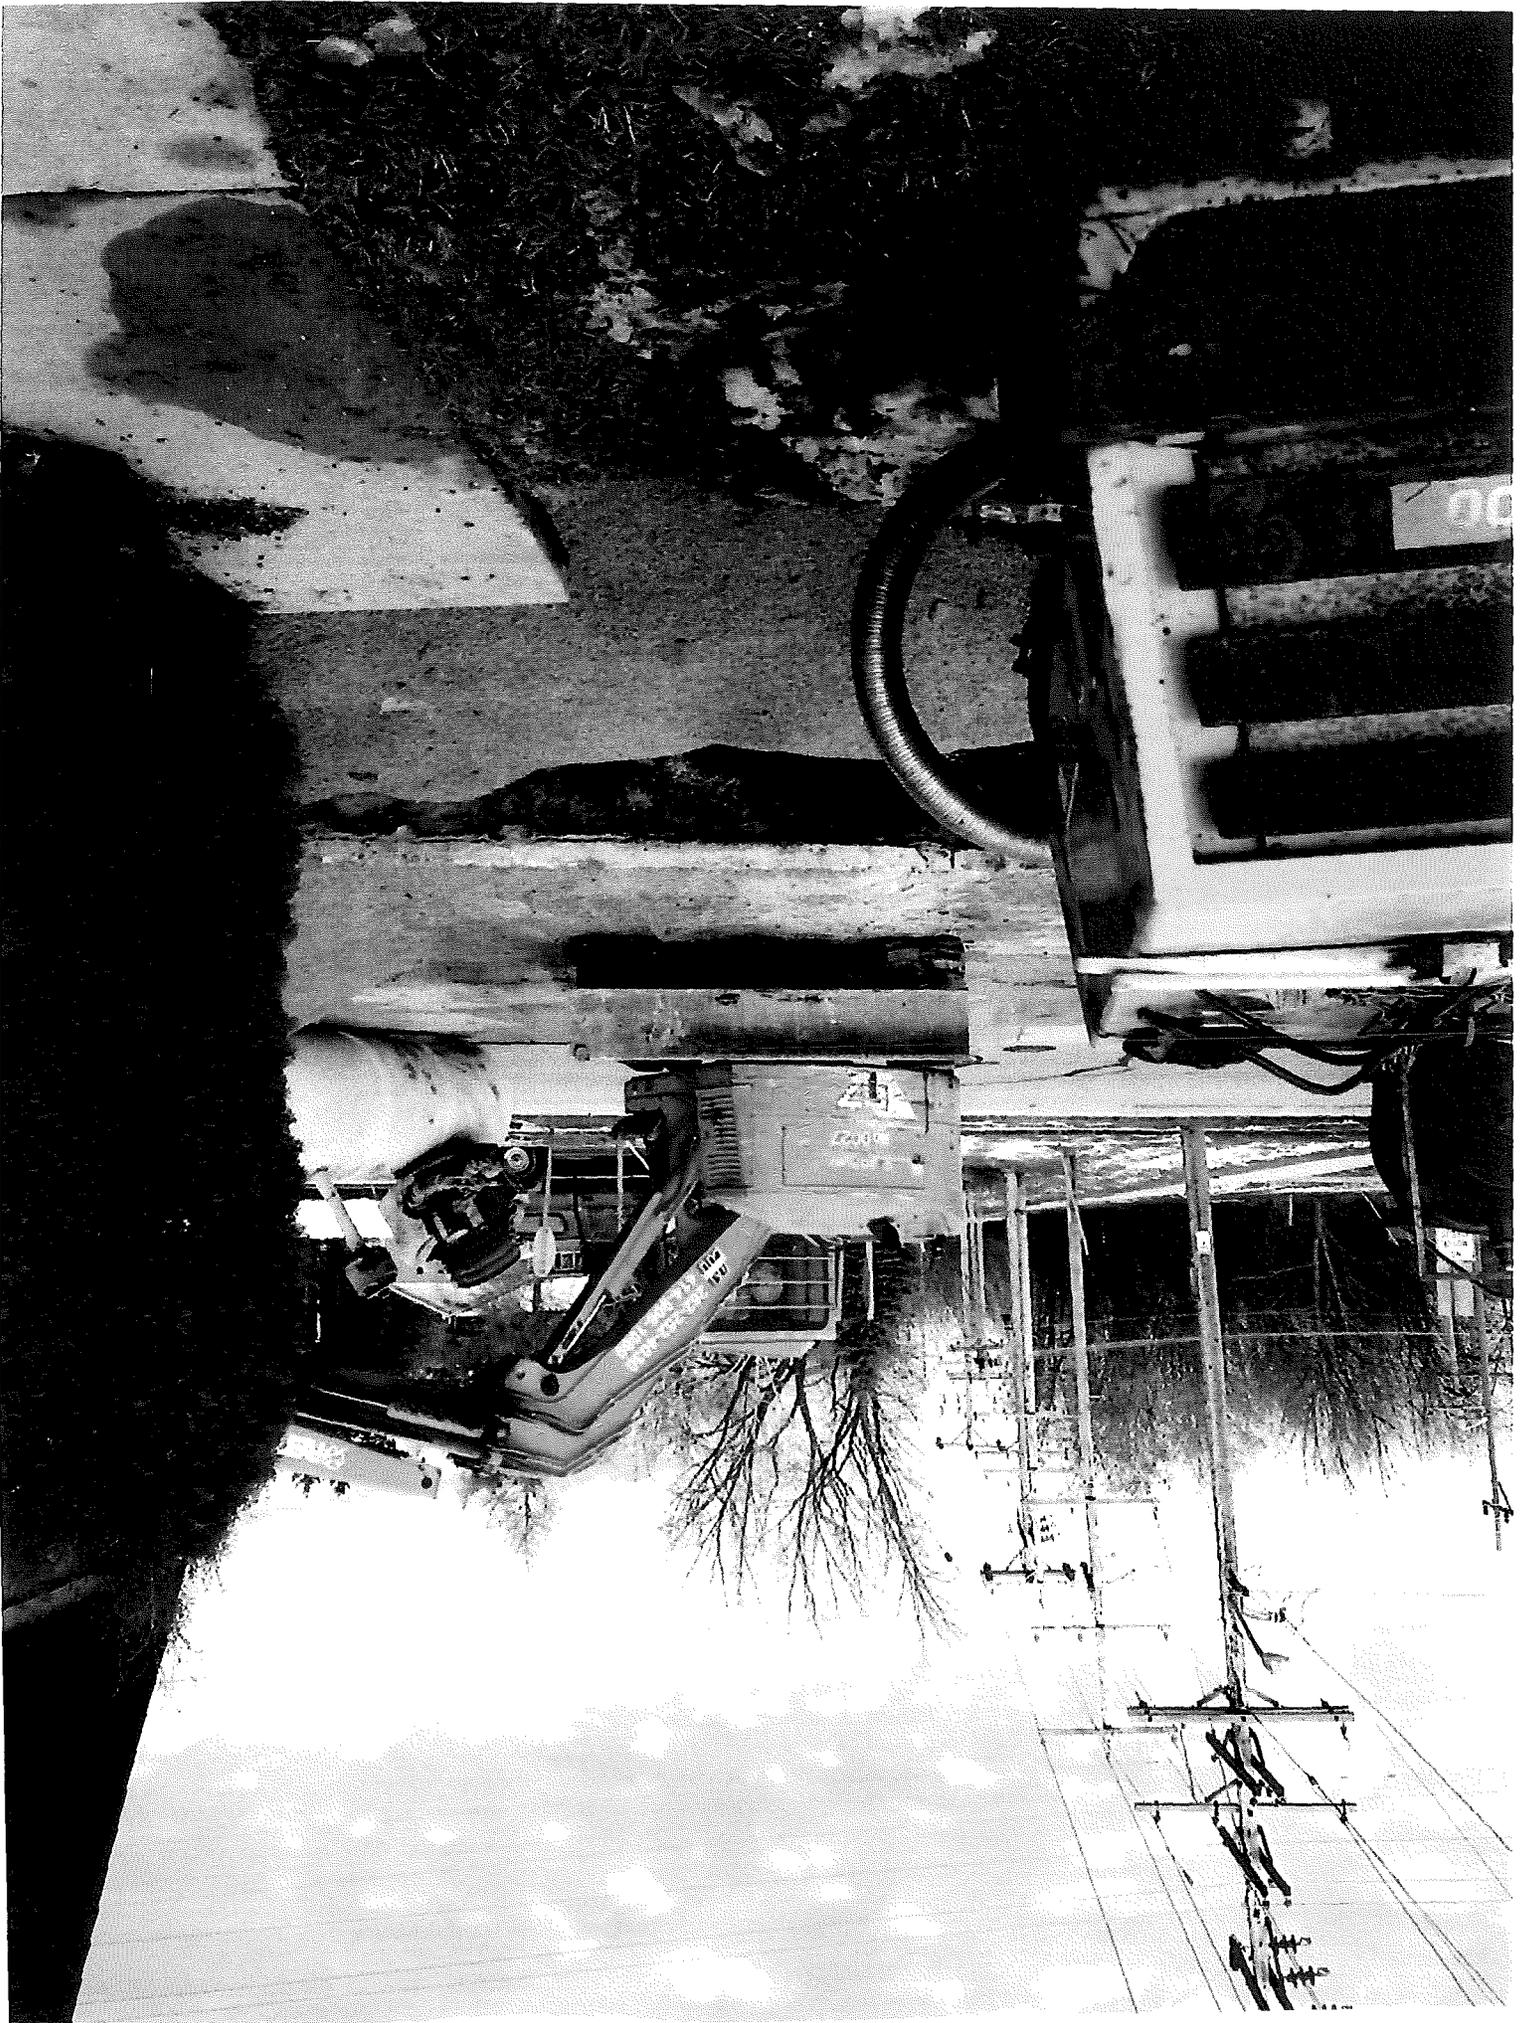
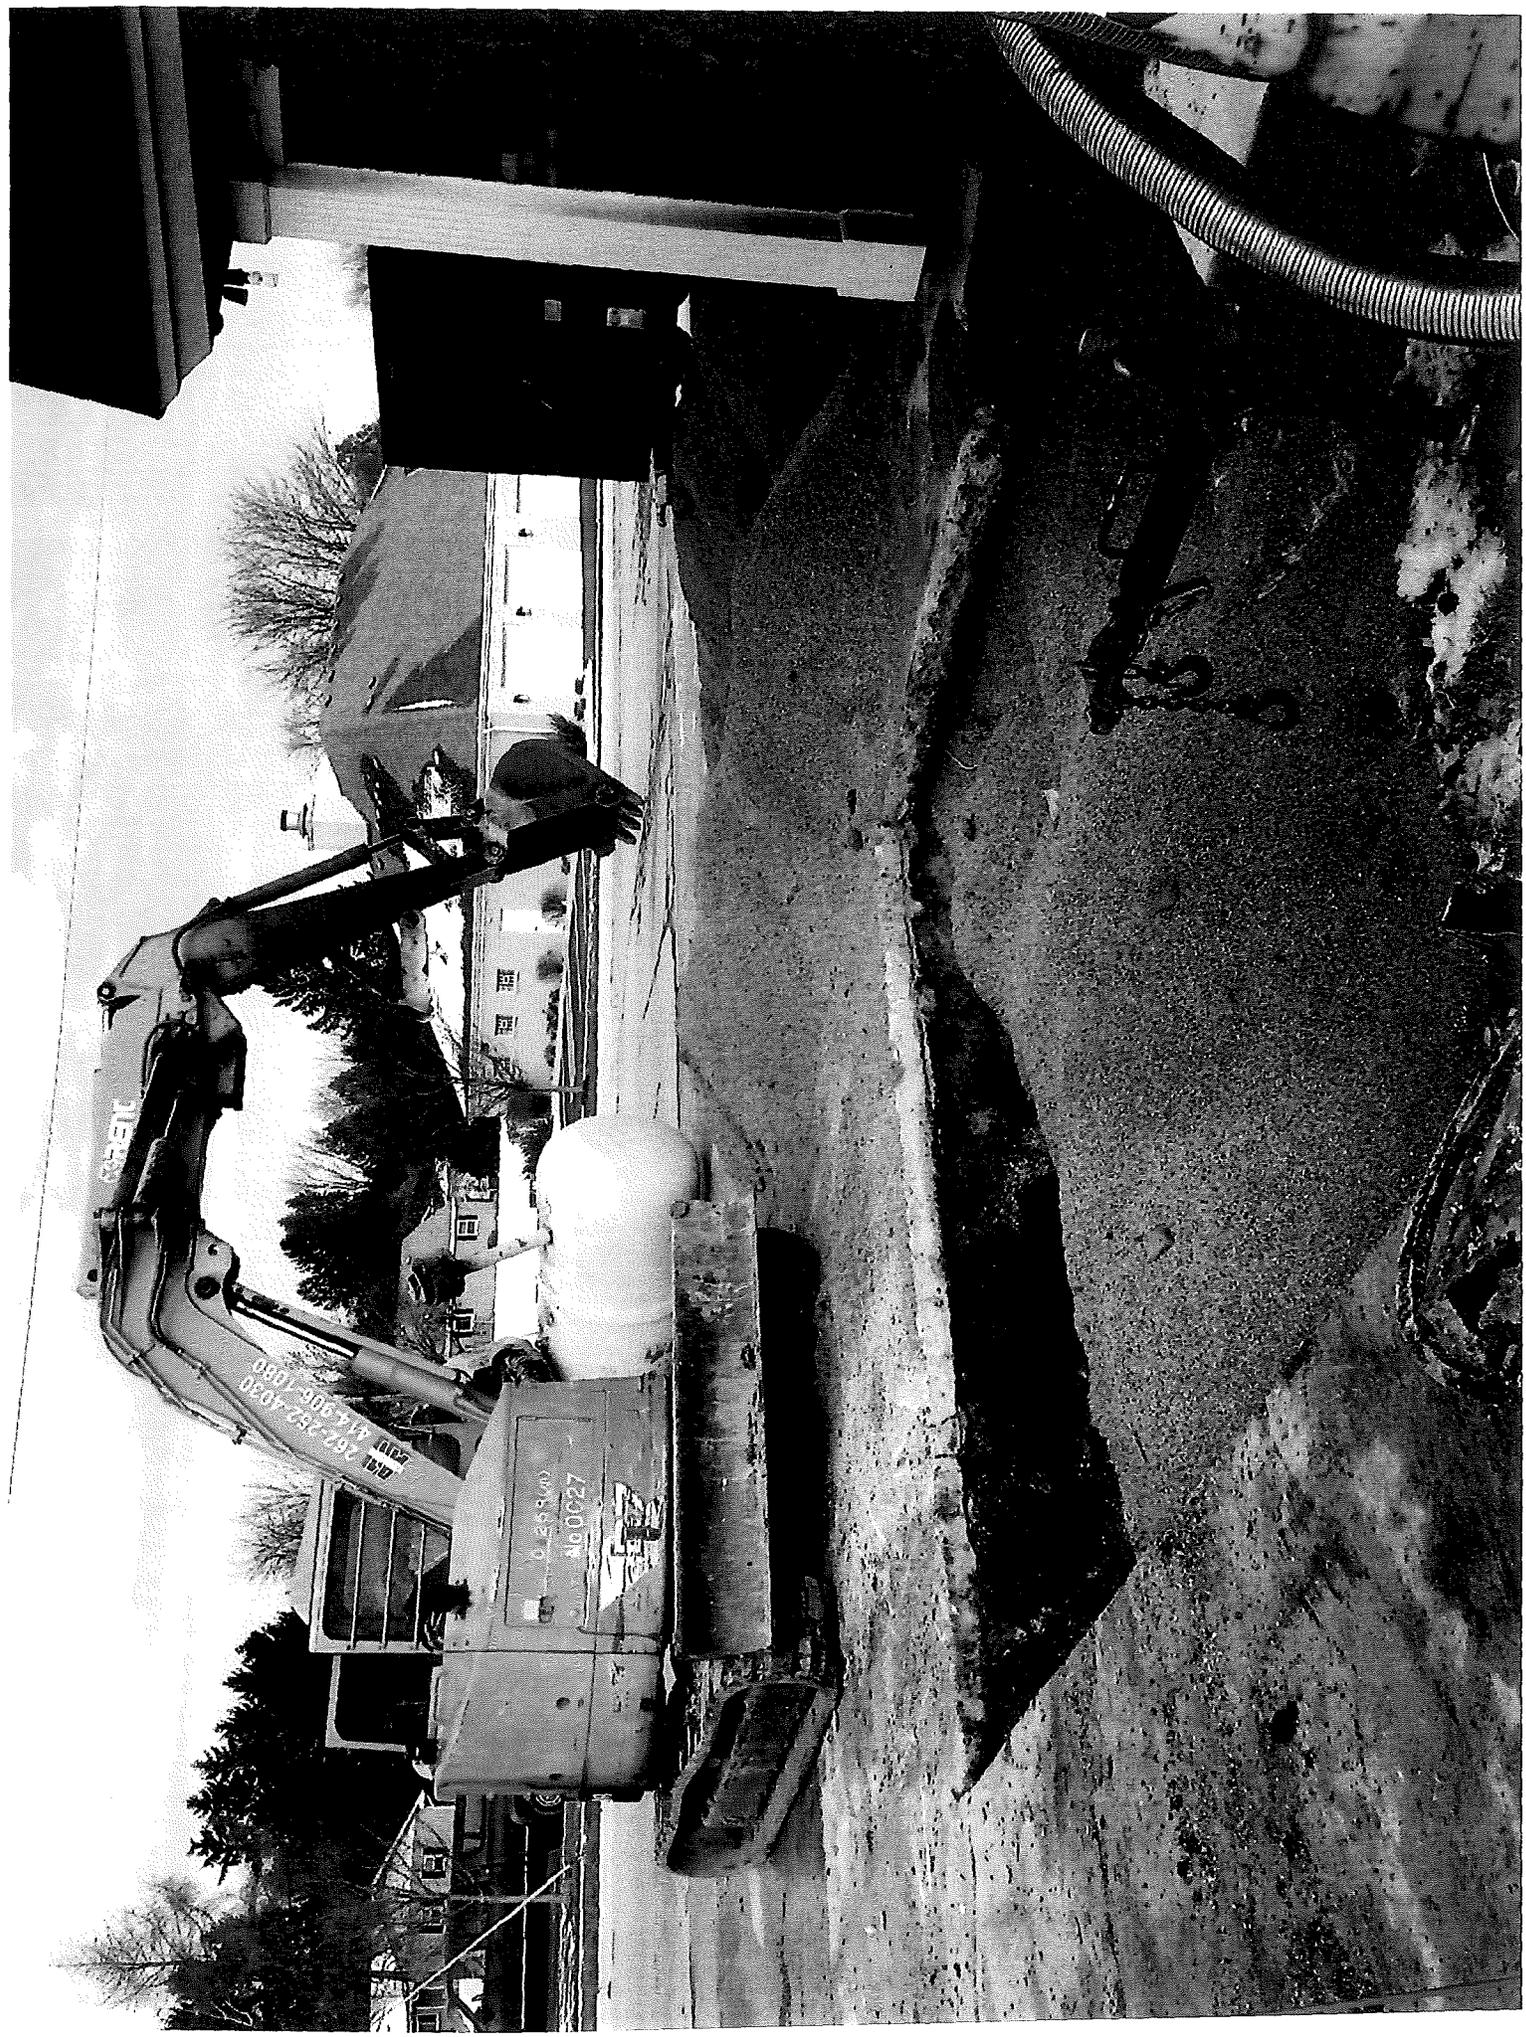
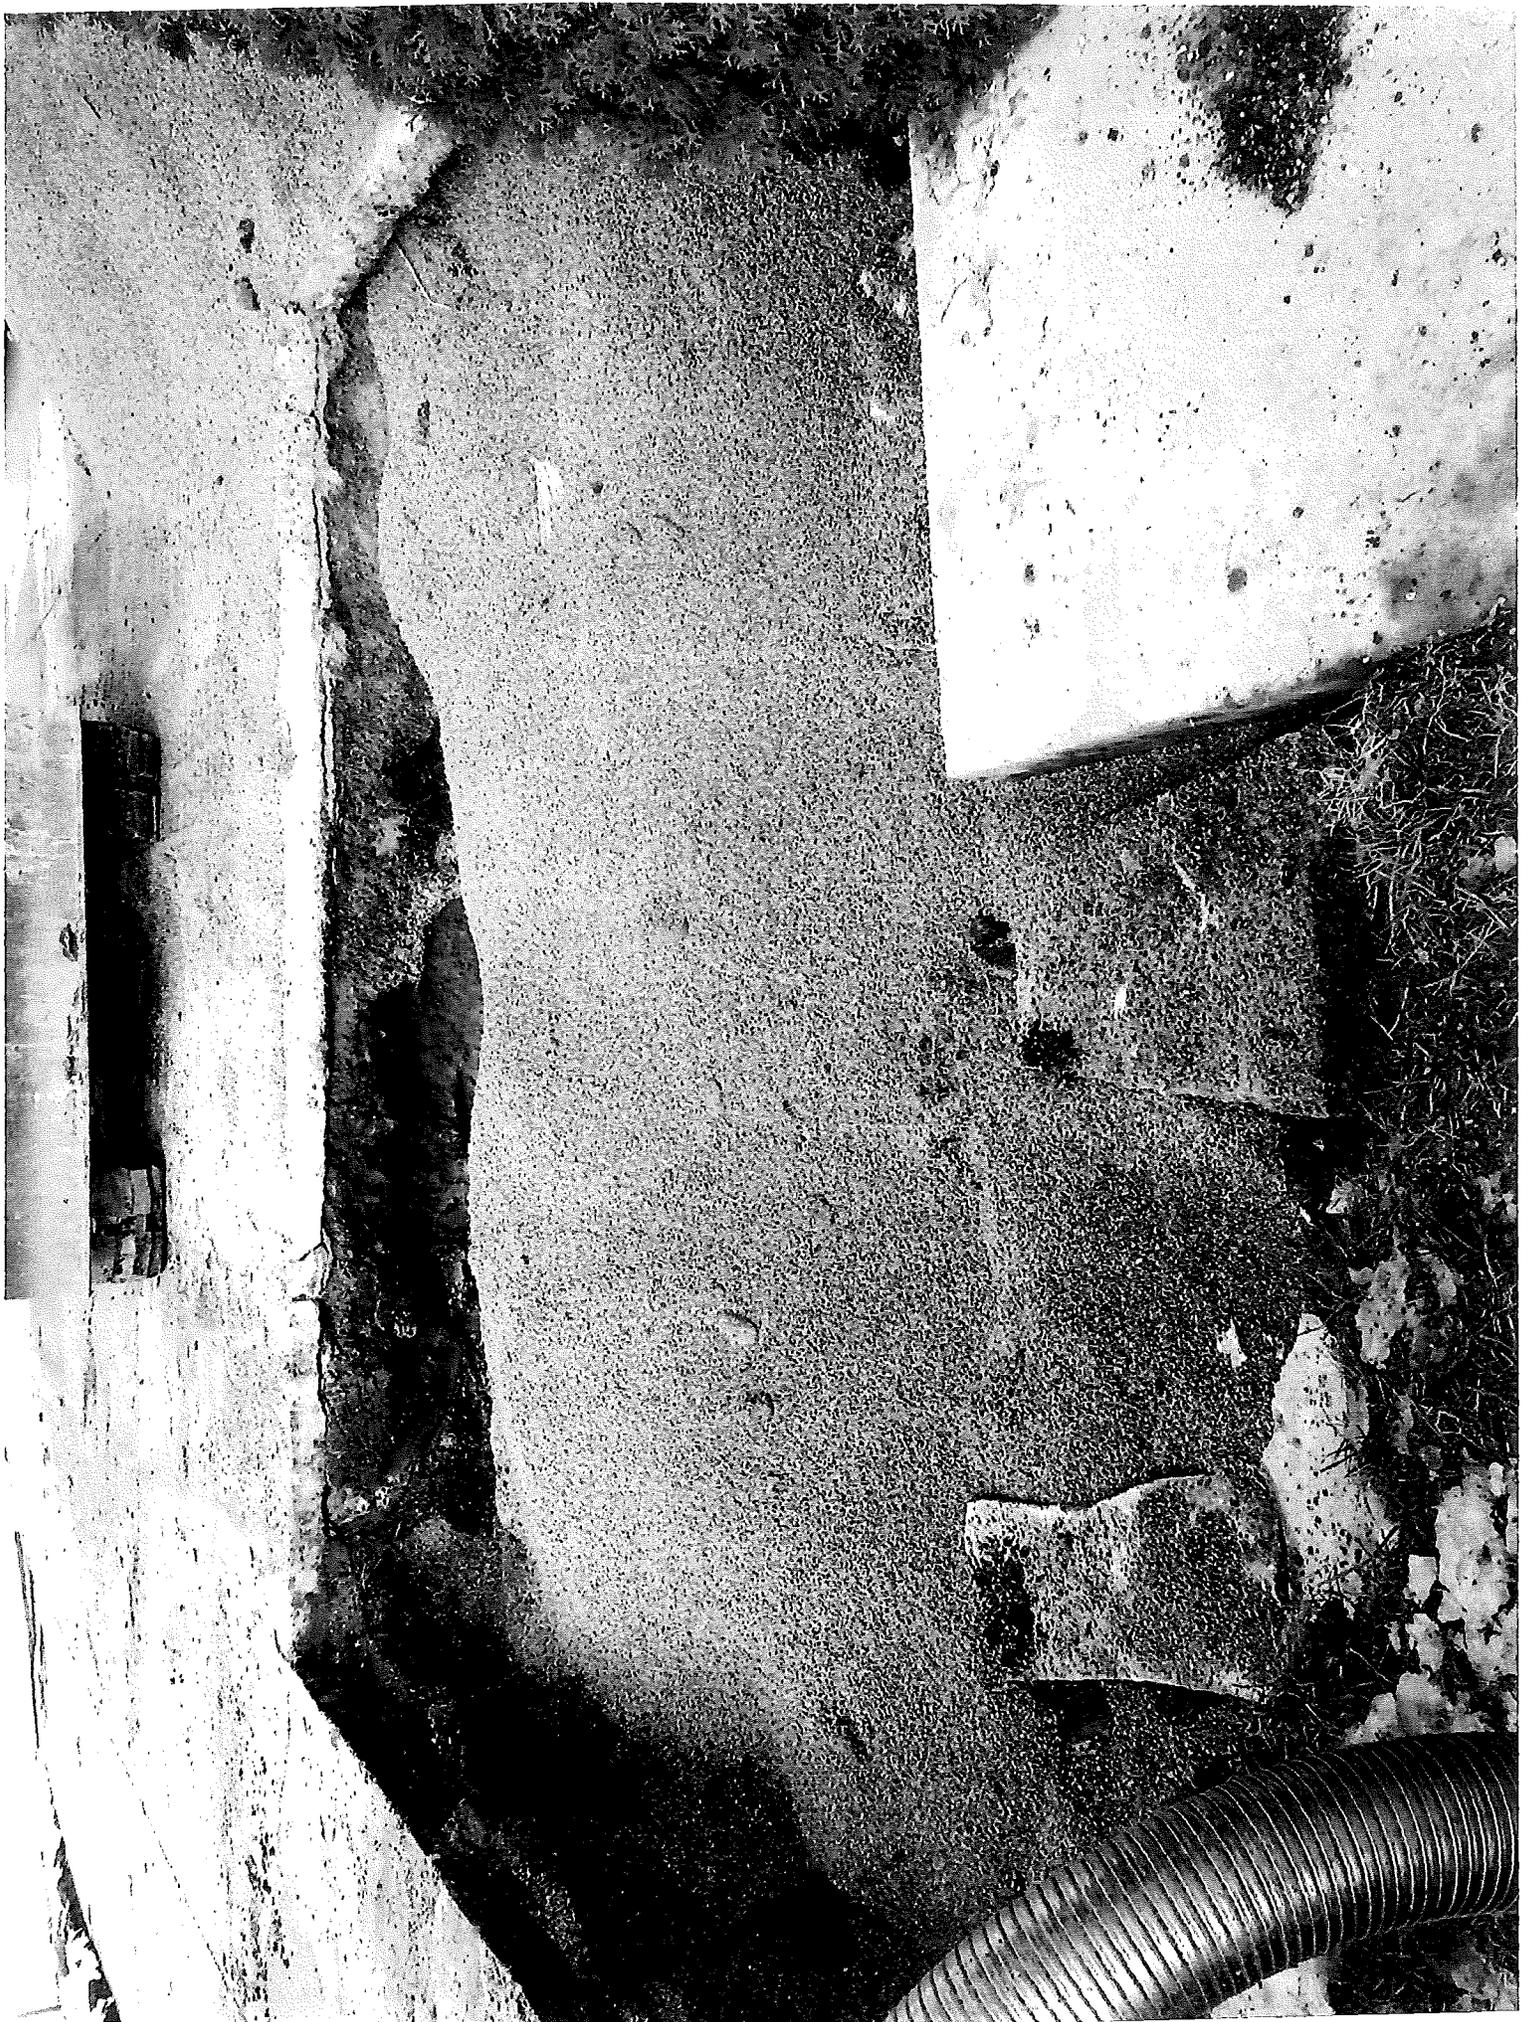
Photographs – UST Closure

As part of the closure activities, all system components were inspected during the removal activities. The inspection indicated that the fiberglass USTs and piping were sound and exhibited no holes.
