SUBJECT: November 17, 2015 telephone call with Ted Hubbes, Braun Intertech

In July 2015, petroleum impacts (asphalt or heavy petroleum product) were observed during excavation/construction activities in the area of Pulverised Limestone 3 (PLS 3), as shown in Figure 1. The identified contaminated soil was separated visually and stockpiled on site pending off-site disposal. In addition, petroleum product (possibly Number 6 Fuel Oil) has been observed seeping through the pavement near a Hydrate Product Tank. The observed area is small (approximately three feet by six inches). It is anticipated that the source of these impacts are the previous aboveground storage tanks (ASTs) and/or historic property use as a Marine Fueling Terminal BRRTs #02-16-000446).

The attached report outlines the removal of impacted soil that was stockpiled during a recent construction project, as well as impacted soil from beneath the area of an observed pavement seep.

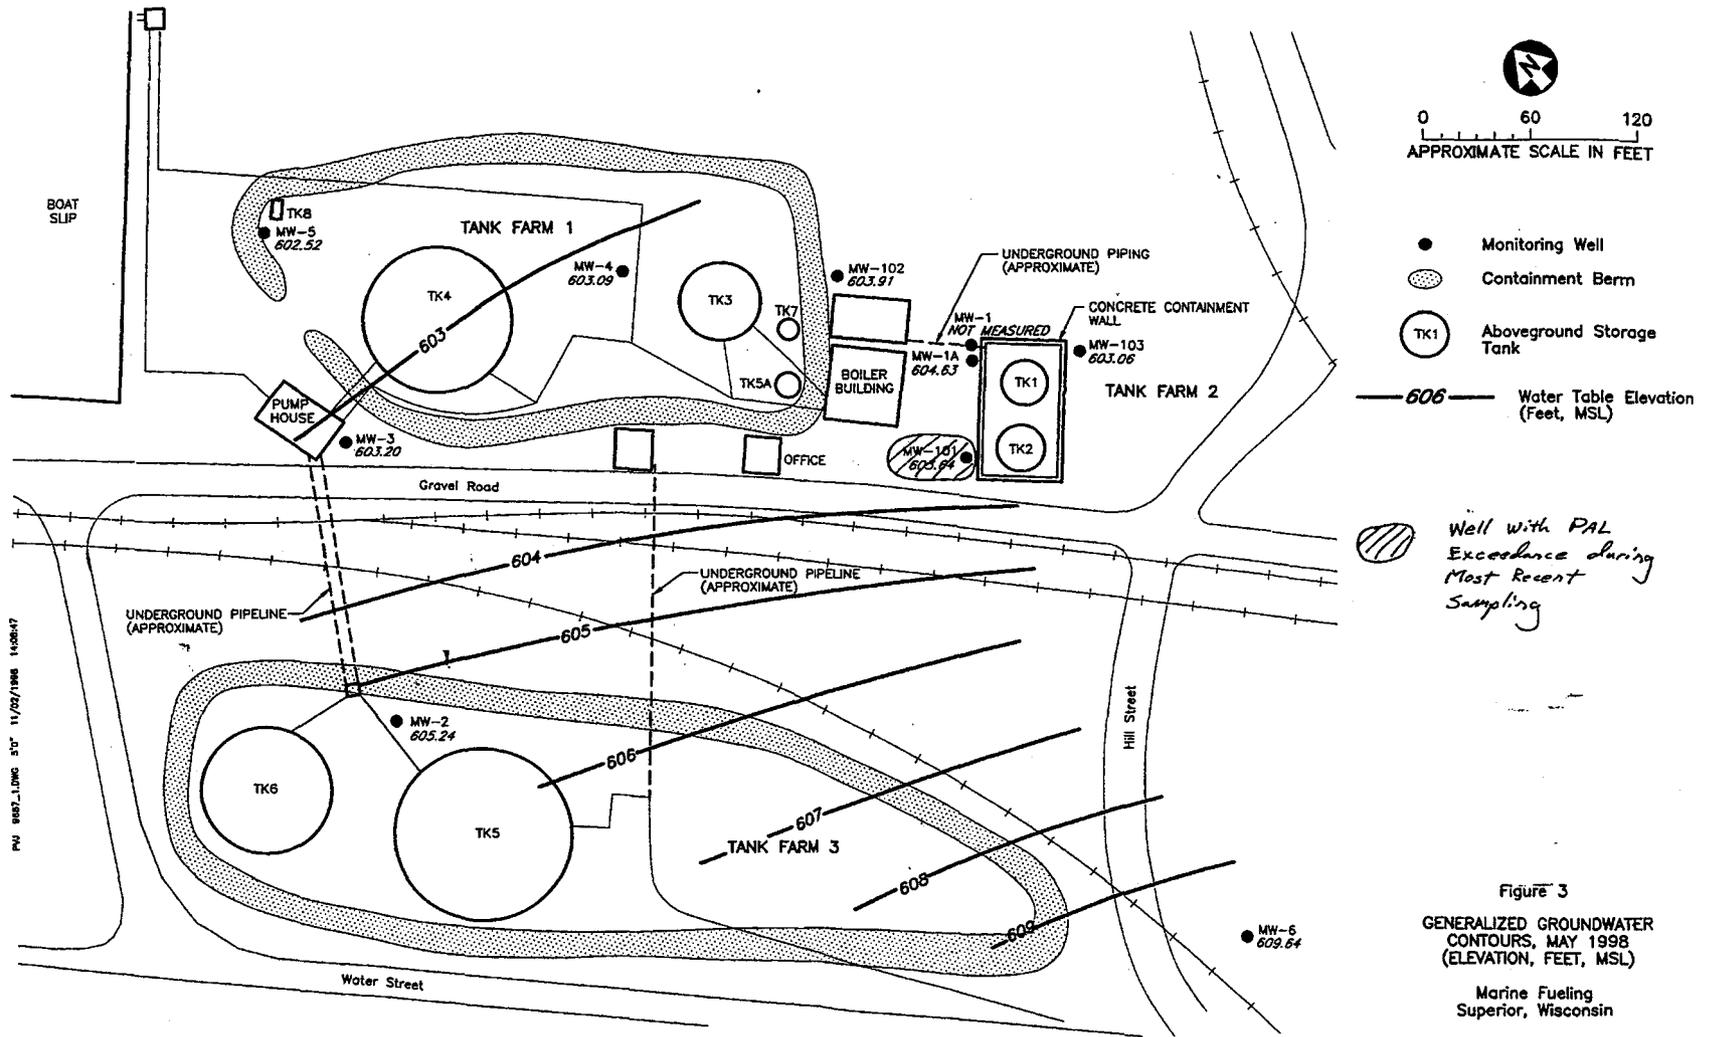
Figure 3  
 GENERALIZED GROUNDWATER  
 CONTOURS, MAY 1998  
 (ELEVATION, FEET, MSL)  
 Marine Fueling  
 Superior, Wisconsin

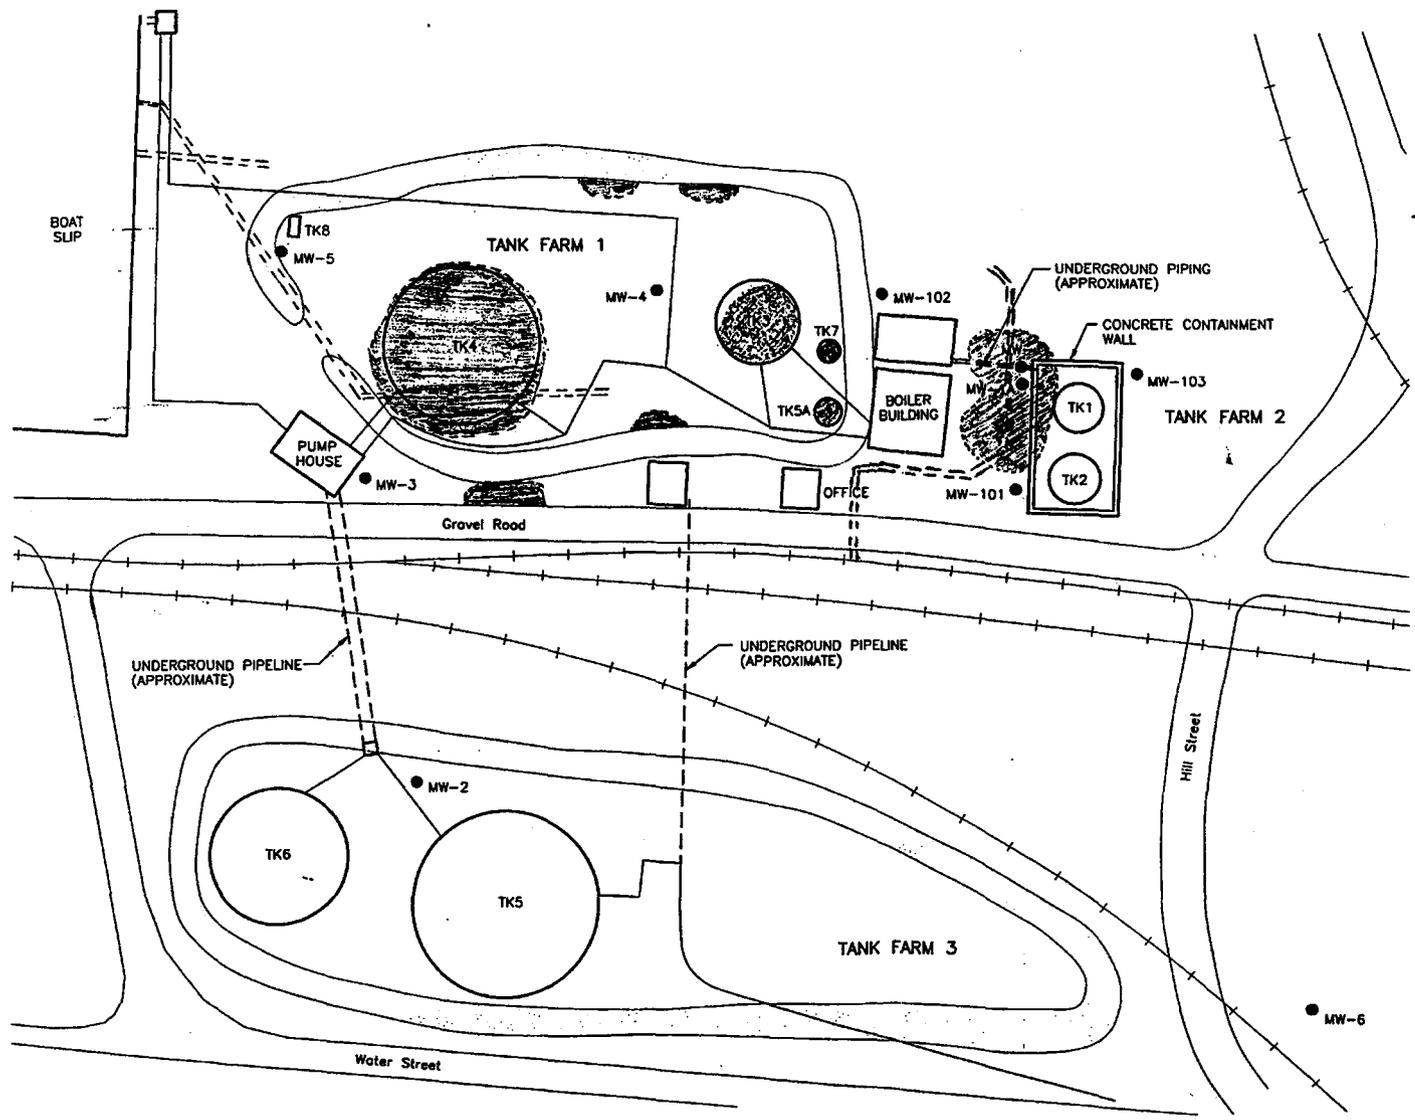
- Monitoring Well
- Containment Berm
- TK1 Aboveground Storage Tank
- ☼ Contaminated Soil Zones (Excavated)
- === Piping (Removed)

Figure 2  
SITE MAP  
Marine Fueling  
Superior, Wisconsin

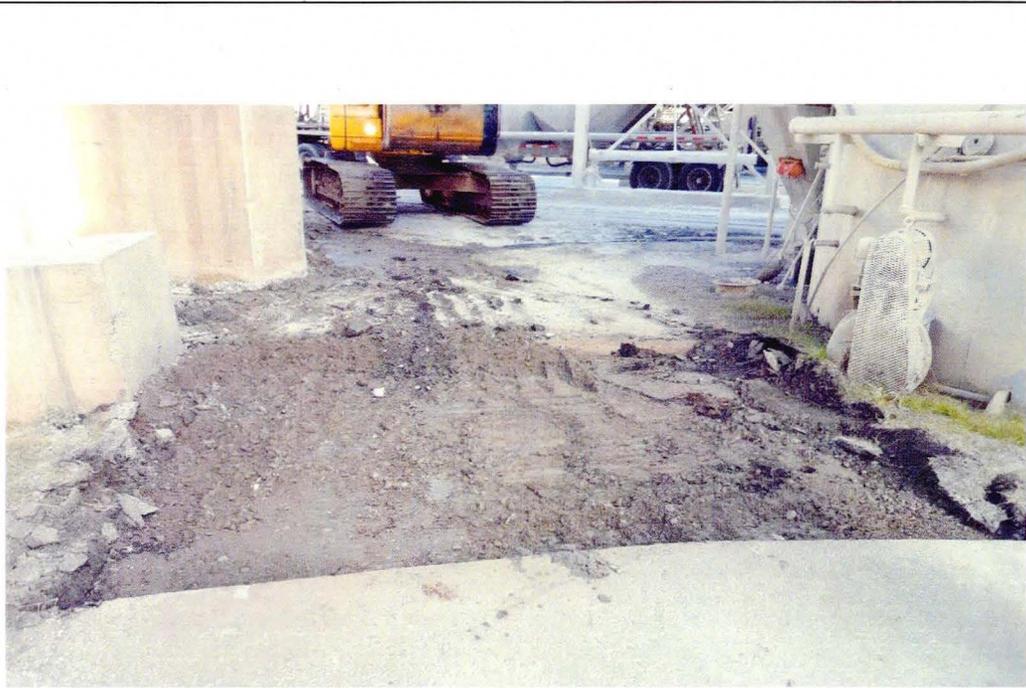
Photograph #1	Graymont (WI) LLC	B1507395
Date:	November 20, 2015	
Location:	800 Hill Avenue Superior, WI	
Subject:	Removed bituminous layer

On November 20, 2015, a focused remedial excavation was completed at the Site. After removing surface bituminous pavement, an abandoned pipe was encountered about 2 feet below grade near the observed pavement seep. The pipe was empty and surrounded by black, tarry soils. An approximately 225 square-foot area was excavated to three to four feet below grade to remove visually impacted soil in the direct-contact zone. This material was removed for off-site disposal to the extent possible. Excavation photographs are included in Attachment A. The location and area of the remedial excavation

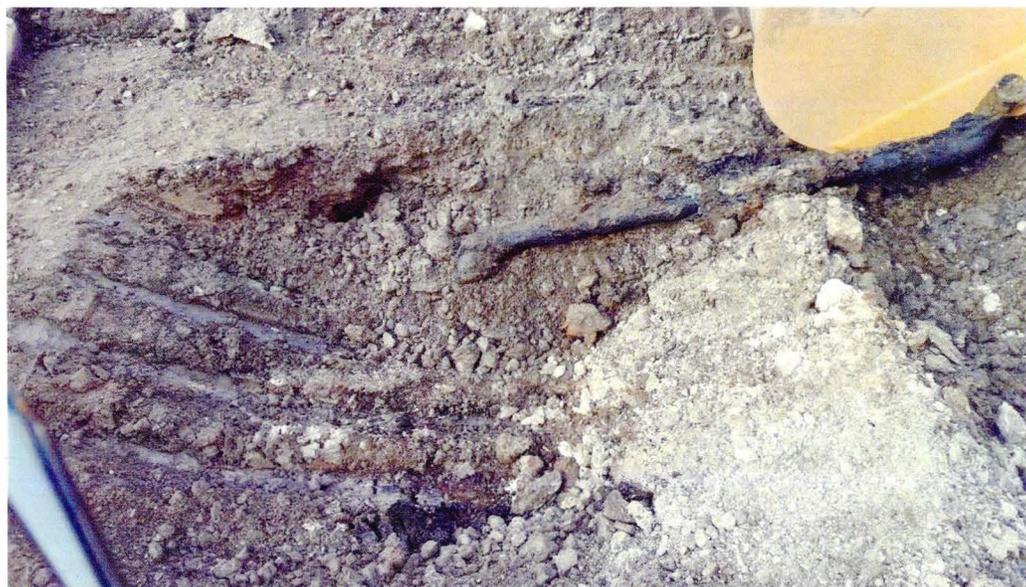
Photograph #2	Graymont (WI) LLC	B1507395
Date:	November 20, 2015	
Location:	800 Hill Avenue Superior, WI	
Subject:	Pipe section removed

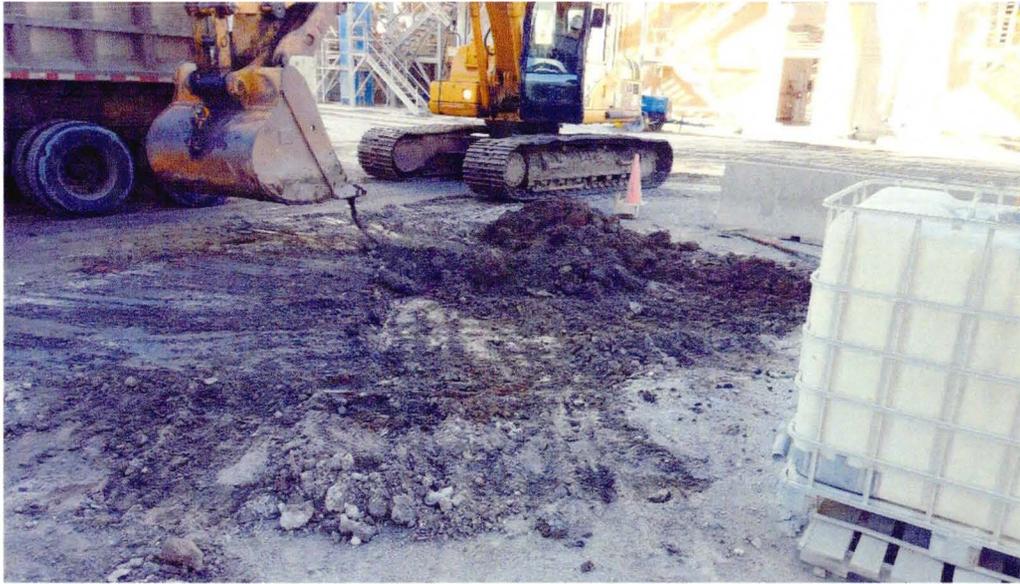
Photograph #3	Graymont (WI) LLC	B1507395
Date:	November 20, 2015

Locations:	800 Hill Avenue Superior, WI	
Subject:	Excavation area

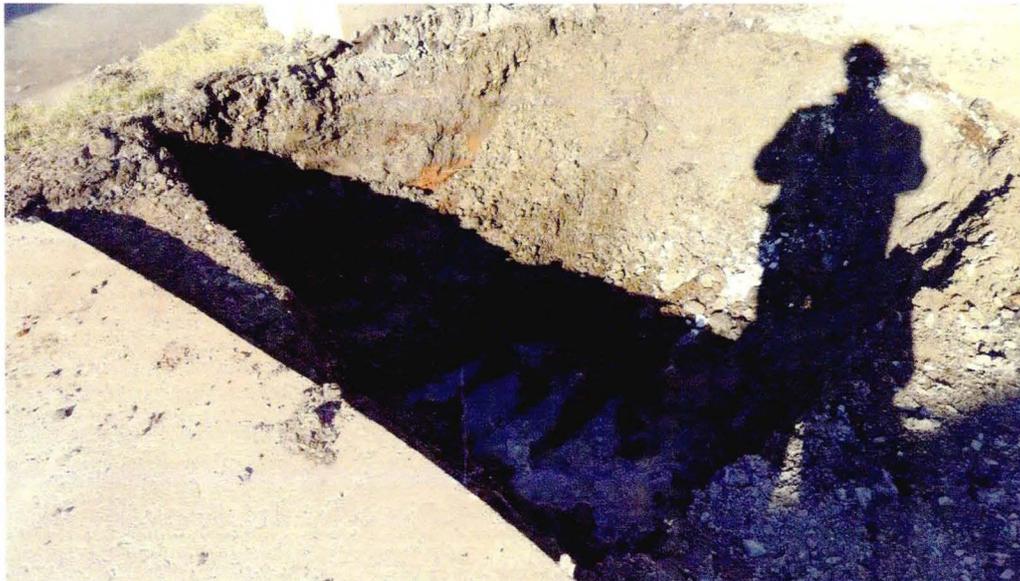
Photograph #4	Graymont (WI) LLC	B1507395
Date:	November 20, 2015

Location:	800 Hill Avenue Superior, WI	
Subject:	Excavation limits

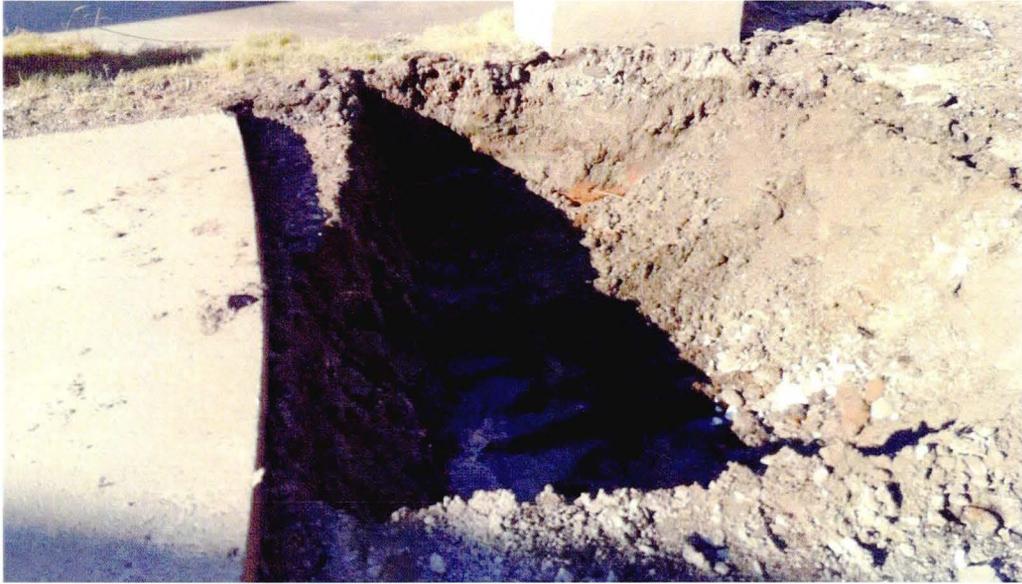
Photograph #5	Graymont (WI) LLC	B1507395
Date:	November 20, 2015	<b>BRAUN</b> INTERTEC
Location:	800 Hill Avenue Superior, WI	
Subject:	Location of base sample

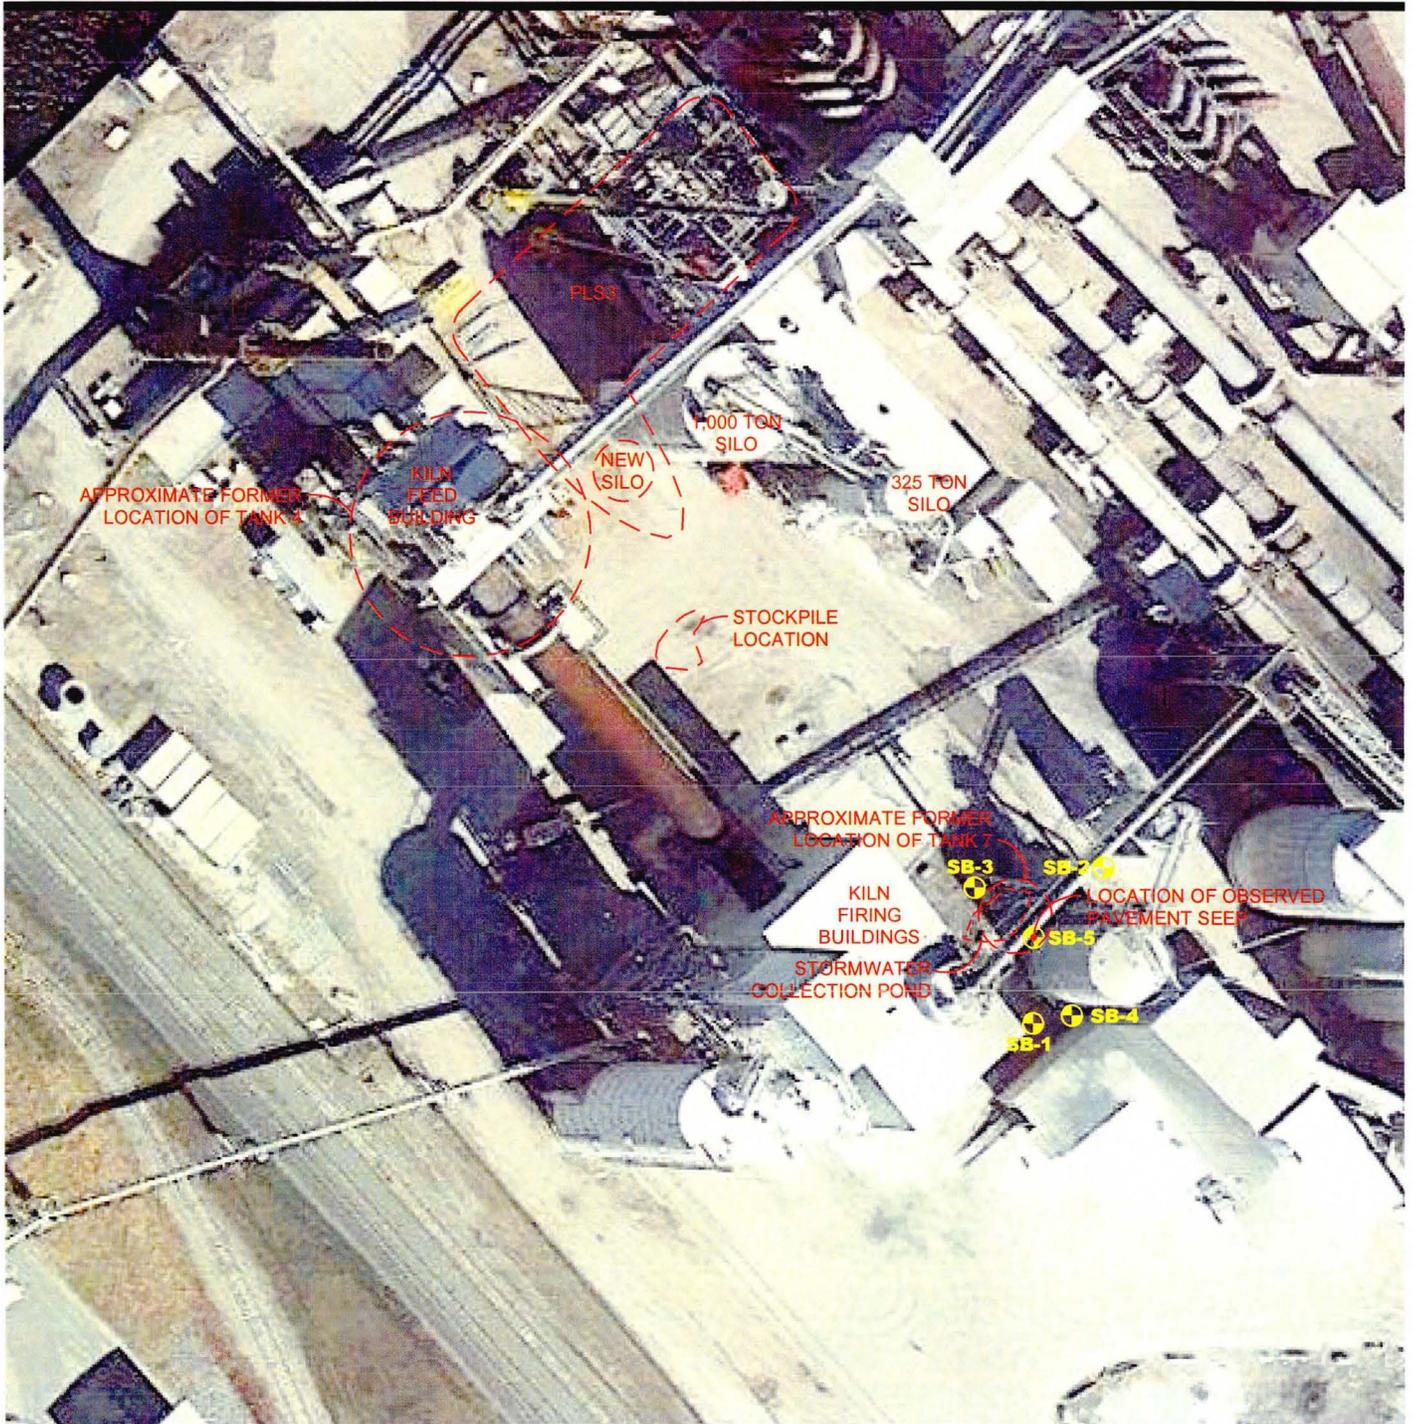
**SOIL BORING LOCATION**

<b>Braun Project B1507395</b>				<b>BORING: SB-01</b>			
Soil Investigation Graymont 800 Hill Avenue Superior, Wisconsin				LOCATION: See attached sketch.			
DRILLER: Range Environmental		METHOD: Geoprobe		DATE: 8/20/15		SCALE: 1" = 4'	
Depth feet	Symbol	Description of Materials (Soil-ASTM D2488 or D2487, Rock-USACE EM1110-1-2908)	BPF	WL	PID ppm	Tests or Notes	
0.0	FILL	FILL: Poorly Graded Sand with Silt.					
					ND		
				▽	ND		An open triangle in the water level (WL) column indicates the depth at which groundwater was observed while drilling. Groundwater levels fluctuate.
					ND		
					ND		
8.0					ND		
		END OF BORING.					
		Water observed at 4 feet while drilling.

<b>Braun Project B1507395</b> <b>Soil Investigation</b> <b>Graymont</b> <b>800 Hill Avenue</b> <b>Superior, Wisconsin</b>				<b>BORING: SB-02</b> <b>LOCATION: See attached sketch.</b>		
<b>DRILLER: Range Environmental</b>		<b>METHOD: Geoprobe</b>		<b>DATE: 8/20/15</b>		<b>SCALE: 1" = 4'</b>
Depth feet	Symbol	Description of Materials (Soil-ASTM D2488 or D2487, Rock-USACE EM1110-1-2908)	BPF	WL	PID ppm	Tests or Notes
0.0						
0.3	BIT	4 inches of bituminous surfacing.				
	FILL	FILL: Poorly Graded Sand with Silt.				
				▽	ND	
					ND	
					ND	
8.0		END OF BORING.				
		Water observed at 3 1/2 feet while drilling.

<b>Braun Project B1507395</b>				<b>BORING: SB-03</b>		
Soil Investigation Graymont 800 Hill Avenue Superior, Wisconsin				LOCATION: See attached sketch.		
DRILLER: Range Environmental		METHOD: Geoprobe		DATE: 8/20/15		SCALE: 1" = 4'
Depth feet	Symbol	Description of Materials (Soil-ASTM D2488 or D2487, Rock-USACE EM1110-1-2908)	BPF	WL	PID ppm	Tests or Notes
0.0	FILL	FILL: Poorly Graded Sand with Silt.			ND	
5.0				▽		
5.5	FILL	FILL: Poorly Graded Sand with Silt, black.			2.0	
	FILL	FILL: Poorly Graded Sand with Silt.				
8.0		END OF BORING.			ND	
		Water observed at 5 feet while drilling.

<b>Braun Project B1507395</b> <b>Soil Investigation</b> <b>Graymont</b> <b>800 Hill Avenue</b> <b>Superior, Wisconsin</b>				<b>BORING: SB-04</b> <b>LOCATION: See attached sketch.</b>			
<b>DRILLER: Range Environmental</b>		<b>METHOD: Geoprobe</b>		<b>DATE: 8/20/15</b>		<b>SCALE: 1" = 4'</b>	
Depth feet	Symbol	Description of Materials (Soil-ASTM D2488 or D2487, Rock-USACE EM1110-1-2908)	BPF	WL	PID ppm	Tests or Notes	
0.0	FILL	FILL: Poorly Graded Sand with Silt.			ND		
				▽	ND		
					ND		
8.0		END OF BORING.			ND		
		Water observed at 4 feet while drilling.
