Site Information			
BRRTS No.	VPLE No.		
02-68-576741			
Parcel ID No.			
1350124			
FID No.	WTM Coordinates		
268280430	X 664703	Y 281000	
BRRTS Activity (Site) Name	WTM Coordinates Represent:		
Krystal Kleeners	<input type="checkbox"/> Source Area <input checked="" type="checkbox"/> Parcel Center		
Site Address	City	State	ZIP Code
145 E. Sunset Drive Acres Ready For Use	Waukesha	WI	53186
3.01

- D. Describe how and when site contamination was discovered.  
In November 2015, Endpoint Solutions Corp. (Endpoint) conducted a Phase I Environmental Site Assessment (ESA) of the property located at 131 East Sunset Drive in the City of Waukesha, Waukesha County, Wisconsin (the Site). The results of the Phase I ESA indicated a dry cleaning operation (most recently Krystal Kleeners) has operated at the Site since the Site was developed in 1988 in the tenant space identified as 145 East Sunset Drive. Although the conditions observed at the dry cleaning operation did not indicate releases of dry cleaning chemicals to the environment were currently occurring, it was not possible to determine whether releases had historically occurred based solely on visual observations. As such, the historical

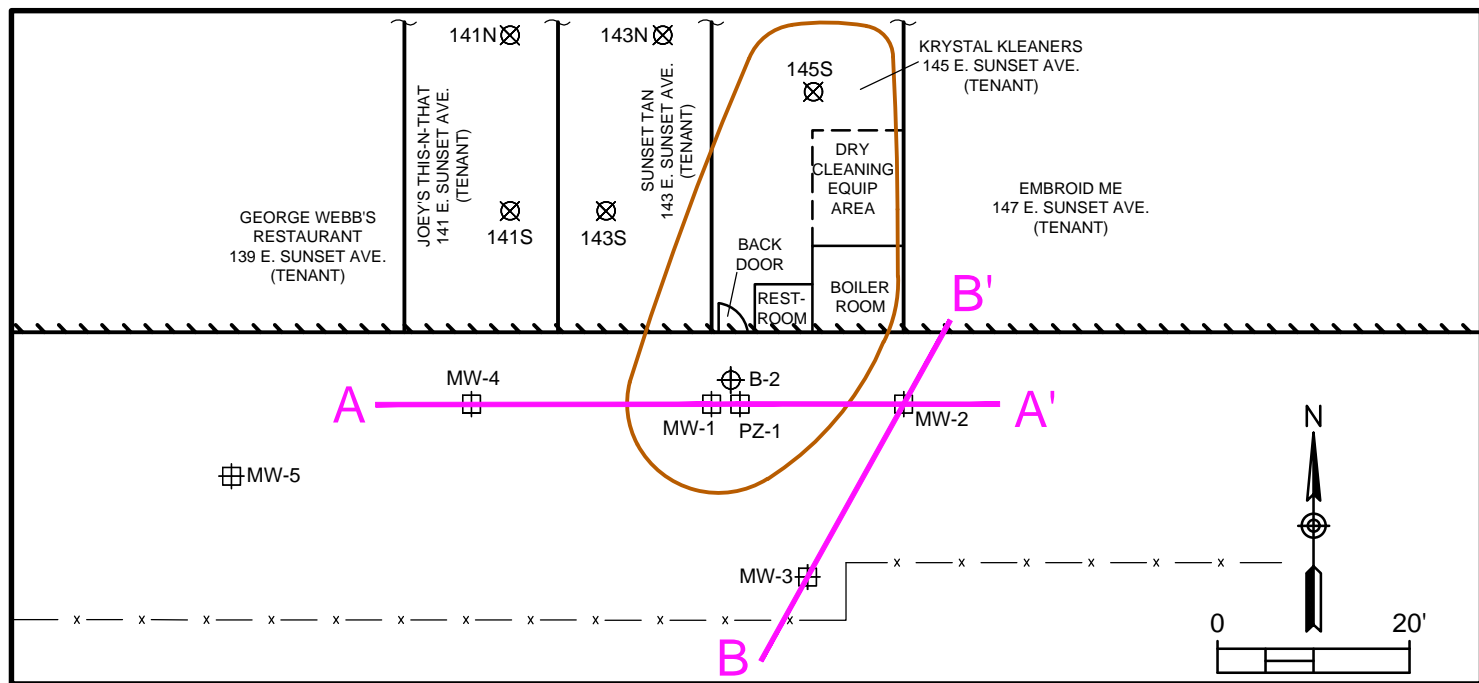
GEOLOGIC CROSS-SECTION		
131 E. SUNSET DRIVE WAUKESHA, WISCONSIN 53186		
<b>Endpoint Solutions</b>		
6871 S. Lovers Lane Franklin, WI 53132		
Phone: (414) 427-1200	DATE: 04/23/19	Fax: (414) 427-1259
DRAWN BY: NWD	REVIEWED BY: TJH	B.3.a
PROJECT NO: 403-001-010

- i. Discuss depth to groundwater and piezometric elevations. Describe and explain depth variations, including high and low water table elevation and whether free product affects measurement of water table elevation. Describe the stratigraphic unit(s) where water table was found or which were measured for piezometric levels.  
The shallow groundwater at the site was encountered at approximately eight (8 to 8.5) ft bgs which would put it in either the silty clay and stone layer of fill or at the interface between the layer of fill and the native fine to coarse sand below.

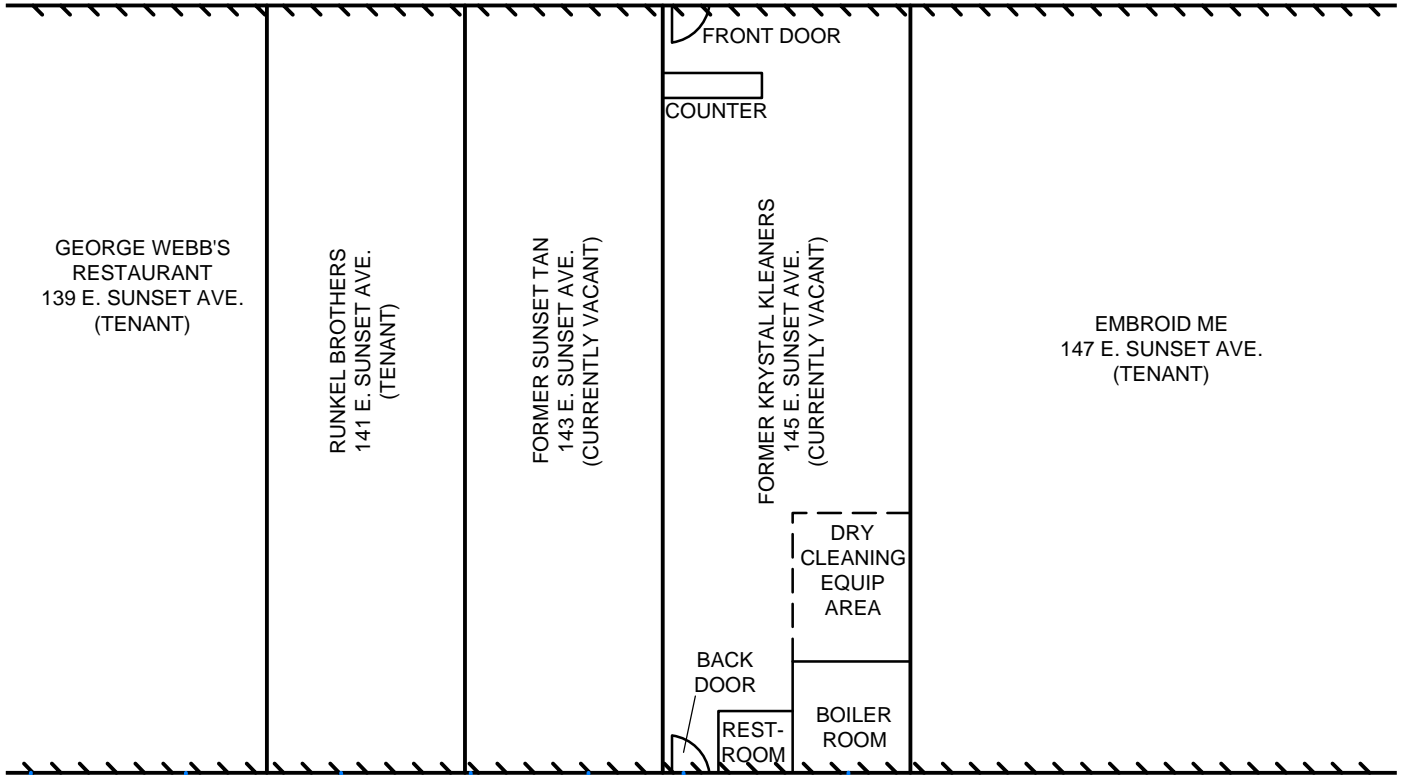
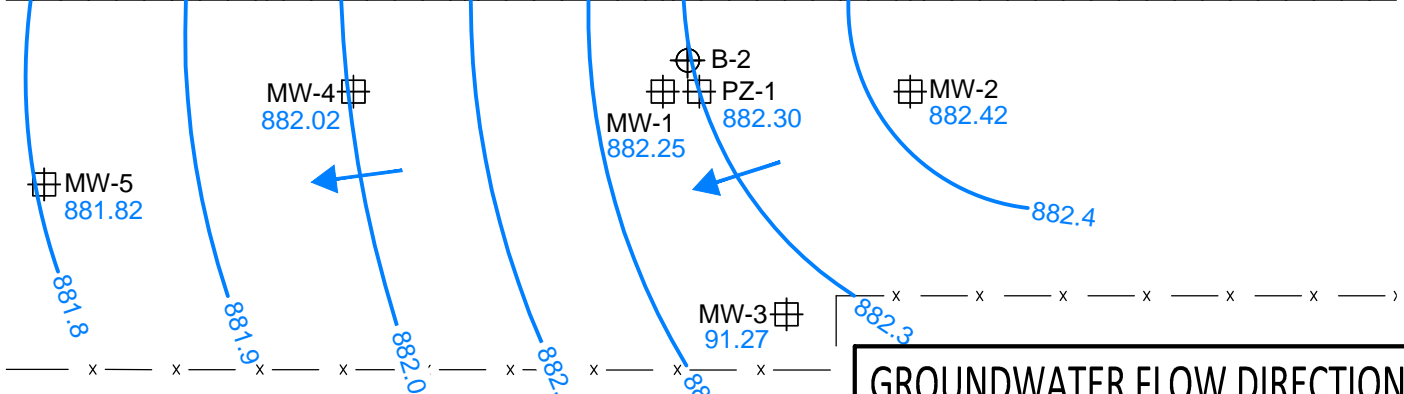
**GROUNDWATER FLOW DIRECTION  
DECEMBER 2017**

EDGE OF BUILDING
	FENCE
	SOIL BORING LOCATION W/ GROUNDWATER SAMPLE
	MONITORING WELL LOCATION
882.25	GROUNDWATER ELEVATION
	GROUNDWATER CONTOUR (0.5 FT CONTOUR INTERVAL)
	GROUNDWATER FLOW DIRECTION

- ii. Discuss groundwater flow direction(s), shallow and deep. Describe and explain flow variations, including fracture flow if present.  
The groundwater elevations collected indicate a westerly flow with a horizontal gradient of approximately 0.015 ft/ft. A comparison of the groundwater elevations measured in monitoring MW-1 and piezometer PZ-1 provide an indication of the vertical groundwater gradient. The groundwater elevation measured in monitoring MW-1 on May 5, 2016 was 94.72 ft (local datum), while the groundwater elevation measured in piezometer PZ-1 was 93.43 ft (local datum). Based on these measurements, the vertical groundwater gradient was 0.0586 ft/ft downward.

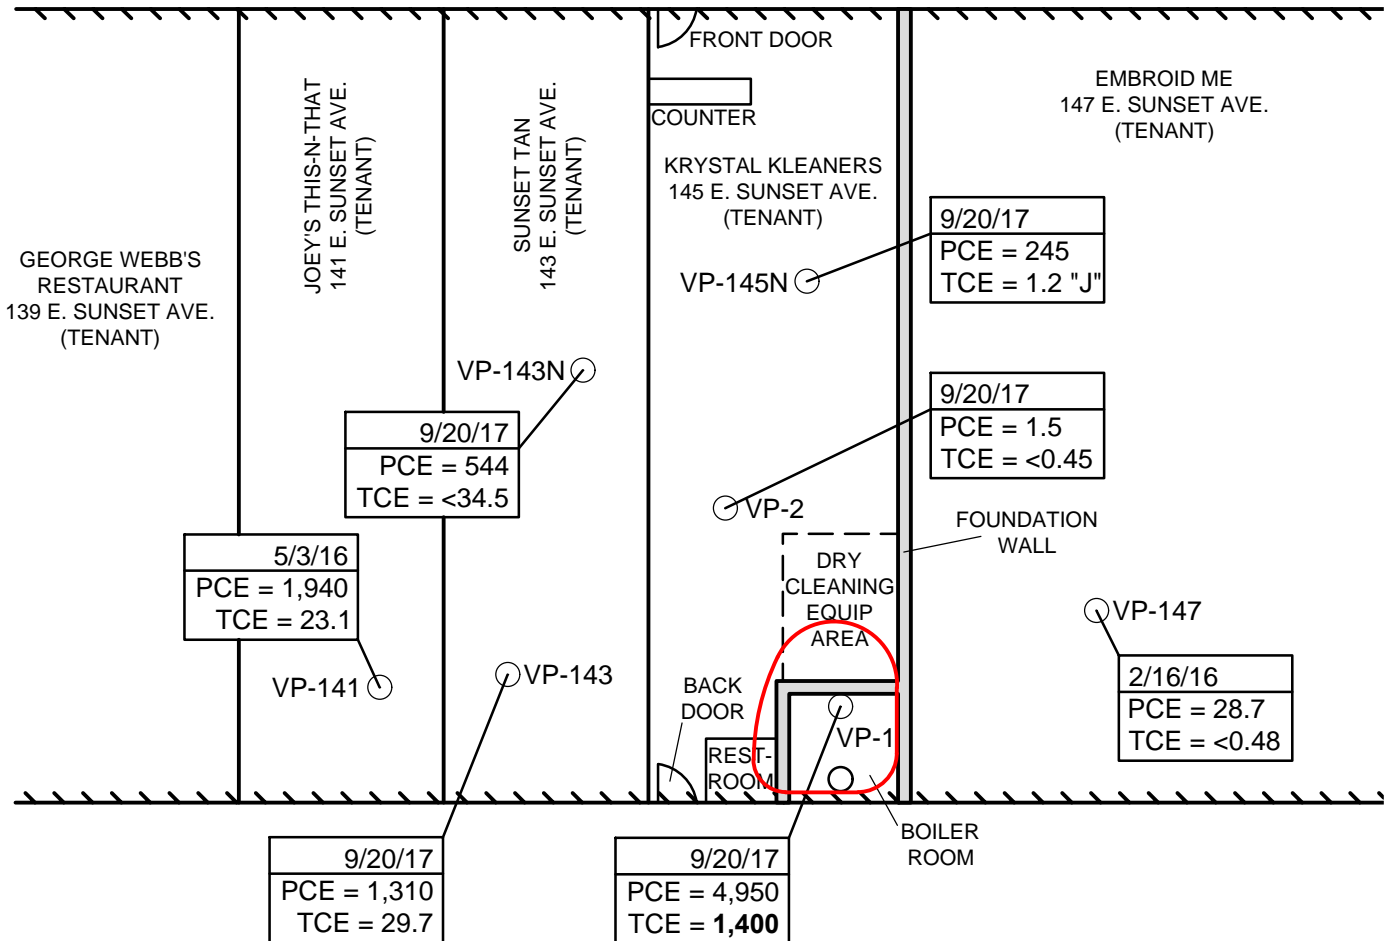
EDGE OF BUILDING  
 FENCE  
 EXTENT OF SMALL COMMERCIAL SUB-SLAB REGIONAL SCREENING LEVEL EXCEEDANCE  
 SUBSLAB VAPOR SAMPLING POINT LOCATION  
 PCE = TETRACHLOROETHENE  
 TCE = TRICHLOROETHENE  
 ALL RESULTS ARE SHOWN IN MICROGRAMS PER CUBIC METER (ug/m<sup>3</sup>)  
 BOLD INDICATES EXCEEDANCE OF SMALL COMMERCIAL SUB-SLAB REGIONAL SCREENING LEVEL

Sub-slab soil vapors which exceed regional screening levels are limited to the 145 East Sunset Drive tenant space, as well as the west-adjointing 143 East Sunset Drive tenant space. No sub-slab vapor exceedances were noted in the sample collected from the 141 East Sunset Drive tenant space or the east-adjointing 147 East Sunset Drive tenant space. Indoor air samples were not collected in the 143 or 145 East Sunset Drive tenant spaces.

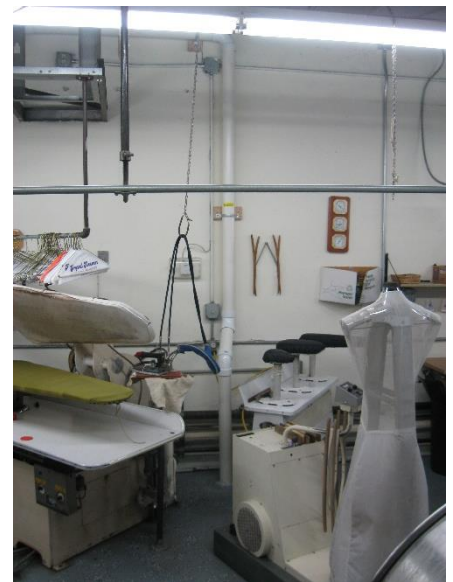
2. 3" secondary suction pipe routing.

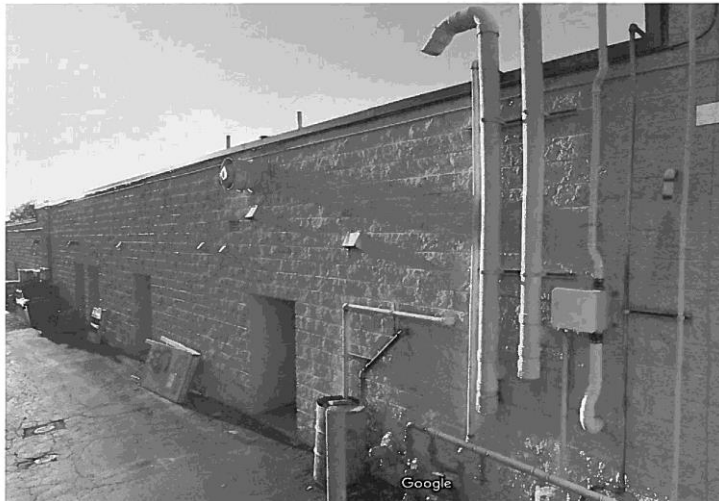
11. Protective barrier of asphalt in parking lot. MW-1 and PZ-1 outside the back door of Krystal Kleeners.

The barrier/cover consists of approximately three (3) inches of concrete inside the building (slab on grade). Outside and adjacent to the building, the cover consists of approximately 3 inches of bituminous asphalt. The barrier is expected to function adequately based on the current use of the site unless disturbed. Photographs of the Protective Barrier/Cover System may be found in **Attachment D.3**.
