SITE NAME: REALTY OPUS PROPERTY - VPLE

SUBJECT: Certificate of Completion for Realty Opus Property
867 Valley Road, Menasha WI
ERP BRRTS # 02-71-555288
VPLE BRRTS # 06-71-578231

SUBJECT: Final Case Closure with Continuing Obligations
Realty Opus Property, 867 Valley Rd, Menasha WI
DNR BRRTS Activity #: 02-71-555288

FIGURE D.2
SURFACE BARRIER INSPECTION AREA
REALTY OPUS, 867 W. VALLEY RD
MENASHA, WISCONSIN

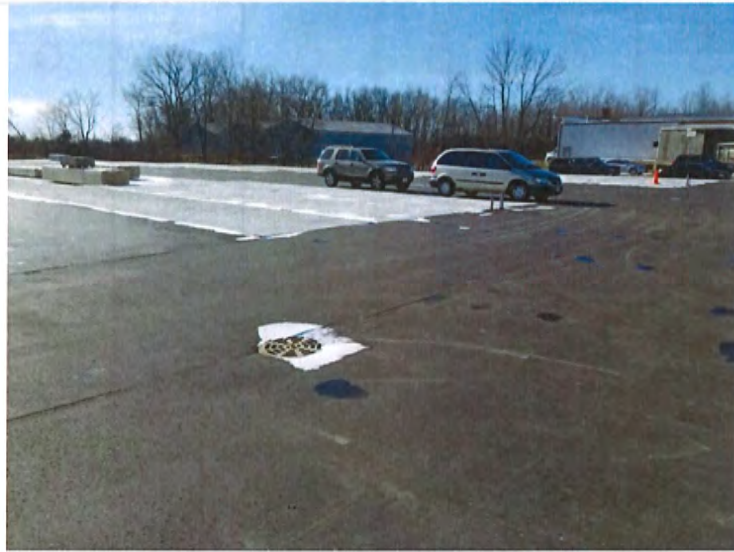
PHOTOGRAPH 1:

Surface Barrier, facing SW

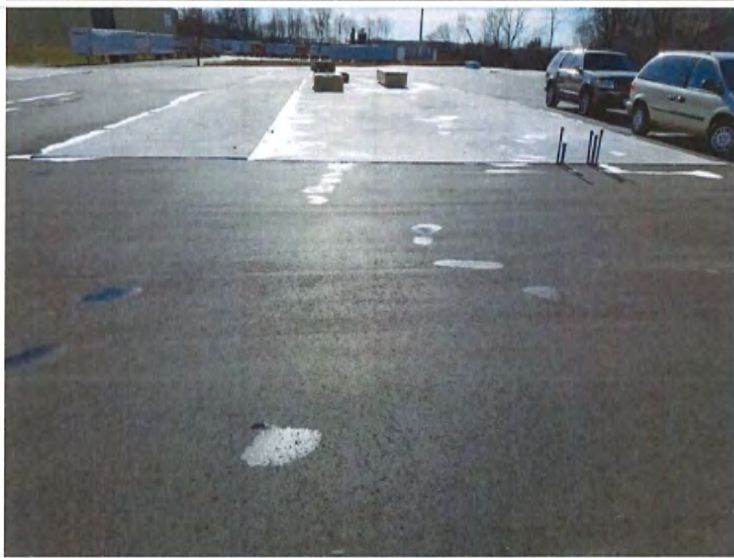
PHOTOGRAPH 2:

Surface Barrier, facing S

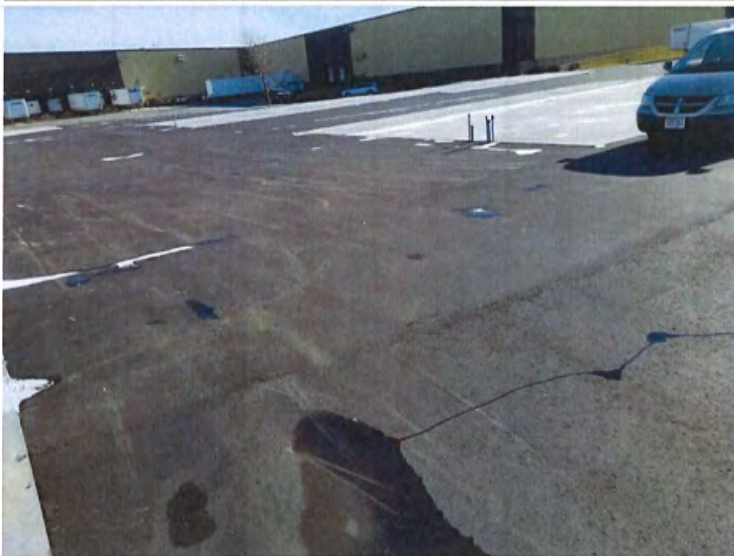
PHOTOGRAPH 3:

Surface Barrier, facing SE
