# State of Wisconsin - Department of Natural Resources Substance Release Notification Report (SERTS)

# **Rosendale Dairy - Manure Spill**

Incident Report—Rosendale Dairy Manure Tanker Rollover—October 9, 2016

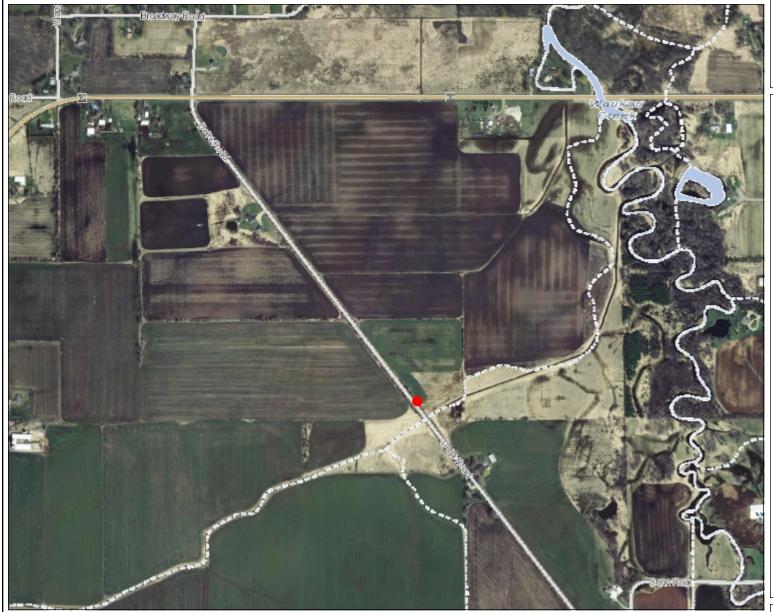
Red Dot: Spill Location WTM: 616887, 393939

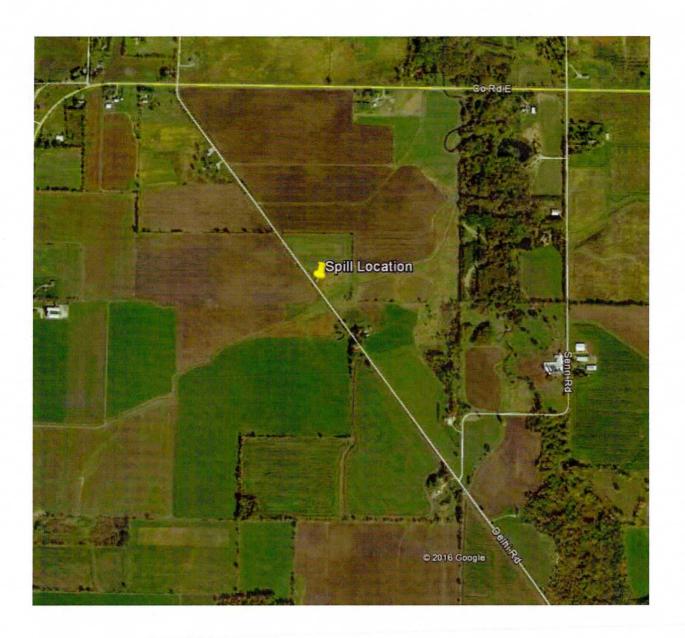
The manure tanker rolled when one of its tires slipped off the road surface and onto the shoulder. The shoulder collapsed, causing the tanker to land on its top in the ditch. Some manure leaked out of the tank and travelled about 100 feet along the ditch in each direction from the tanker. Earthen berms were created using shovels and a skid steer with soil from the neighboring field to prevent further spread of the spill.

Spill before cleanup.

Hyler Septic was called and brought a septic truck to the scene. They were able to access the manure remaining in the truck through the release valve, and removed around 4,000 gallons. The septic truck also pumped the manure out of the ditch. About 1,000 gallons of clean water was brought in the flush the ditch, and the septic truck pumped the wash water out as well.

The following day, about 1,000 gallons of clean water was used to flush the ditch a second time, and pumped out. The earthen dams were then removed. The water remaining in the ditch appeared clean. Pictures of the spill and cleanup, as well as a site map showing the spill area have been attached.

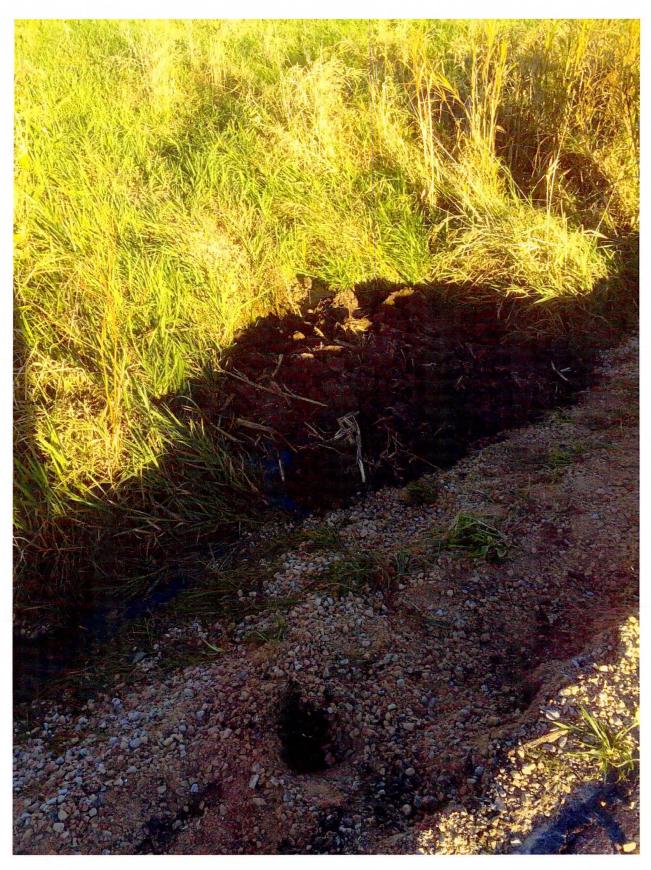
Earthen dam in ditch.

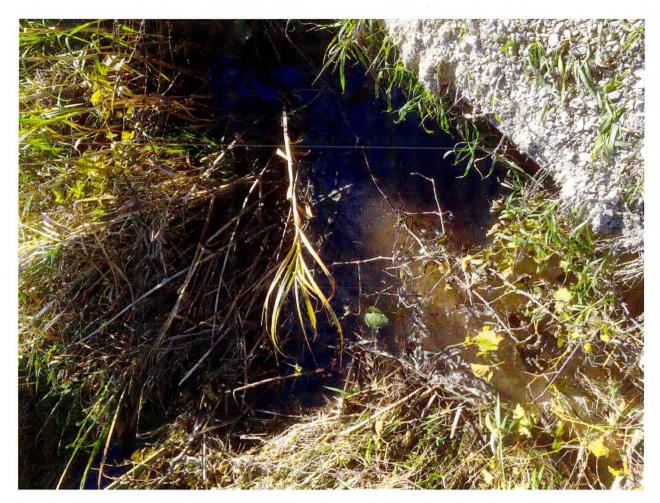
Clean water in ditch after second flush.
