### Technical Assistance, Environmental Liability Clarification or Post-Closure Modification Request

1.0	BACKGROUND 1
1.1	Site Description1
1.2	Site History1
1.3	Previous Reports & Agency Correspondence
2.0	SUMMARY OF RESULTS4
2.1	Soil Conditions
2.2	Groundwater Conditions
2.3	Soil-Gas Analysis6
3.0	REMEDIAL OPTIONS
4.0	REMEDIAL DESIGN
4.1	Installation of Sub-Slab Depressurization System

#### PHOTO LOG FOR BRIGHT CLEANERS – FRANLIN CENTRE 7249 SOUTH 76<sup>TH</sup> STREET, FRANKLIN, WISCONSIN

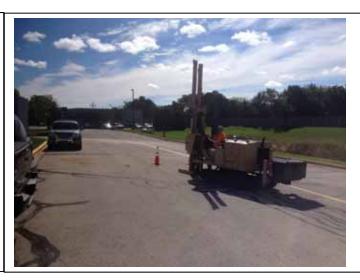
Photo No. 3 showing the advancement of a boring (TW-1) in the driveway south of the Bright Cleaners tenant space, view to the east.

Soil samples were collected continuously from ground surface to the bottom of each boring for lithologic description and soil screening. An experienced geologist documented the subsurface conditions (soil type, photo-ionization detector [PID] measurements, the presence of staining, odors etc.). Our field observations and lithologic descriptions are summarized in the boring logs included in **Appendix C**.

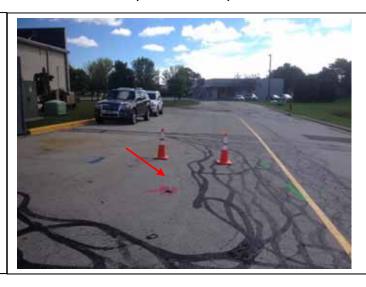
Photo No. 4 showing a temporary well (TW-1, red arrow) in the driveway south of the Bright Cleaners tenant space in the foreground and the advancement of a boring (TW-3) in the background, view to the northeast.

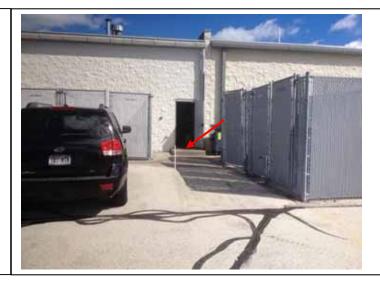
Photo No. 5 showing a temporary well (TW-2, red arrow) located near the rear door of the Bright Cleaners tenant space, view to the north.

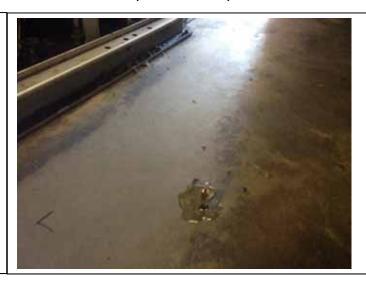
Photo No. 7 showing a sub-slab vapor probe (SV-2) installed next to the dry cleaning plant. Leak testing is being performed on the probe by mechanical means using the water dam method.

approximately ½-inch below the top of the concrete floor for leak testing. The hole was then cleared of any debris prior to installing the soil gas probe. The soil gas probes consisted of a brass MIP adapter/compression coupling, covered with a silicone tube, which was inserted and seated firmly into the 5/8-inch diameter hole drilled through the hard surface. Leak testing was performed on each soil gas probe by mechanical means using the larger diameter hole as a water dam. The annulus of the 1-inch hole was filled with distilled water and monitored for fluctuations prior to and during sampling to verify that a leak had not occurred. Apex installed vapor pins in the concrete slab in 4 locations to allow for future sample collection, if warranted.

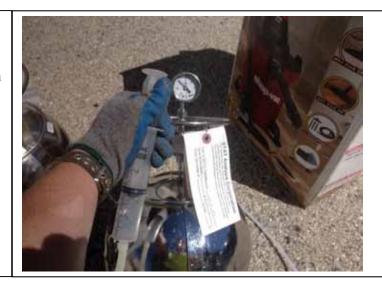
Photo No. 8 showing a Summa® canister sample train being leak tested with a shut-in test by applying a negative pressure using a syringe and plunger.

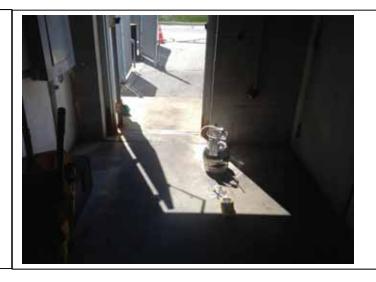
Photo No. 9 showing a vapor probe (SV-3) located near the rear door of the Bright Cleaners tenant space being purged and screened for volatile emissions using a photoionization detector prior to sample collection, view to the south.

Prior to sample collection, the sub-slab gas probes were purged a minimum of three probe volumes of air from the sampling media to ensure representative samples of sub-slab soil gas and field screened for volatile organic emissions using a photoionization detector (PID) equipped with a 10.6 eV PID lamp. Soil gas samples were collected using batch-certified 6-liter Summa<sup>®</sup> canisters (evacuated stainless steel canister) with (30-minute) flow control valves with a flow rate of less than 200 milliliters per minute (mL/min). The laboratory-supplied regulator assembly was attached to the Summa® canister and a 3-foot section of 0.25-inch Teflon-lined polyethylene tubing was connected to the regulator using Swagelock® compression fittings. Leak testing was performed on each Summa® canister sample train prior to sample collection by performing a shut-in test. The shut-in test was performed by connecting the sample train tubing to a syringe and plunger. With the Summa® canister valve closed, a vacuum of approximately 20-inches mercury was applied to the sample train and maintained for 30 seconds. The pressure was observed to remain stable for the duration of the test. A photo log including photographs of the sub-slab soil gas sampling locations are included as Appendix A; soil-gas sampling details (i.e., results of field screening and leak testing; sample duration, initial and final canister pressures; and laboratory identification numbers) are recorded in the soil-gas sample logs included in Appendix B.

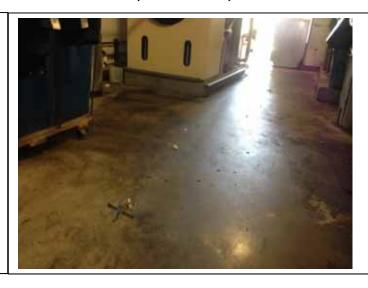
Photo No. 10 showing a sub-slab vapor probe installed north of the dry cleaning plant (SV-1) in the foreground and a second installed next to the plan (SV-2), view to the south.

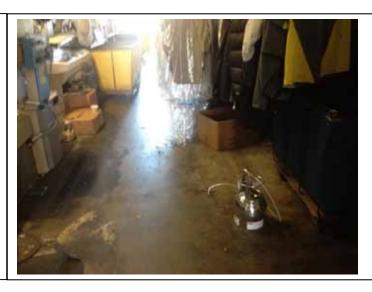
Photo No. 11 showing the collection of a sub-slab vapor sample (SV-1) located north of the dry cleaning plant in the Bright Cleaners tenant space, view to the north.

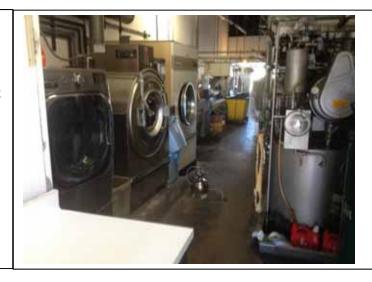
Photo No. 12 showing the collection of a sub-slab vapor sample (SV-2) located adjacent to the dry cleaning plant in the Bright Cleaners tenant space, view to the north.

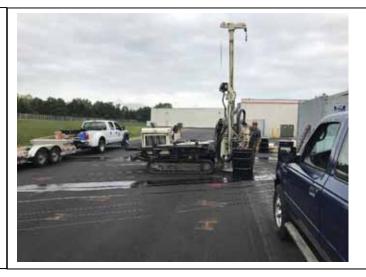
Photo No. 13 showing a monitoring well (MW-1) being installed south of the Bright Cleaners tenant space, view to the west.

A Geoprobe rig was used to advance a borehole at each monitoring well location to document the soil conditions and to collect soil samples. A truck-mounted hollow-stem auger drill rig was then used at three locations (MW-1 through MW-3) to advance an 8-inch diameter borehole into the underlying aquifer zone; each well was installed to depths ranging from 15 to 20 feet bgs.

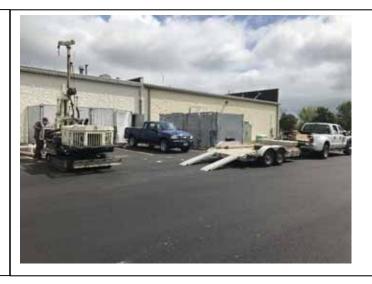
Photo No. 14 showing a monitoring well (MW-2) being installed southwest of the Bright Cleaners tenant space, view to the northeast.

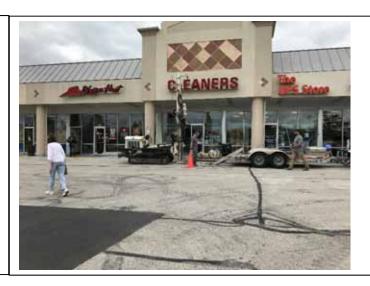
Photo No. 15 showing a monitoring well (MW-3) being installed north of the Bright Cleaners tenant space, view to the south.

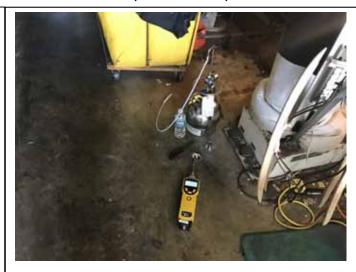
Photo No. 16 showing a vapor probe (SV-4) located in the northern portion of the Bright Cleaners tenant space being purged and screened for volatile emissions using a photoionization detector prior to sample collection, view to the south.

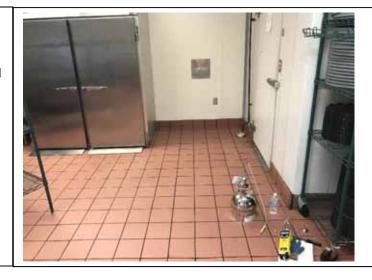
Photo No. 17 showing a vapor probe (SV-6) located in the Pizza Hut tenant space being purged and screened for volatile emissions using a photoionization detector prior to sample collection, view to the west.

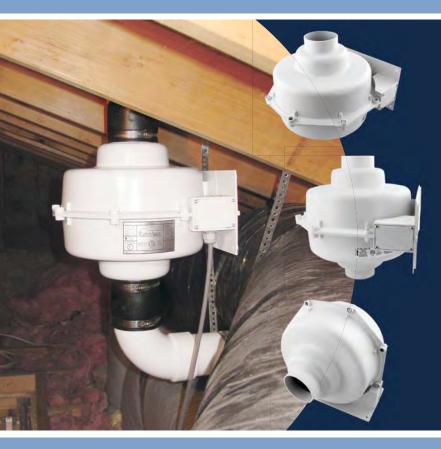
# **GP Series**

# **Radon Mitigation Fan**

All RadonAway™ fans are specifically designed for radon mitigation. GP Series Fans offer a wide range of performance options that make them ideal for most sub-slab radon mitigation systems.

- 2. A PVC pipe of at least 3 inches in diameter extends from the extraction sump to the intake side of an in-line fan (Specifications enclosed in **Appendix F**) capable of achieving a static vacuum of at least 0.25 inches water column (wc) at the suction point and measurable vacuum at the farthest edges of the area served by the suction pit under worst case conditions (all exhaust fans and heating systems running, during cold weather) as determined by a differential pressure reading of at least -0.003 inches wc below the slab or visible downward flow of air at test holes using chemical or smoke sticks;
