From: Sager, John E - DNR
Sent: Monday, December 10, 2018 9:36 AM
To: 'Wright, Clifford C.'
Subject: RE: SRC T25 Basin HC Investigation Update and Request 12/7/18

Facility-Wide Groundwater Monitoring Network			
SUPERIOR REFINING COMPANY LLC SUPERIOR REFINERY SUPERIOR, WISCONSIN

Tank 25 Basin Hydrocarbon-Impacted Soil Investigation (March 2018)

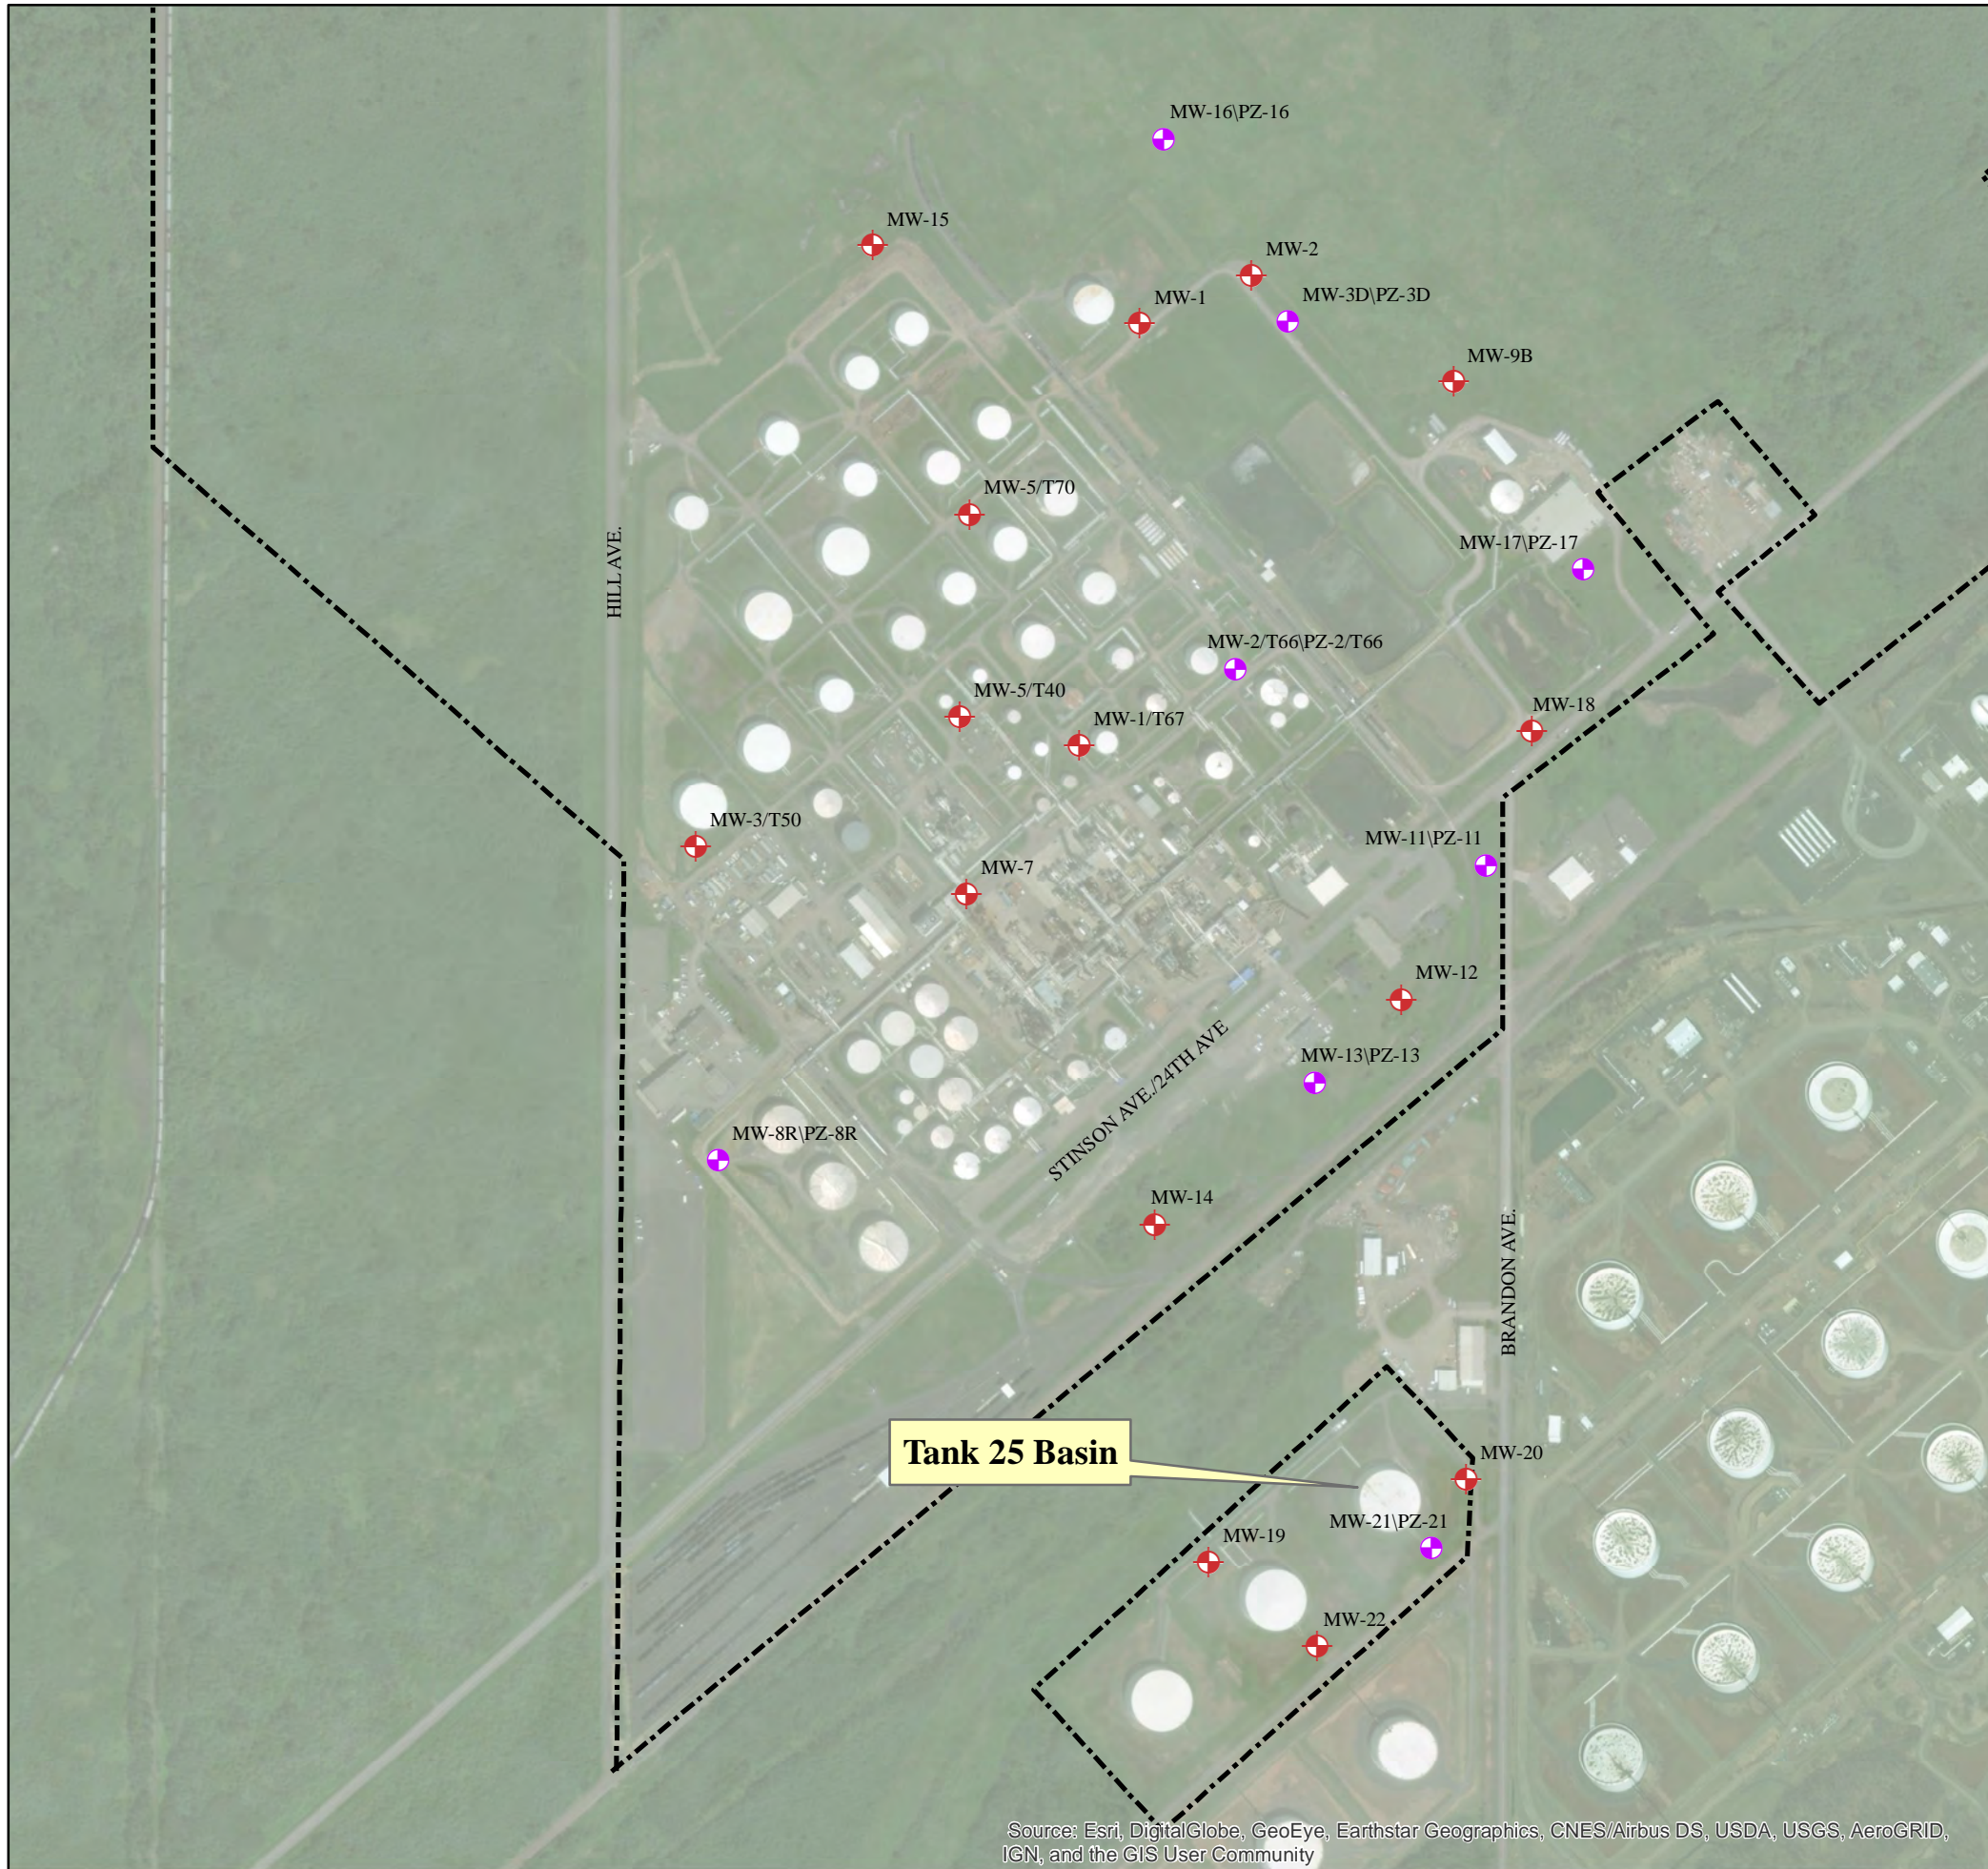
Gannett Fleming, Inc. 8025 Excelsior Drive Madison WI 53717-1900 (608) 836-1500 www.gannettfleming.com	
Project No.	34265.003	Date	02/16/16
Figure	1

2. *Fig1_Location-map* shows SRC property boundaries. Note that the property line is relatively close to T25.
3. *Fig2_Site-plan* includes the 30 soil boring locations, etc. from the March 2018 HC investigation.

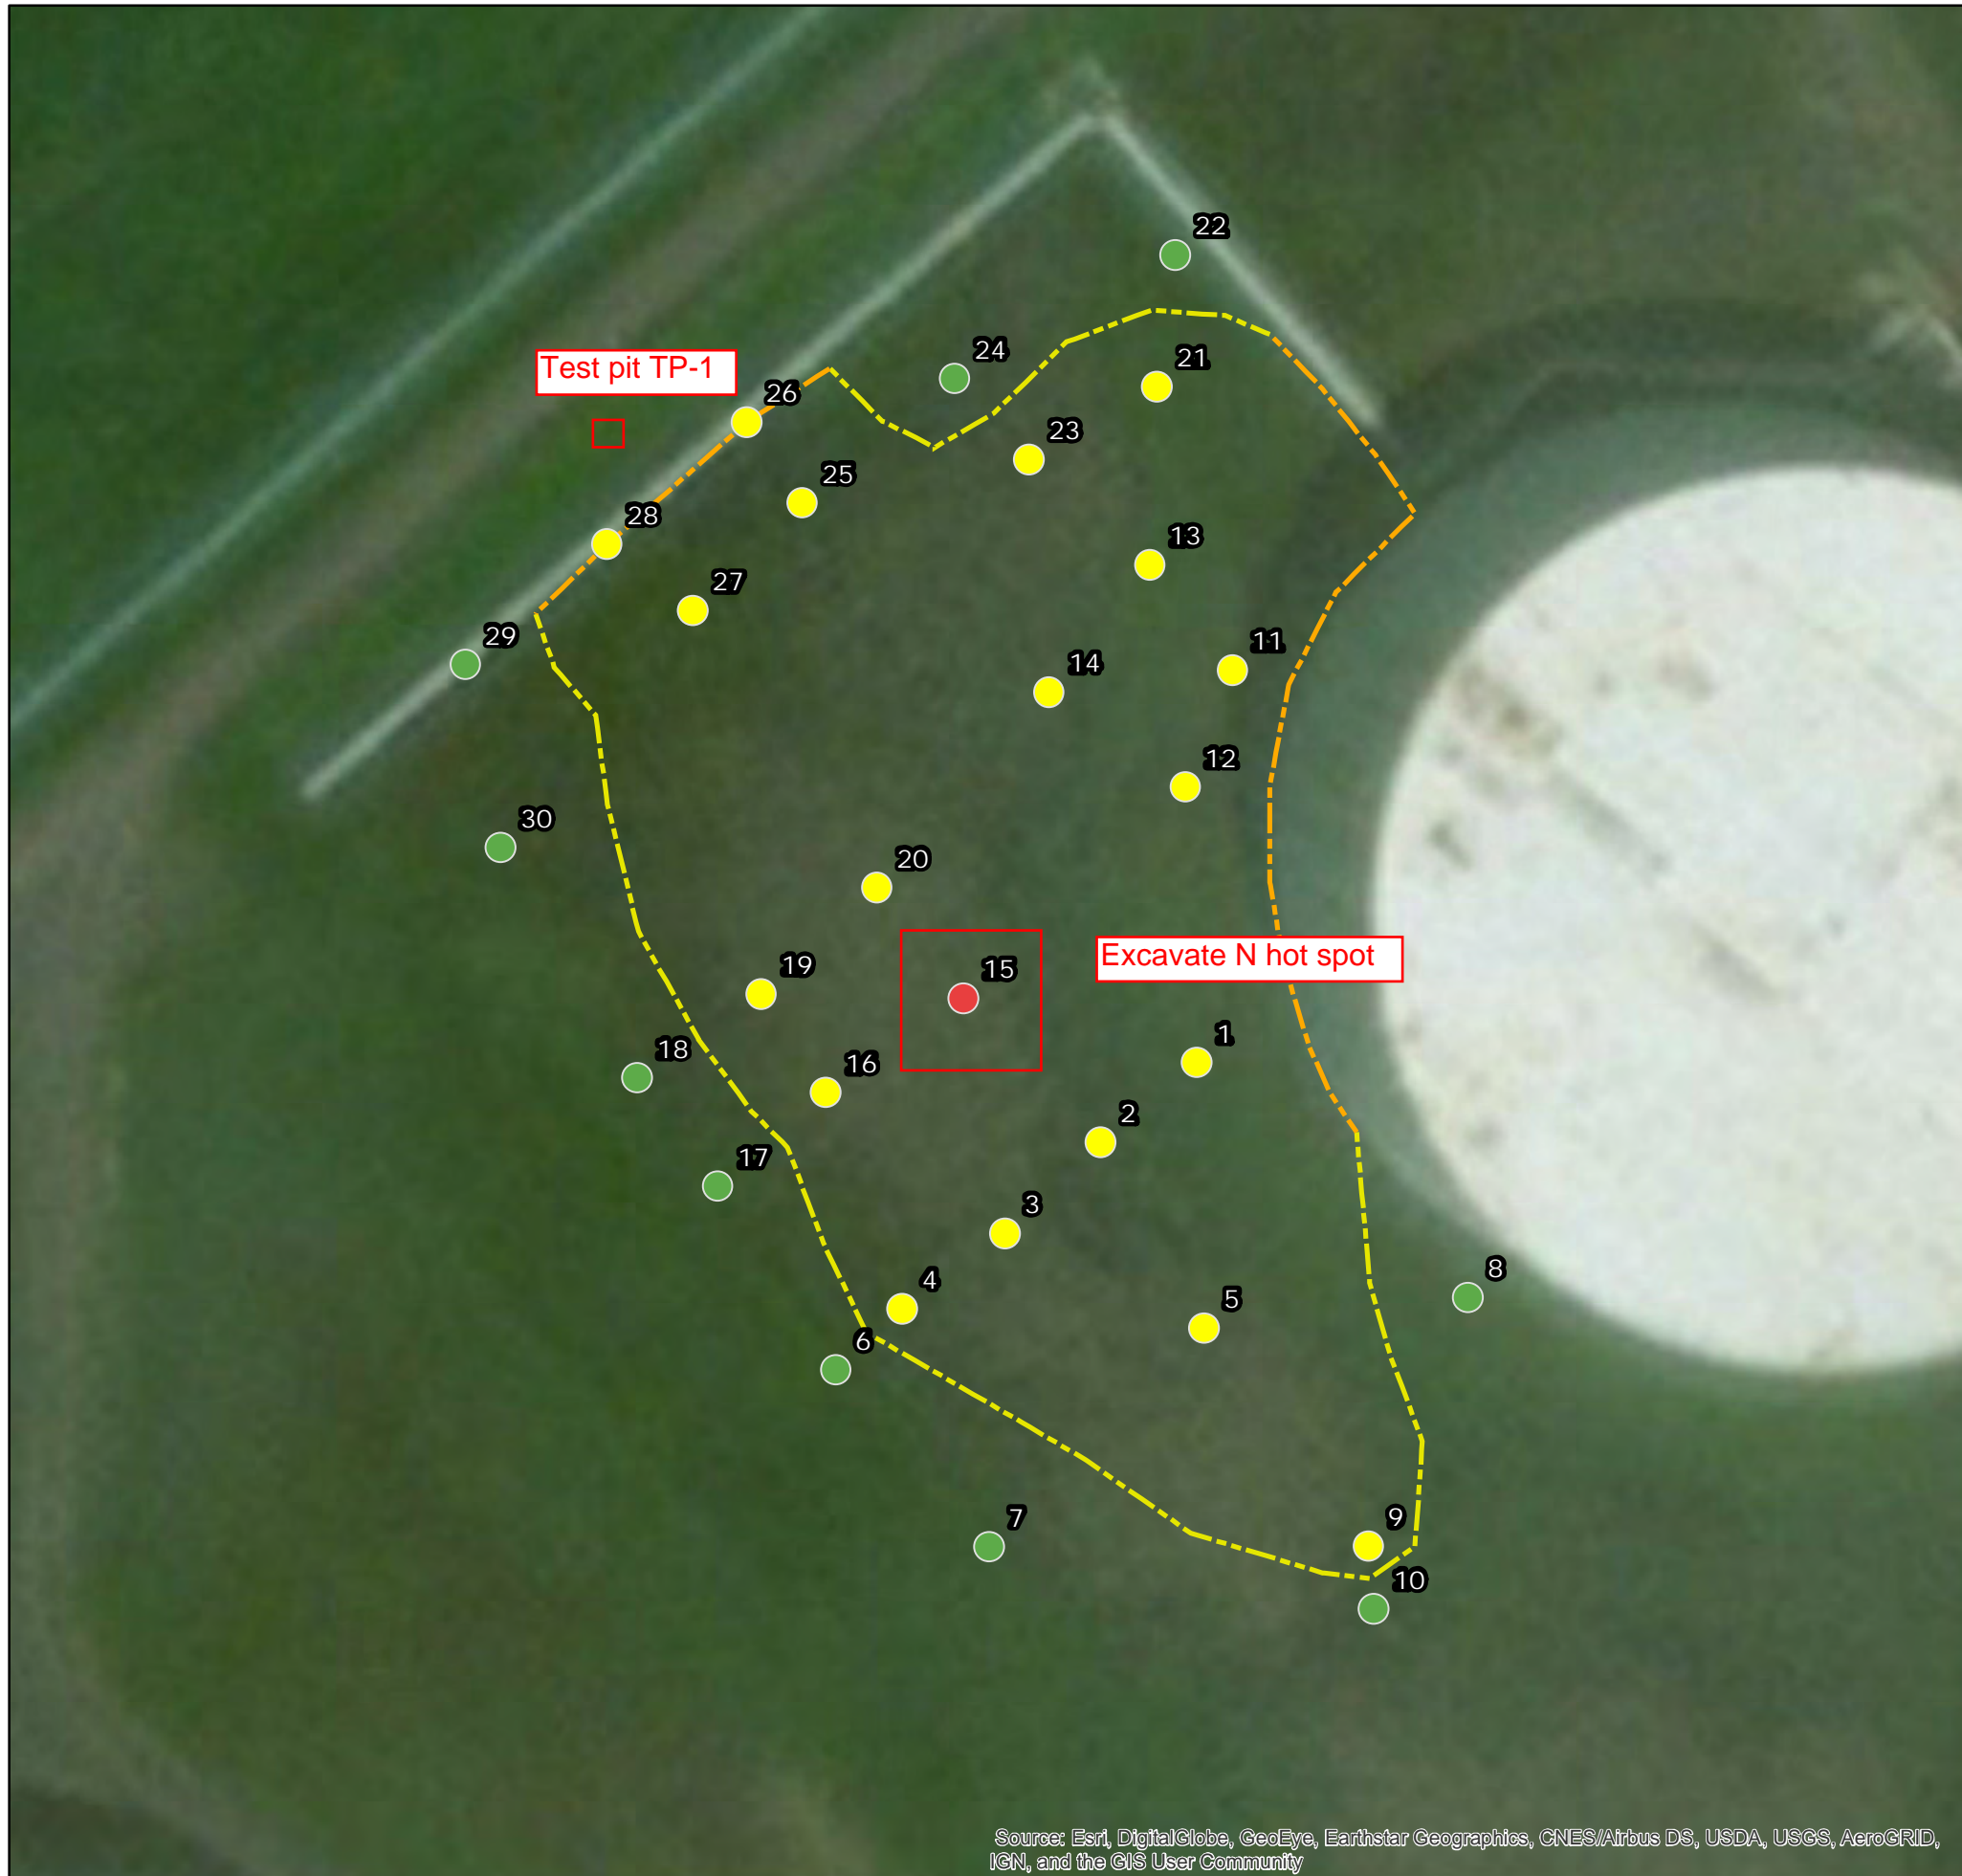
Project No.	34265.003	Date	4/17/18	Figure	2
-------------	-----------	------	---------	--------	---

4. *Tab2_PID-rdgs* is an internal reference document that I prepared on Dec 4. Given that PID readings at GP-26 and GP-28 were not <10 parts per million, volume (ppmv), one could argue that the lateral extent of impacted soil has not yet been completely defined **to the NW** (see *Fig2_Site-plan*), as you and I discussed on Dec 3. Digging test pit TP-1 as shown on Figure 2 is one option. According to Matt Turner at SRC though, TP-1 would be located on the slope of the tank berm and may be difficult to mechanically excavate. Using a hand auger would be a second option but might be difficult to get started with frost in the ground, etc. In addition, note that the vertical extent of the HC has been defined.

- Soil Boring Location That Screened Above 10ppmv and Had Detected Concentrations Above Applicable Direct Contact Limits
- Soil Boring Location That Screened Above 10ppmv and Had Detected Concentrations Below Applicable Direct Contact Limits
- Soil Boring Location That Screened Below 10ppmv

Estimated Horizontal Extent Of Hydrocarbon-Impacted Soil

- 1) Tank 25 is currently being used to store crude oil.
- 2) Not all boring locations that screened above 10ppmv were analyzed for PVOCs/Naphthalene.

To remove the shallow-soil N hot spot, SRC proposes to:

- Excavate an area around GP-15 (e.g., 20 feet square and 4 feet deep).
- Field screen soil samples at 0-2 and 2-4 ft below ground surface from each of the four sidewalls.
 - If PID readings are <10 ppmv, then backfill with clean material, etc.
 - If a PID reading is >10 ppmv, then either collect a soil sample to document that the residual HC is below NR 720 industrial direct contact RCLs for PVOCs and N or resume excavation activities if necessary.
