Spill Notification for WRR Environmental Services Co., Inc.

EPA ID# WID990829475 FID# 618026530 Spill ID# Unknown

ID 20210312WC18-1 – Paint related material

Spill Notification for WRR Environmental Services Co - Paint container spill 03112021

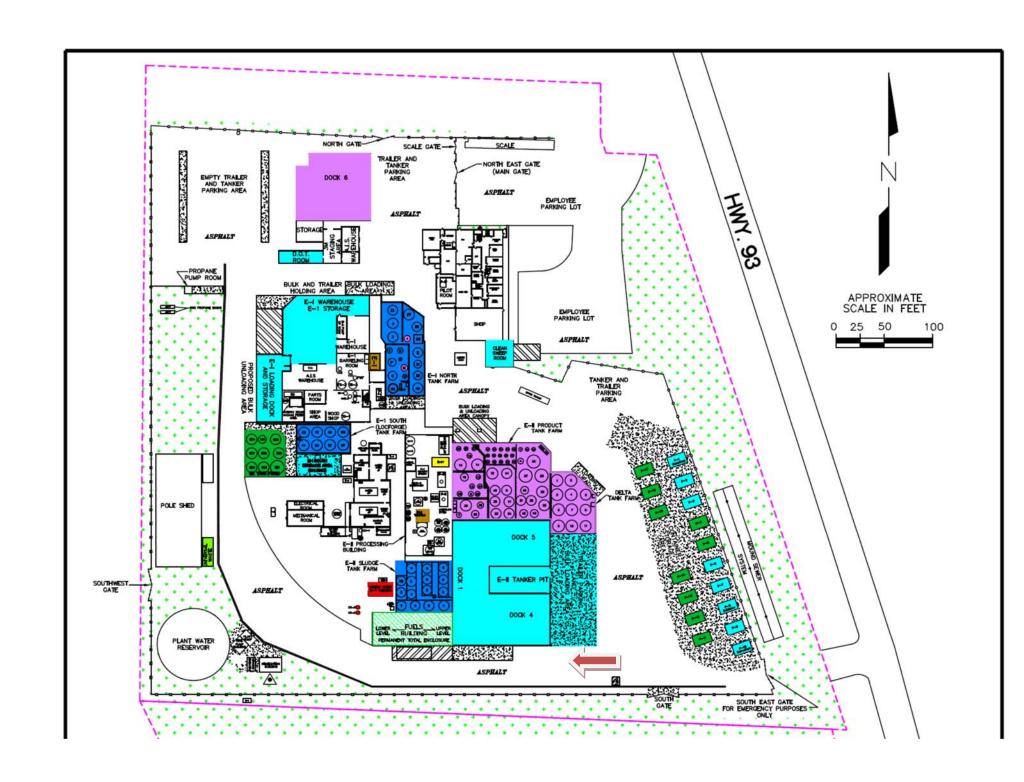
The release was contained to the black topped area. No material impacted soil or contaminated the WRR stormwater collection area.

Included with this report is a facility map with the release location marked with a red arrow.
