**DRAFT REPORT
FY16 PHASE 1 REGIONAL SITE INSPECTIONS
FOR PERFLUORINATED COMPOUNDS**

**TRUAX FIELD AIR NATIONAL GUARD BASE
MADISON, WISCONSIN**

FY16 Phase 1 Regional Site Inspections For Perfluorinated Compounds

Wisconsin Air National Guard Truax Air National Guard Base Madison, WI

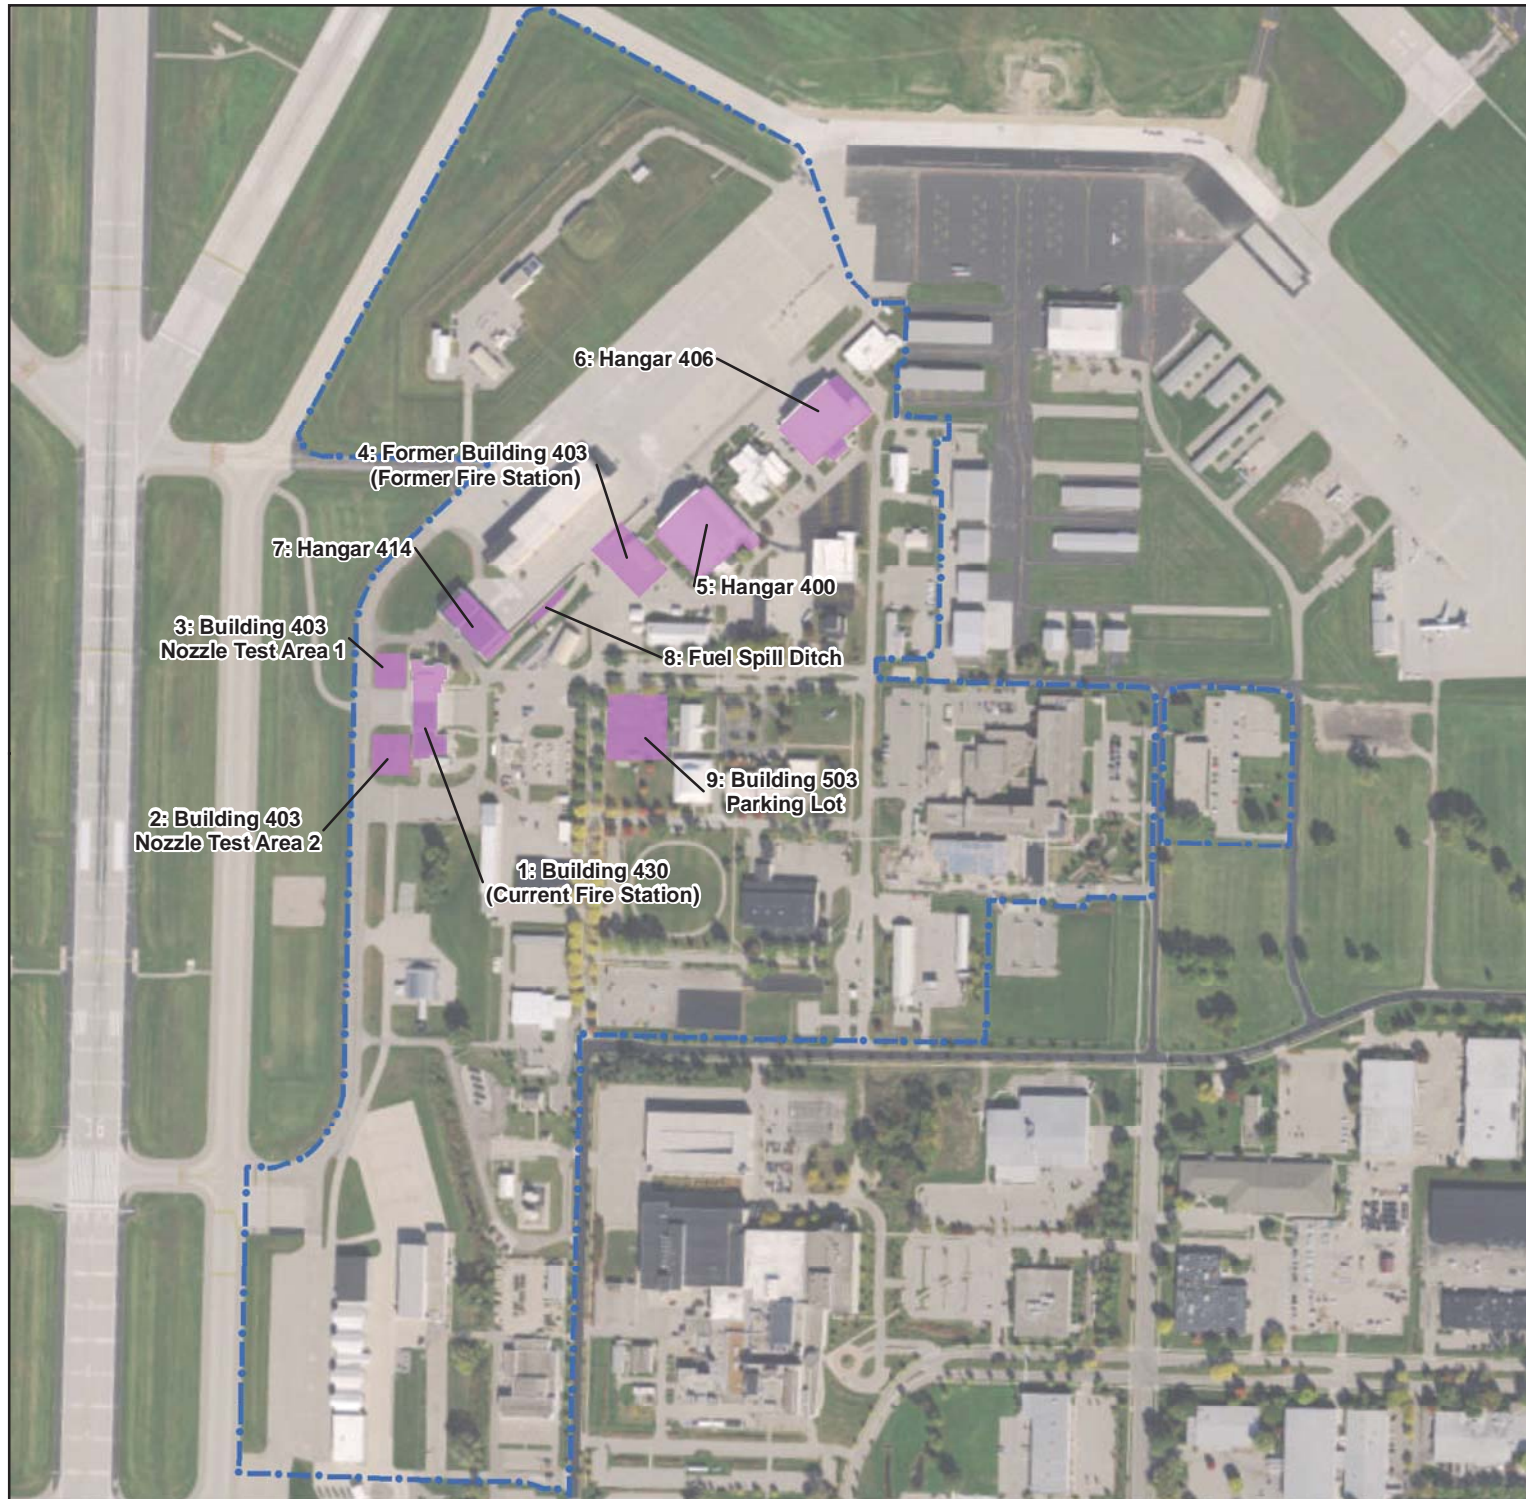
PRL LOCATION MAP

The findings of AFFF use and storage at each of the 9 PRLs recommended for inclusion in the SI, as documented in the PA Site Visit Report, are summarized below. The PRLs are illustrated on **Figure 3** and **Table 1** presents the identified PRL and associated recommendations based on the PA completed by BB&E.
