Off-Site Liability Exemption and Liability Clarification Application

FIGURE 1
SITE LOCATION MAP
249 EAST HAMPTON AVENUE
MILWAUKEE, WISCONSIN

Phase I Environmental Site Assessment
245-261 East Hampton Avenue
Milwaukee, Wisconsin

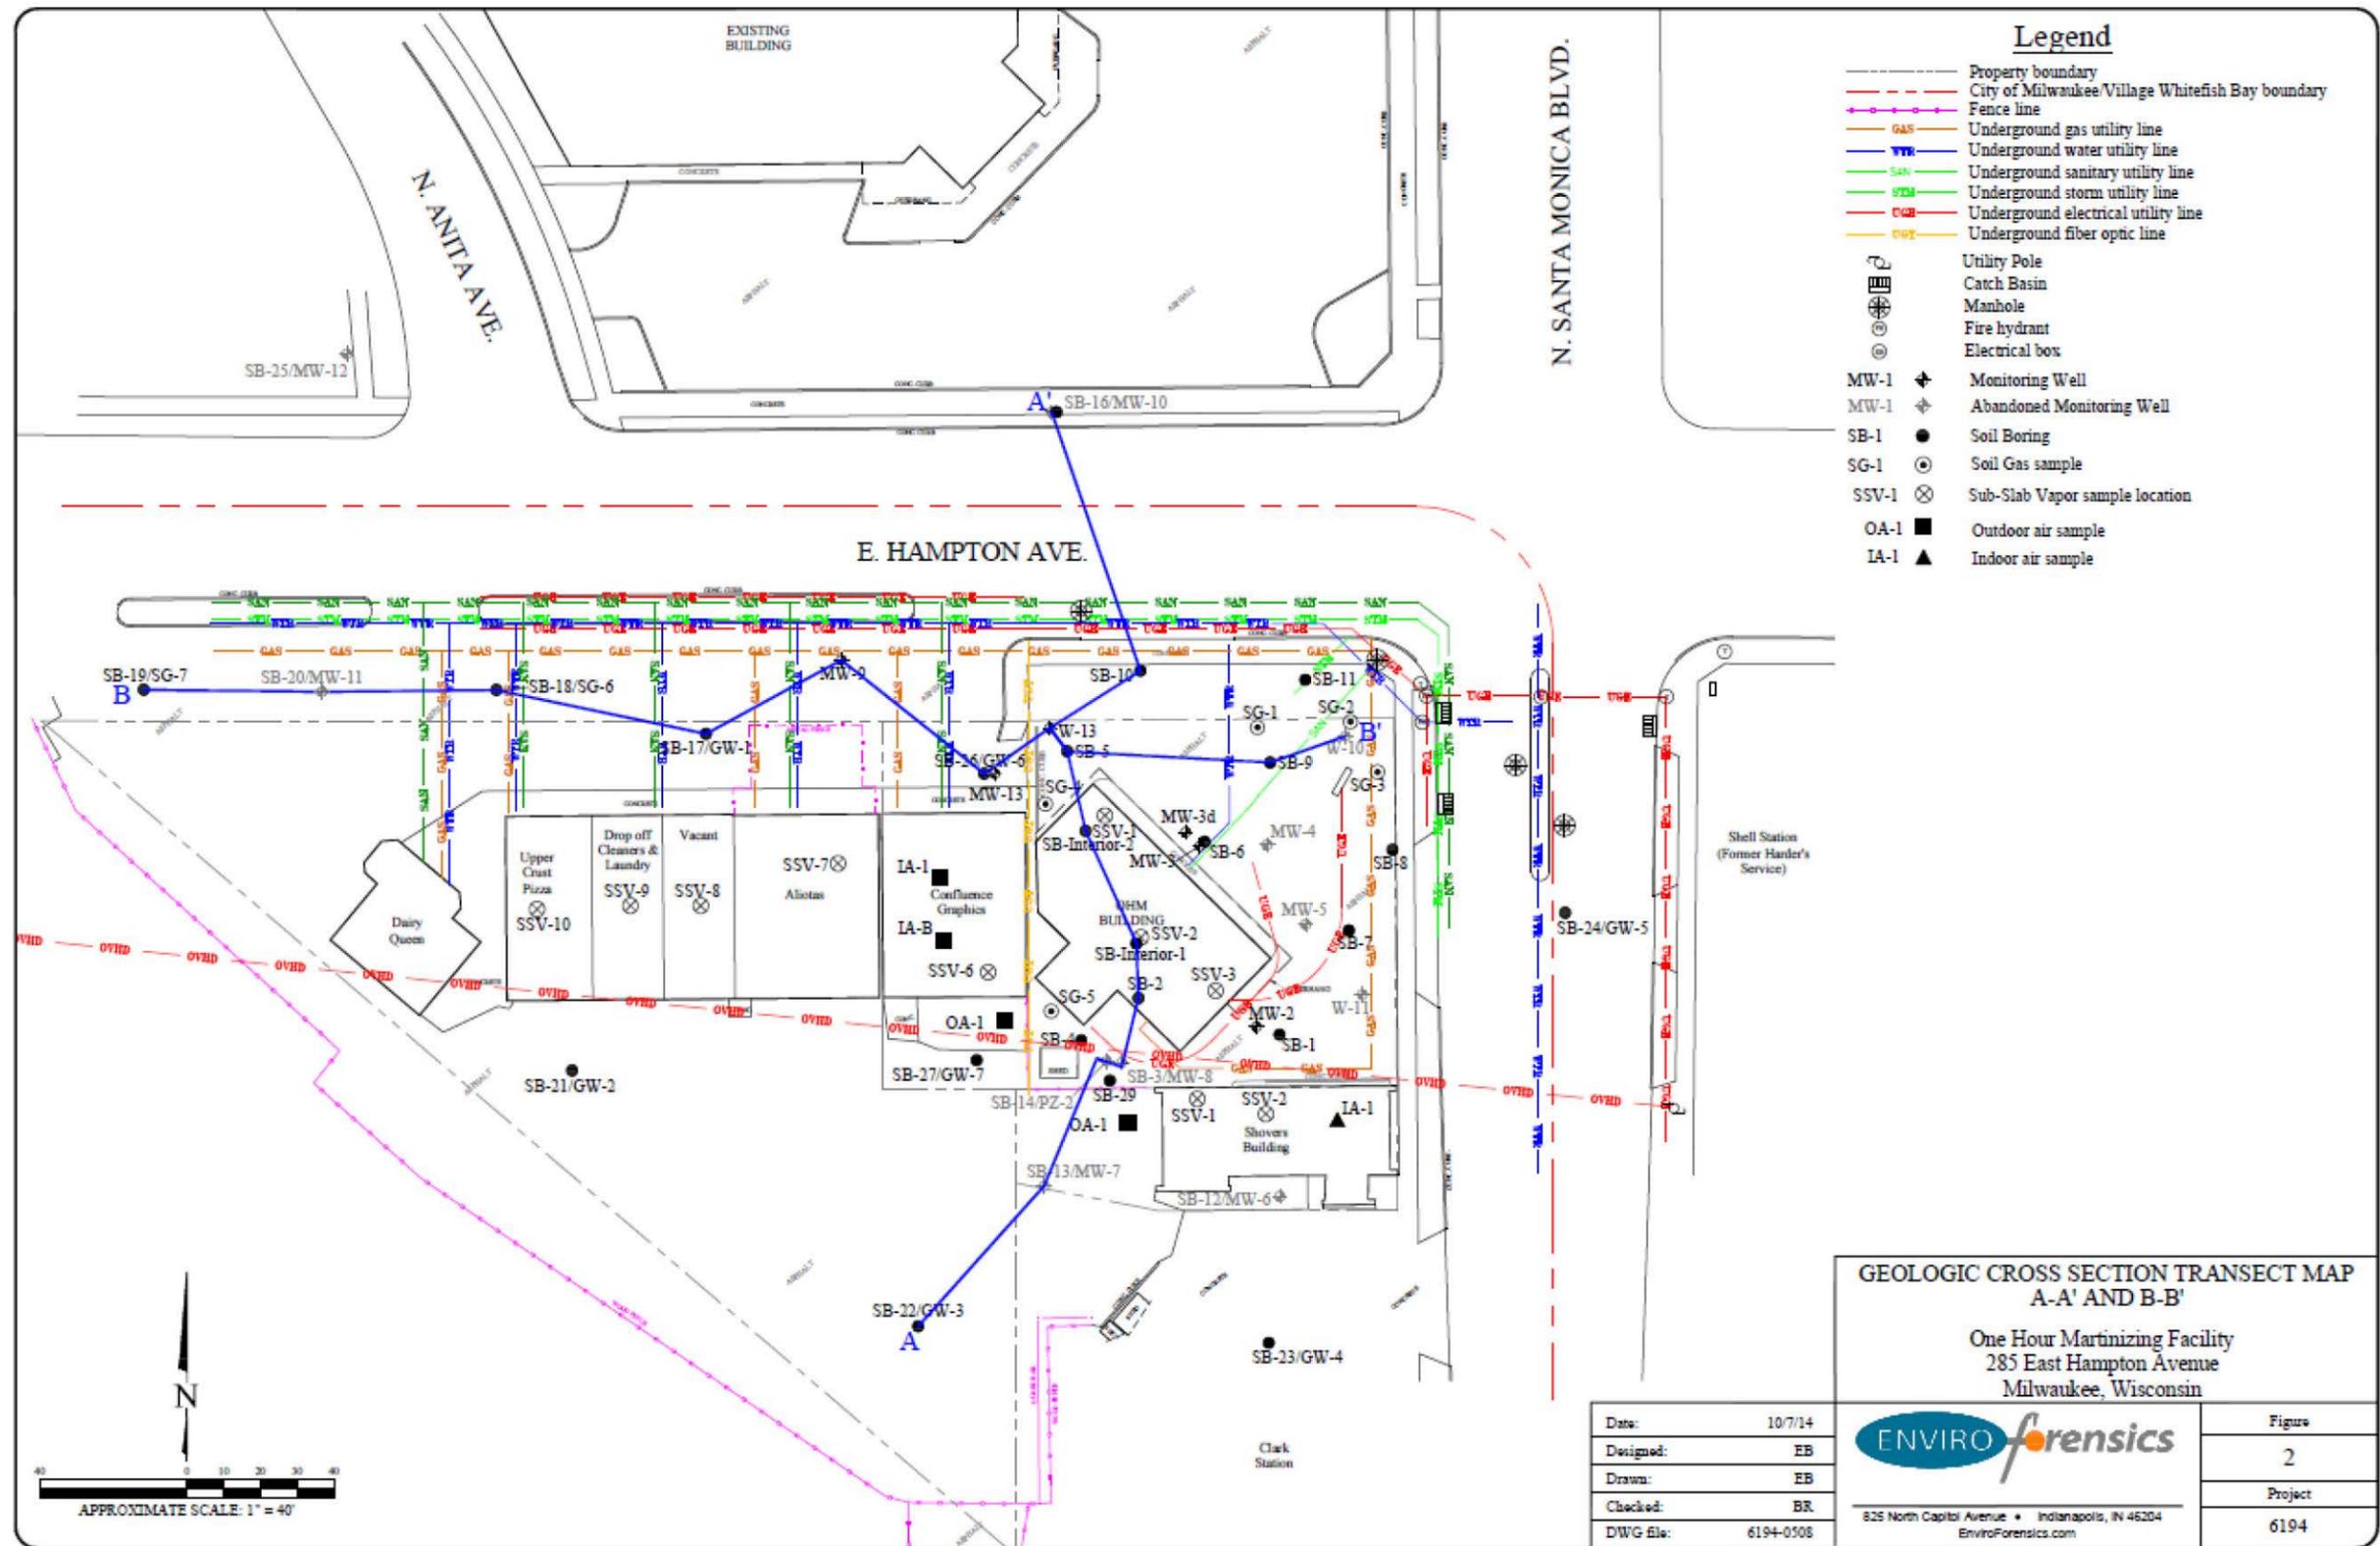
FIGURE 4
GEOLOGIC CROSS SECTION TRANSECT MAP FOR ONE HOUR MARTINIZING
285 EAST HAMPTON AVENUE
MILWAUKEE, WISCONSIN

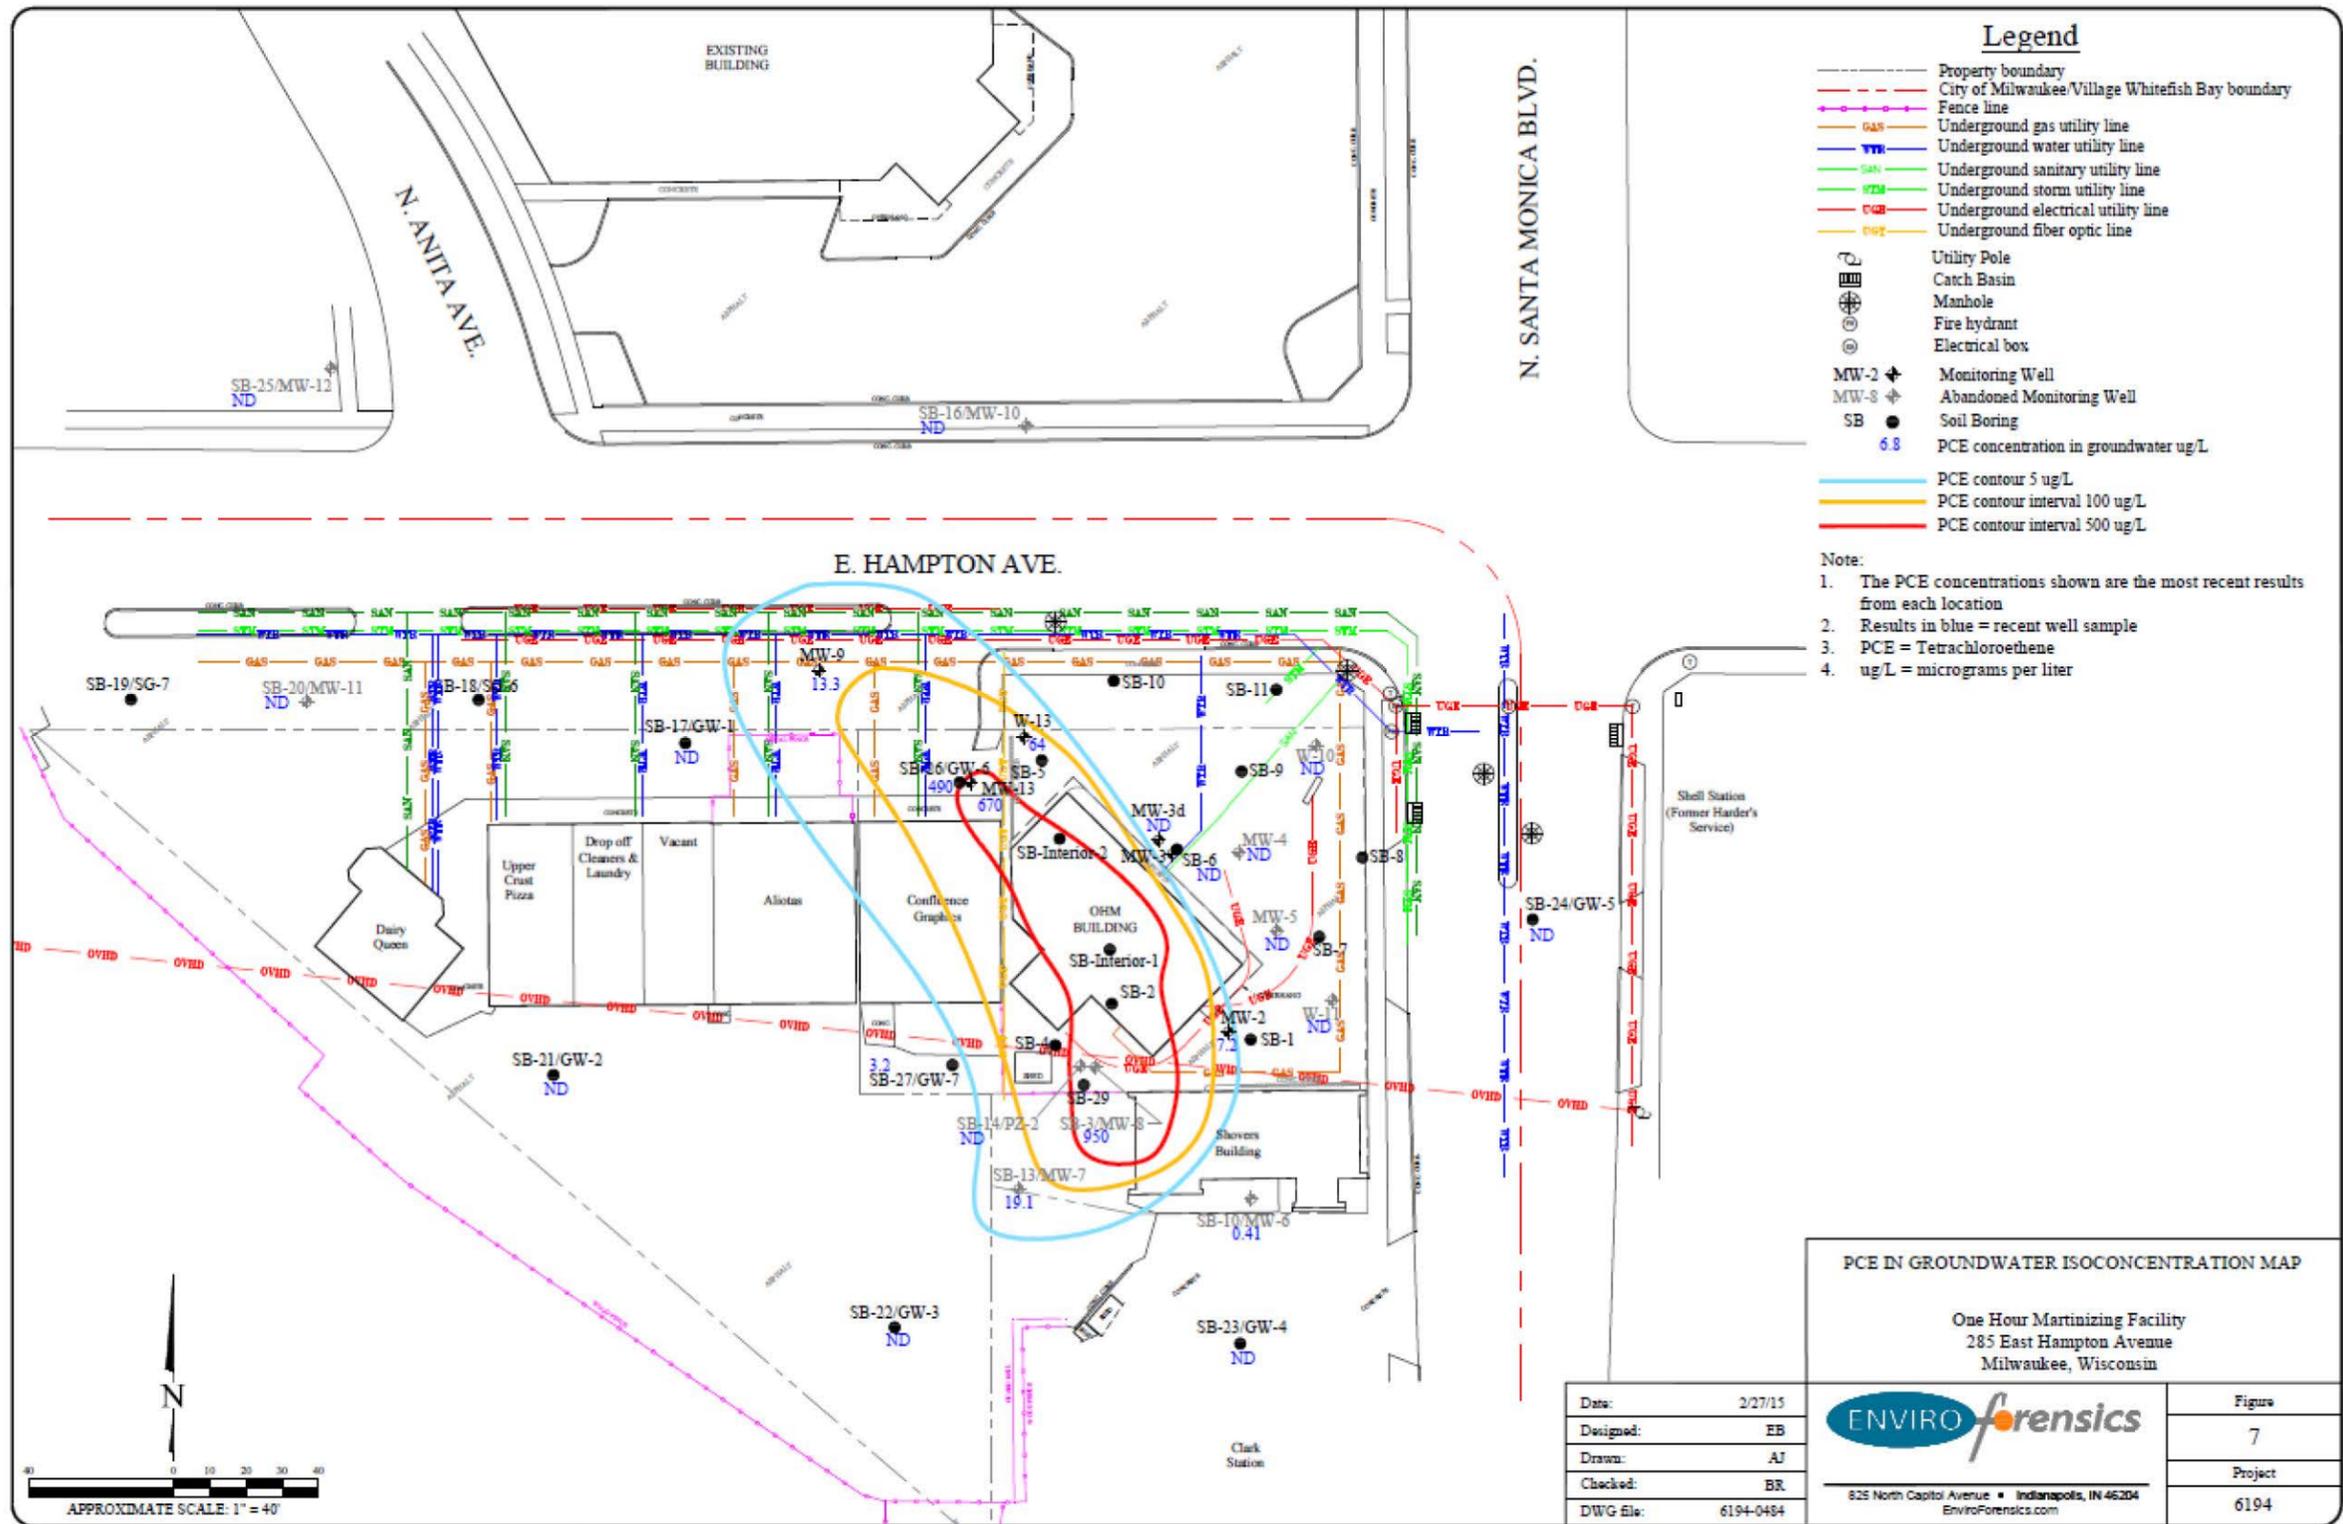
FIGURE 7
PCE IN GROUNDWATER ISOCONCENTRATION MAP FOR ONE HOUR MARTINIZING
285 EAST HAMPTON AVENUE
MILWAUKEE, WISCONSIN

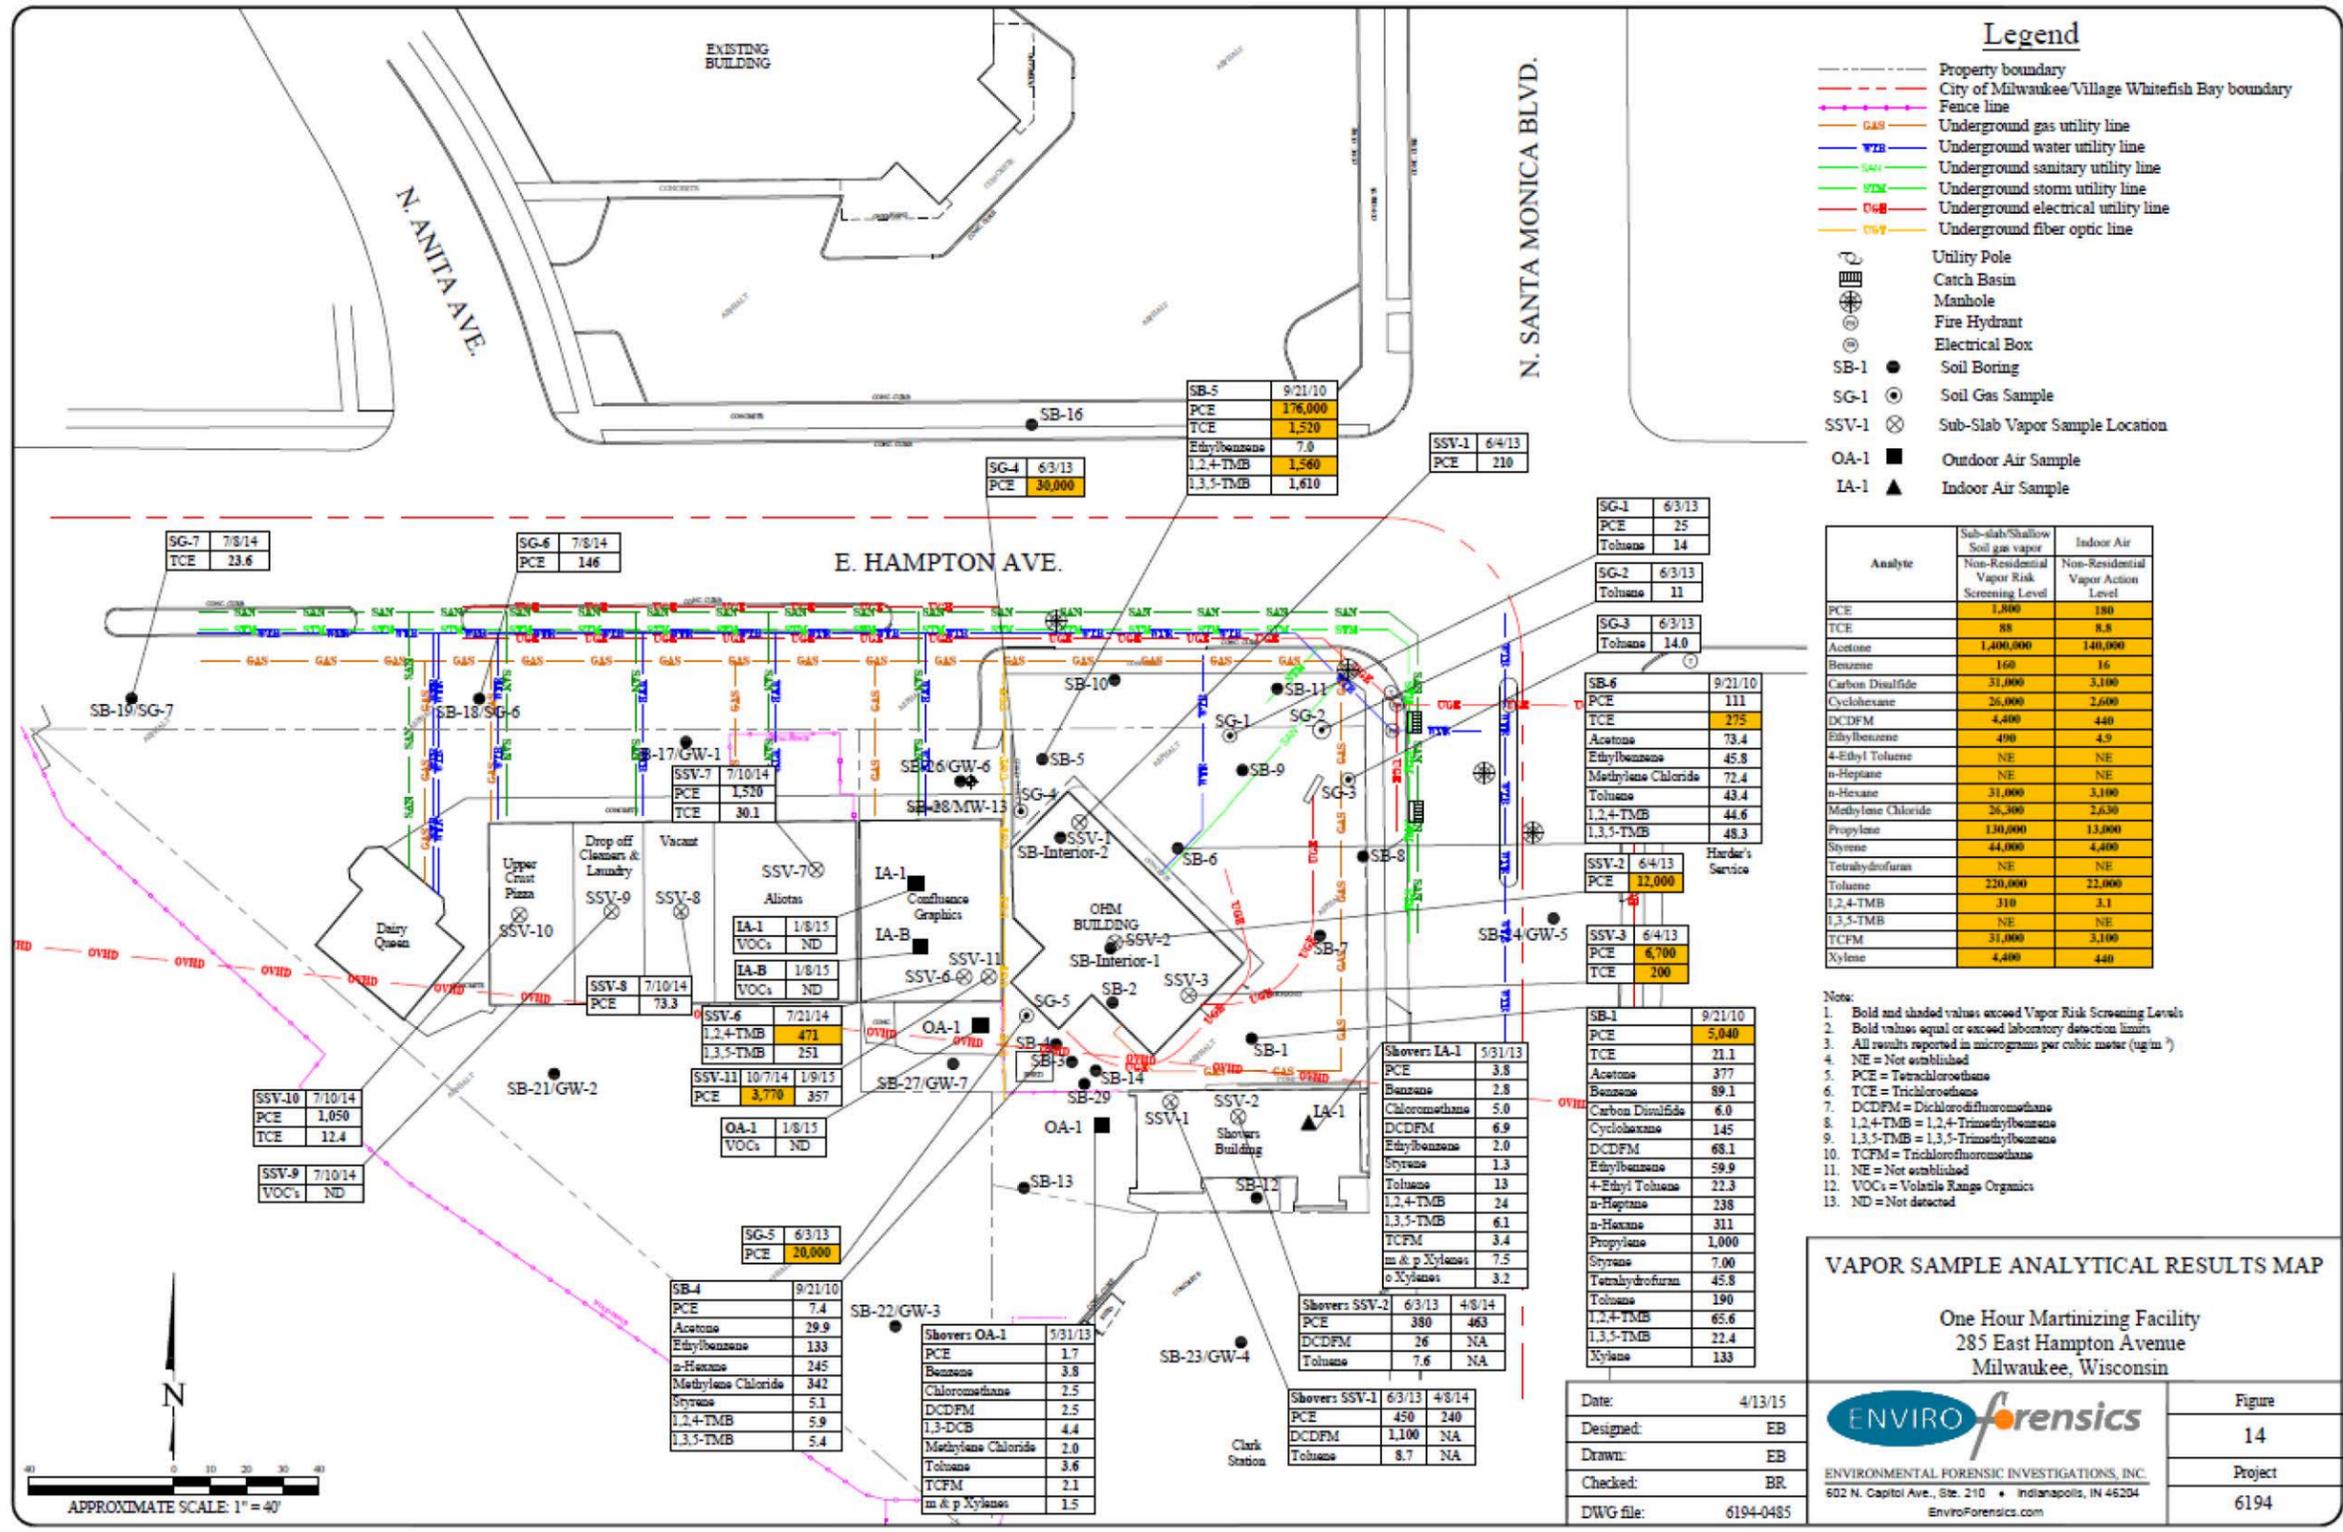
FIGURE 9
VAPOR SAMPLE ANALYTICAL RESULTS MAP FOR ONE HOUR MARTINIZING
285 EAST HAMPTON AVENUE
MILWAUKEE, WISCONSIN

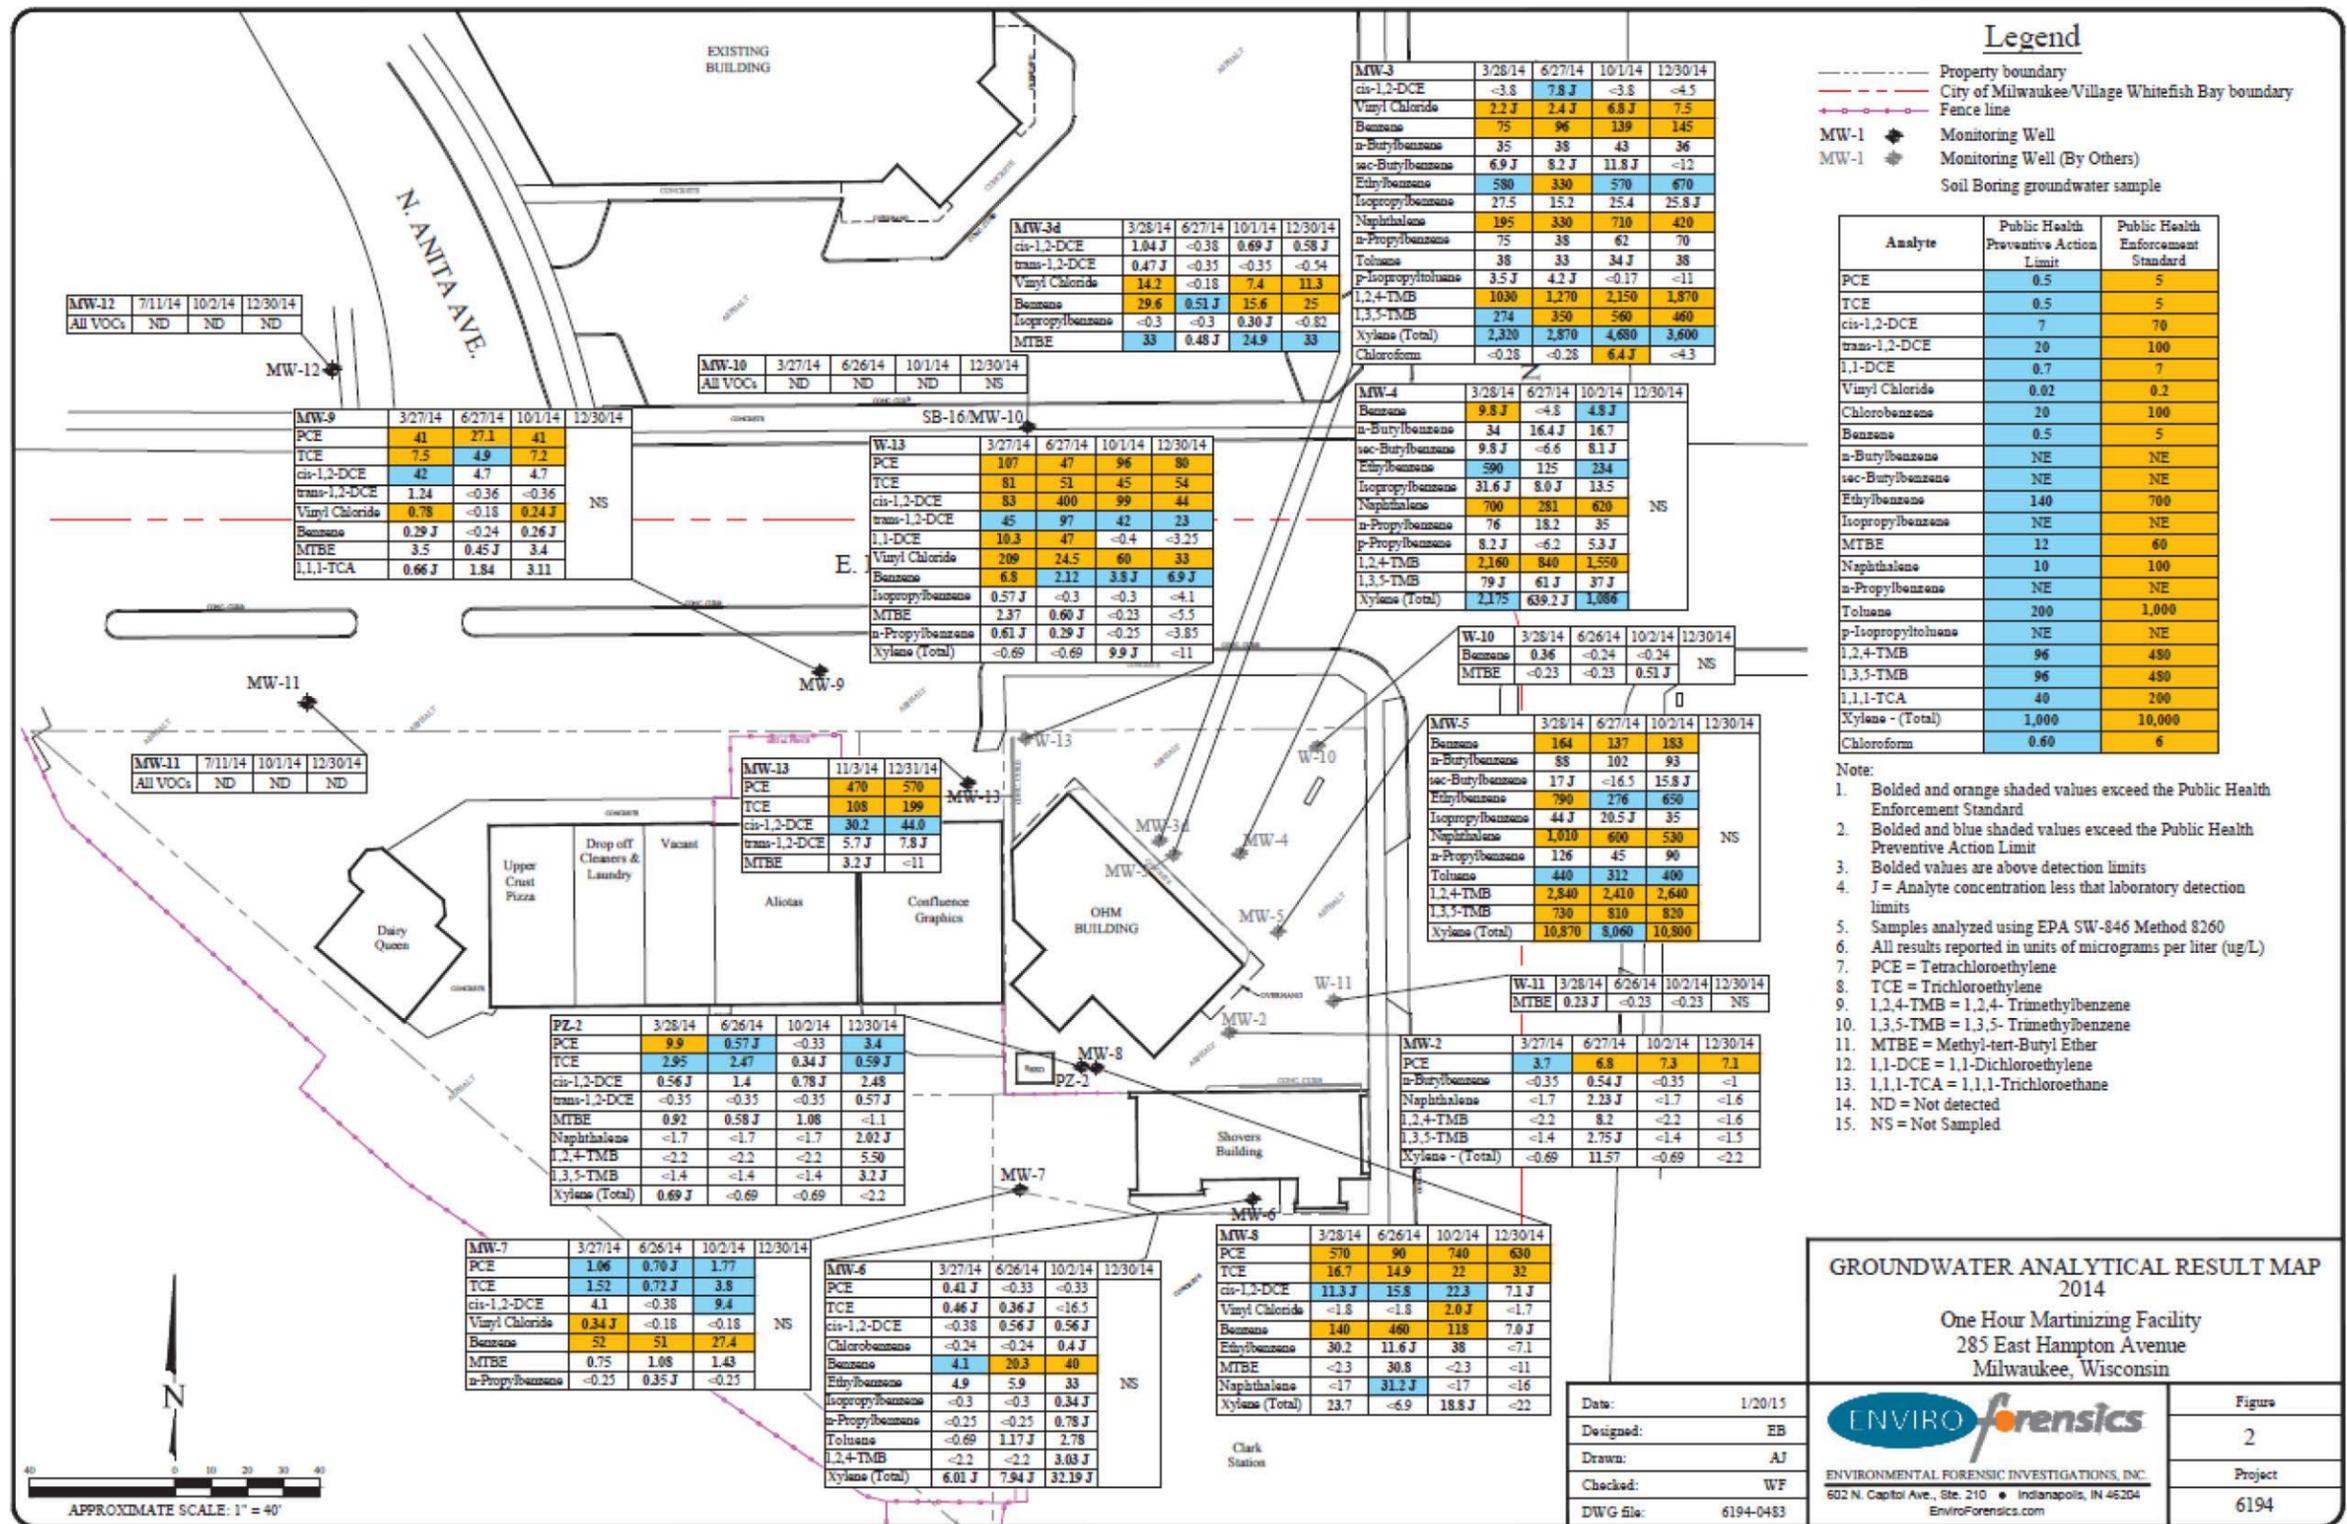
FIGURE 11
 GROUNDWATER ANALYTICAL RESULTS MAP 2014 FOR ONE HOUR MARTINIZING
 285 EAST HAMPTON AVENUE
 MILWAUKEE, WISCONSIN

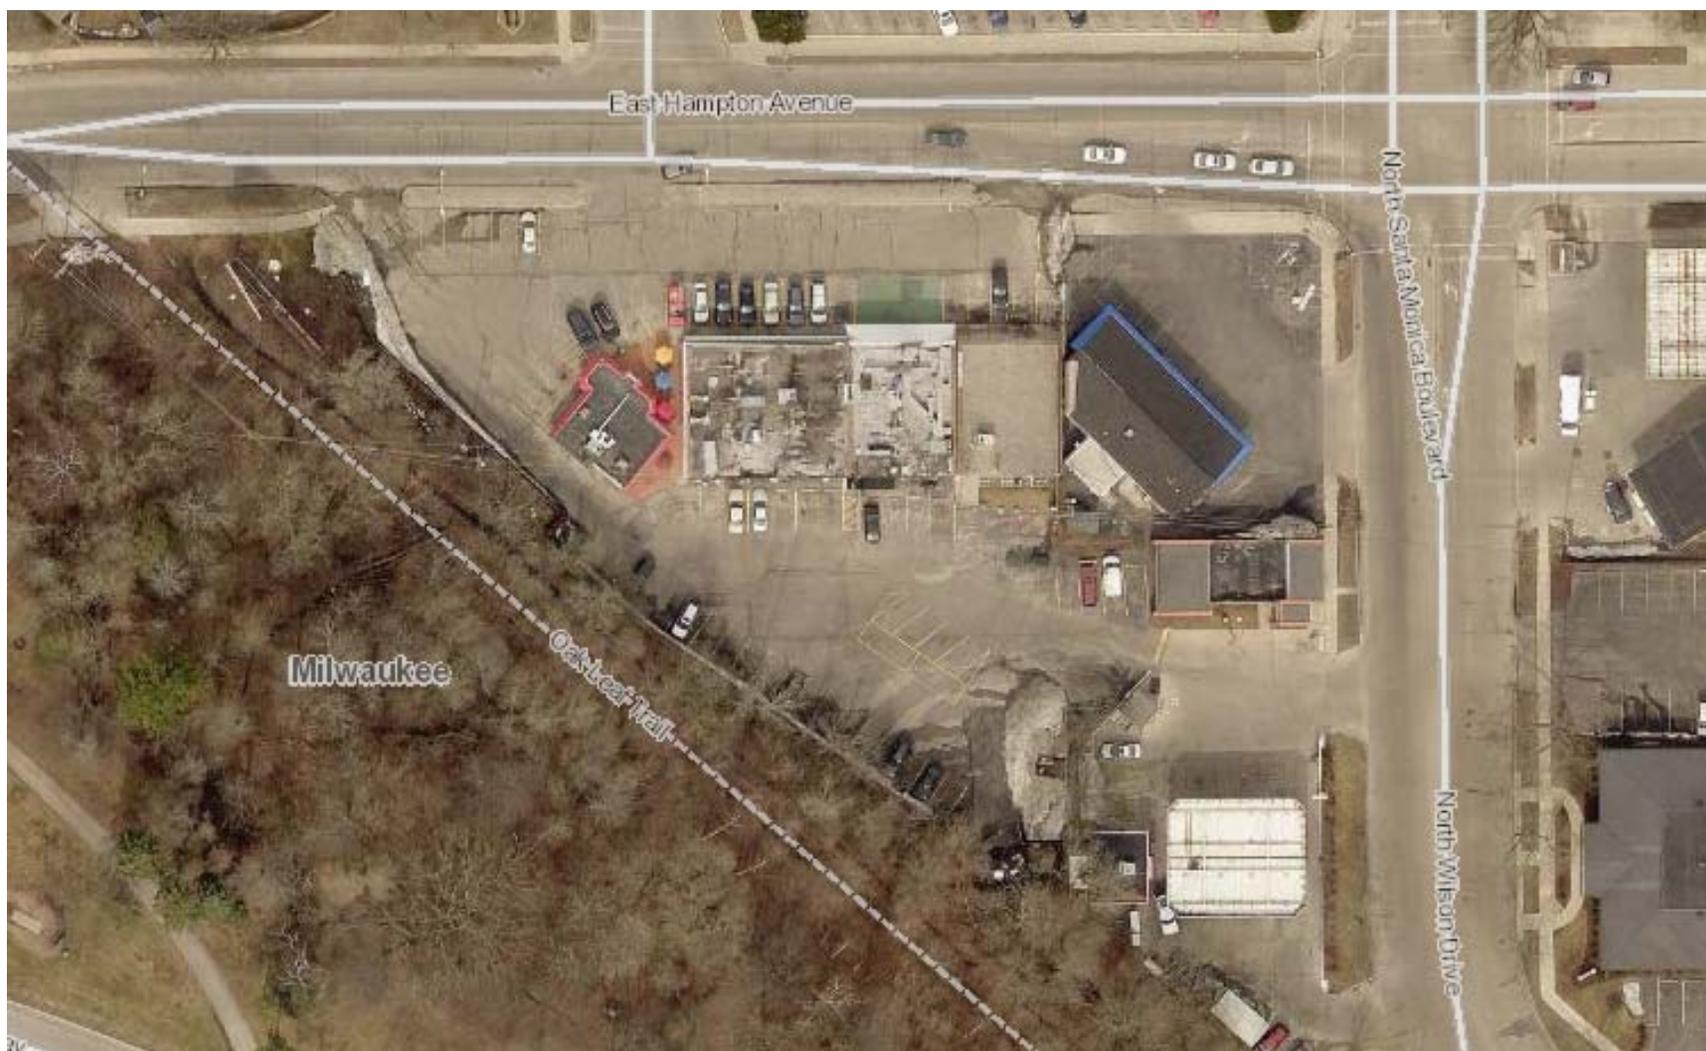
Figure
2

Site Diagram
245-261 East Hampton Avenue
Milwaukee, Wisconsin

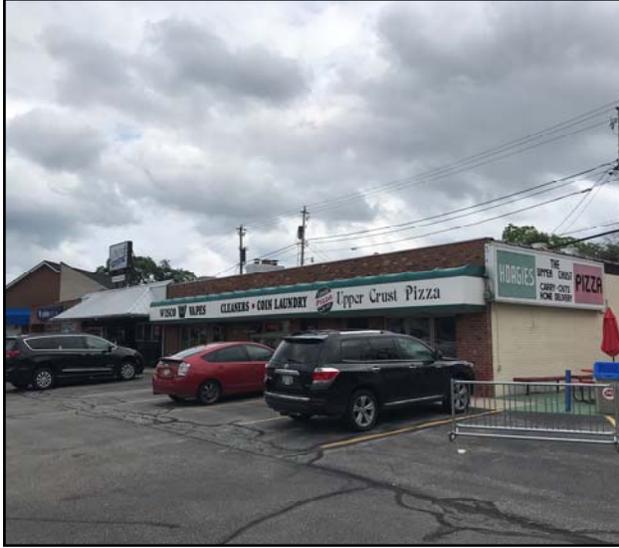
Photograph 1 - The subject property is located at 249-261 East Hampton Avenue in Milwaukee, Wisconsin. The subject property currently contains a commercial shopping center and associated parking lot.

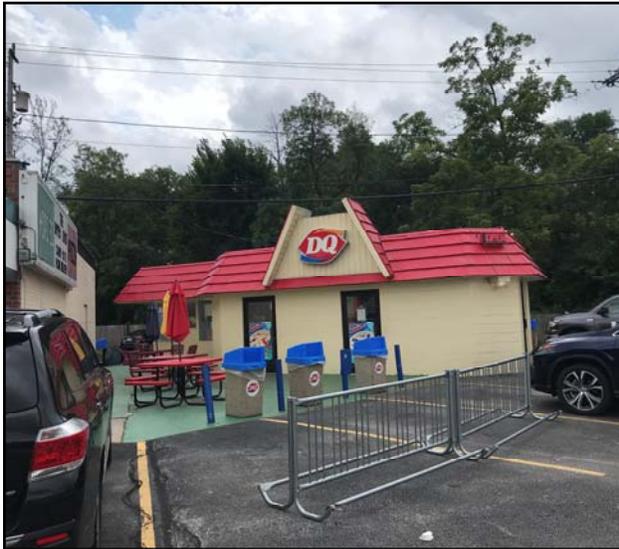
Photograph 2 - The subject property is located at 245 East Hampton Avenue in Milwaukee, Wisconsin. The subject property currently contains a Dairy Queen and an associated parking lot.

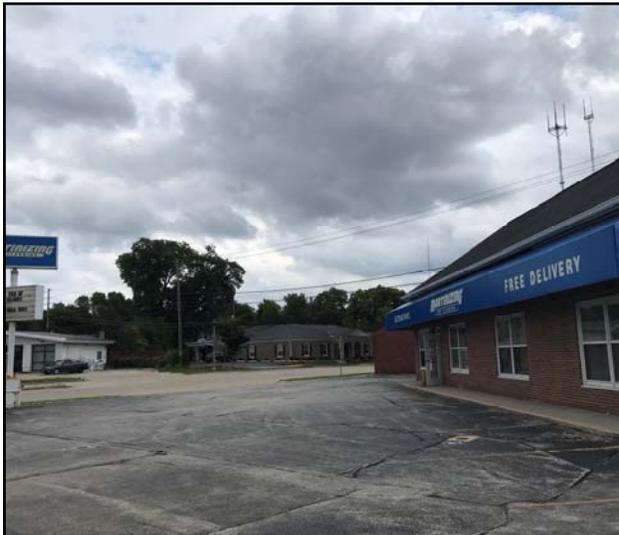
Photograph 3 - The northeast adjoining property (285 E Hampton Ave - One Hour Martinizing) is referenced on the DNR LUST/UST and was closed in 2017. The same property is an open ERP site.

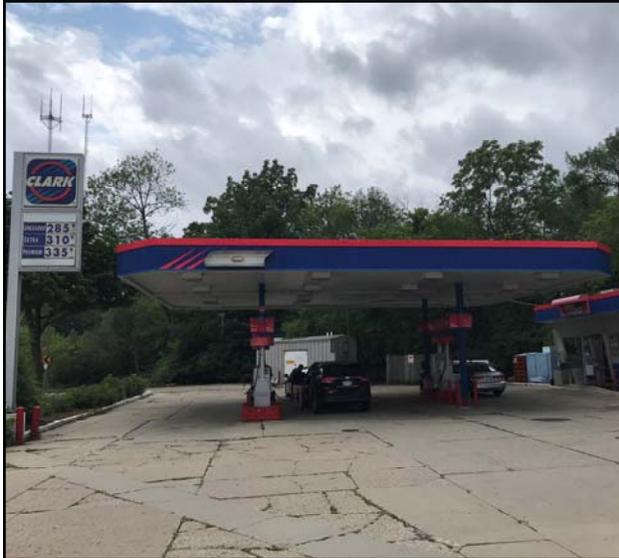
Photograph 4 - The southeast adjoining property (4751 N Santa Monica Blvd – Clark Oil Station) is referenced as a closed site on the DNR LUST/UST database.

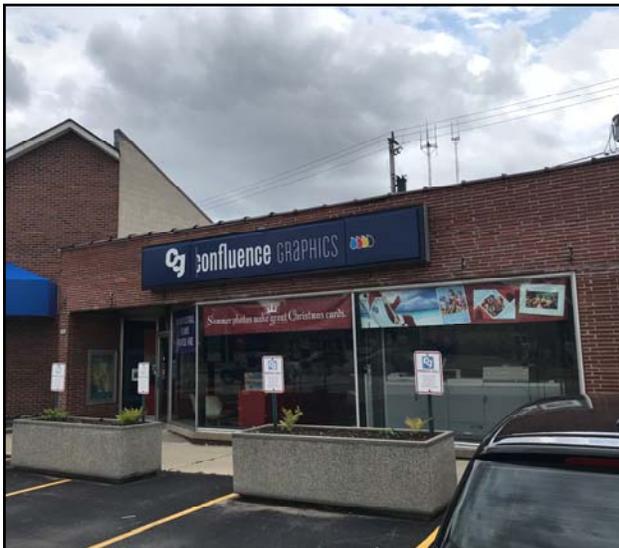
Photograph 5 - The east adjoining property.

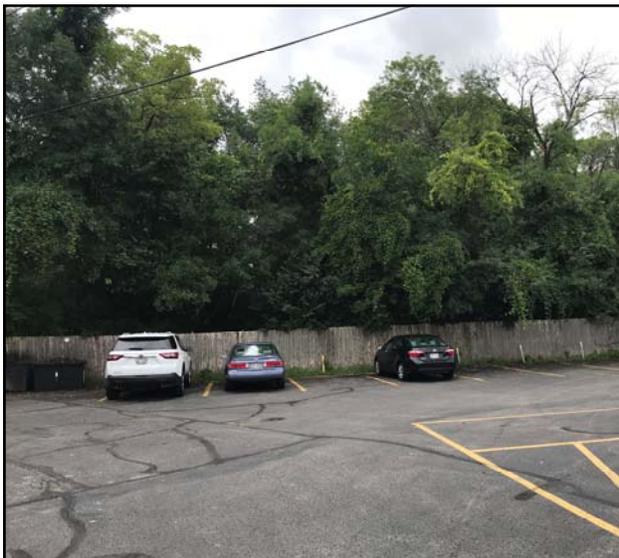
Photograph 6 - The southern parking lot of the building with the solid waste dumpsters.

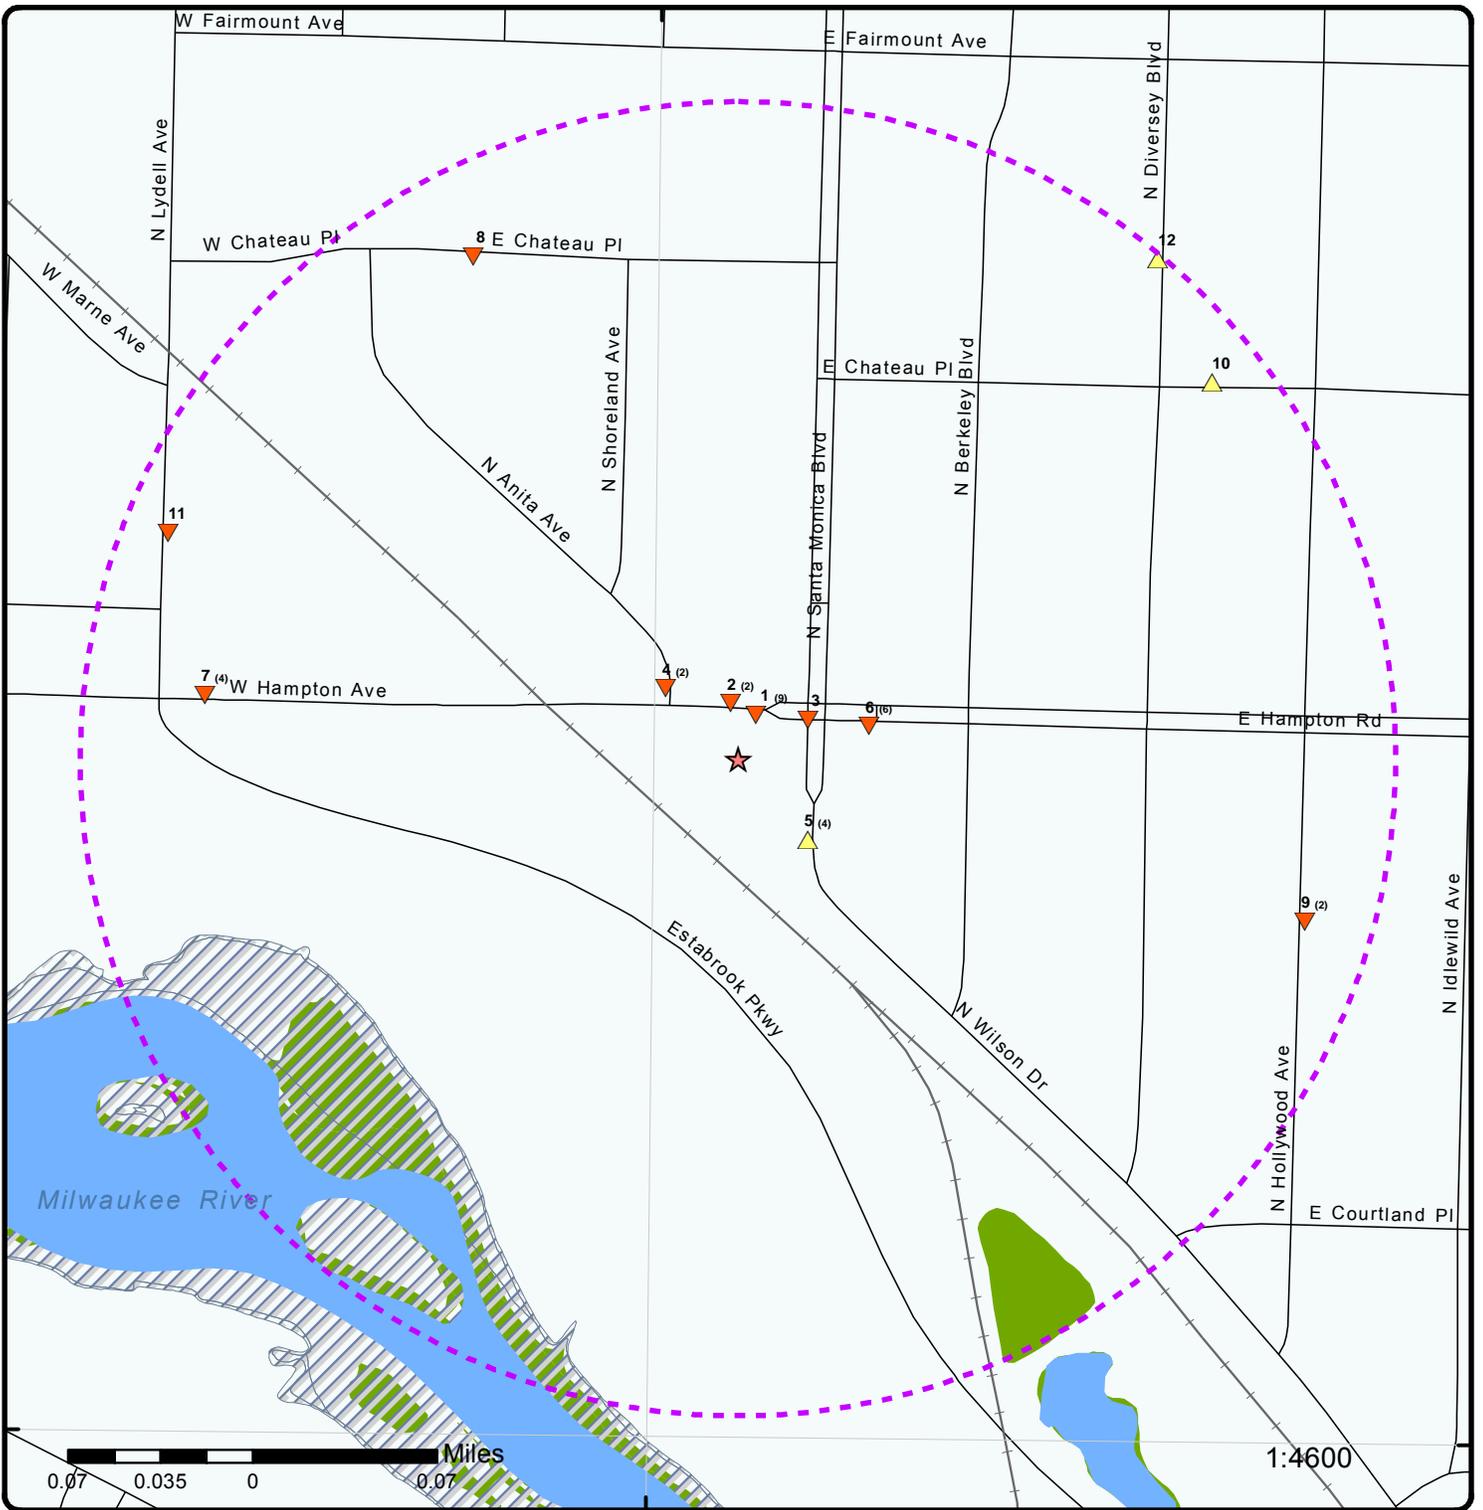
Map : 0.25 Mile Radius

A search of the DRYCLEANERS database, dated Jan 1, 2013 has found that there are 1 DRYCLEANERS site(s) within approximately 0.25 miles of the project property.

<u>Lower Elevation</u>	<u>Address</u>	<u>Direction</u>	<u>Distance (mi/ft)</u>	<u>Map Key</u>
One Hour Martinizing	285 E Hampton Avenue Milwaukee WI 53217	NNE	0.02 / 95.51	1
