Off-Site Liability Exemption and Liability Clarification Application

FIGURE 1
SITE LOCATION MAP
249 EAST HAMPTON AVENUE
MILWAUKEE, WISCONSIN

Phase I Environmental Site Assessment
245-261 East Hampton Avenue
Milwaukee, Wisconsin

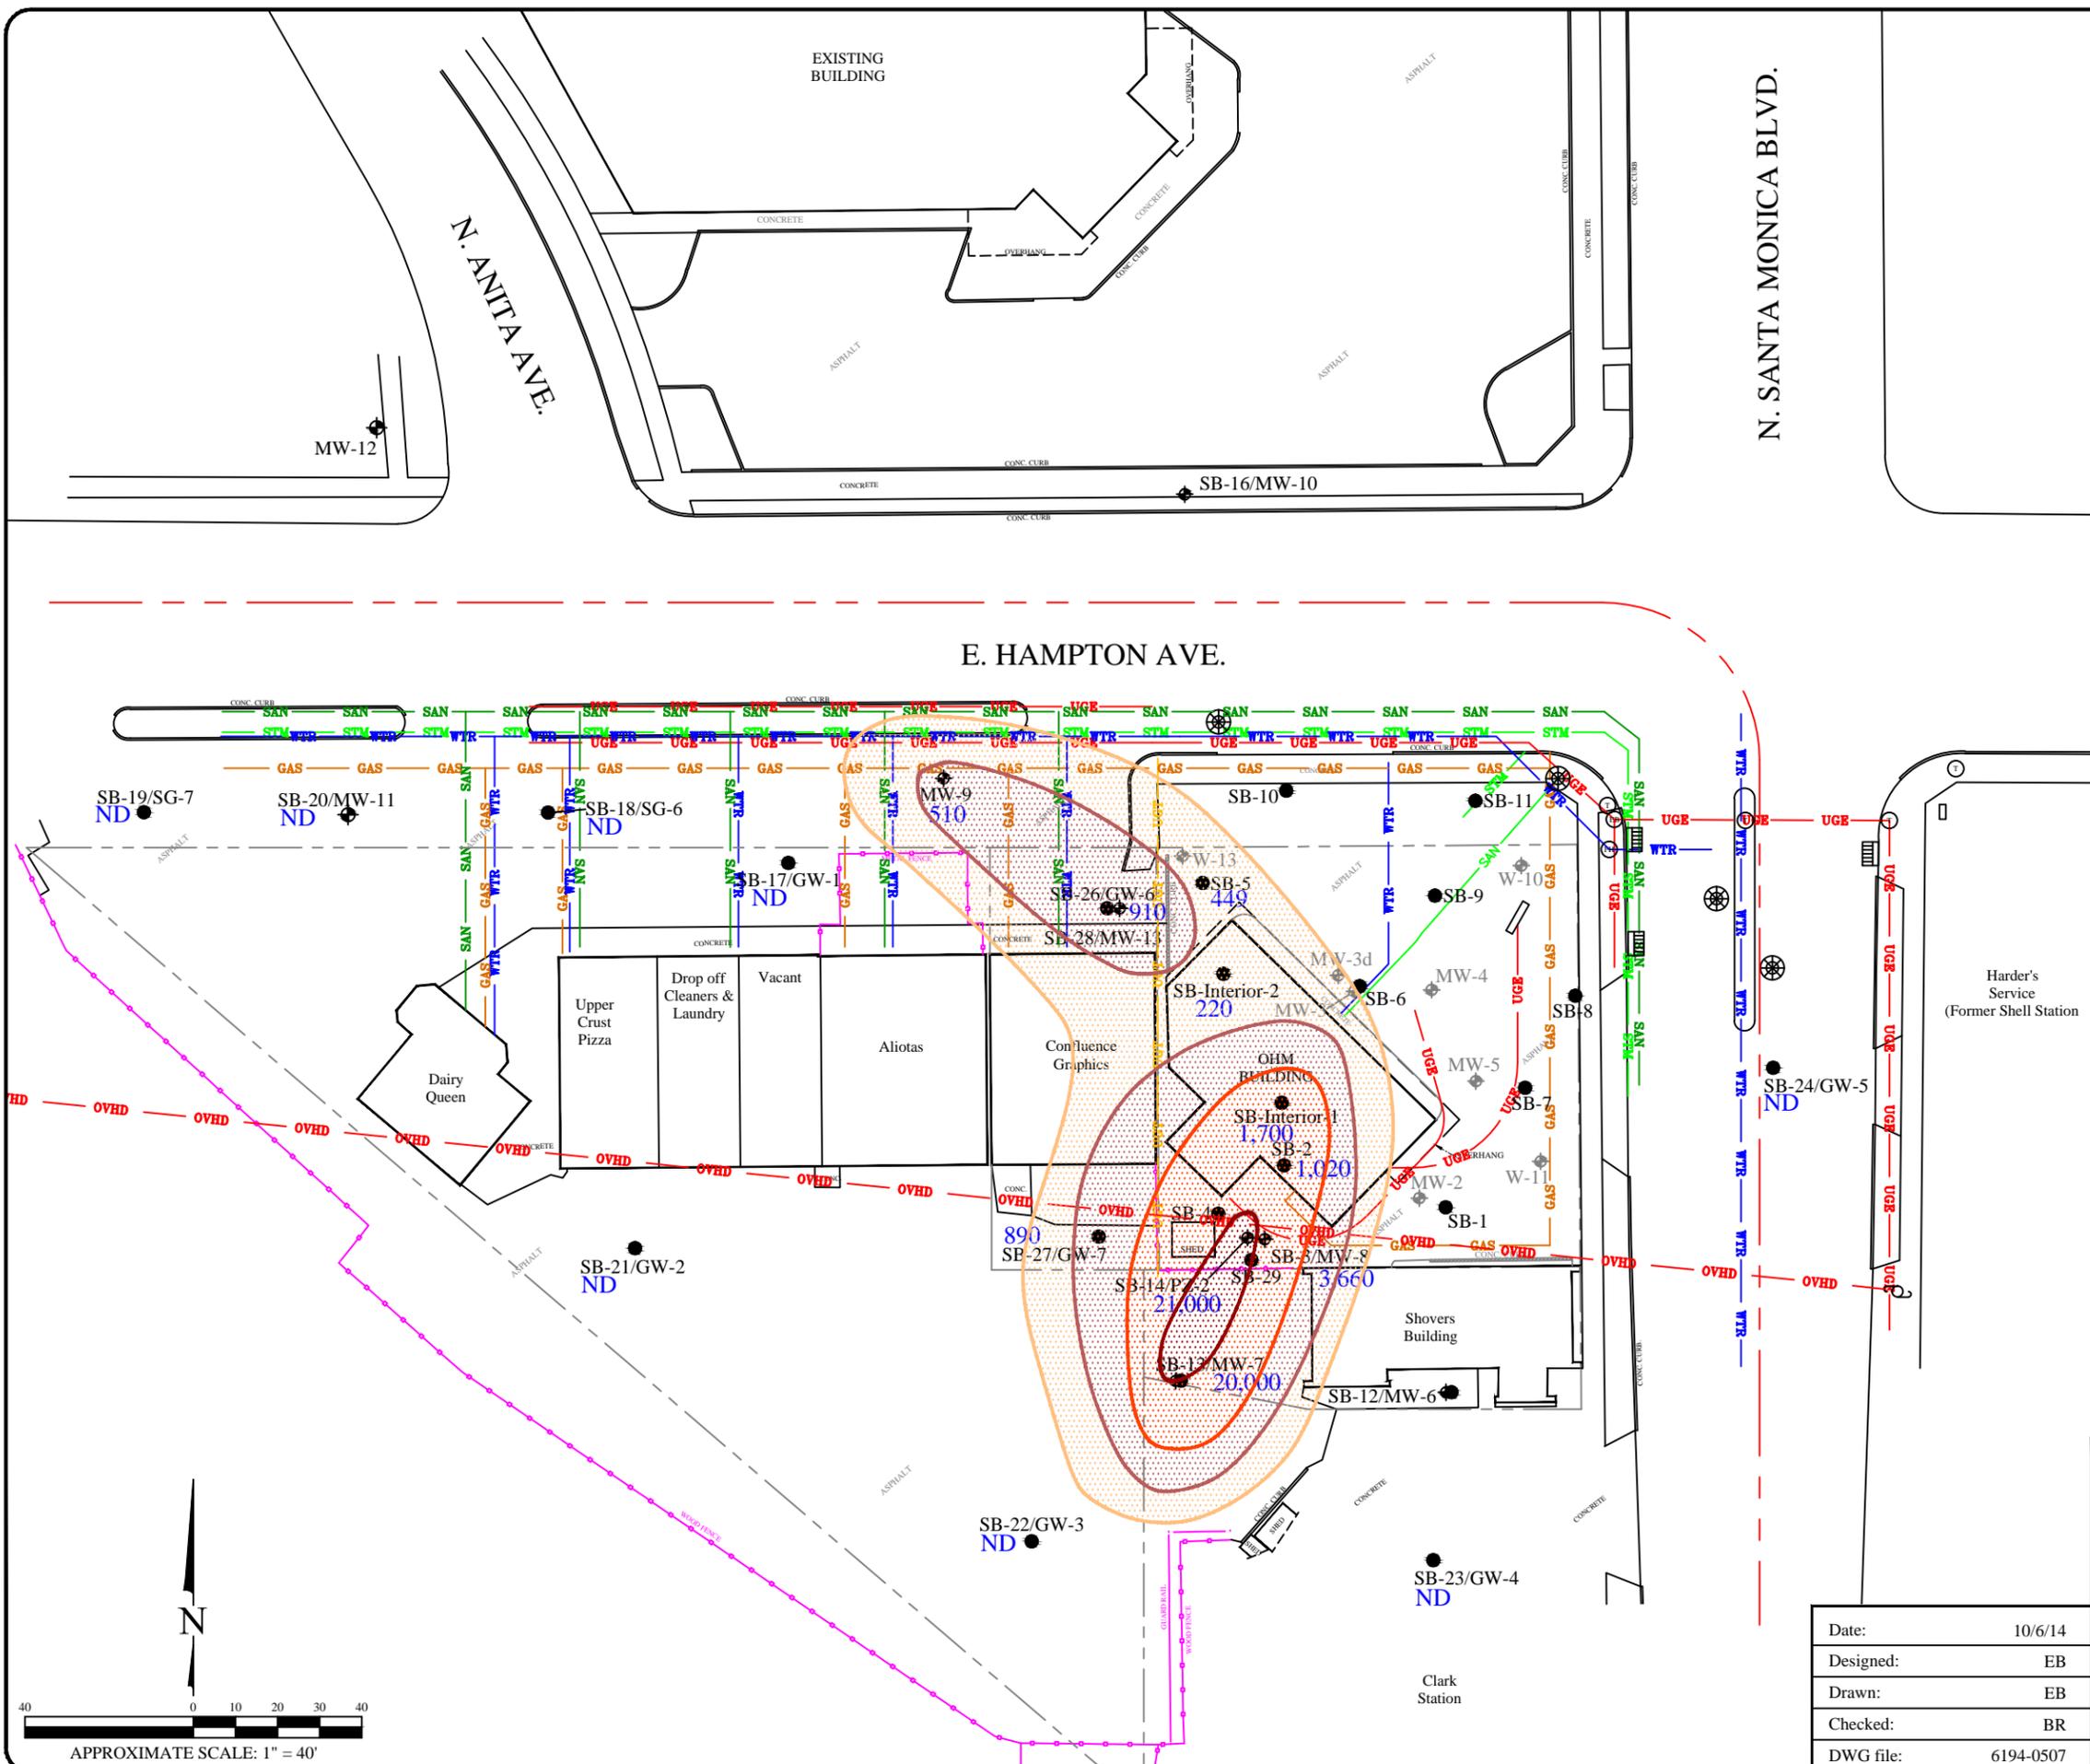
PCE IN SOIL ISCONCENTRATION MAP	
One Hour Martinizing Facility 285 East Hampton Avenue Milwaukee, Wisconsin	
	Figure 11
ENVIRONMENTAL FORENSIC INVESTIGATIONS, INC. 602 N. Capitol Ave., Ste. 210 • Indianapolis, IN 46204 EnviroForensics.com	
Date: 10/6/14 Designed: EB Drawn: EB Checked: BR DWG file: 6194-0507	Project 6194

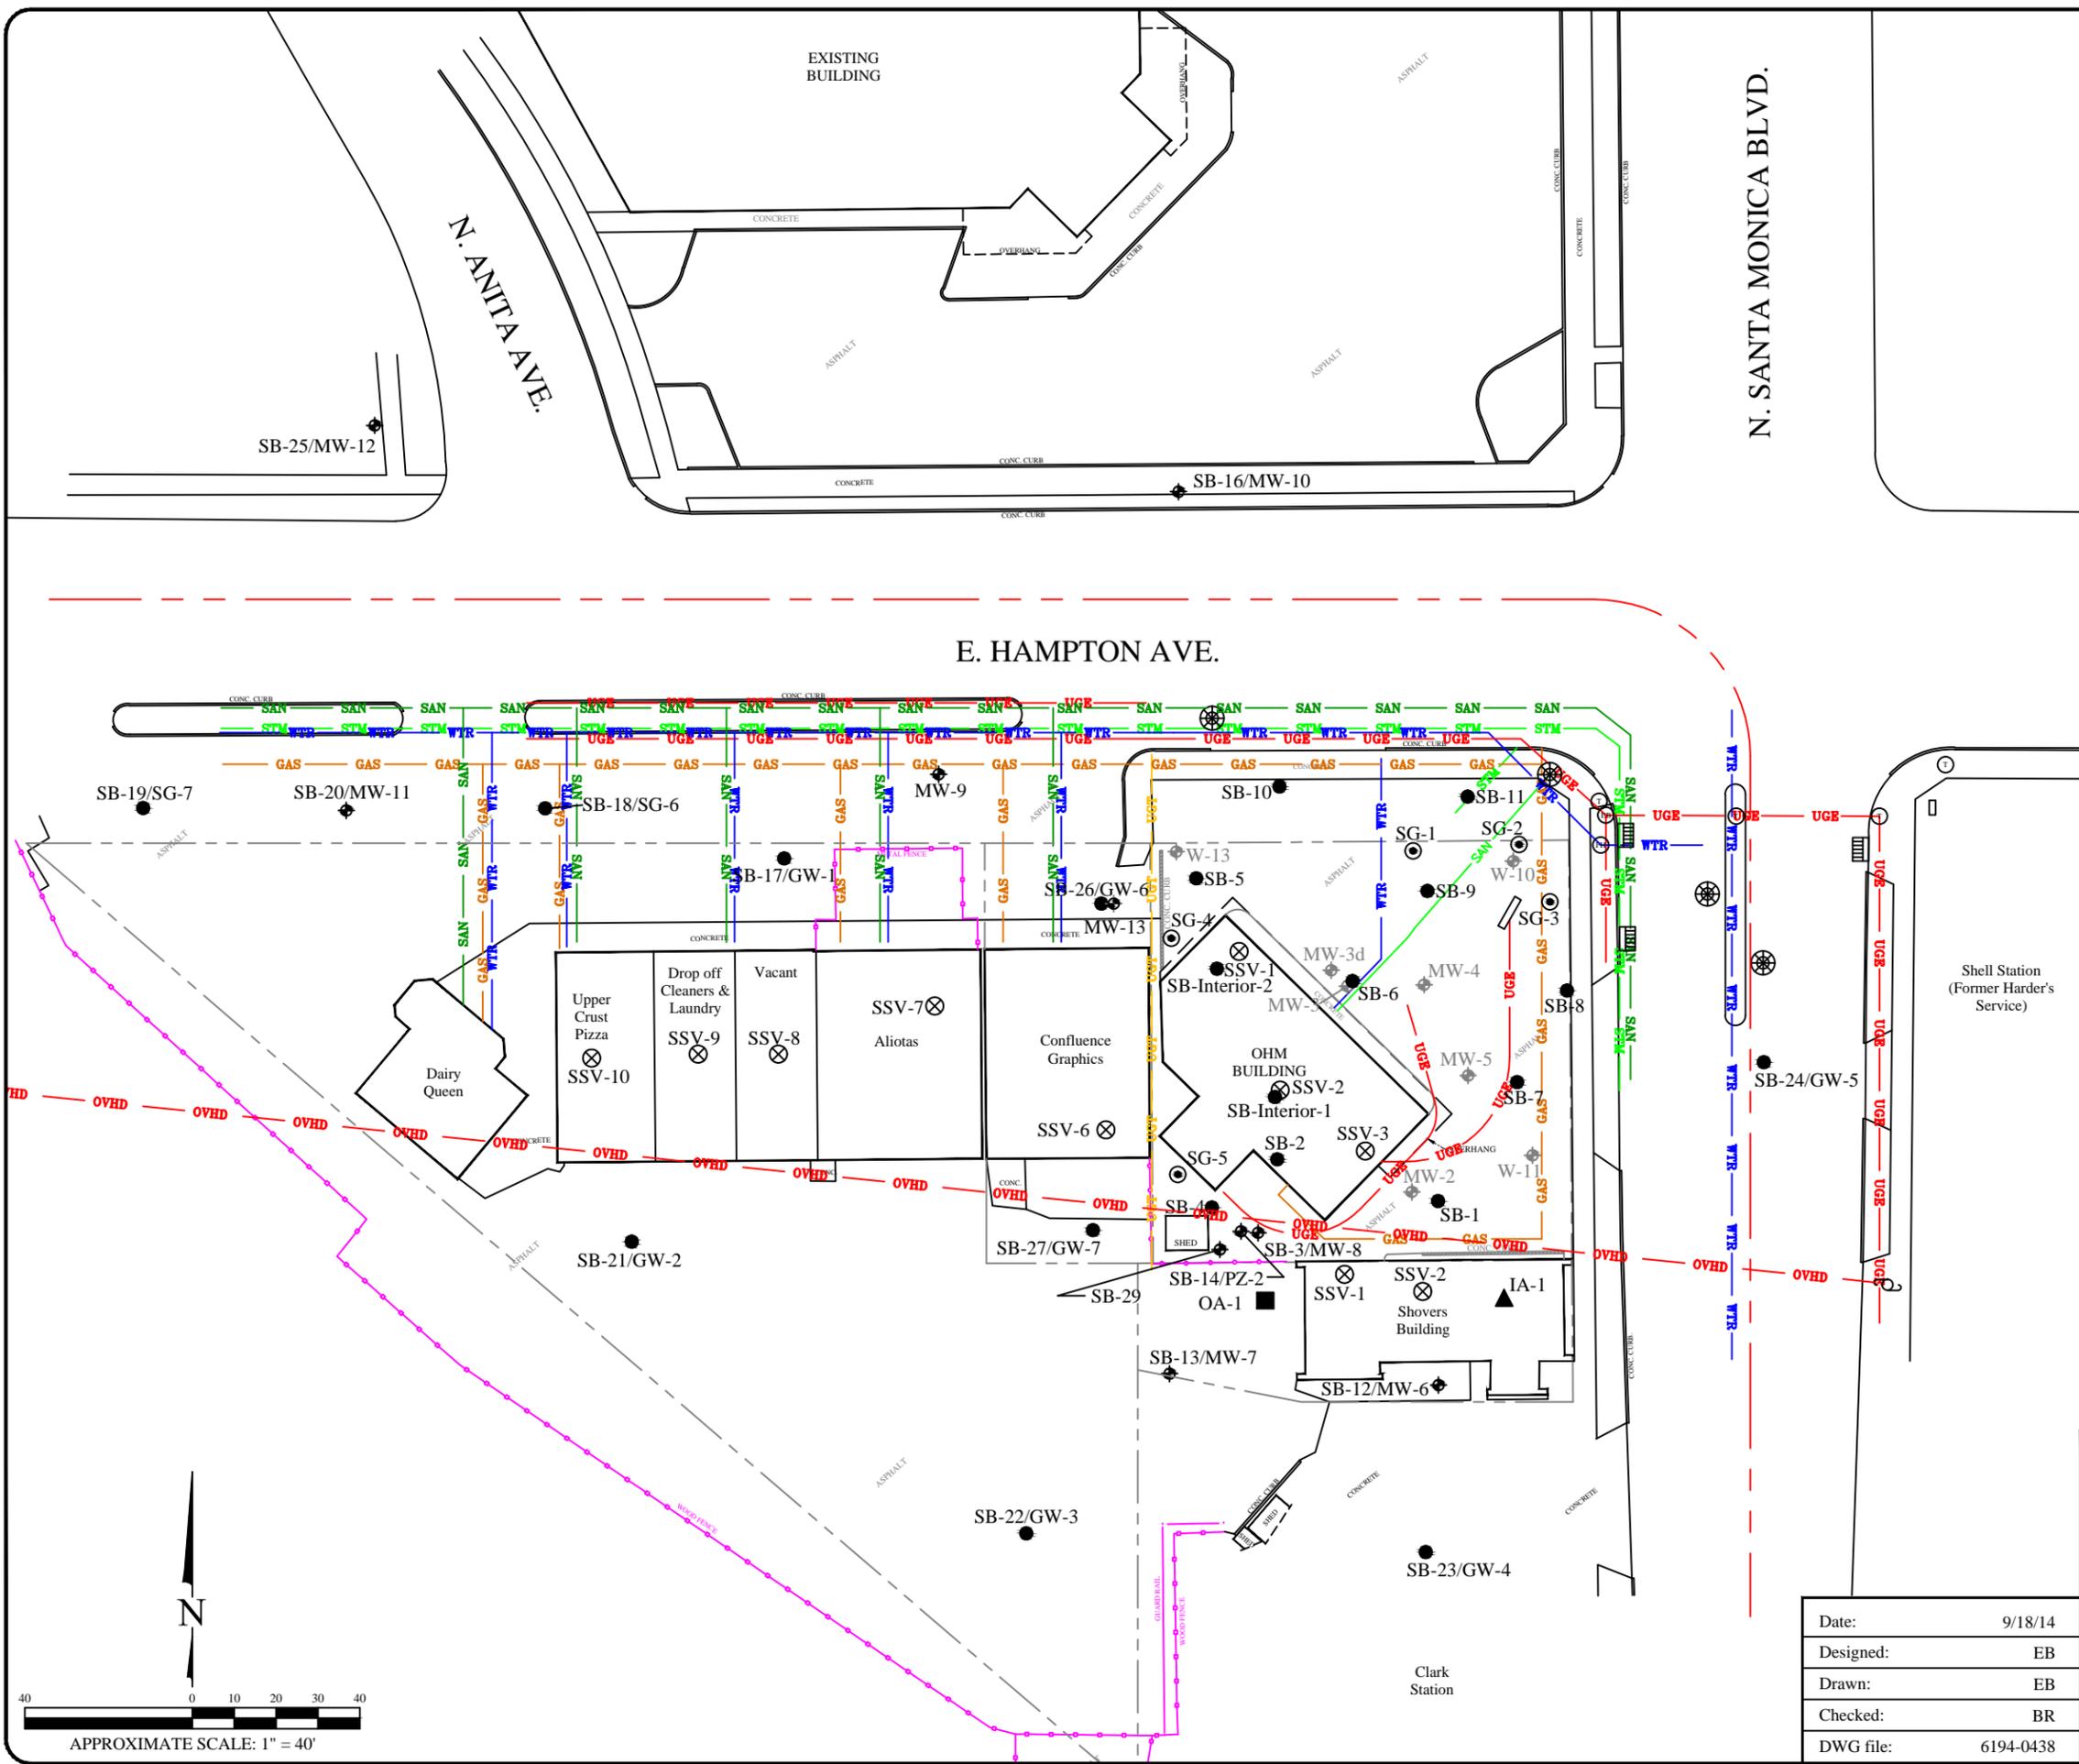
SITE PLAN											
One Hour Martinizing Facility 285 East Hampton Avenue Milwaukee, Wisconsin											
	Figure 2										
ENVIRONMENTAL FORENSIC INVESTIGATIONS, INC. 602 N. Capitol Ave., Ste. 210 • Indianapolis, IN 46204 EnviroForensics.com

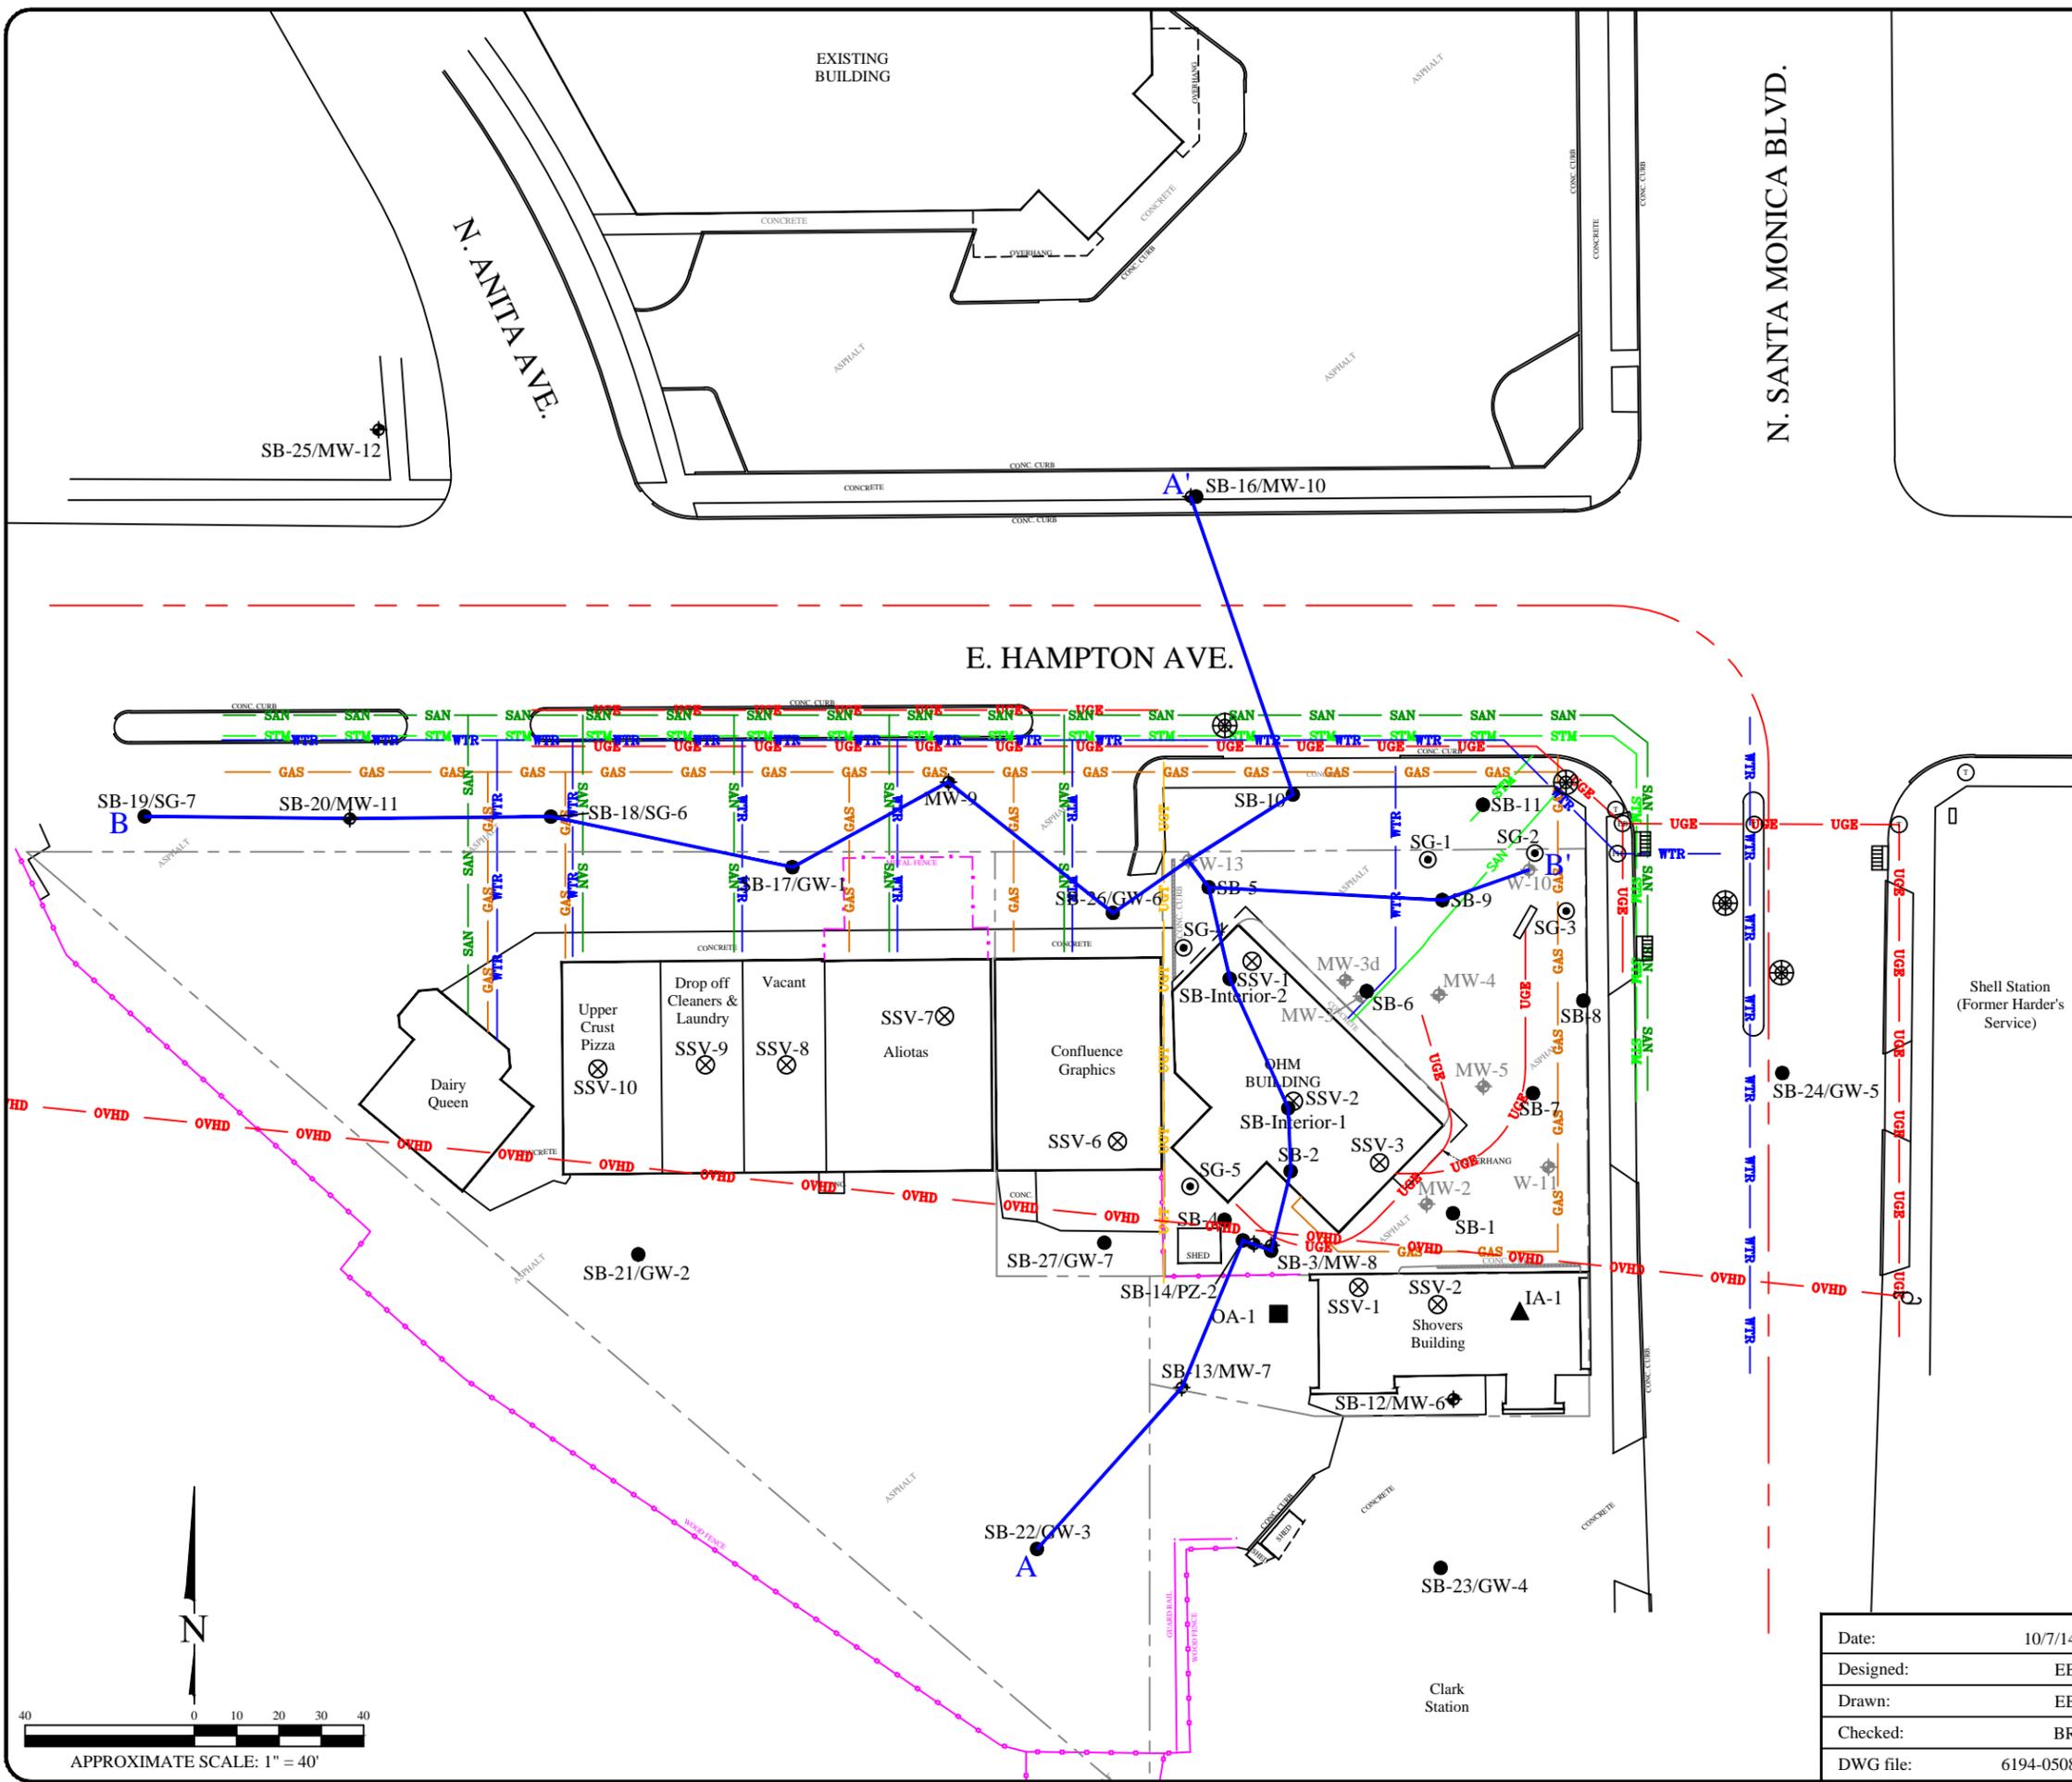
Figure	3
Project	6194

**GEOLOGIC CROSS SECTION TRANSECT MAP
A-A' AND B-B'**

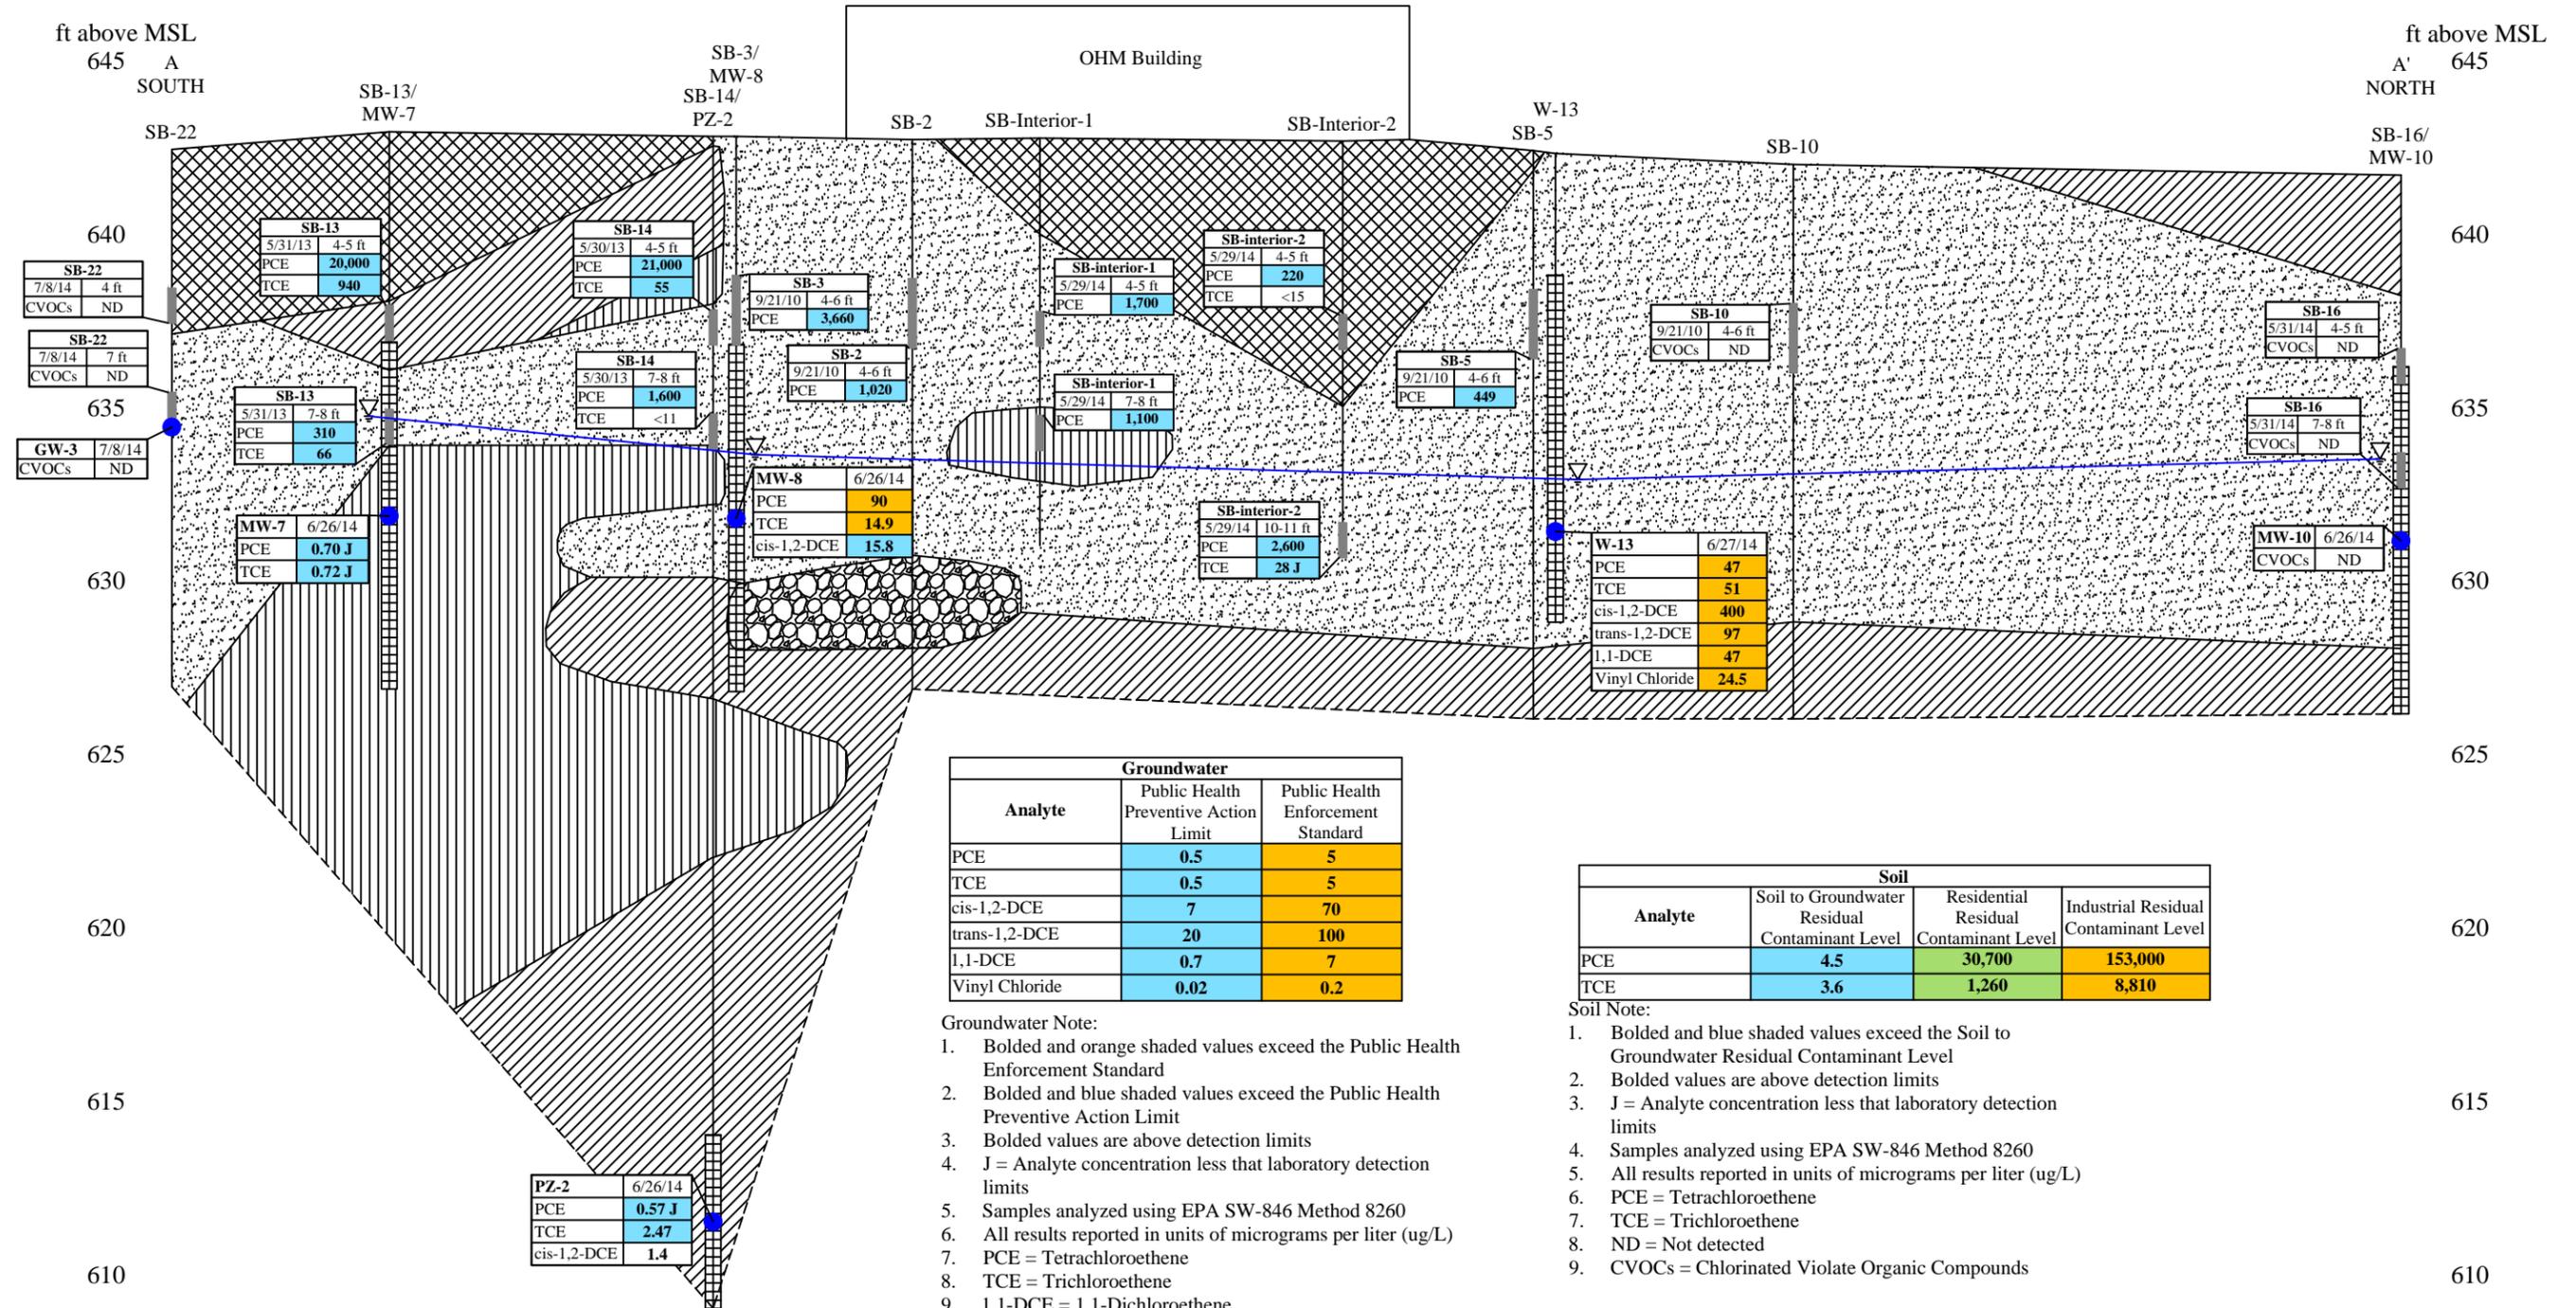
Figure	4
Project	6194

- Fill
- Sand
- Clay
- Silt
- Gravel
- Observed groundwater elevation on June 26, 2014
- Monitoring well screen
- Dashed boundaries are inferred
- ft above MSL = Feet above Mean Sea Level
- Soil sample depth interval
- Groundwater sample depth interval

GEOLOGIC CROSS SECTION SHOWING DATA POINTS WITH SOIL AND GROUNDWATER ANALYTICAL RESULTS

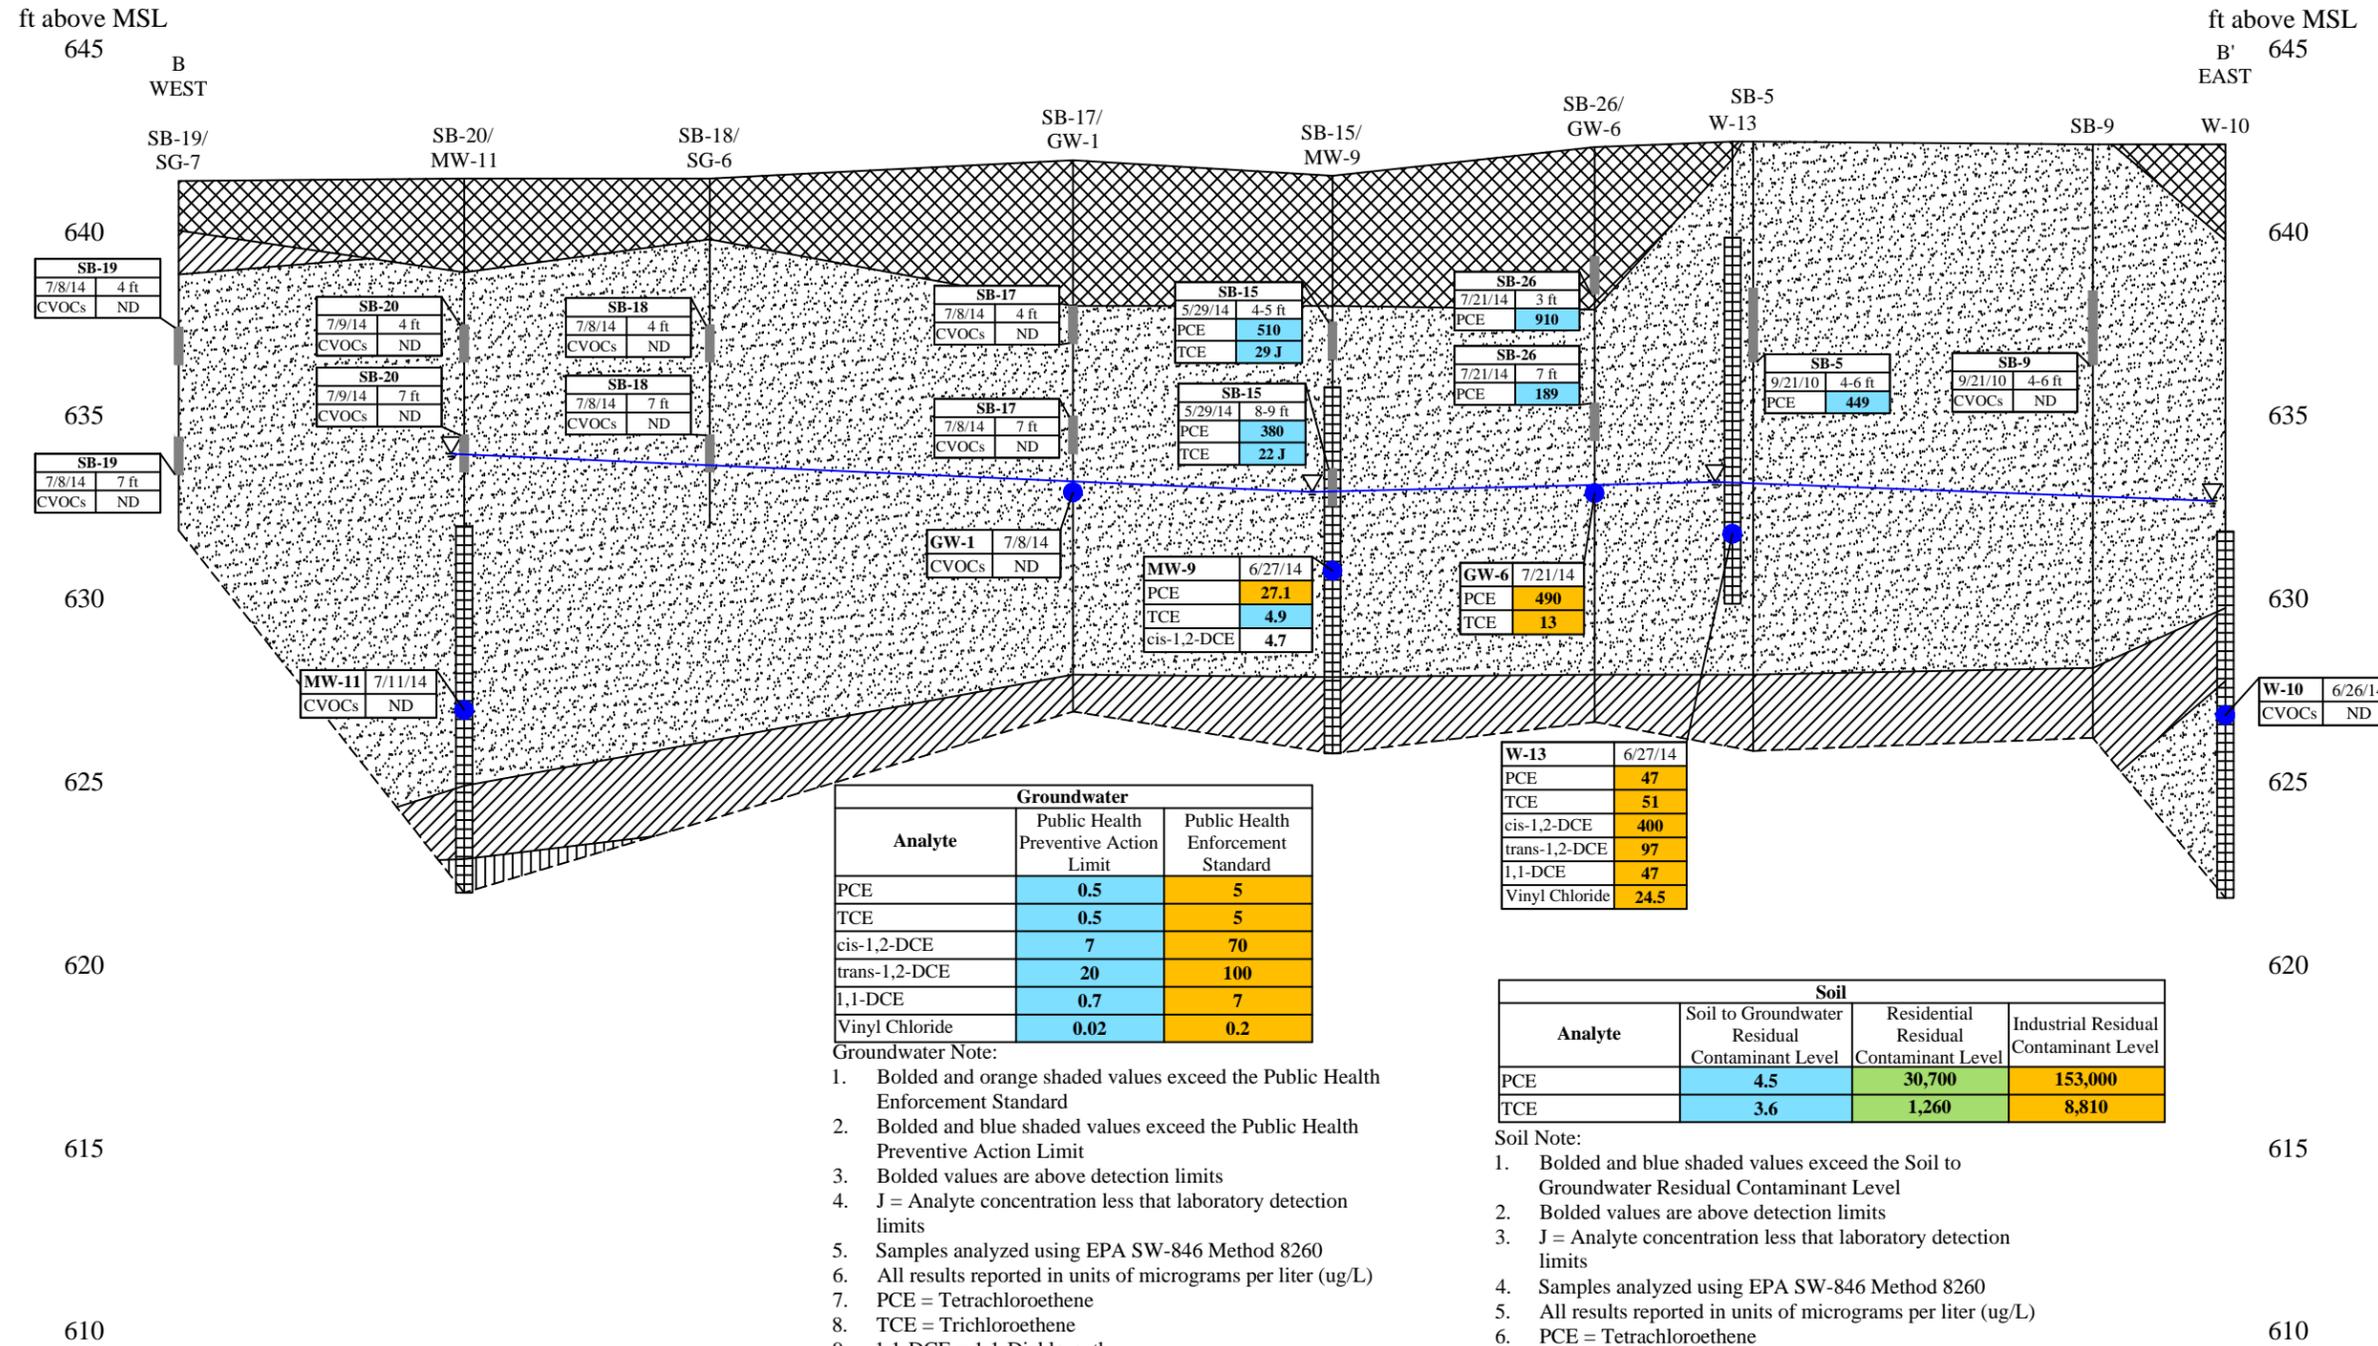
- Fill
- Sand
- Clay
- Silt
- Gravel
- Observed groundwater elevation on June 26, 2014
- Monitoring well screen
- Dashed boundaries are inferred
- ft above MSL = Feet above Mean Sea Level
- Soil sample depth interval
- Groundwater sample depth interval

GEOLOGIC CROSS SECTION SHOWING DATA POINTS WITH SOIL AND GROUNDWATER ANALYTICAL RESULTS

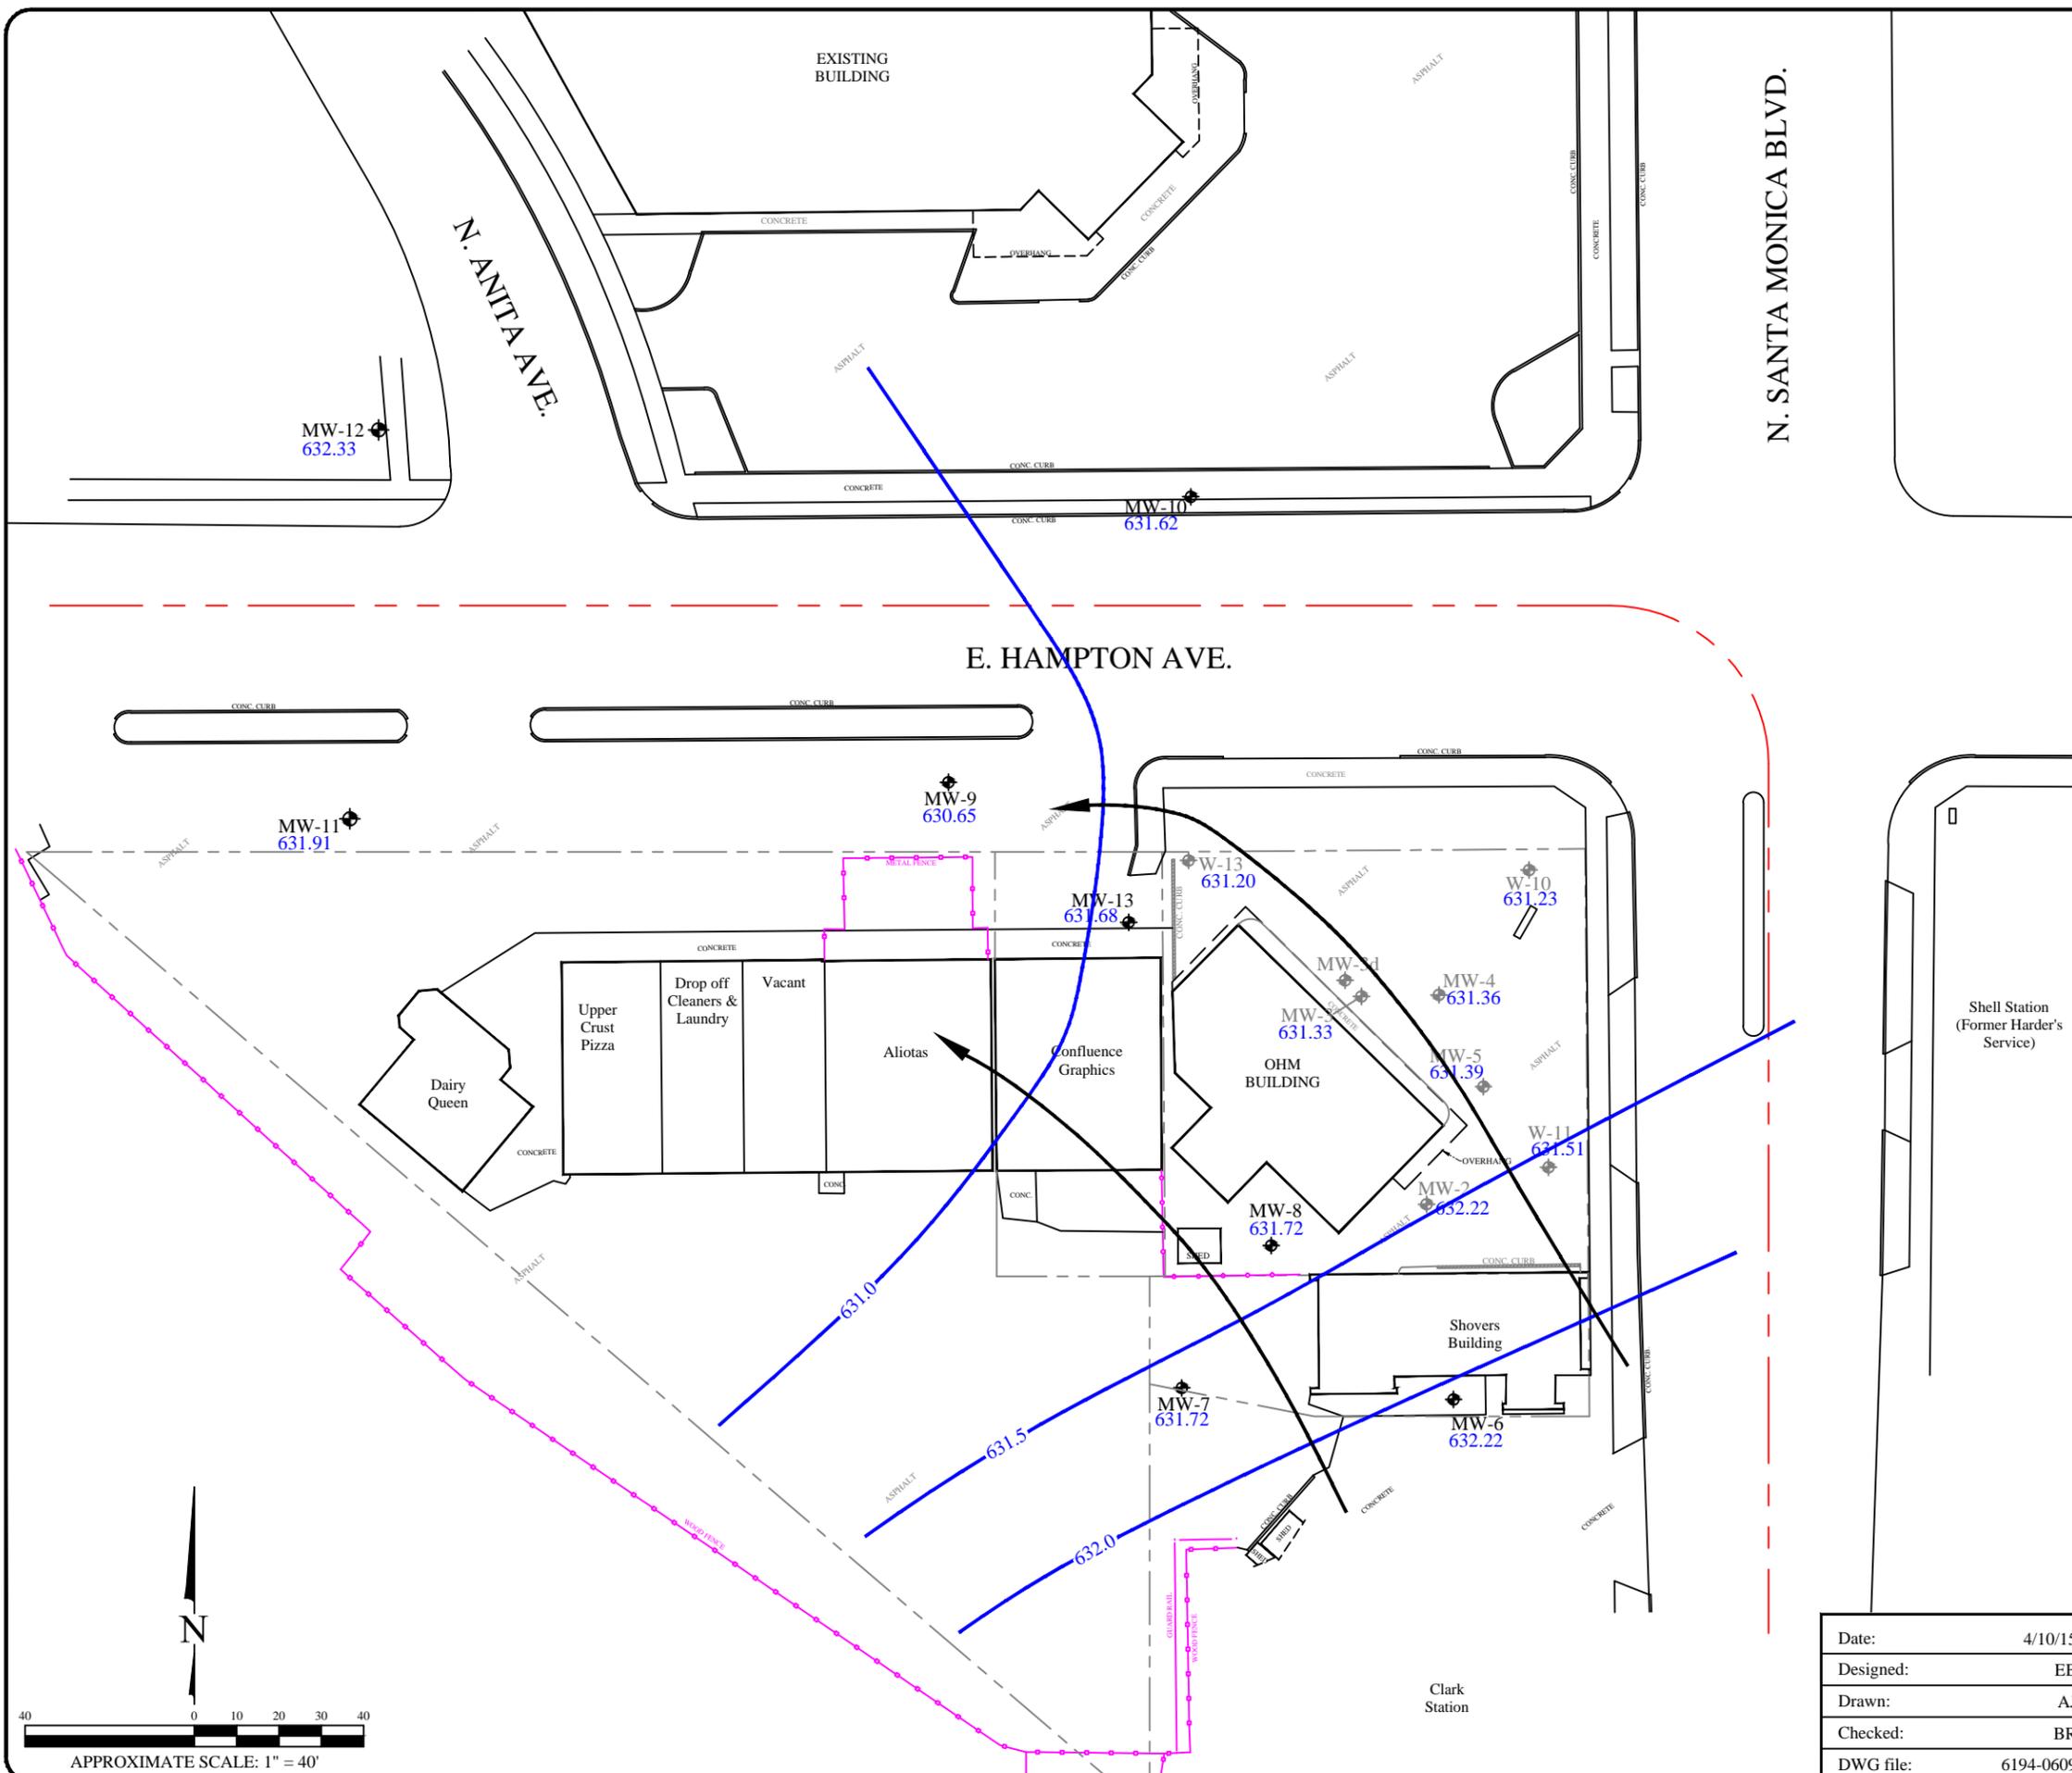
GROUNDWATER ELEVATION CONTOUR MAP MARCH 2014 One Hour Martinizing Facility 285 East Hampton Avenue Milwaukee, Wisconsin
