Off-Site Liability Exemption and Liability Clarification Application

FIGURE 1
SITE LOCATION MAP
249 EAST HAMPTON AVENUE
MILWAUKEE, WISCONSIN

Phase I Environmental Site Assessment
245-261 East Hampton Avenue
Milwaukee, Wisconsin

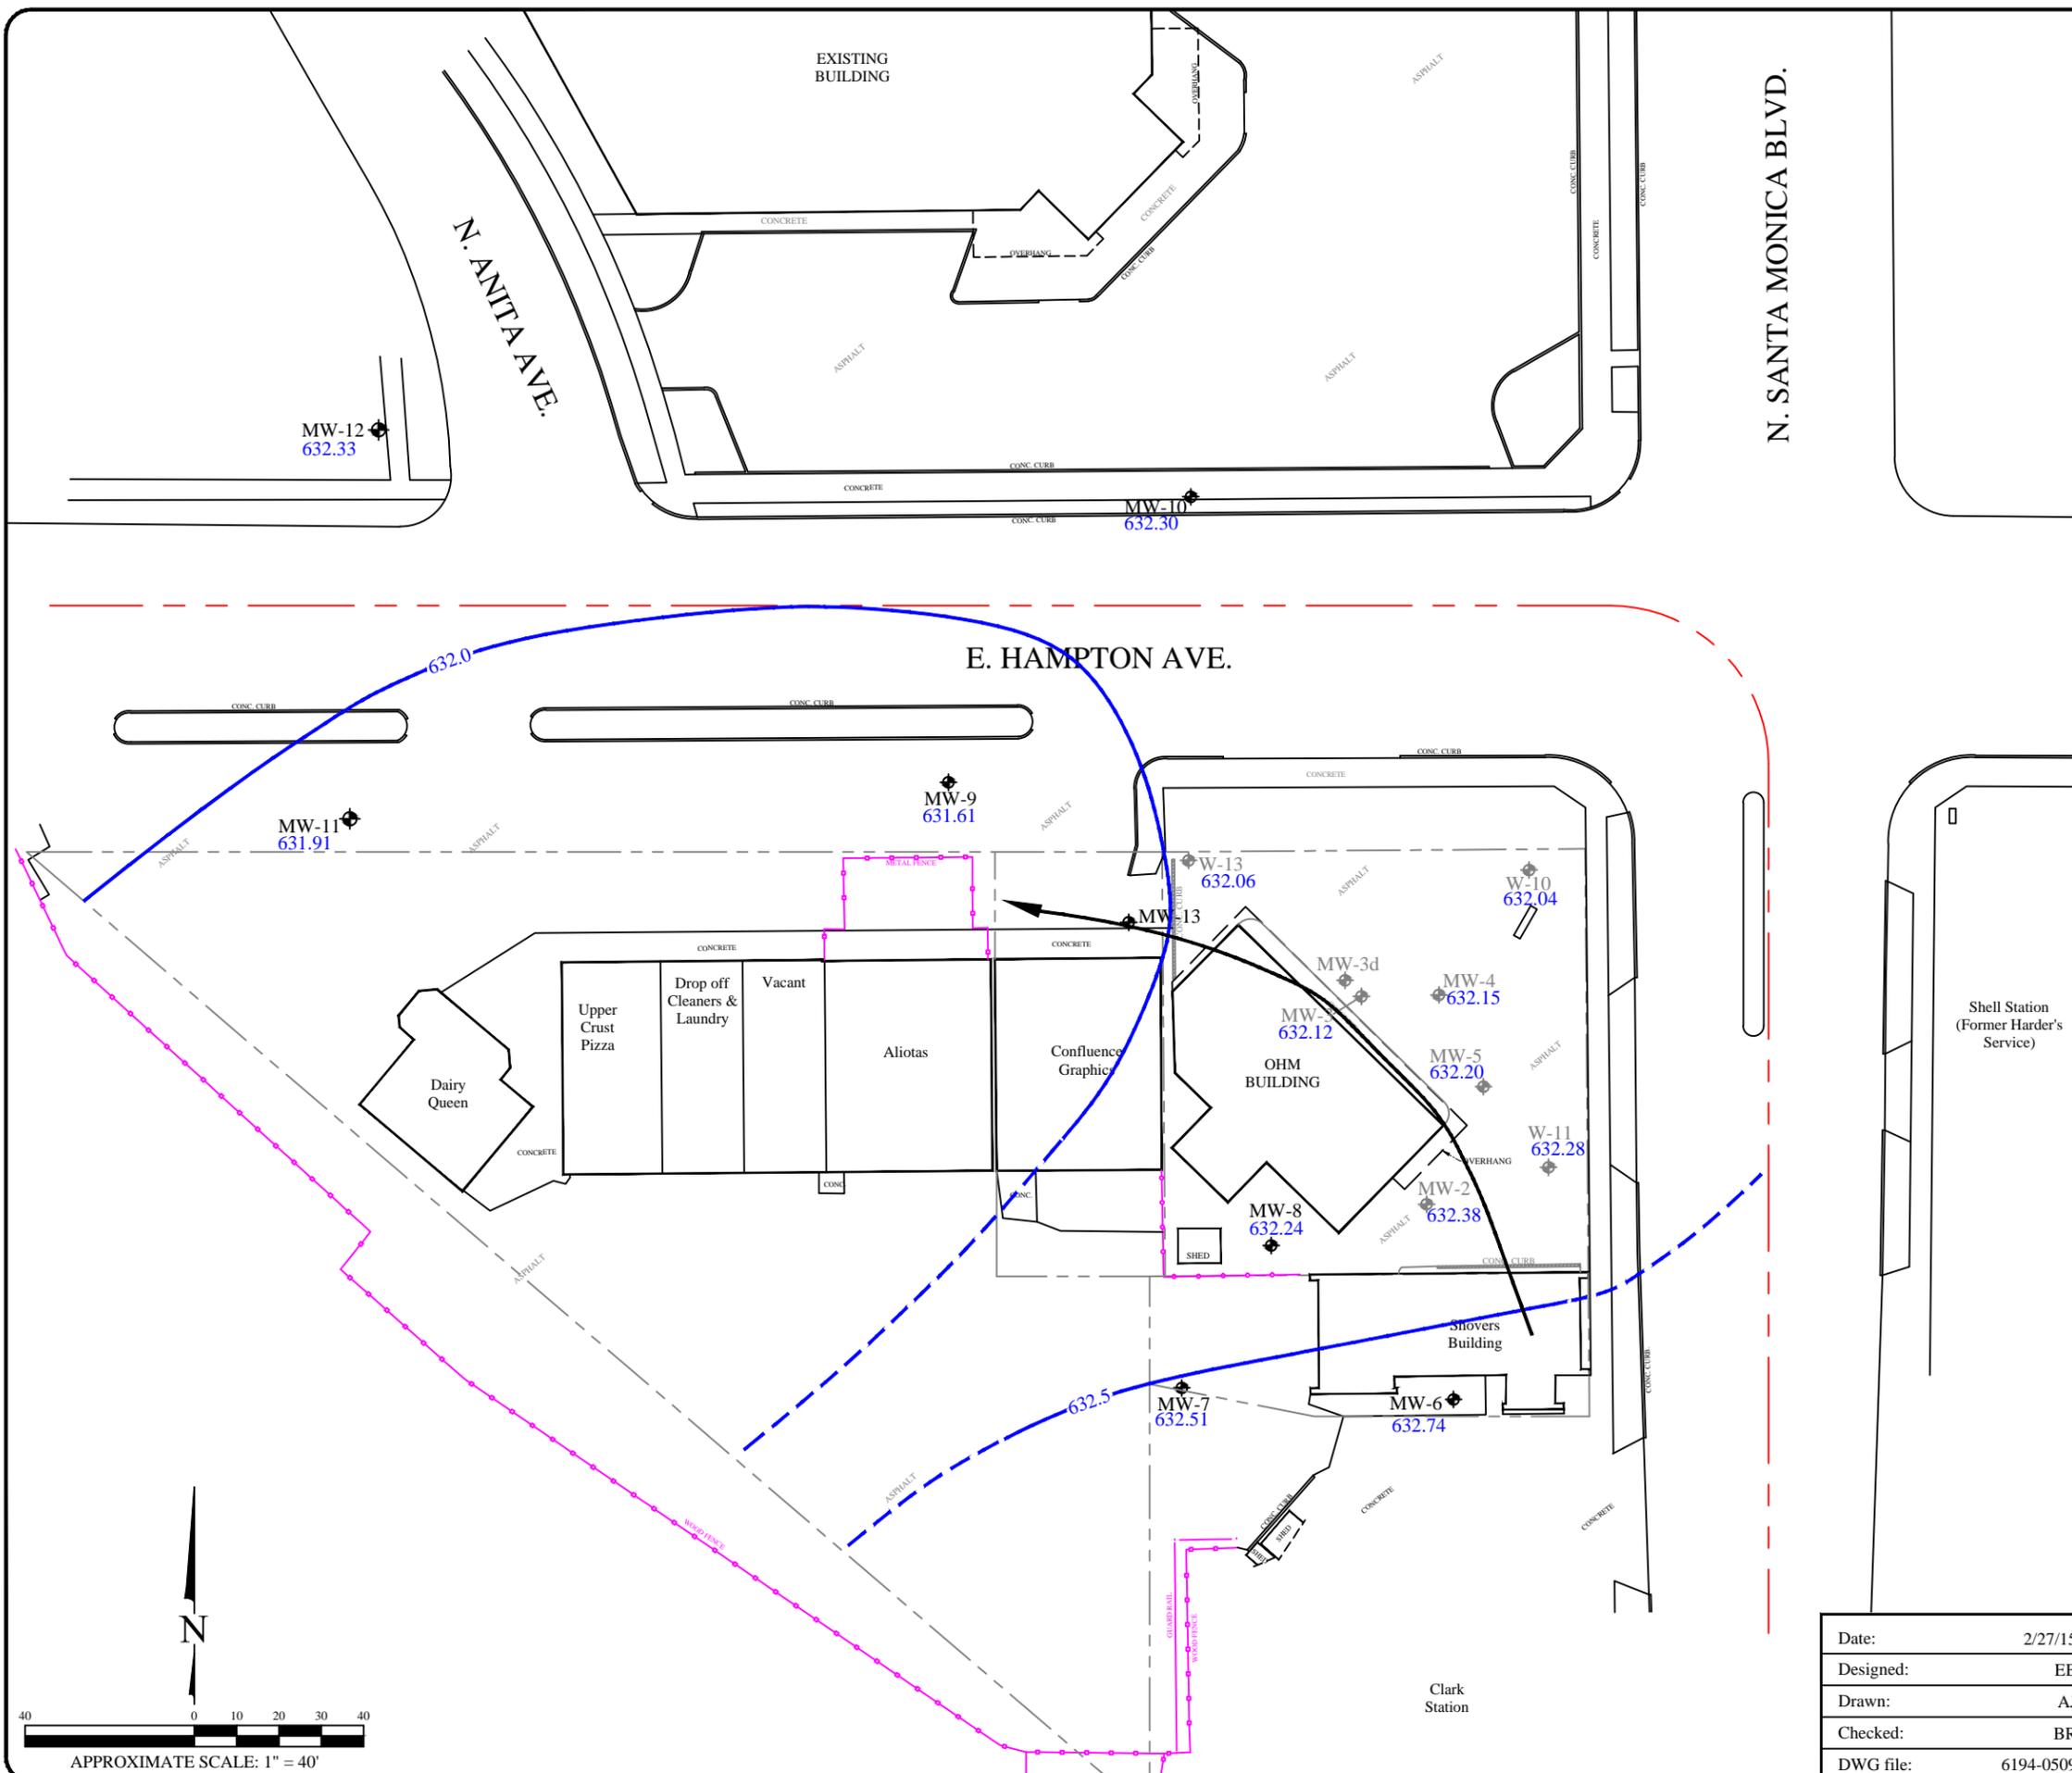
Figure	8
Project	6194

GROUNDWATER ELEVATION CONTOUR MAP
 OCTOBER 1, 2014
 One Hour Martinizing Facility
 285 East Hampton Avenue
 Milwaukee, Wisconsin

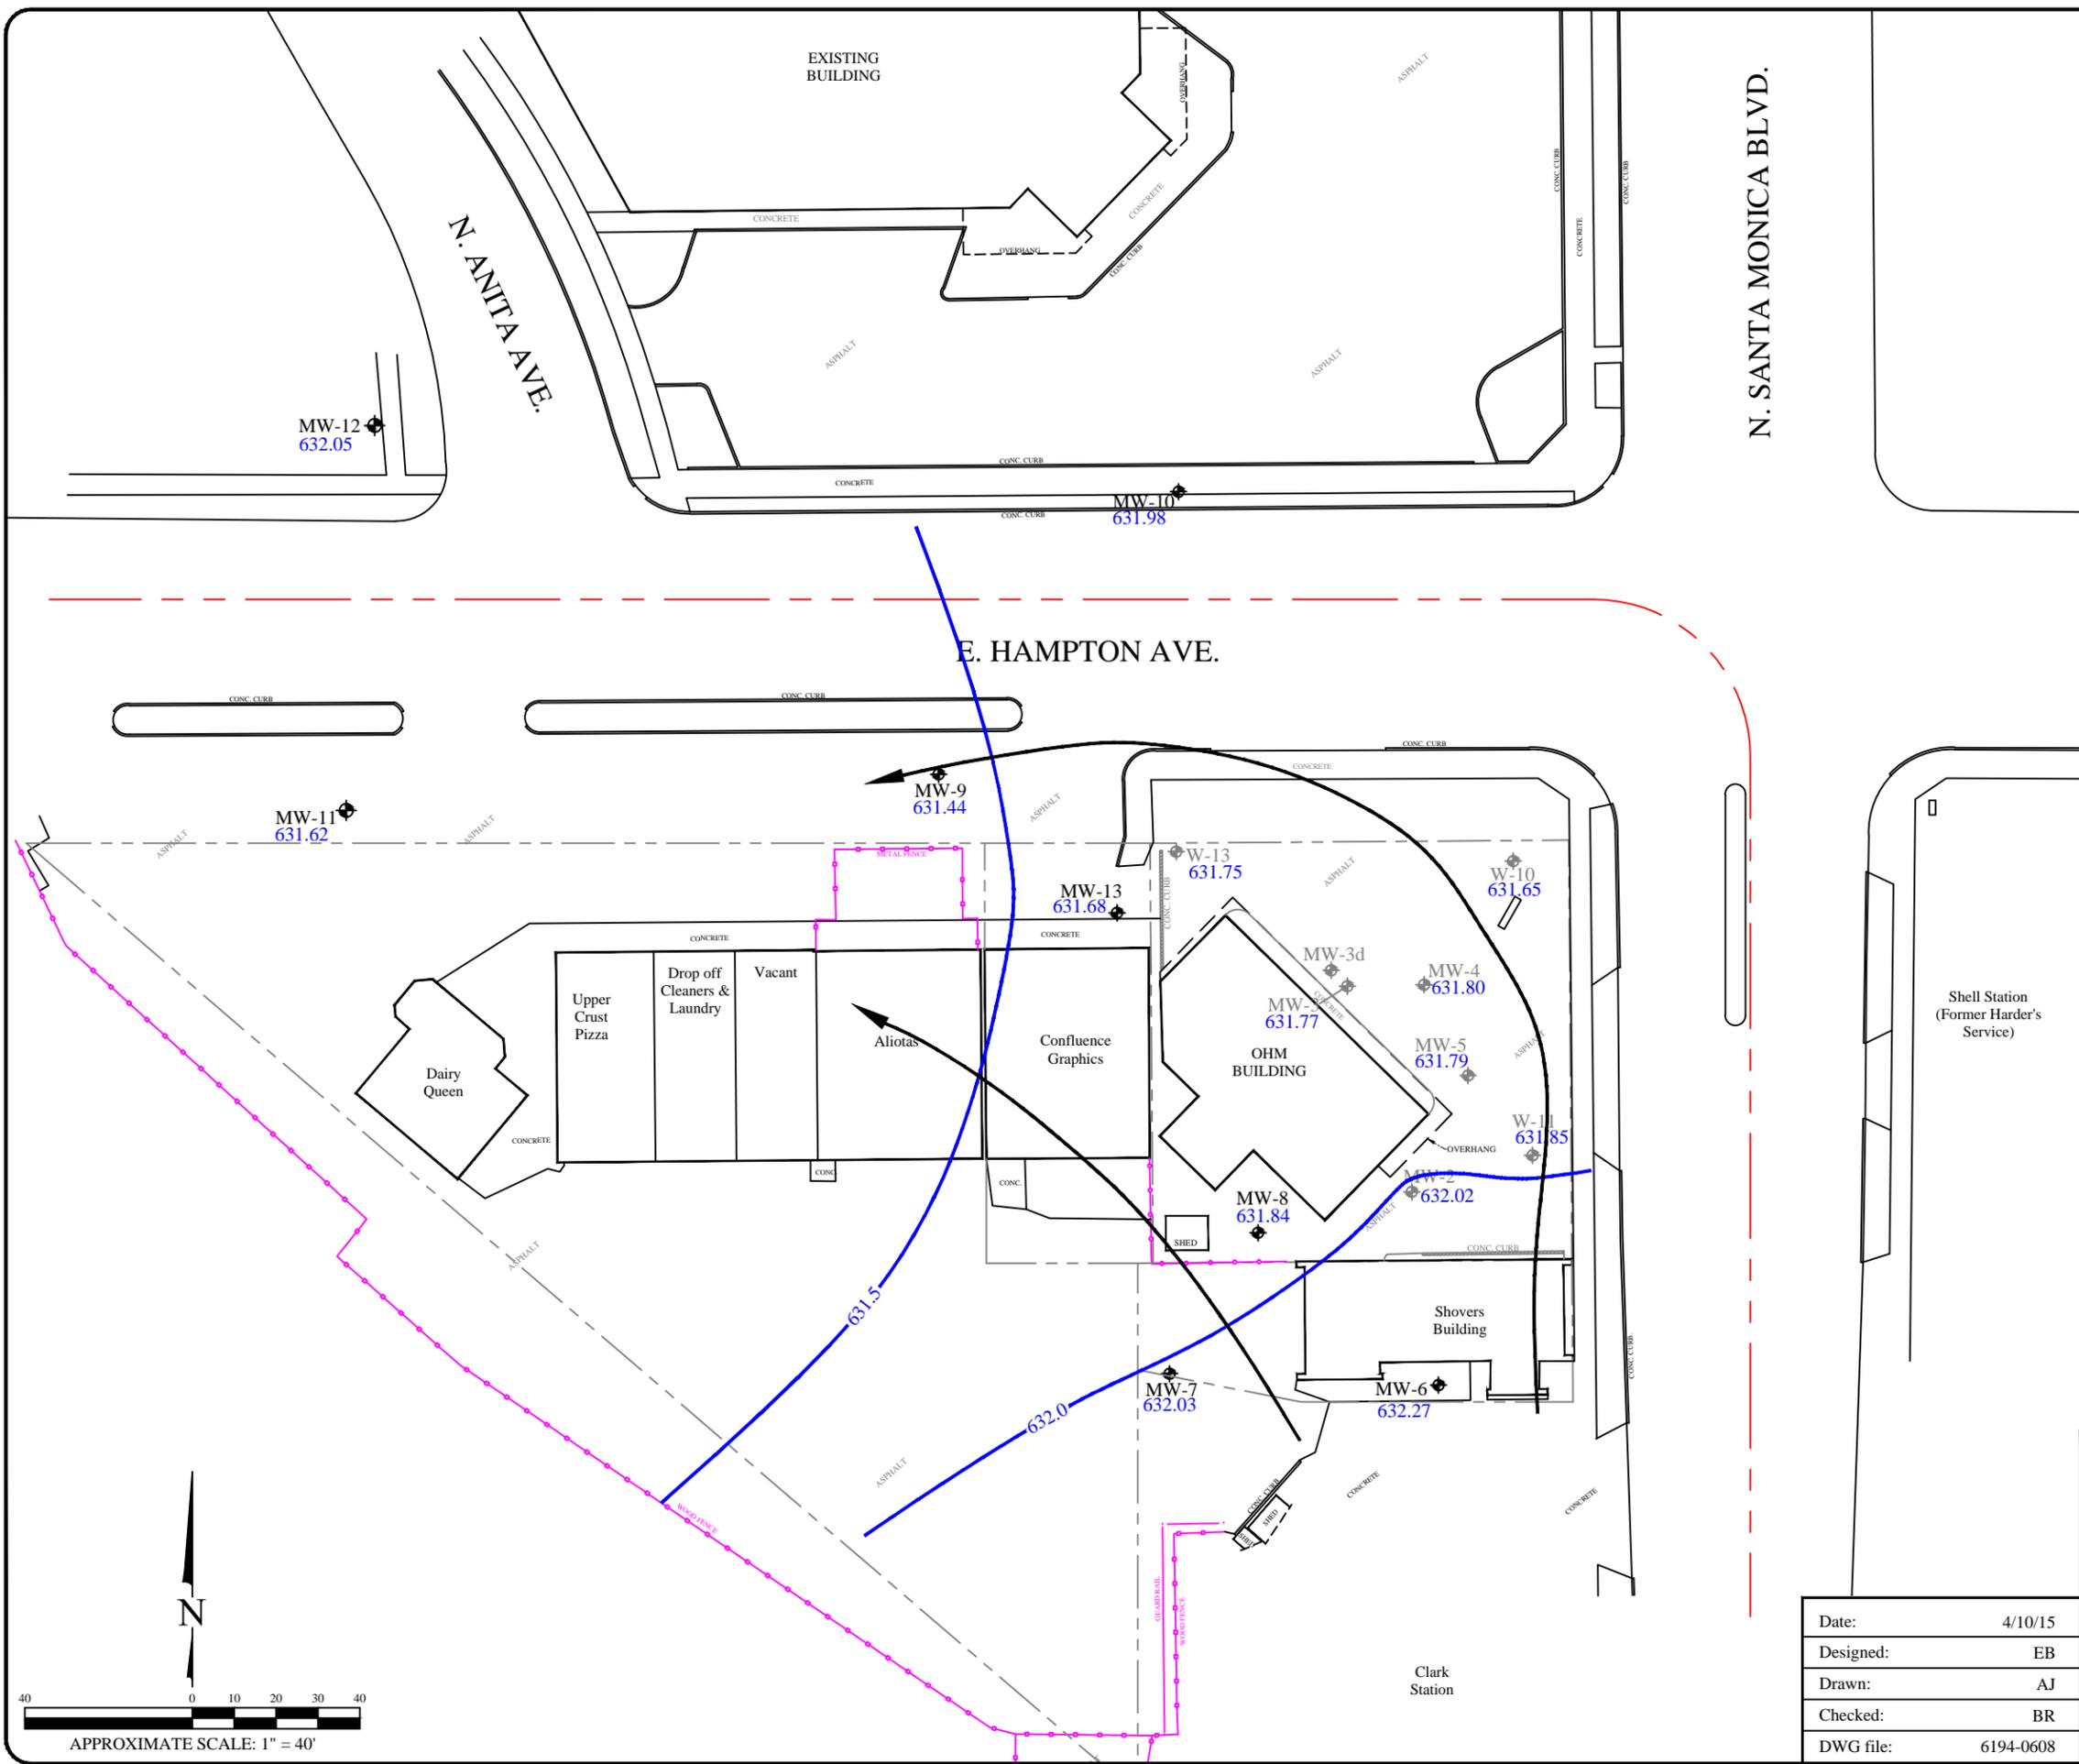
GROUNDWATER ELEVATION CONTOUR MAP
DECEMBER 2014
One Hour Martinizing Facility
285 East Hampton Avenue
Milwaukee, Wisconsin

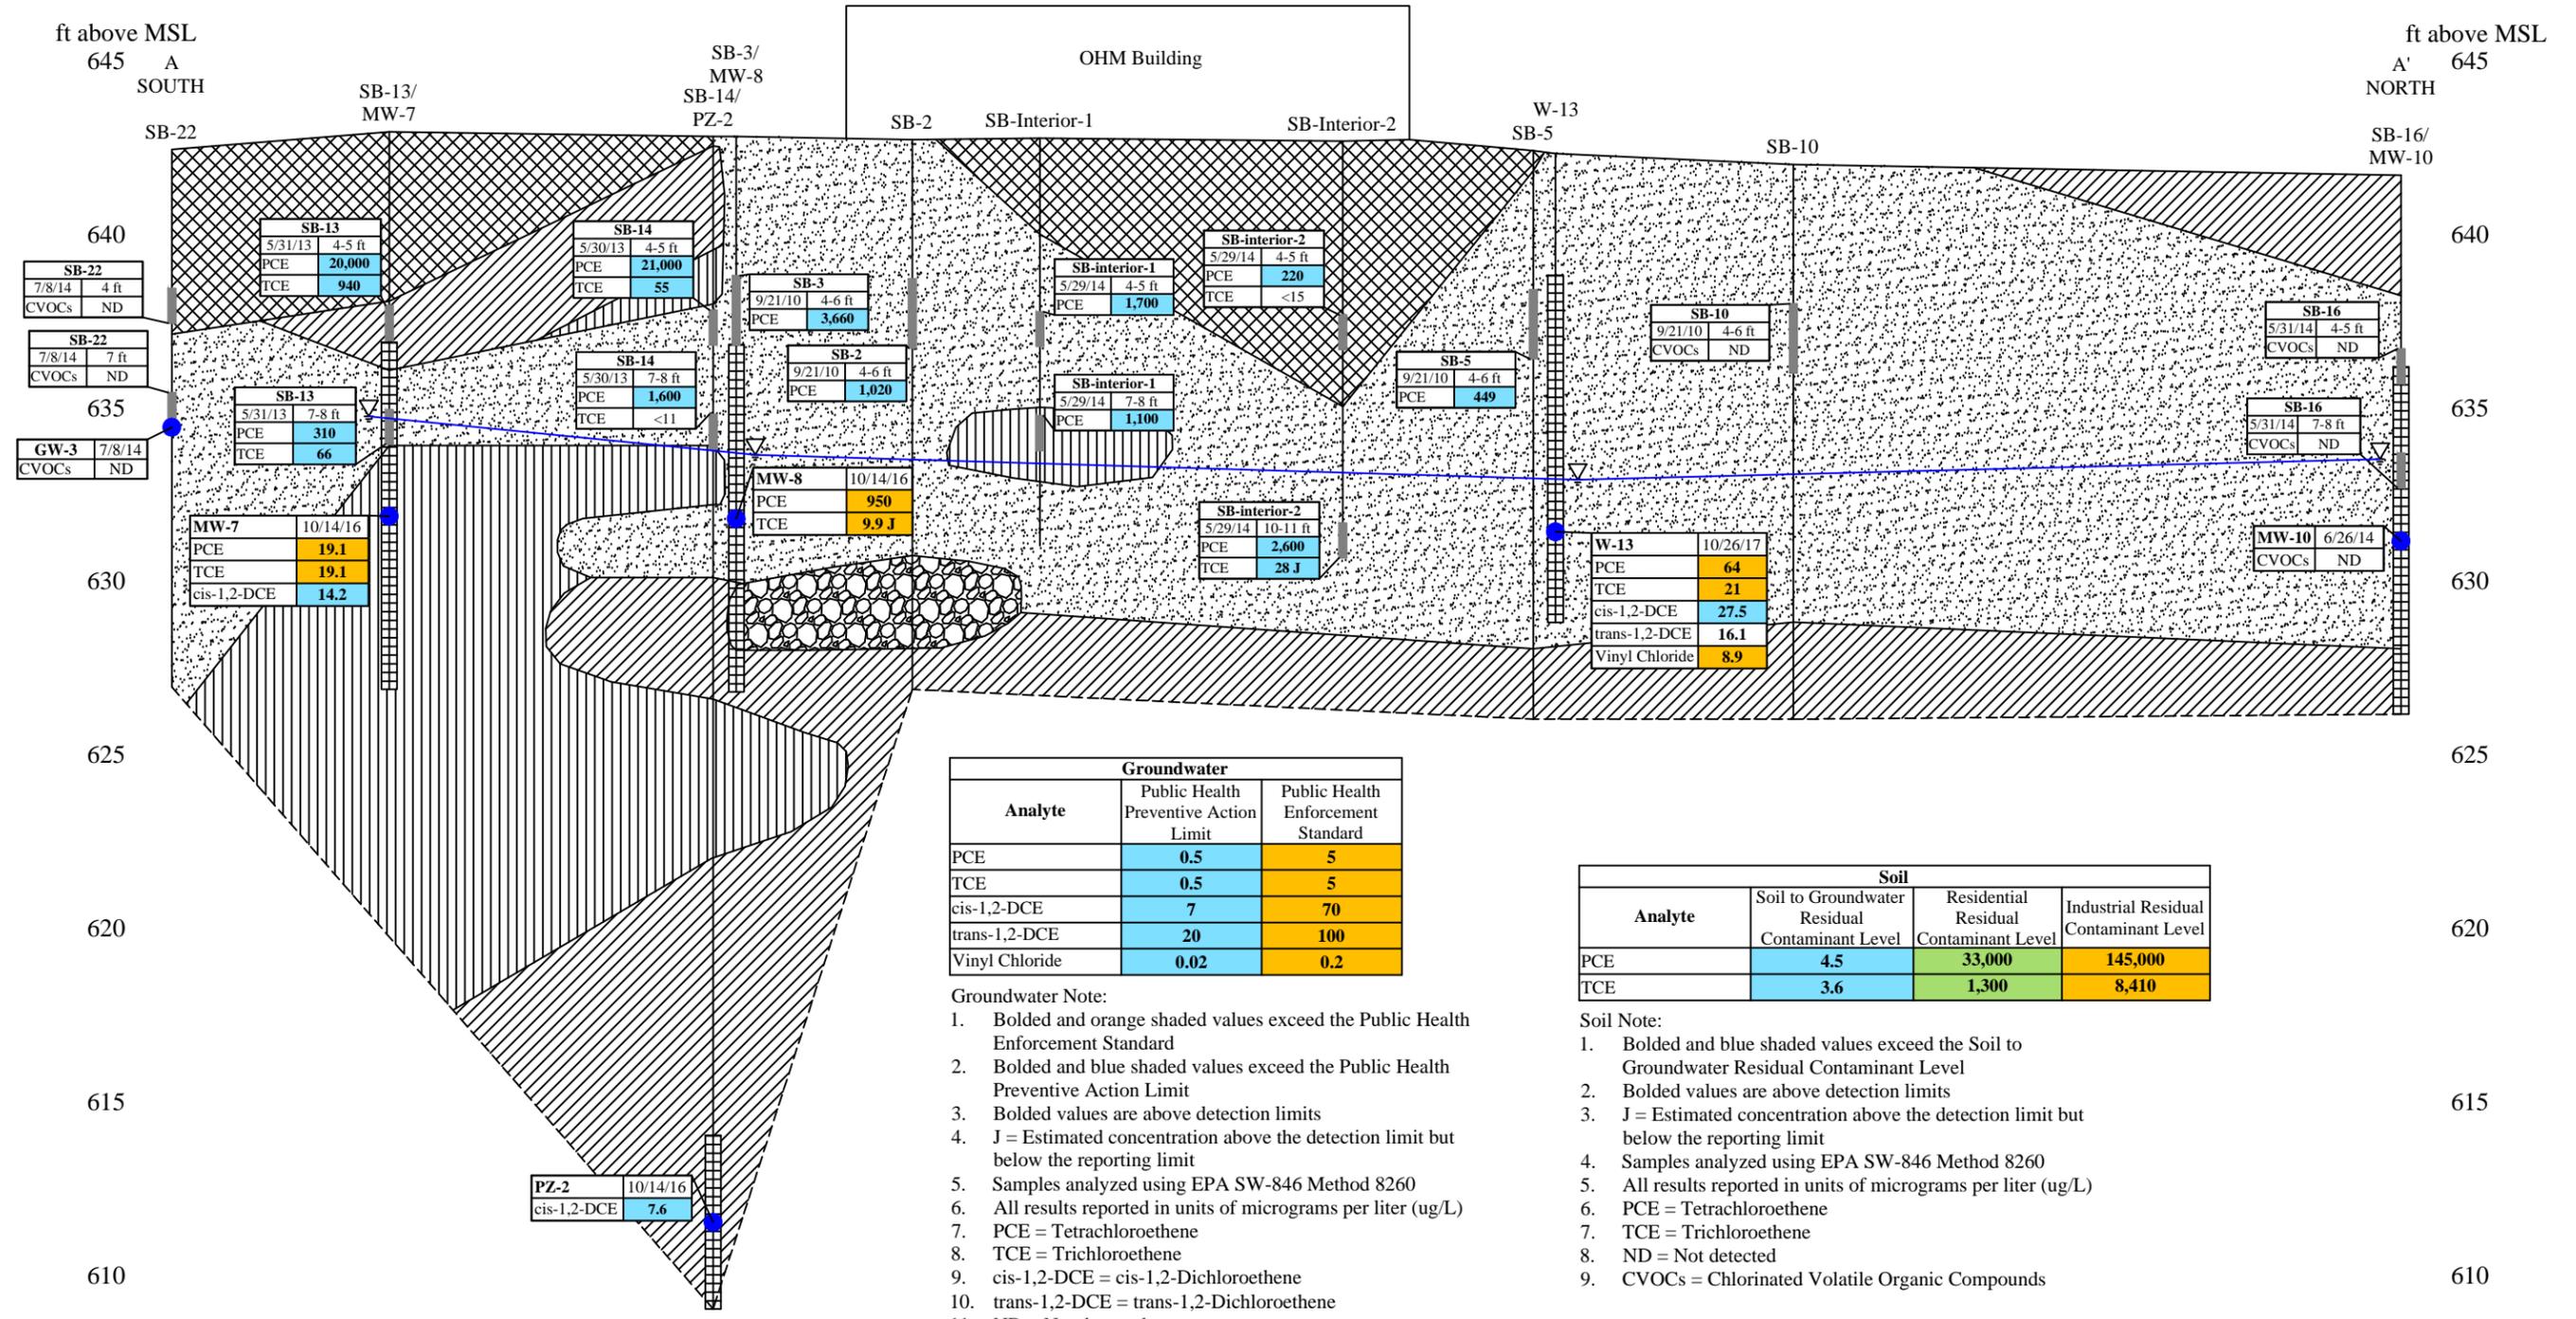
- Observed groundwater elevation on June 26, 2014
- Monitoring well screen
- Dashed boundaries are inferred
- ft above MSL = Feet above Mean Sea Level
- Soil sample depth interval
- Groundwater sample depth interval

GEOLOGIC CROSS SECTION A-A'

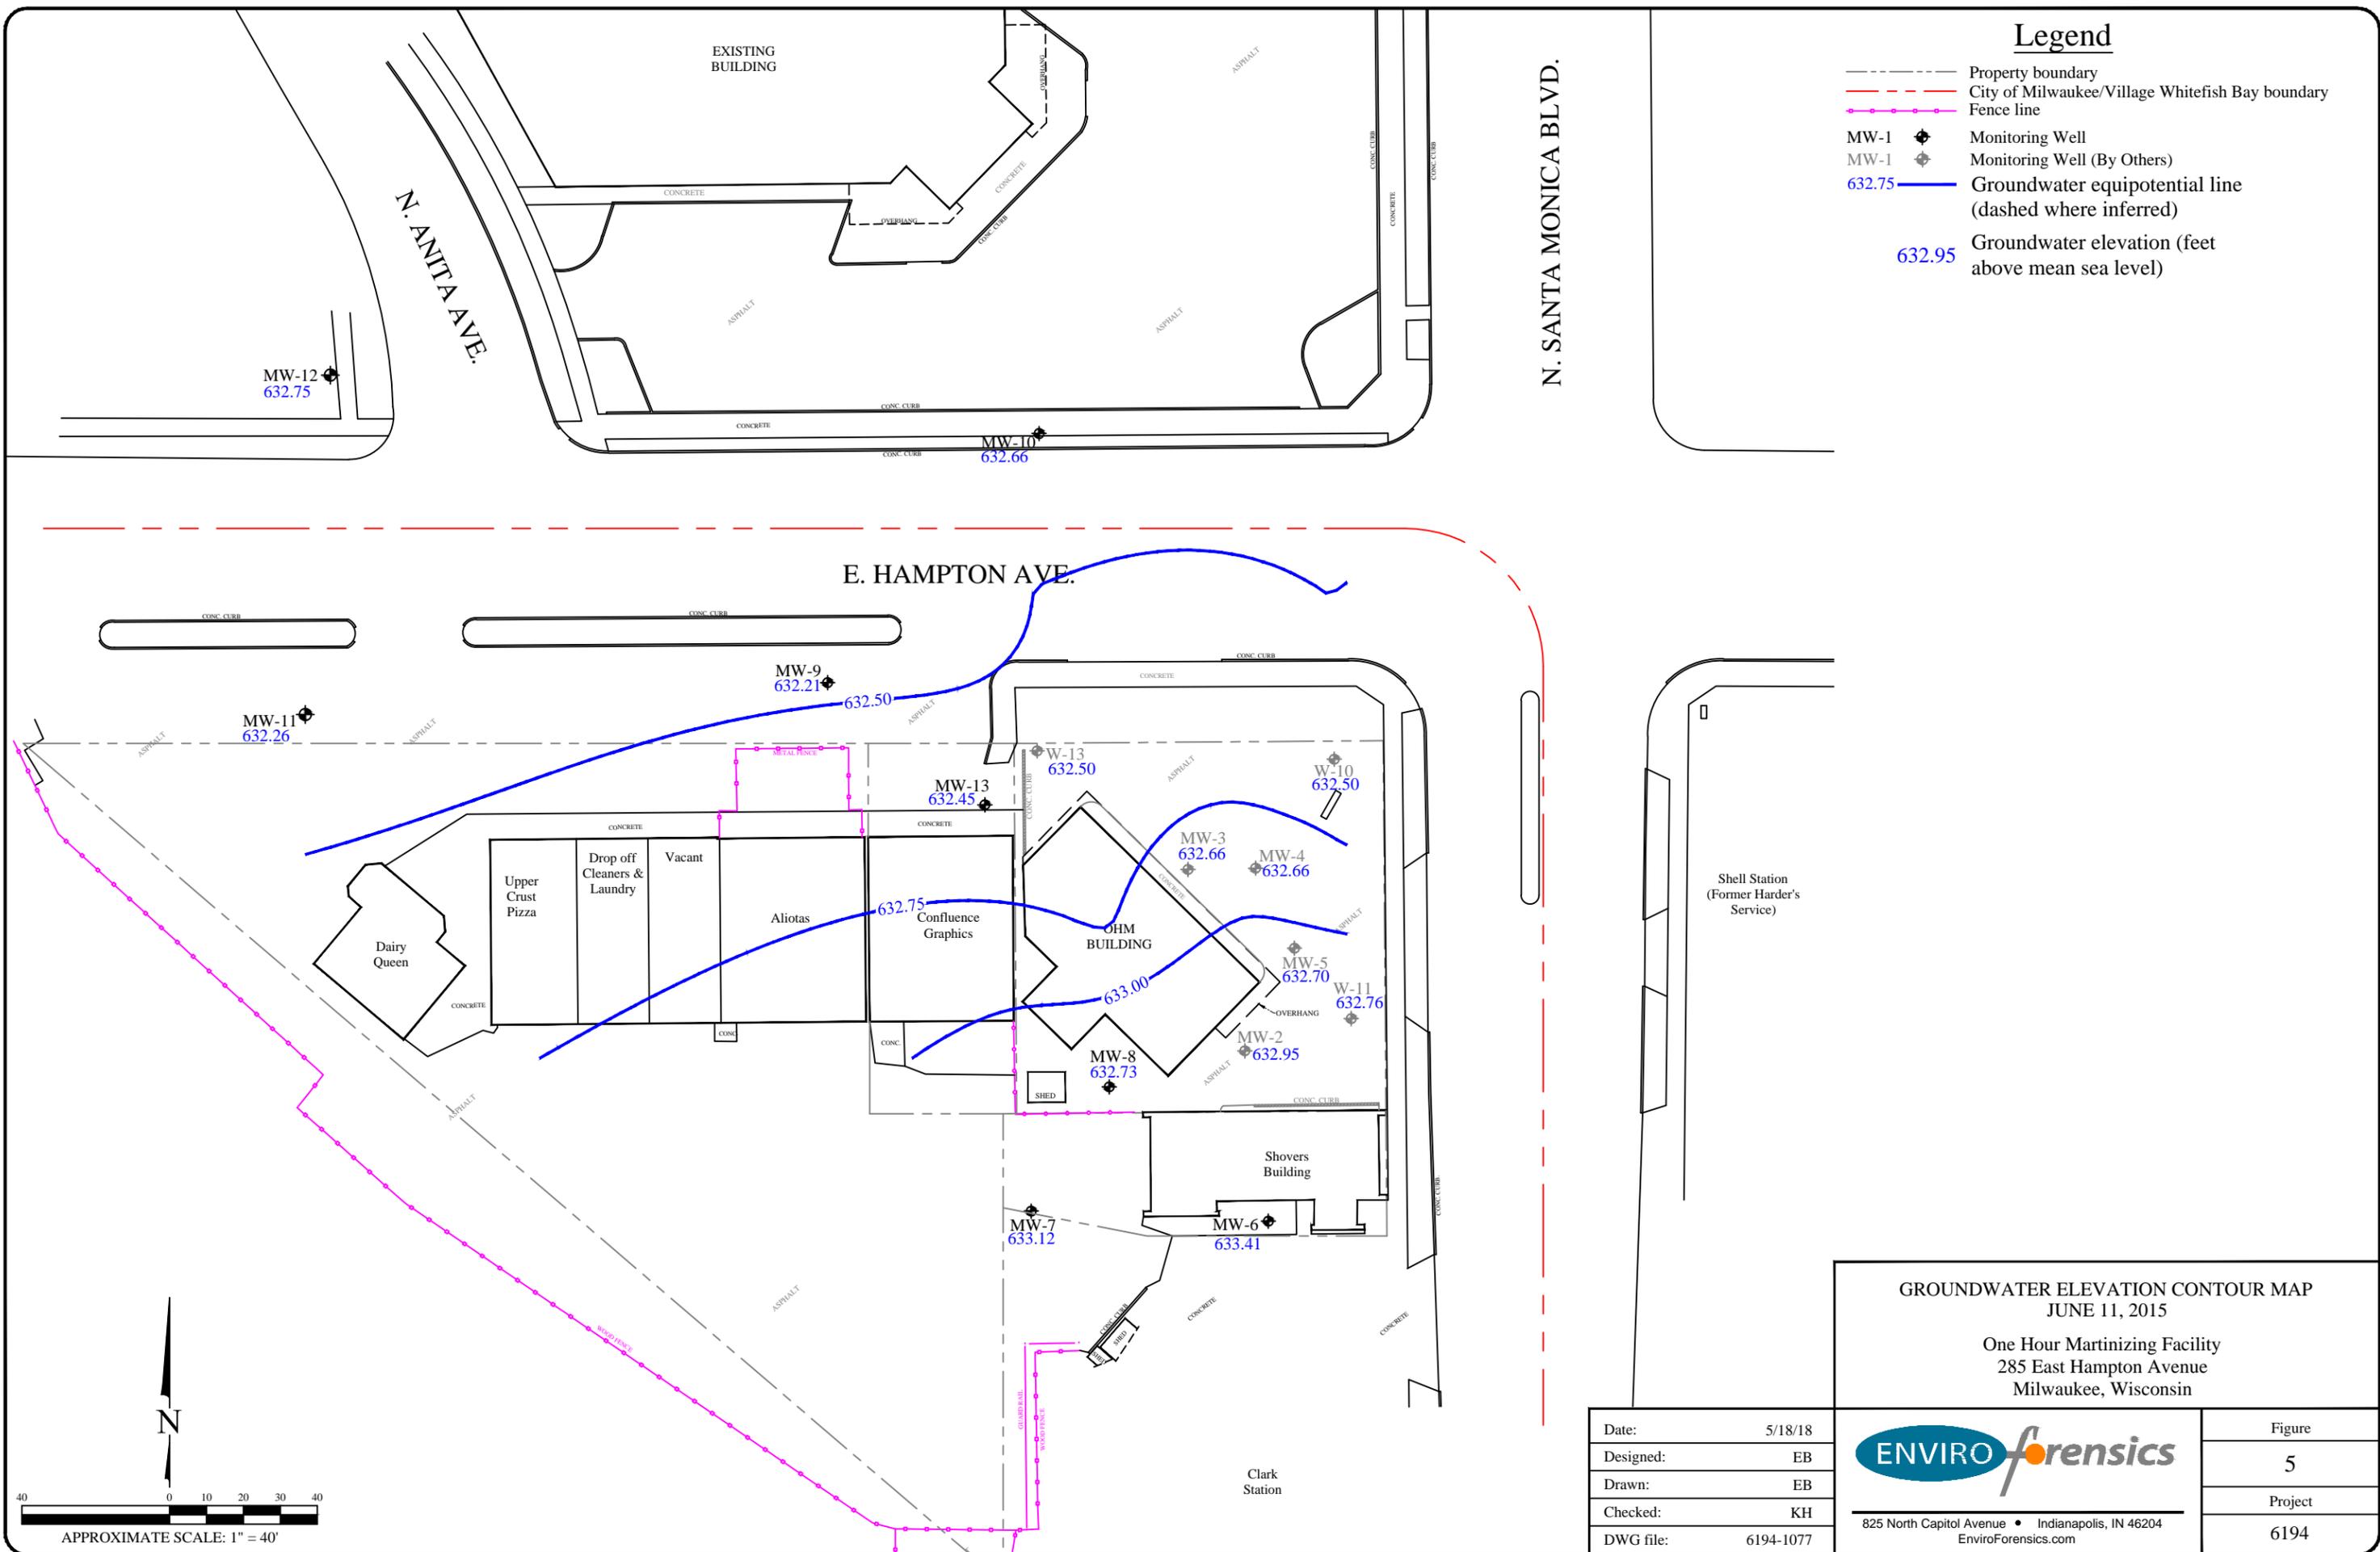
GROUNDWATER ELEVATION CONTOUR MAP JUNE 11, 2015 One Hour Martinizing Facility 285 East Hampton Avenue Milwaukee, Wisconsin											
<table border="1" style="width: 100%; border-collapse: collapse;"> <tr><td>Date:</td><td>5/18/18</td></tr> <tr><td>Designed:</td><td>EB</td></tr> <tr><td>Drawn:</td><td>EB</td></tr> <tr><td>Checked:</td><td>KH</td></tr> <tr><td>DWG file:</td><td>6194-1077</td></tr> </table>	Date:	5/18/18	Designed:	EB	Drawn:	EB	Checked:	KH	DWG file:	6194-1077

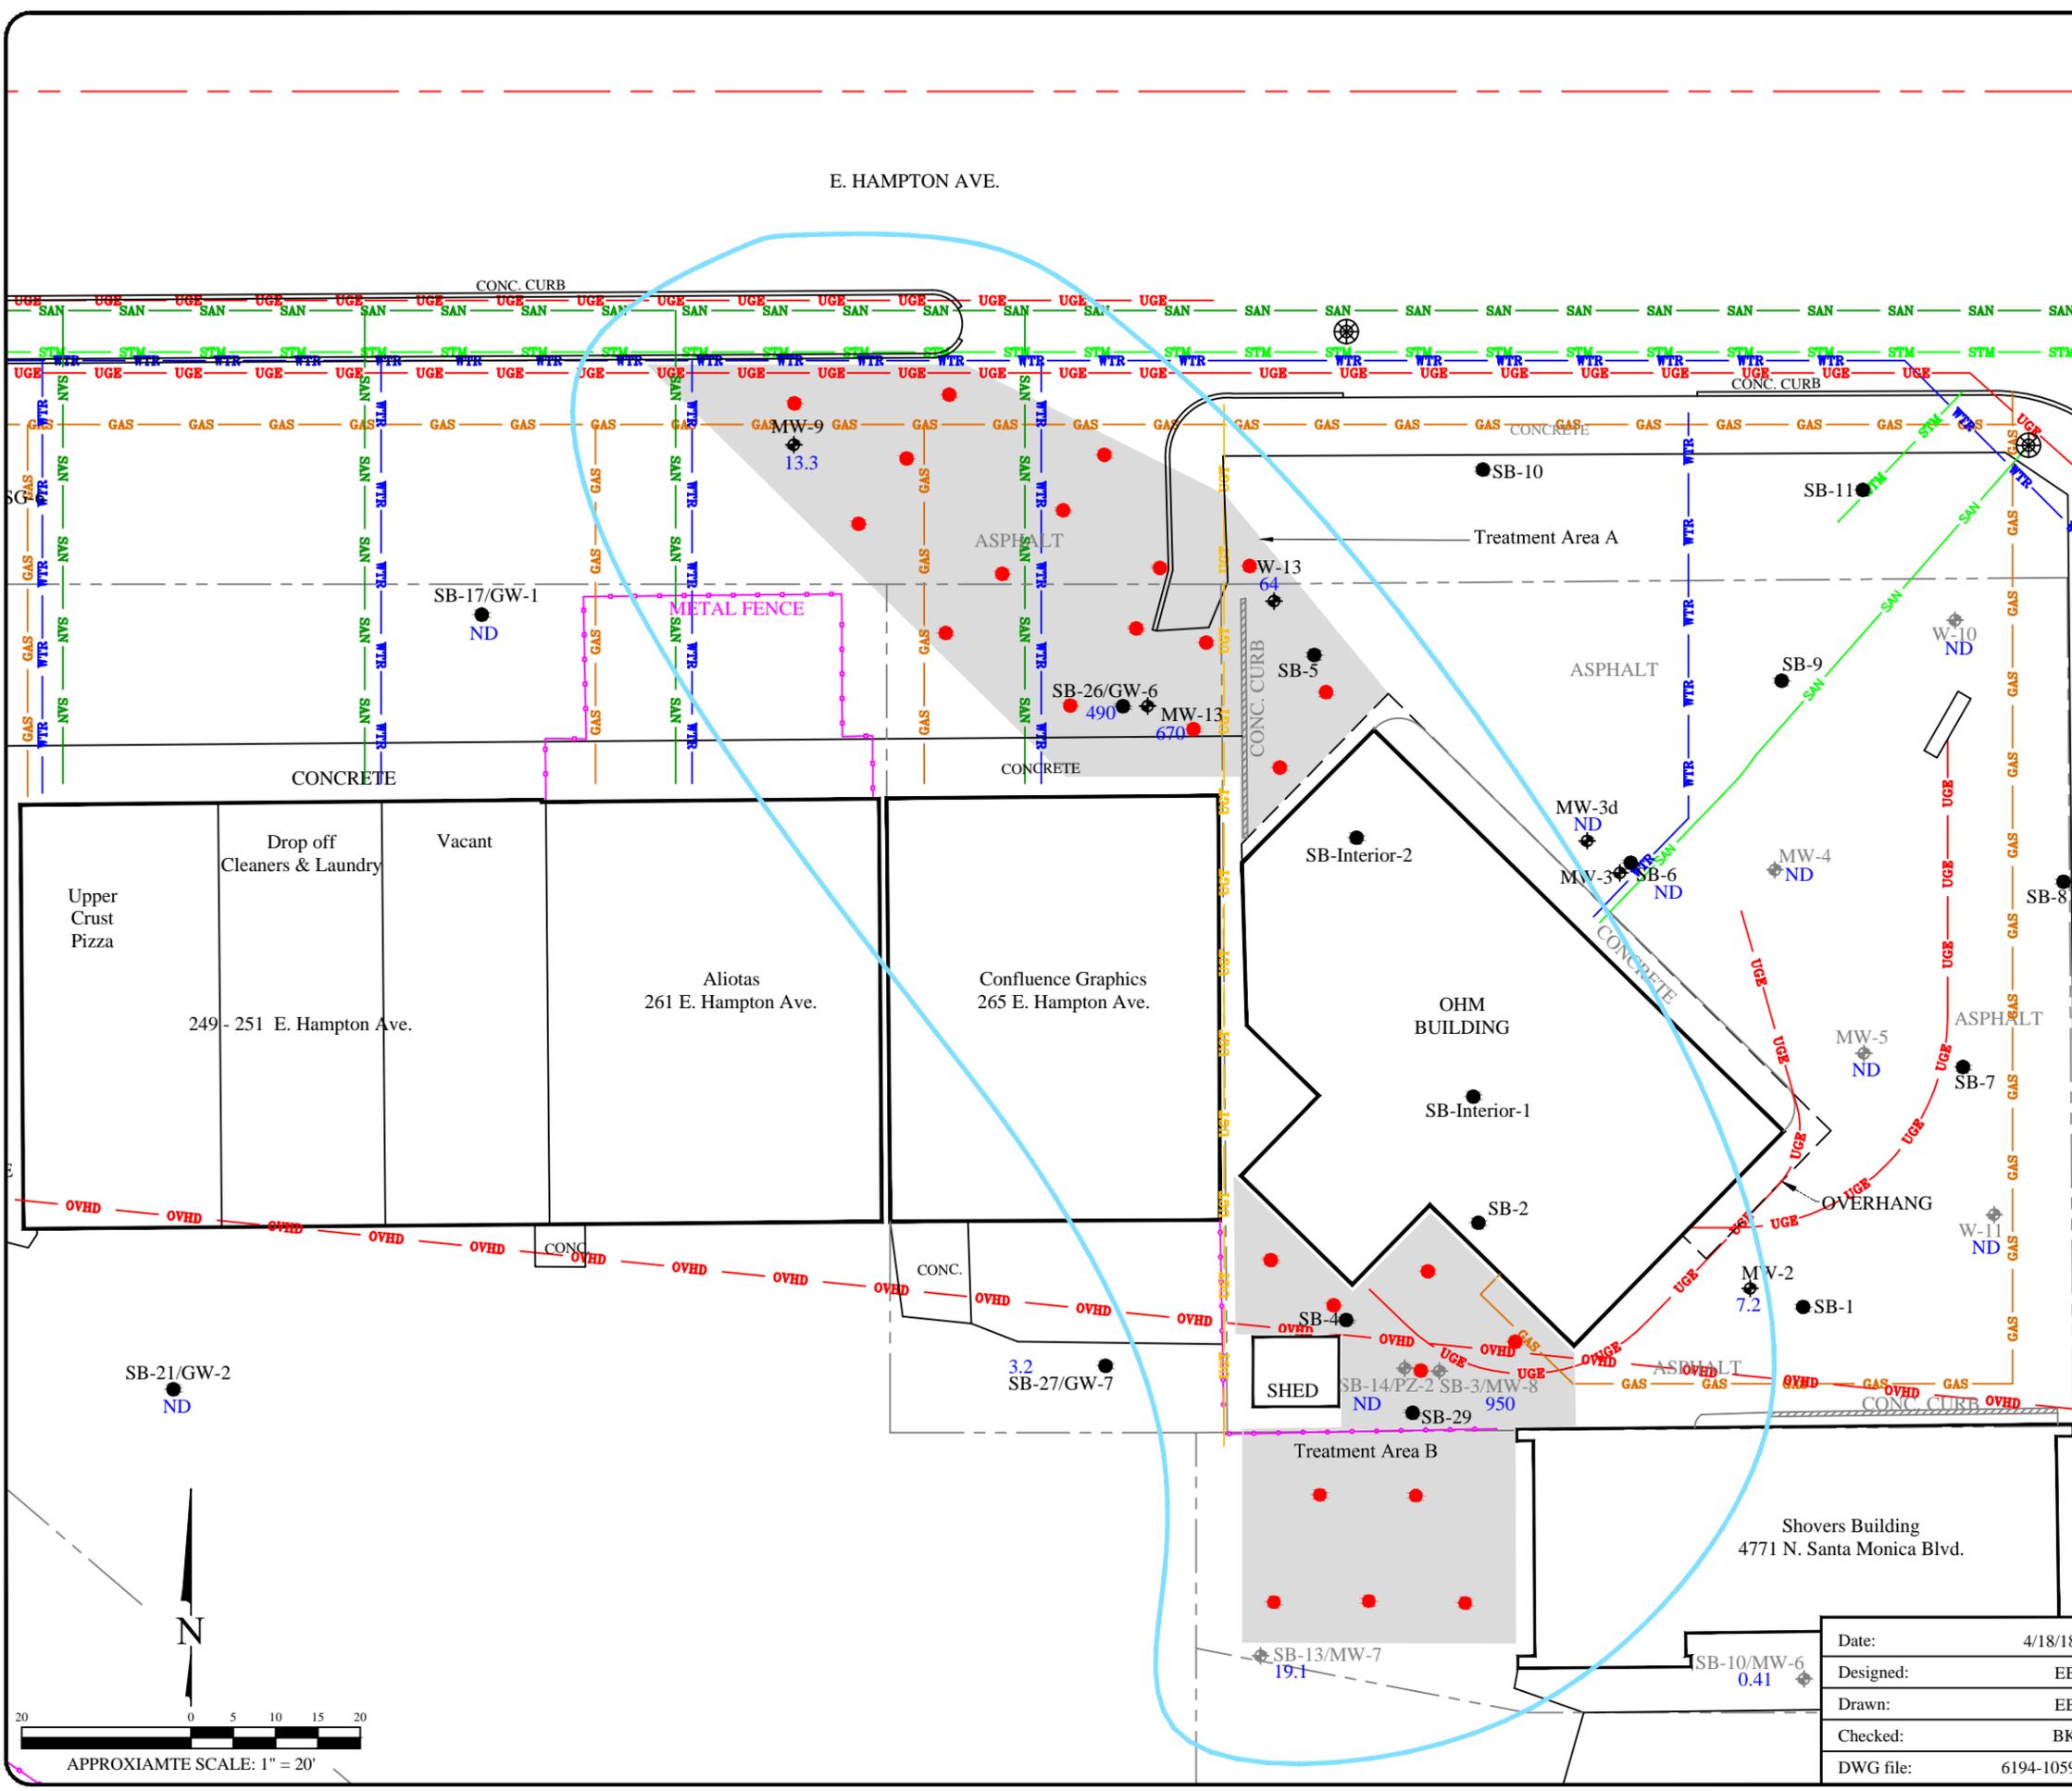
PROPOSED INJECTION POINT LAYOUT

The RAOR recommended the injection of an amendment to accelerate the dichlorination of the chlorinated VOCs. This will require the installation of injection points and applying a pressure to inject the amendment into the formation. Caution should be taken, especially in sandy soils, when injecting as this process can “push” the contaminants outside the limits of the proposed treatment area. Further, dechlorination of PCE results in the production of vinyl chloride which has significantly lower soil, groundwater, and vapor regulatory standards and also presents the potential for impacts to migrate beyond the current limits of the investigation.

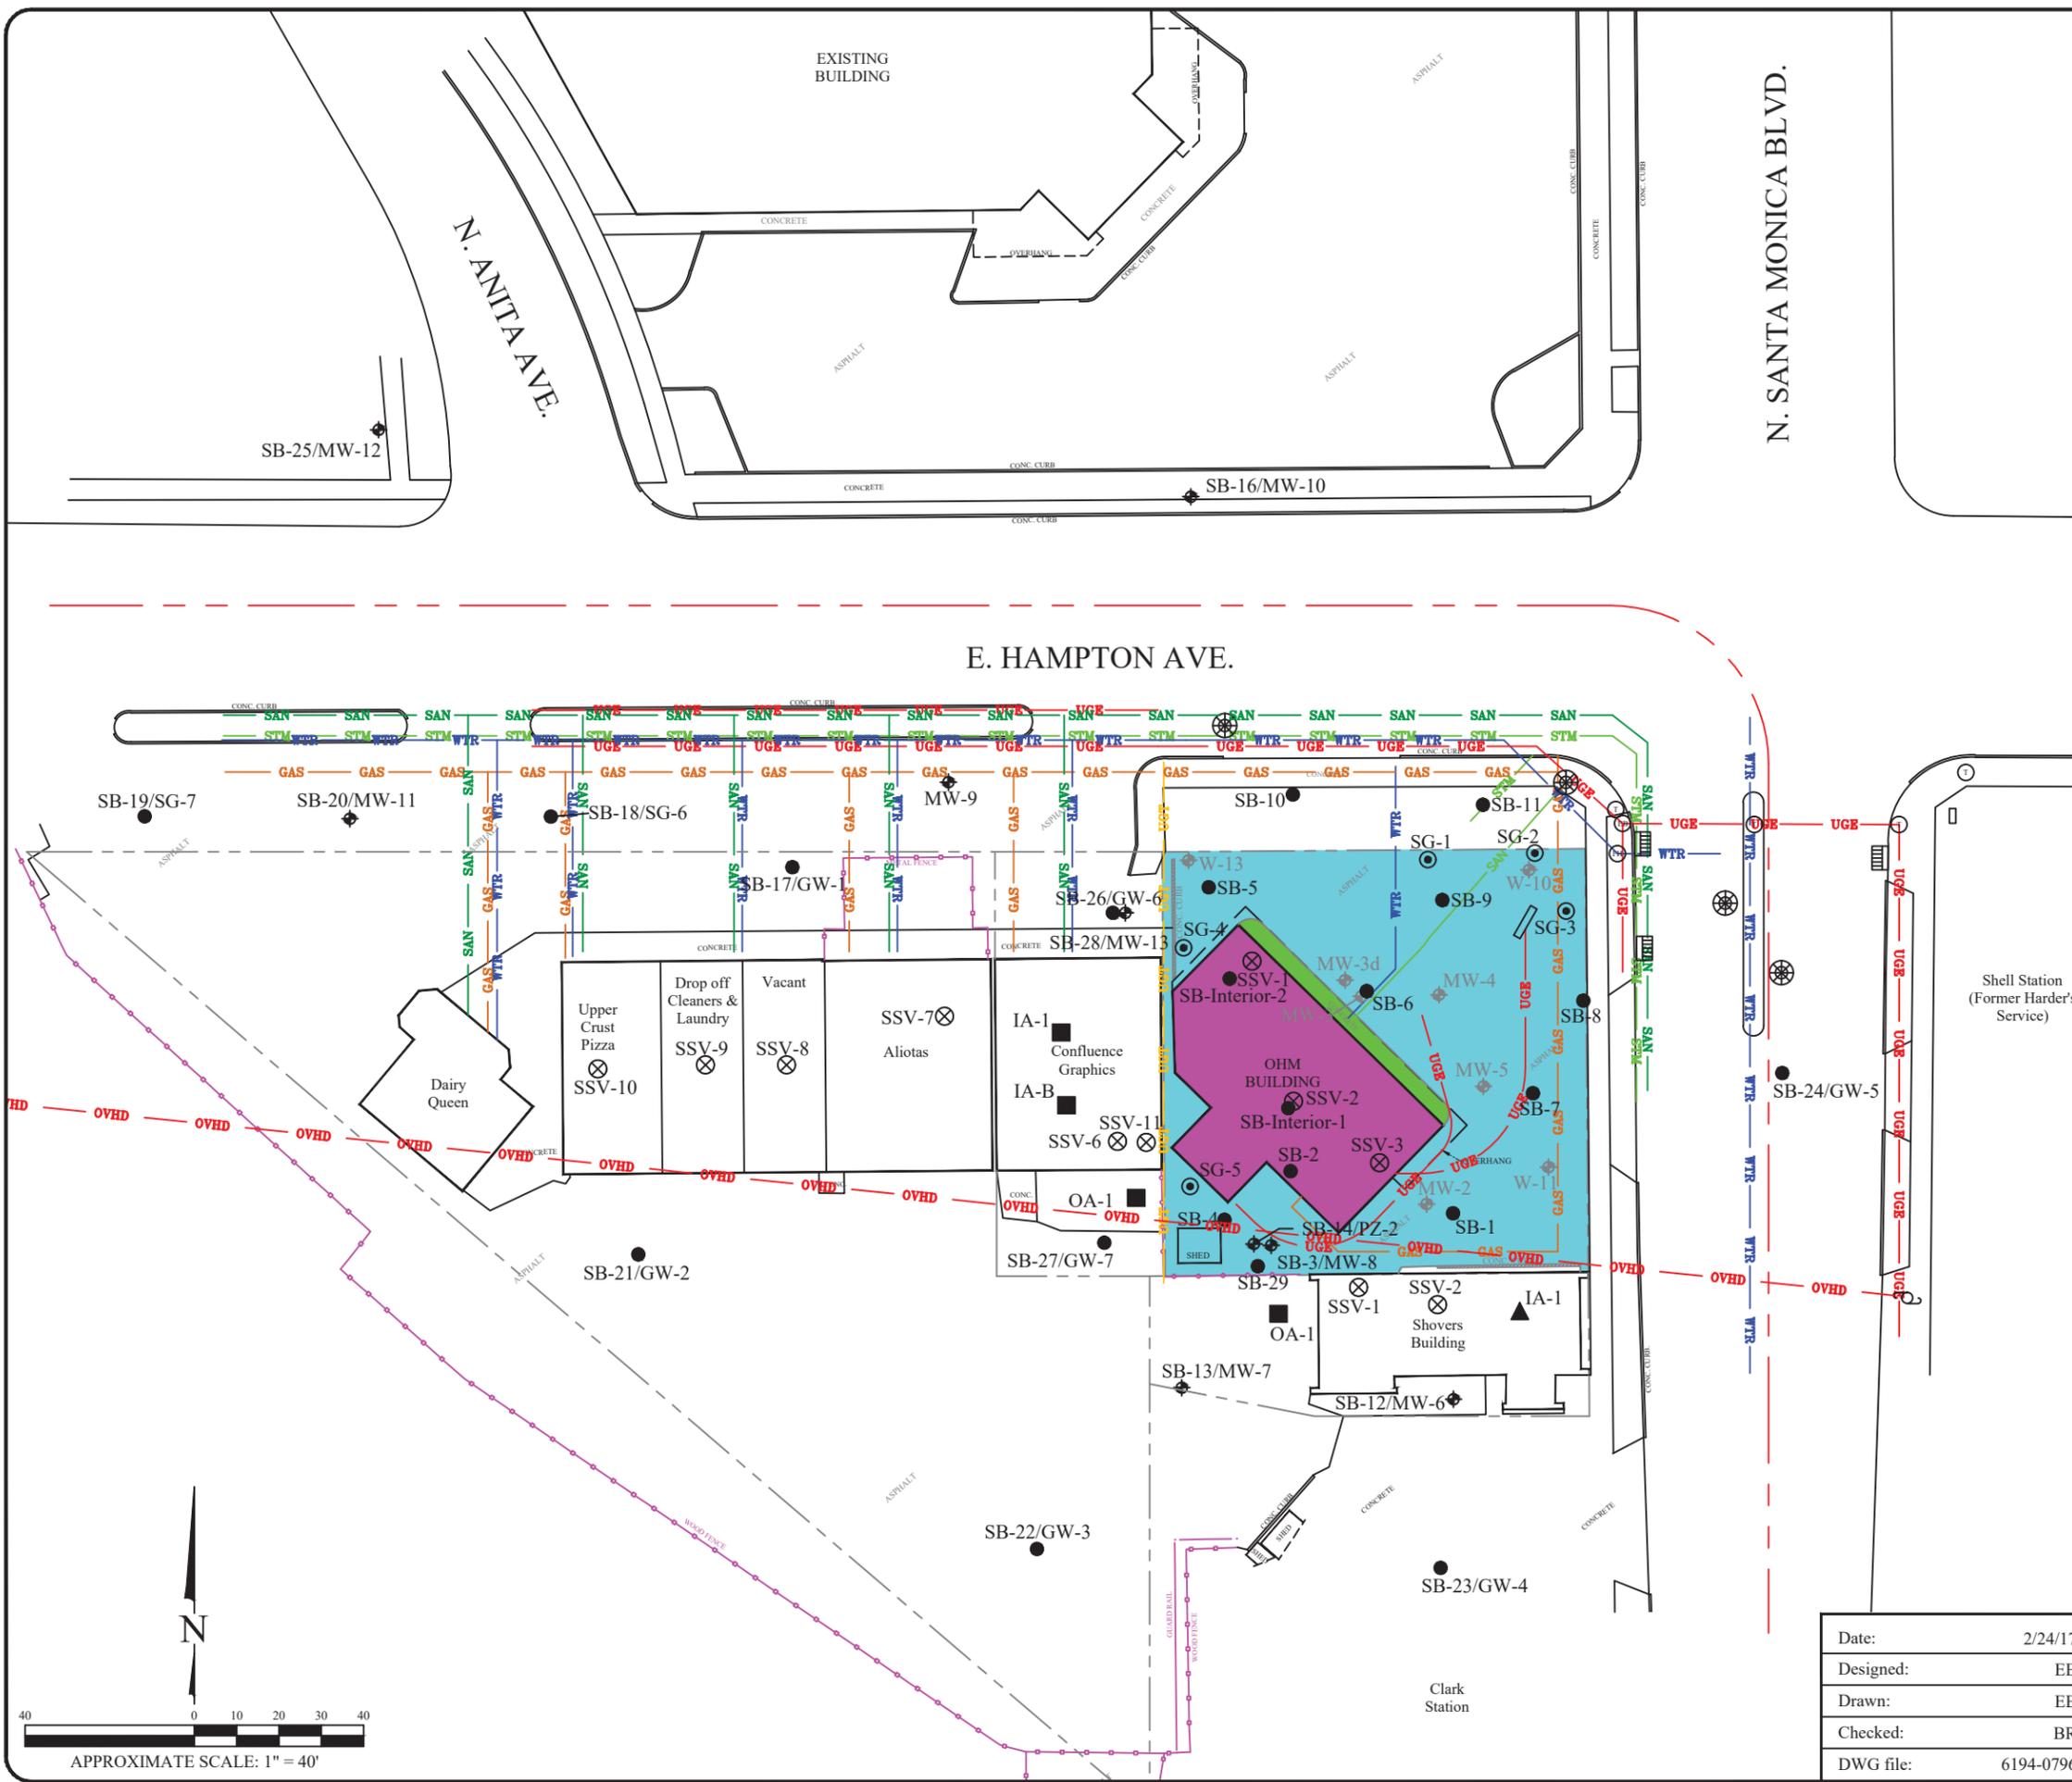
LOCATION AND EXTENT OF ASPHALT/ CONCRETE CAP
