Based on the above data, Hampton WFB, LLC is requesting written determination from the from the WDNR that Hampton WFB, LLC is not responsible for investigation or remediation of soil, groundwater, or vapor contamination on its Property and has met the conditions in s.292.13, Stats., to qualify for the liability exemption, including but not limited to the following provisions:

Phase I Environmental Site Assessment 245-261 East Hampton Avenue Milwaukee, Wisconsin

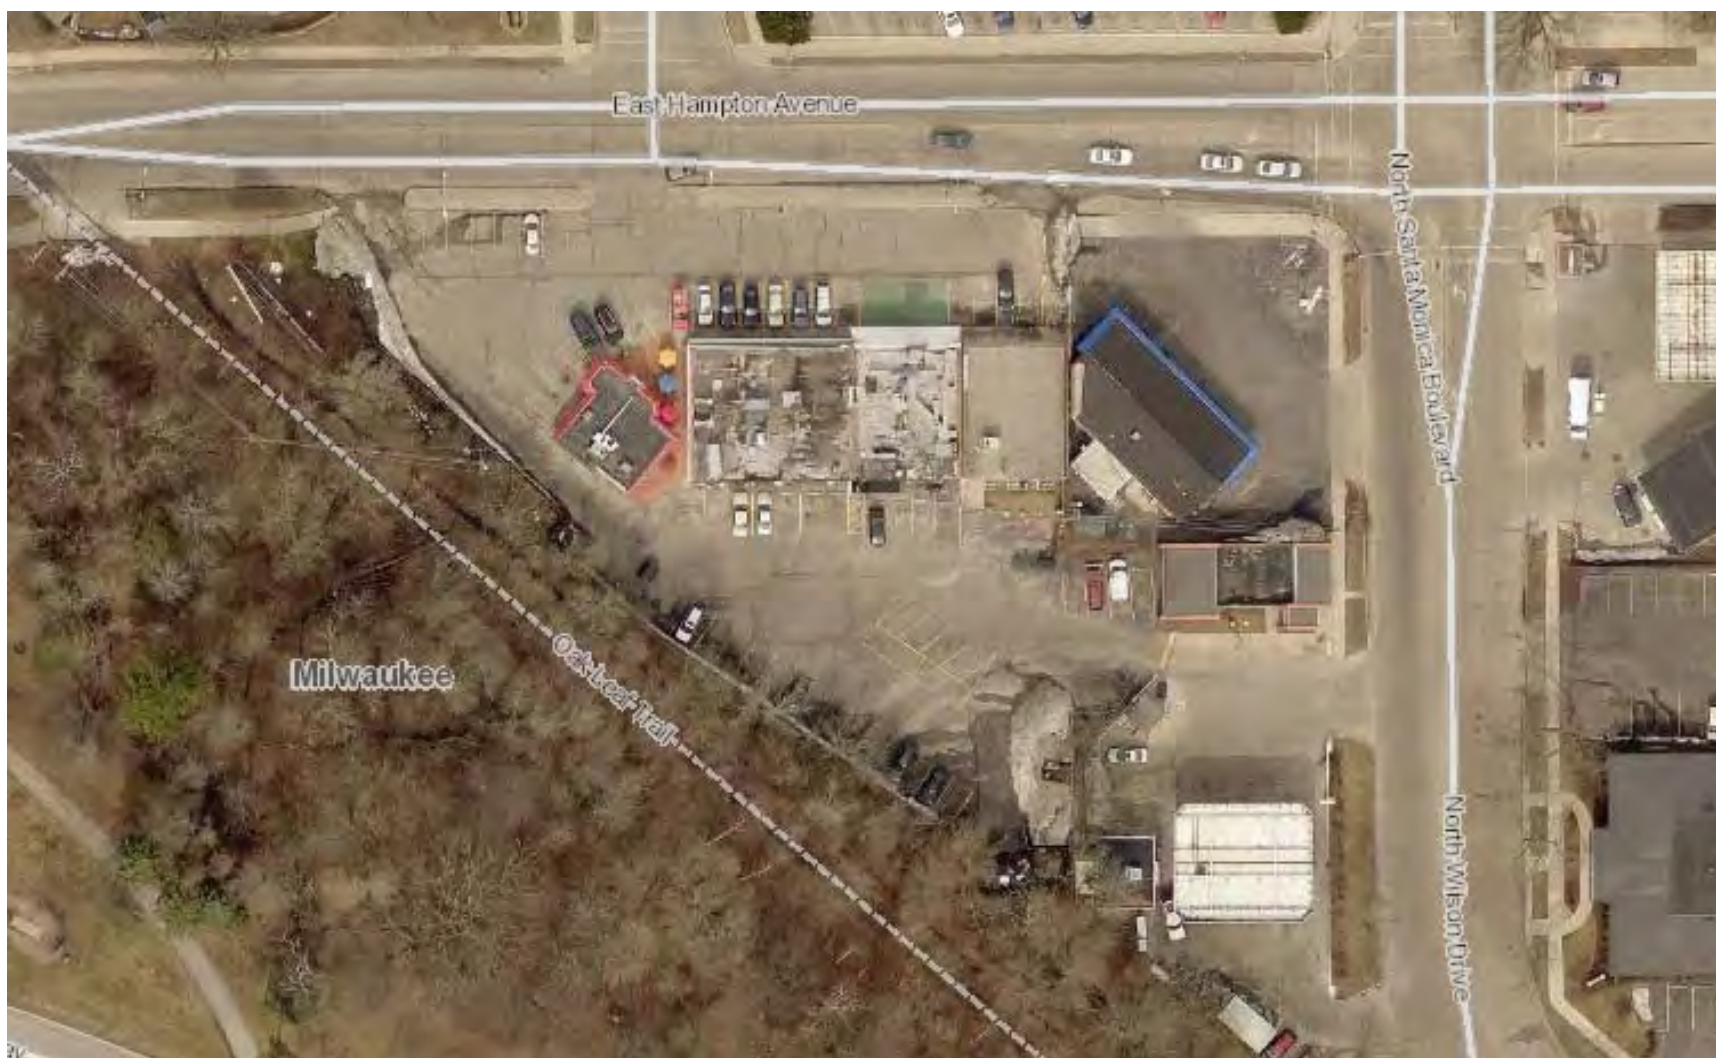
Figure
2

Site Diagram
245-261 East Hampton Avenue
Milwaukee, Wisconsin

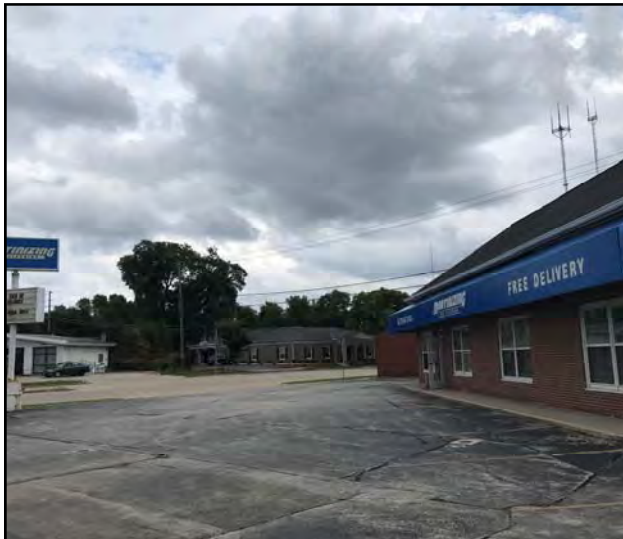
Photograph 3 - The northeast adjoining property (285 E Hampton Ave - One Hour Martinizing) is referenced on the DNR LUST/UST and was closed in 2017. The same property is an open ERP site.

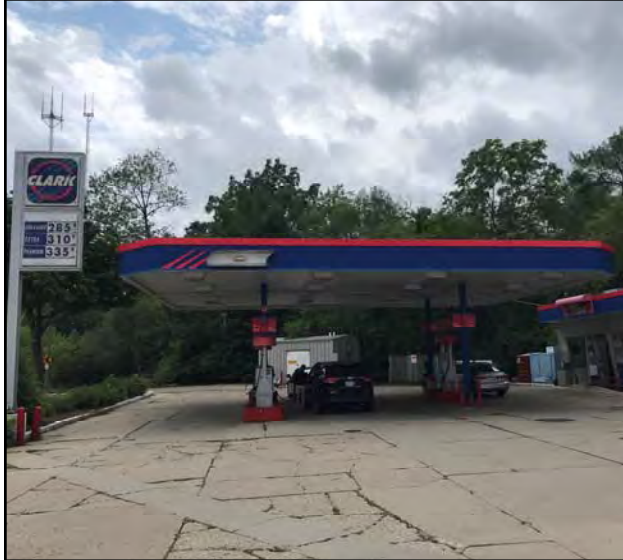
Photograph 4 - The southeast adjoining property (4751 N Santa Monica Blvd – Clark Oil Station) is referenced as a closed site on the DNR LUST/UST database.

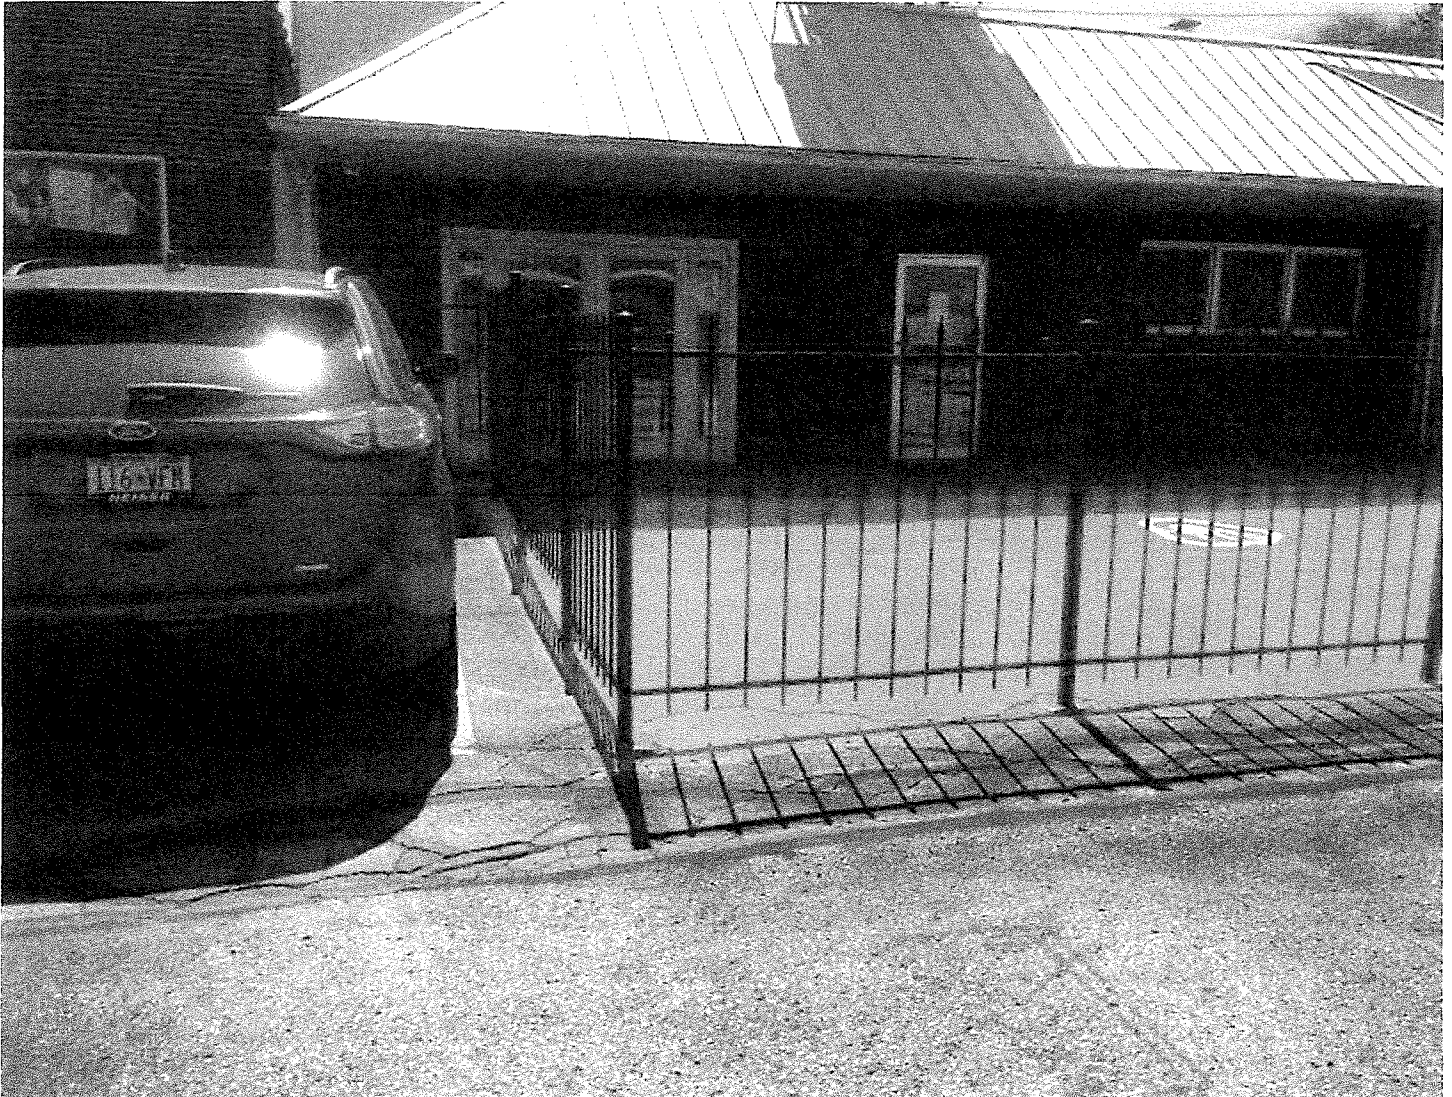
View of the asphalt/concrete cap in the north parking area. View is to the south.

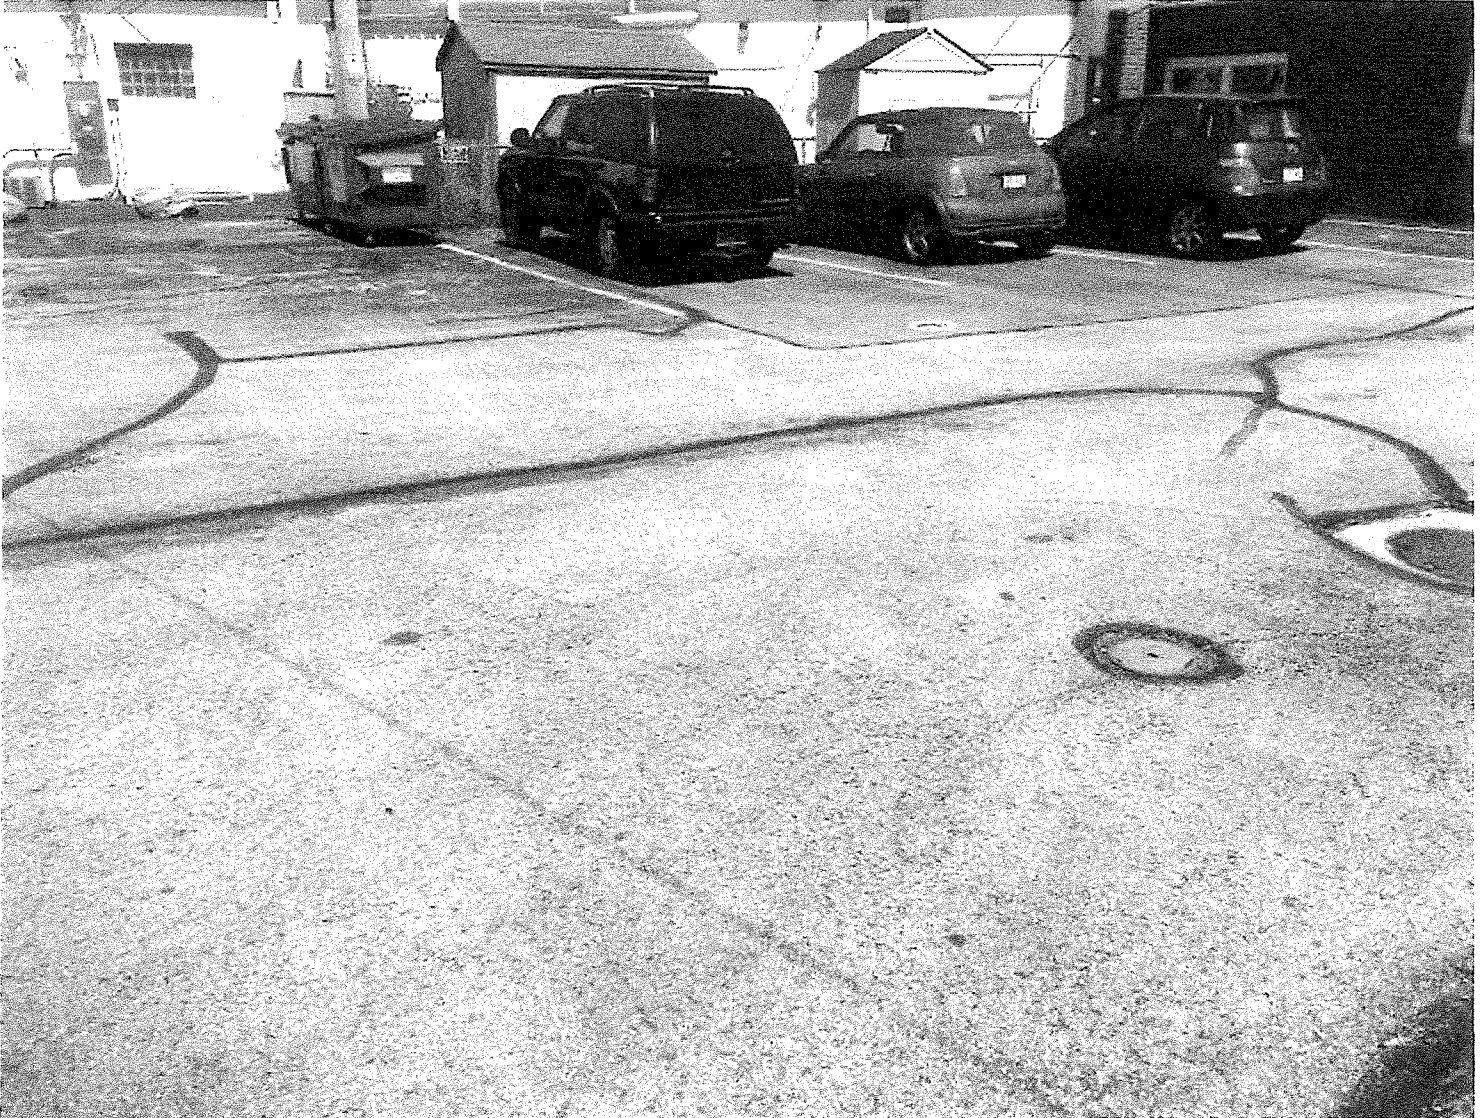
View of the asphalt cap in the south parking area. View is to the northeast.

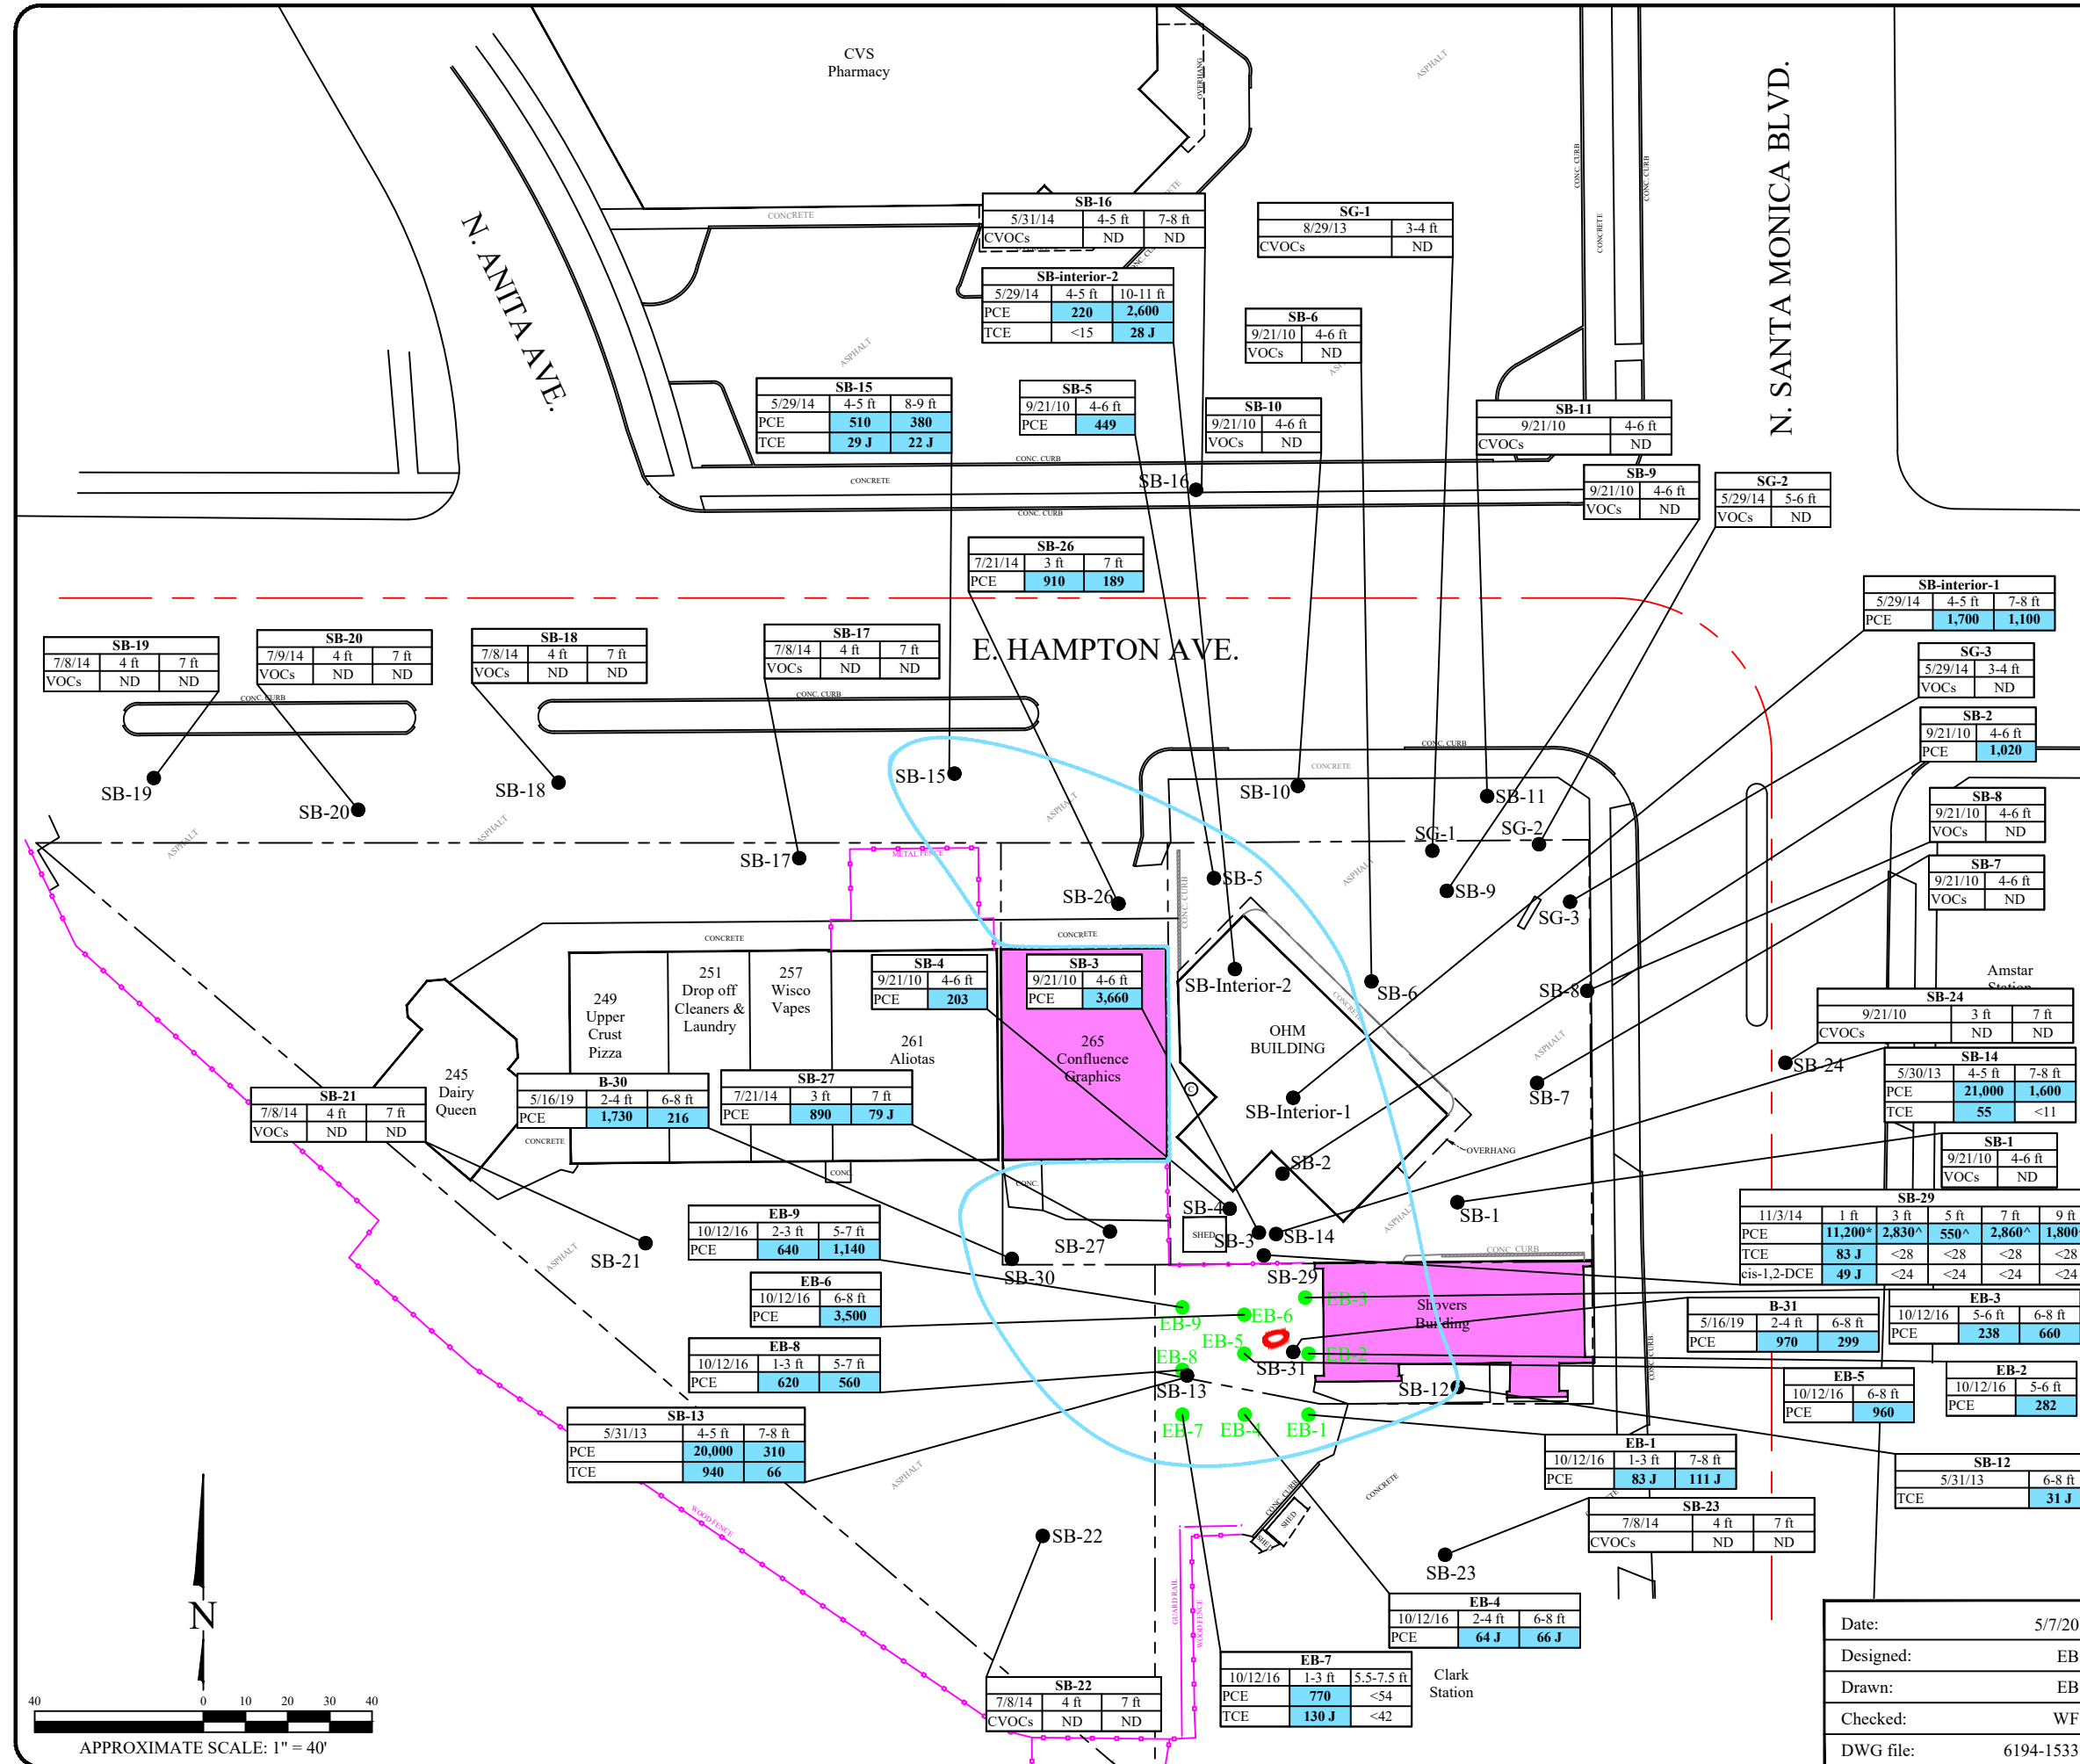
SOIL CONTAMINATION

One Hour Martinizing Facility
285 East Hampton Avenue
Milwaukee, Wisconsin
