Technical Assistance, Environmental Liability Clarification or Post-Closure Modification Request

Property Name Pershing Plaza Shopping Center	FID No. (if known) 230007690
BRRTS No. (if known) 02-30-582211	Parcel Identification Number 03-122-11-104-008

Use this space or attach additional sheets to provide necessary information, explanations or specific questions to be answered by the DNR.
Vapor Mitigation System Commissioning Plan & Pressure Field Extension Test Results for review and approval.

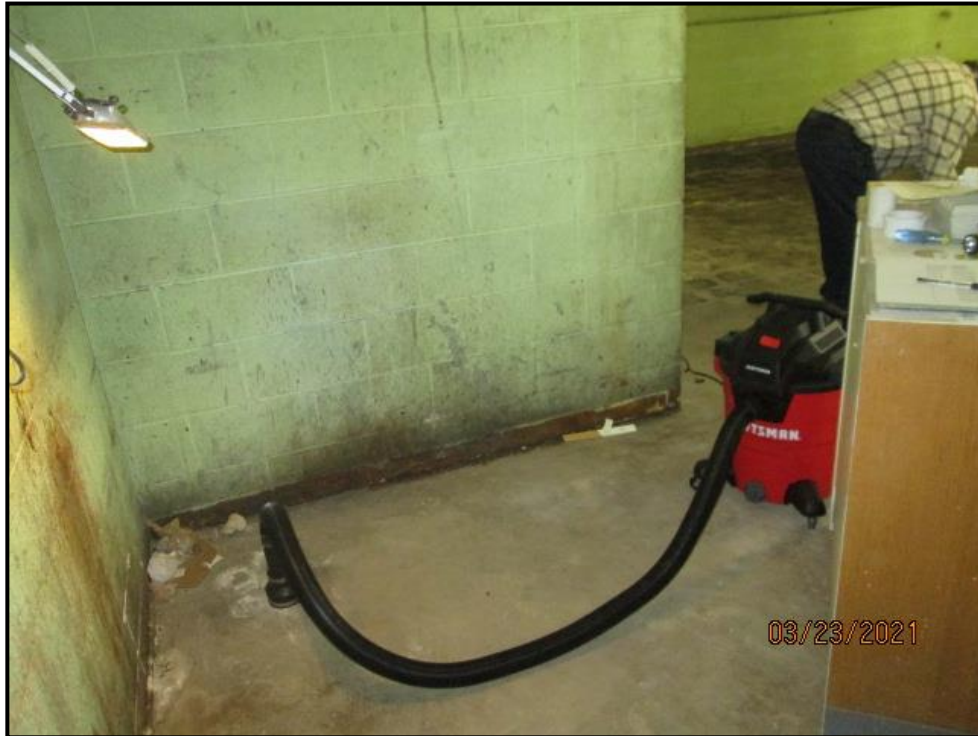
3.5" Extraction Hole with shop vac (same hole for VMS), viewing North.

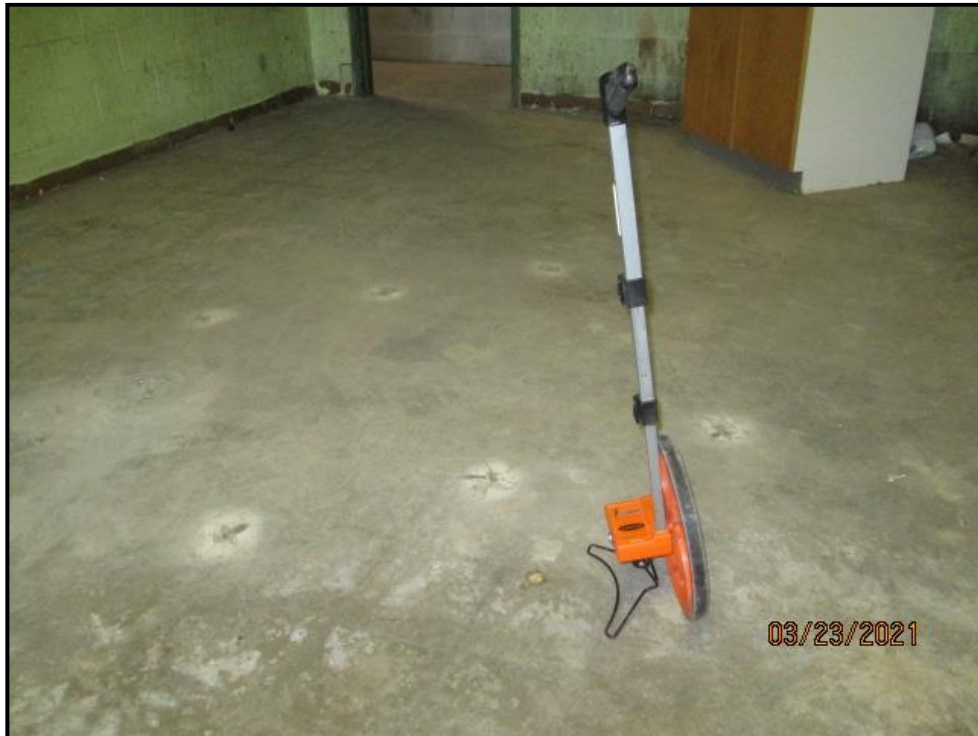
Former location of Dry Cleaner Machine (Former Lakeside Cleaners) and PFE-6, viewing North

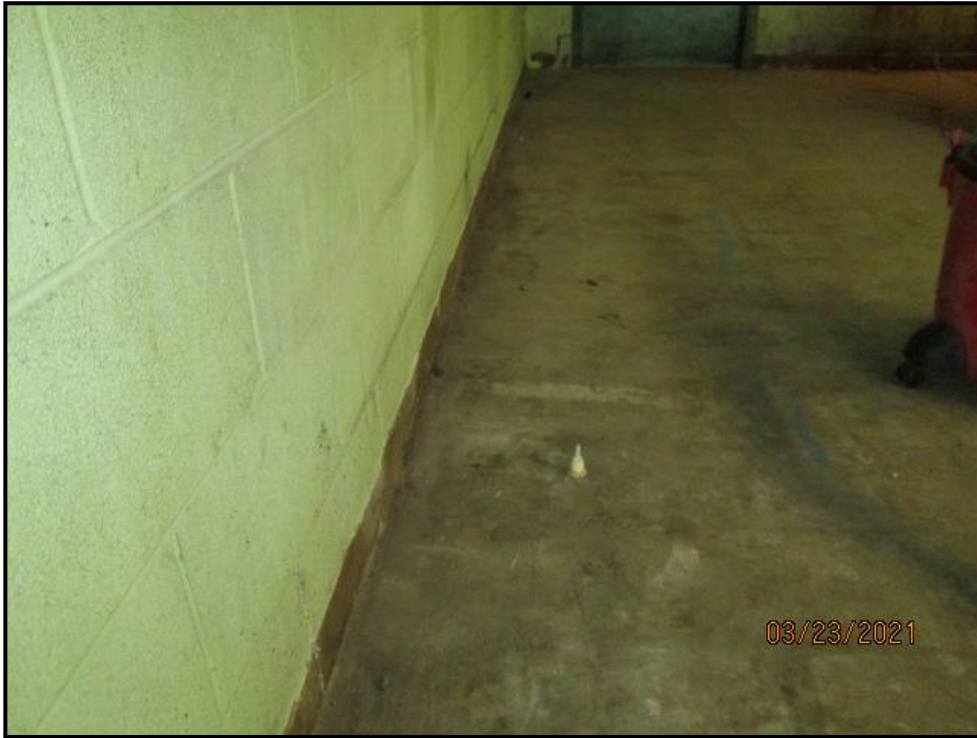
View of PFE- 1(FLC), viewing West.

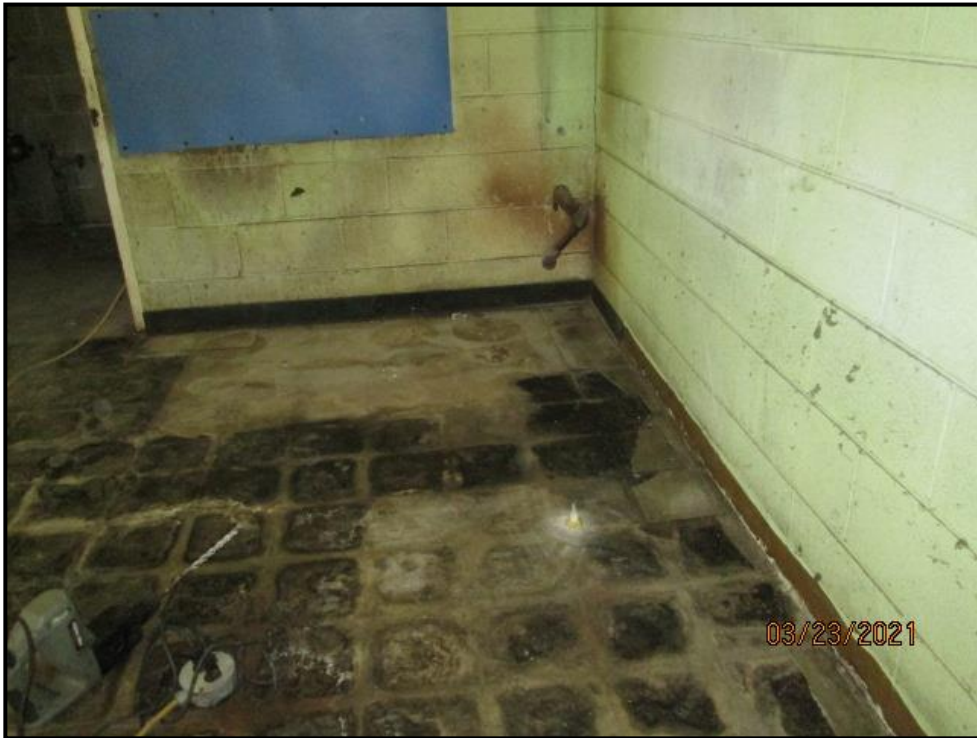
View of PFE-2 (FLC), viewing West.

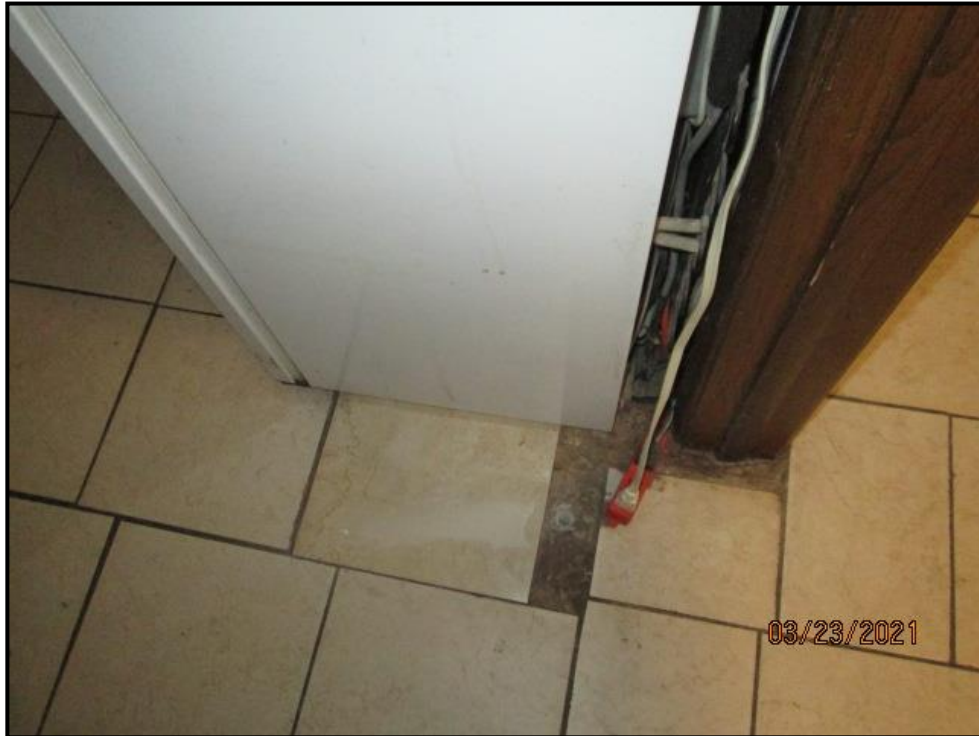
View of PFE-4 (Julie Nails & Spa), viewing down and North.

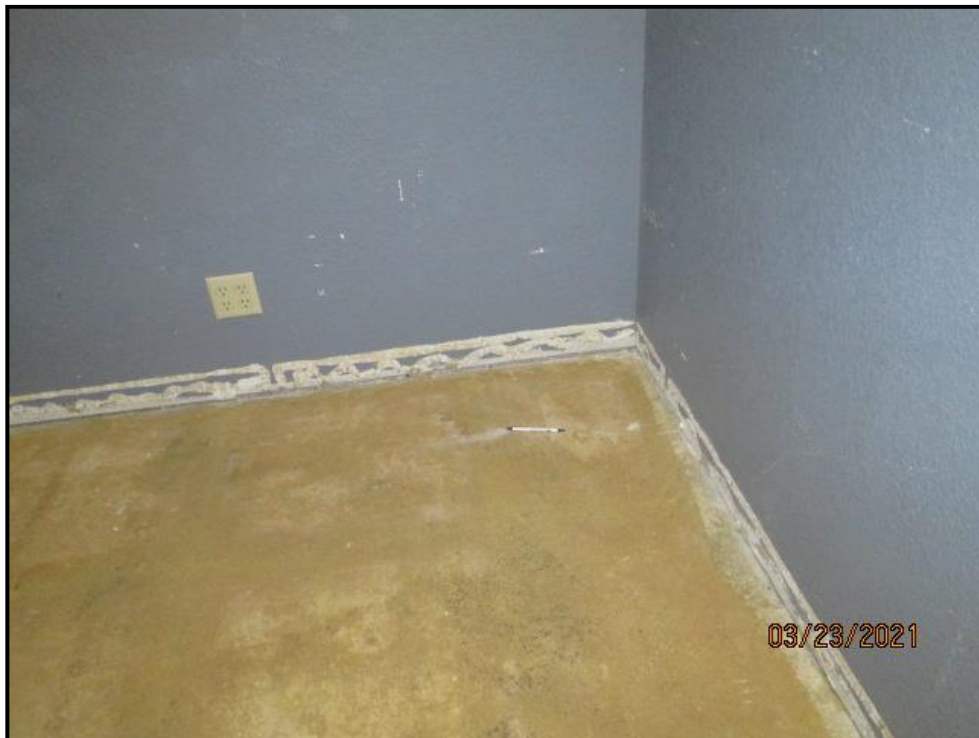
View of PFE-5 (Paladin Protection Academy), viewing West.

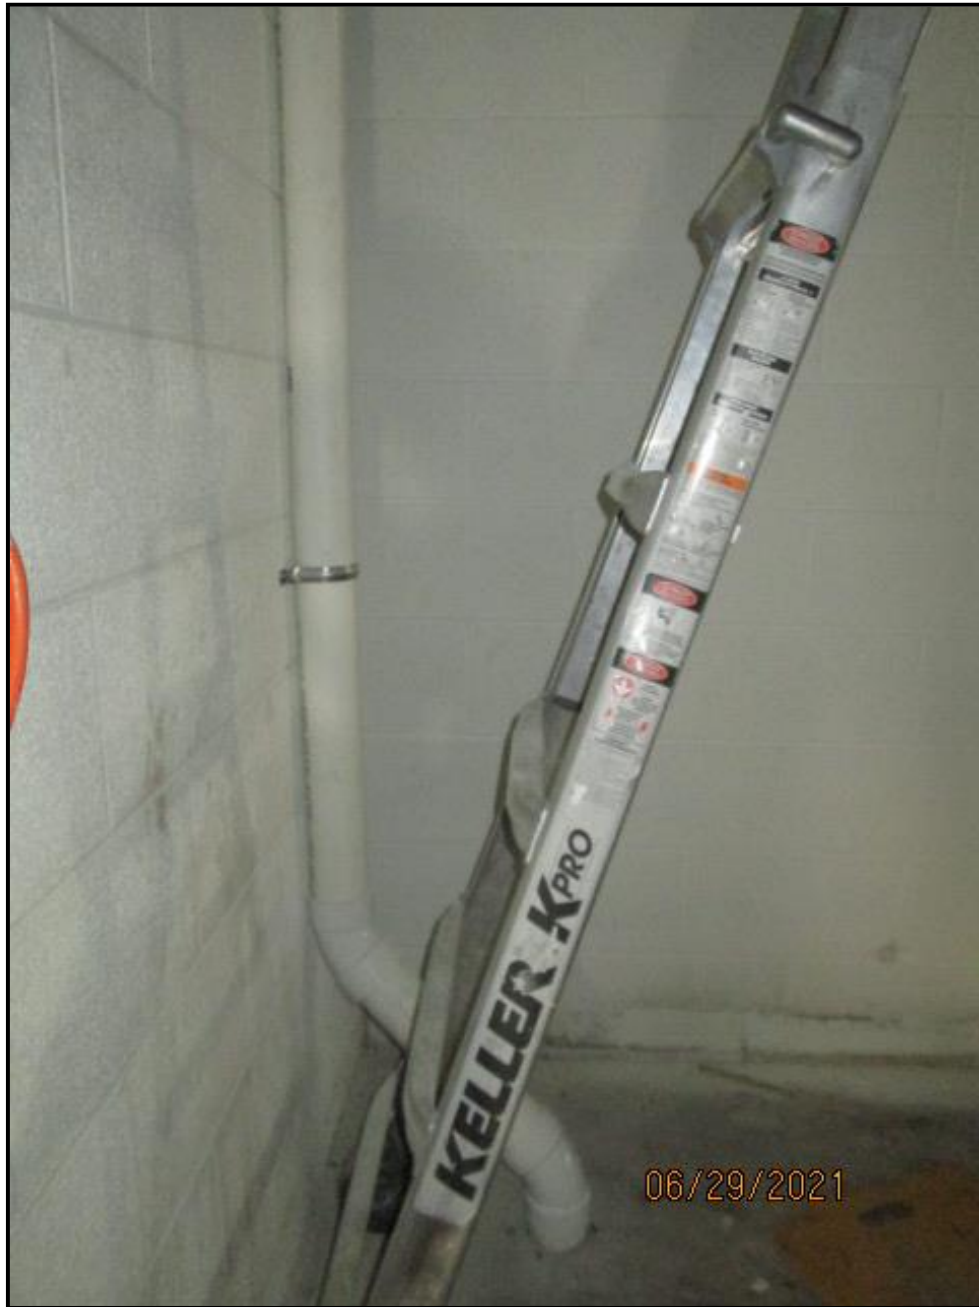
Interior lower piping for Vapor Mitigation System (VMS) (FLC), viewing North.

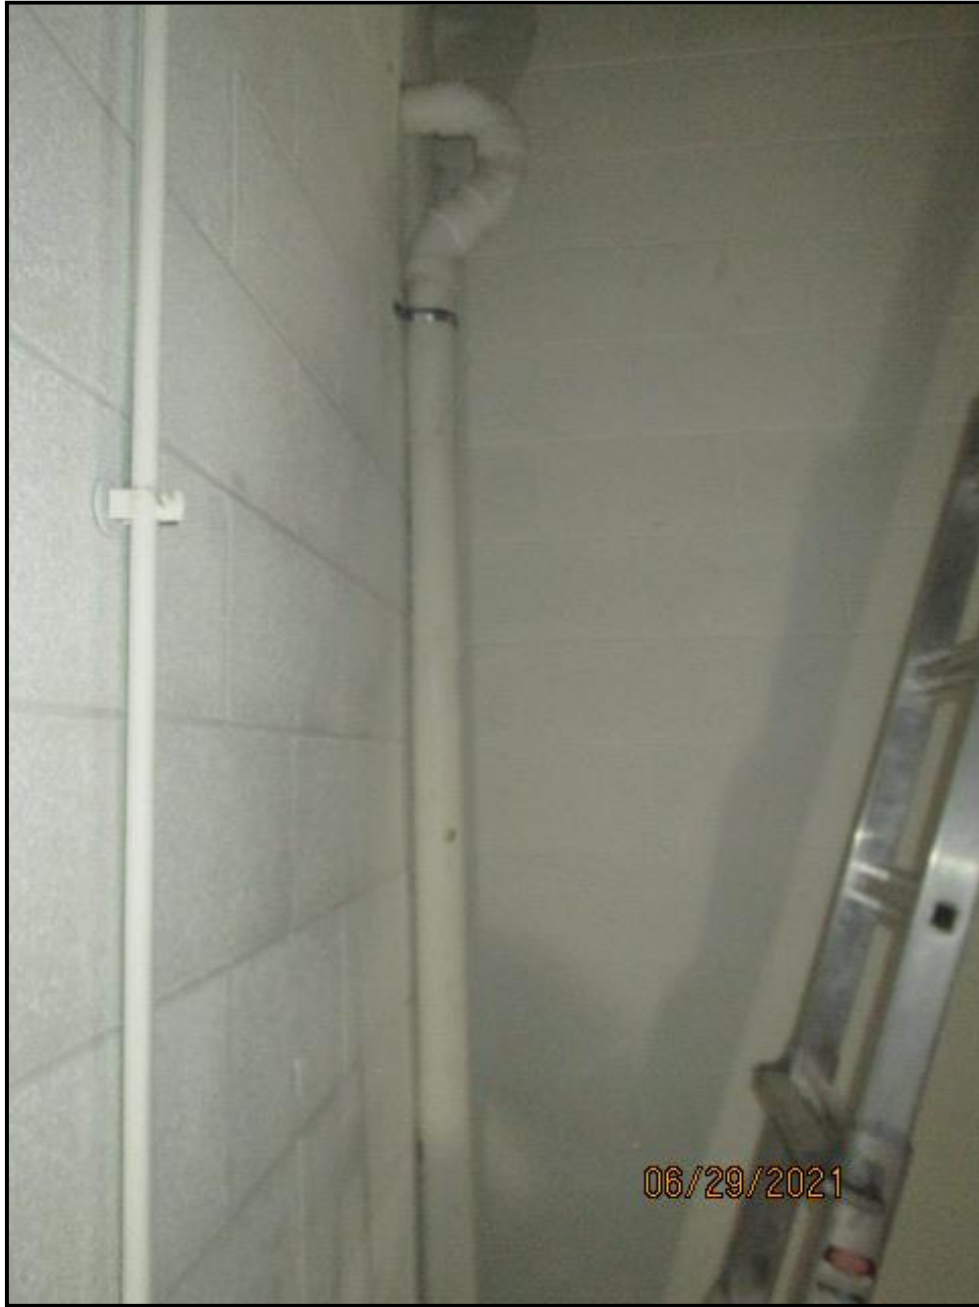
Interior upper piping for VMS (FLC), viewing North.

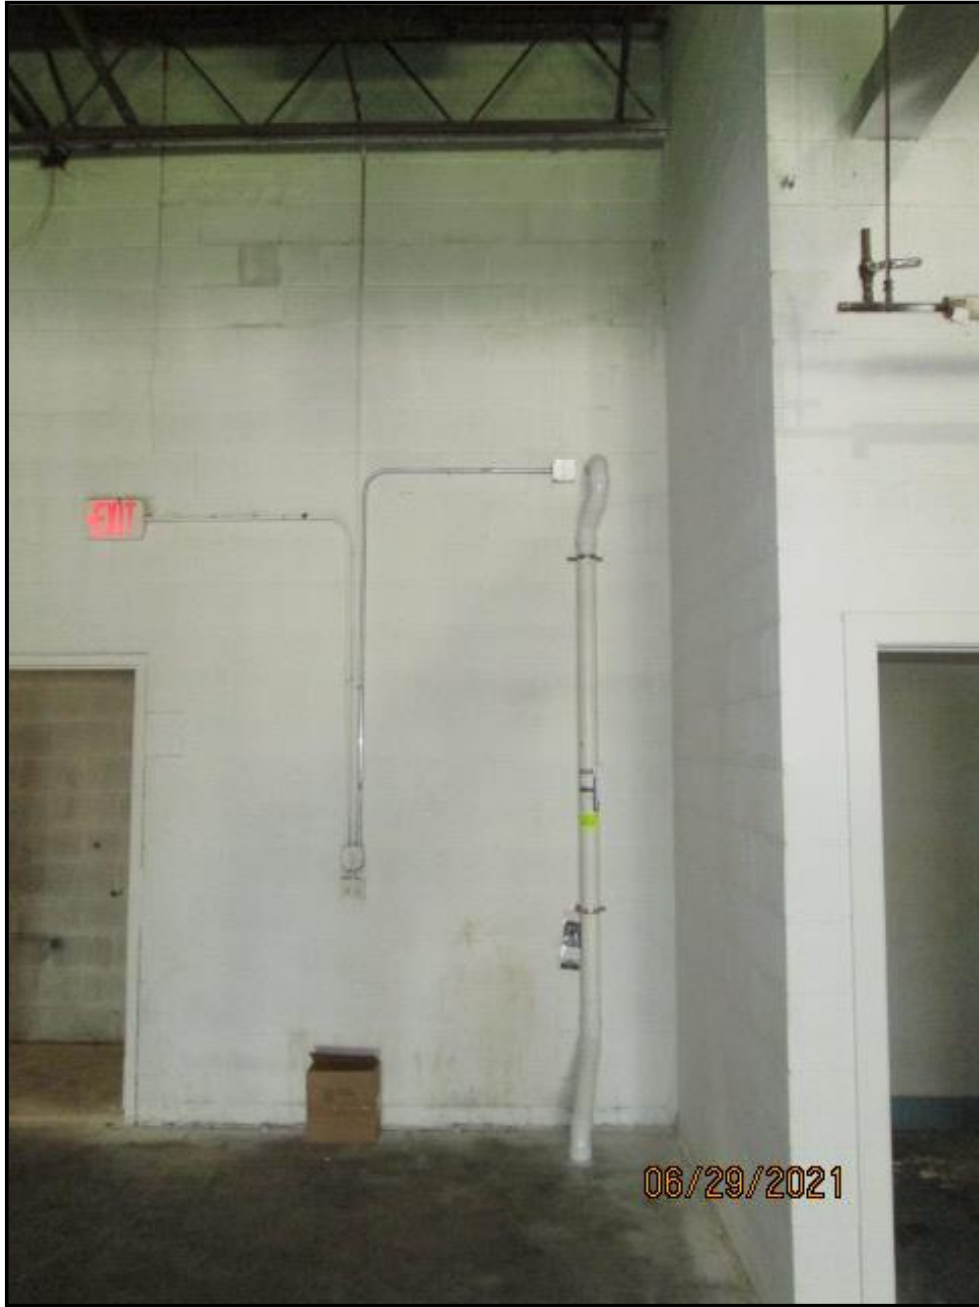
Interior completed VMS (FLC), viewing North.

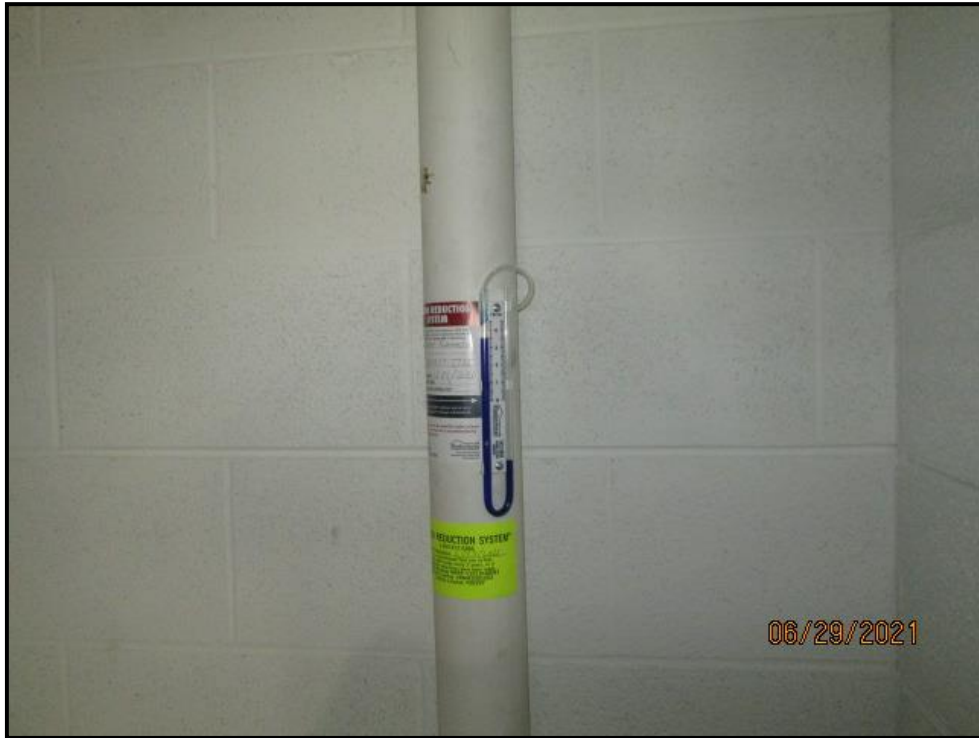
Interior installed manometer on VMS piping (FLC), viewing West.

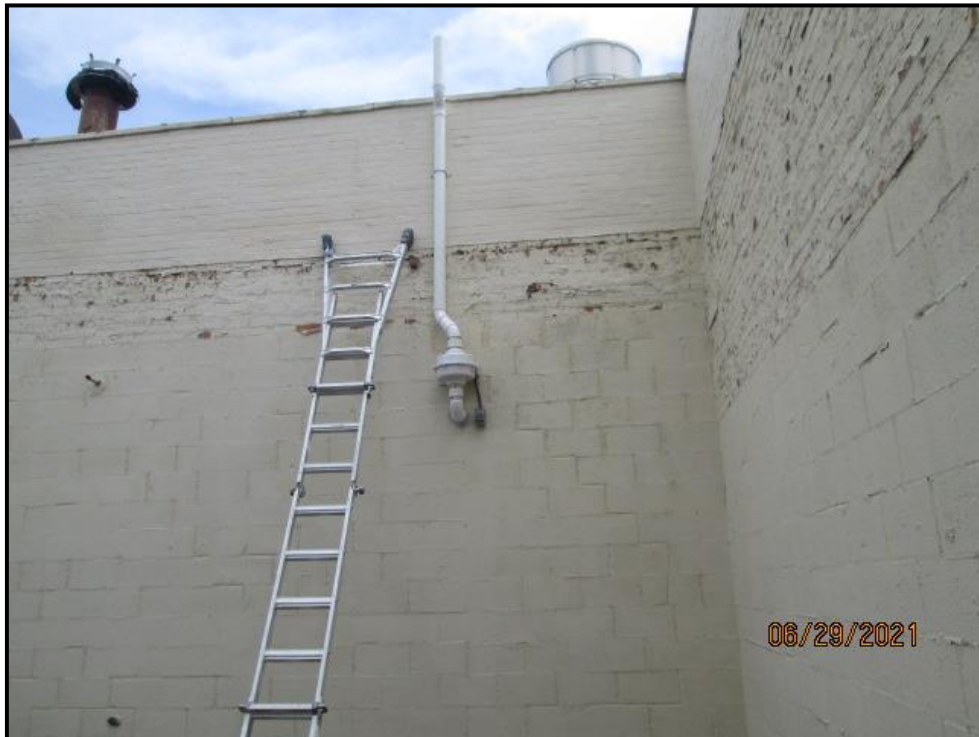
Exterior completed VMS piping with fan and electrical outlet (FLC), viewing East.

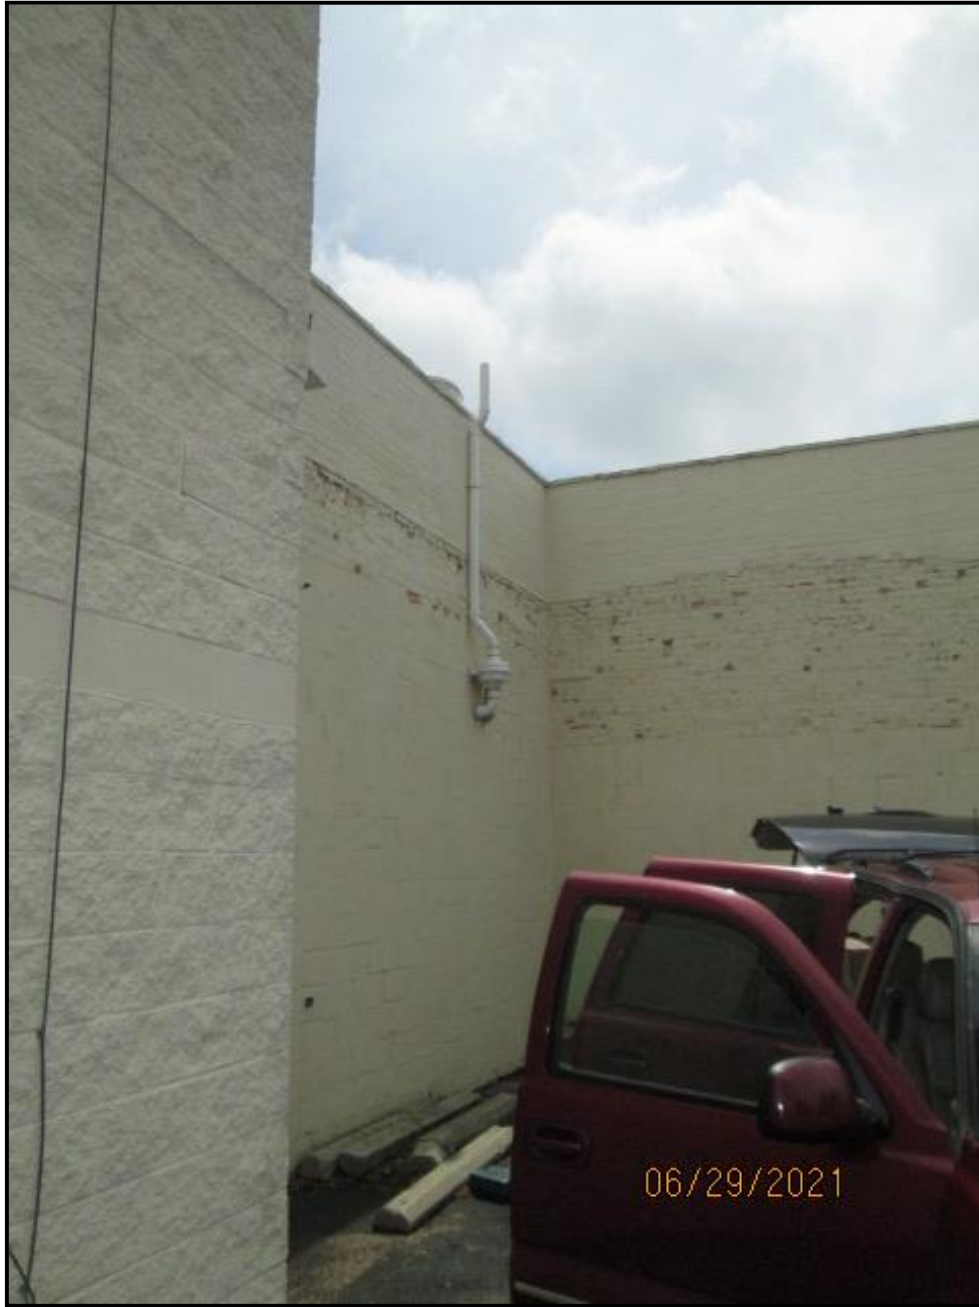
Exterior completed VMS piping with fan (FLC), viewing Southeast.
