Re: Technical Review Request for the Proposed Military Creek Trailhead Plan and Land-Use at the "Open" BRRTS Site  
Former C M Christiansen Co Property (now owned by Town of Phelps), Phelps, WI  
DNR BRRTS# 02-64-000068

Technical Review Request – Former C. M. Christiansen Property, Phelps, WI  
February 22, 2021

**Existing Conditions Photos – December 4, 2020**

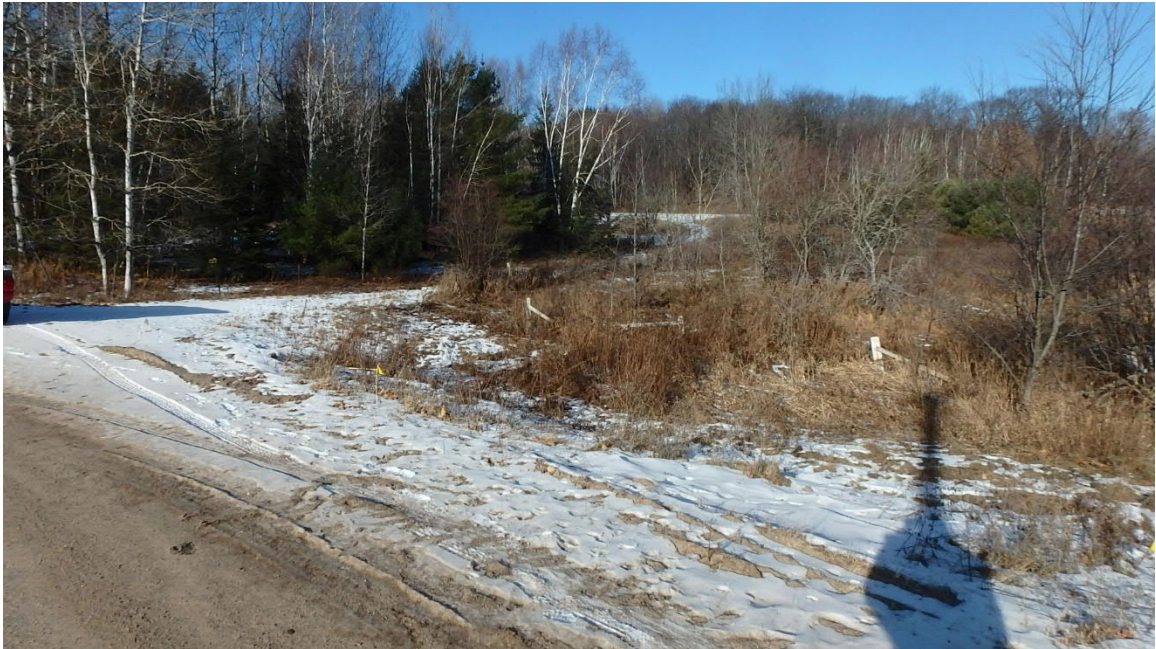
Photo PC030002 - Looking northwest on December 4, 2020 from CTH E toward the access gravel road and existing trail on the Town of Phelps parcel # 19-1391 toward the area of the proposed parking lot. The existing access gravel road will be modified to have a 30 ft paved access drive and a 16 ft wide gravel ATV/snowmobile trail following the existing gravel road and trail on the parcel. Lowlands adjacent to Military Creek and drainage is in photo right.

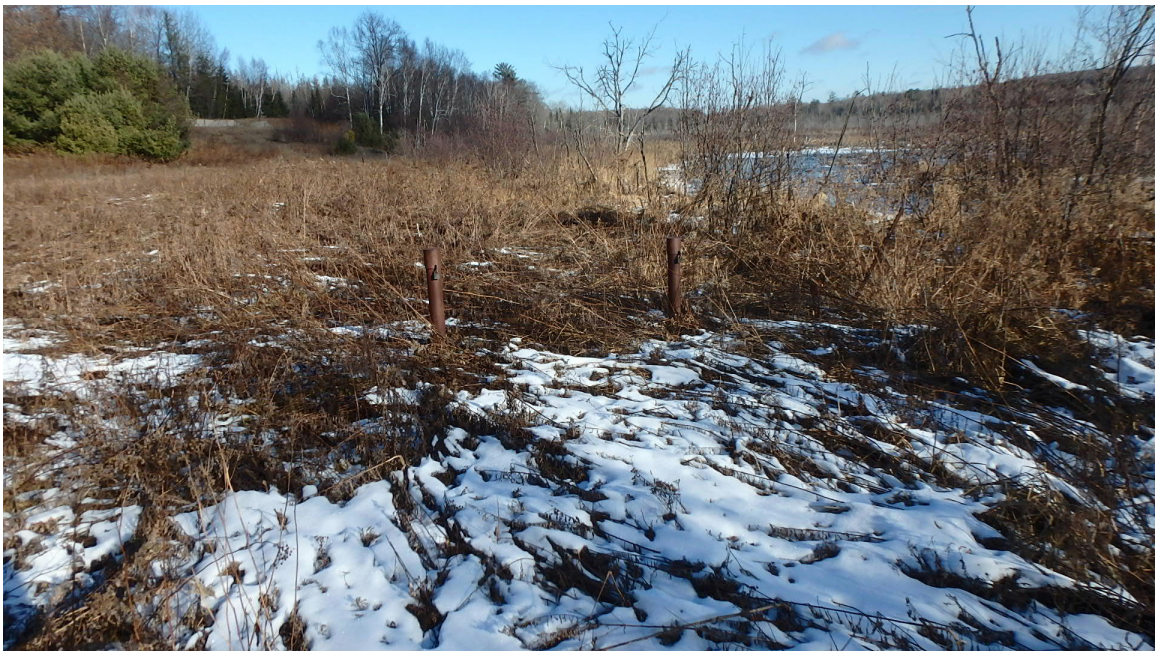
Photo PC030002- Looking northeast across 1999 remediation area 2B showing established vegetation over prior excavated area and monitoring wells positioned in lowlands adjacent to Military Creek (seen in photo right) with higher elevation ridge and existing trails past pine trees in photo left.

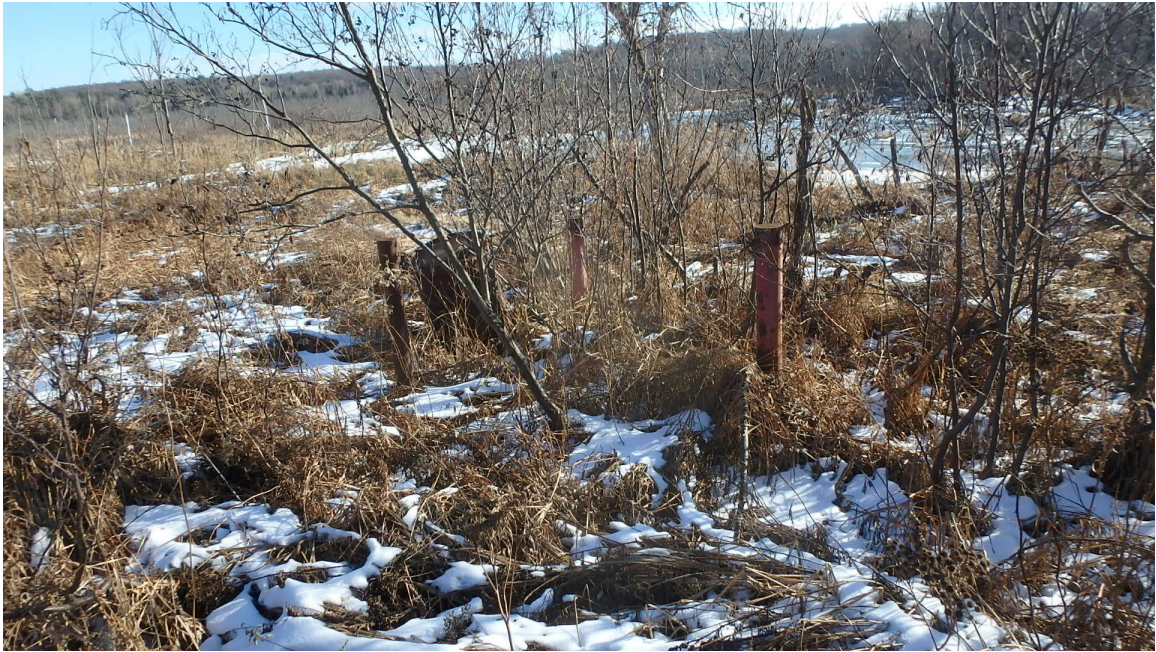
Photo PC030015- Looking northeast across 1999 remediation areas 2B and 3 showing established vegetation over prior excavated areas and monitoring wells positioned in lowlands adjacent to Military Creek drainage area east of the parcel.

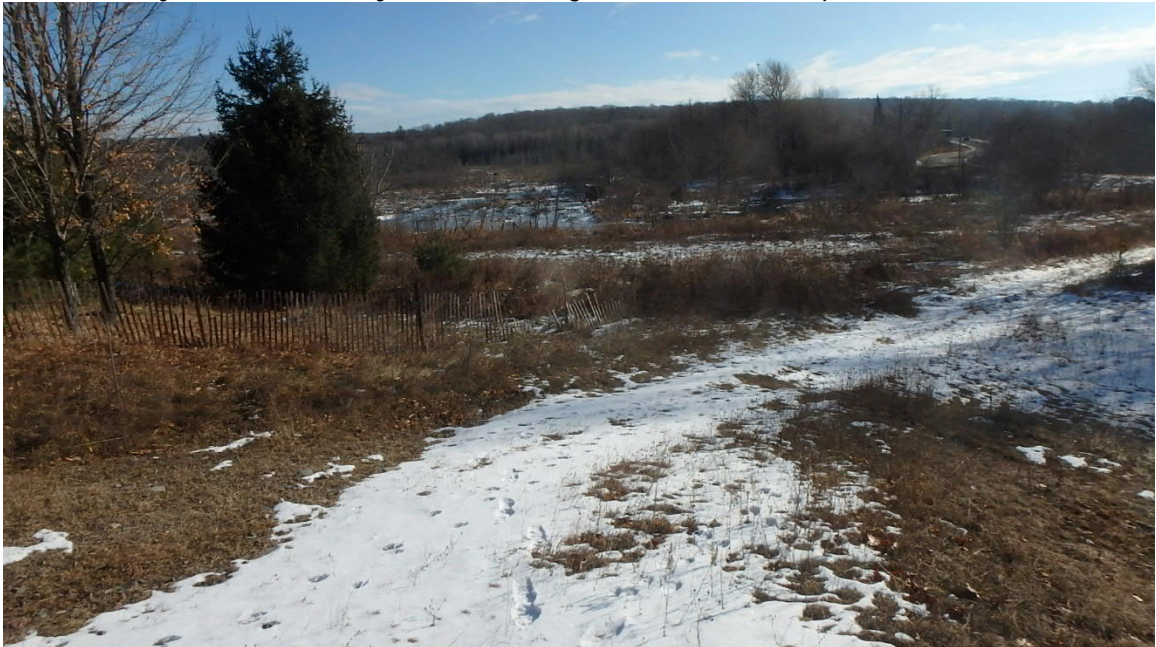
Photo PC030018 – Looking southeast toward the Military Creek lowlands east of the parcel and fencing previously installed on the property east of the existing gravel road and trail on the parcel. CTH E and Military Creek crossing is in photo right.

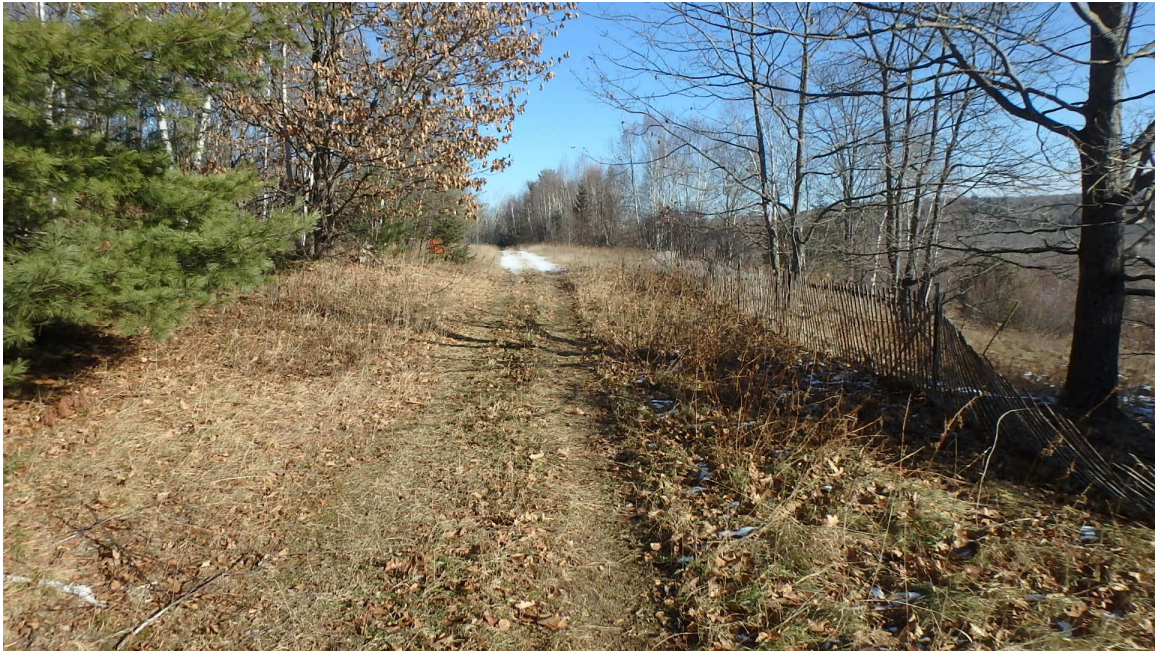
Photo PC030024- Looking northeast along existing trail toward 1999 remediation areas 4 and 5 on the left side of the trail and not near the proposed parking area for the trailhead project.

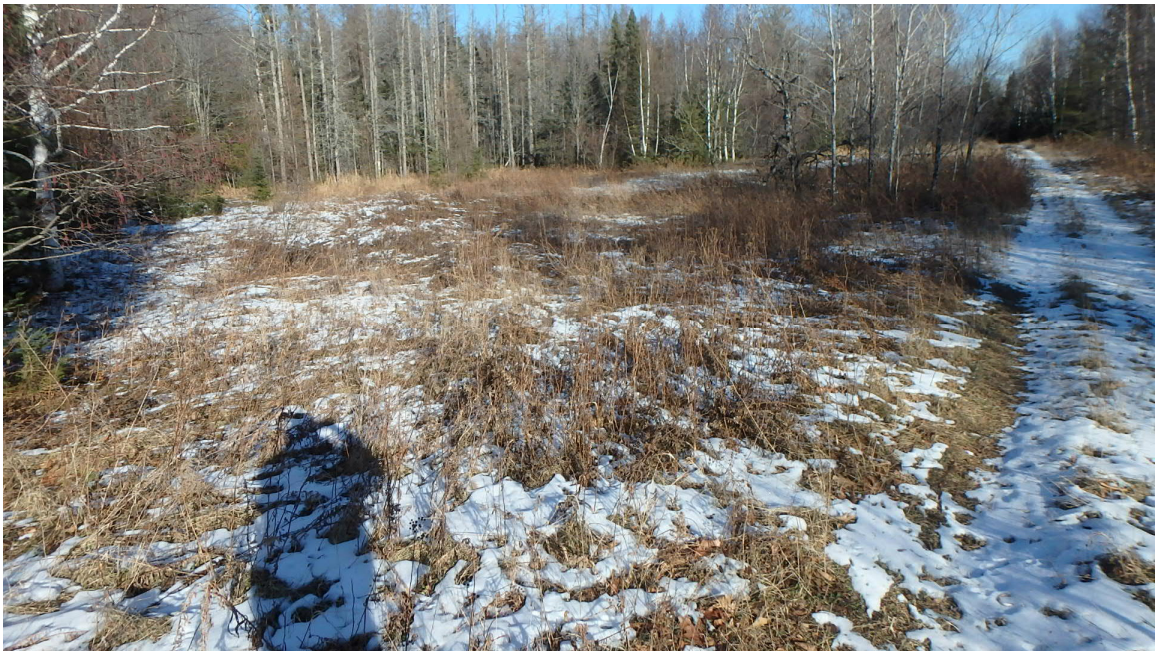
Photo PC030032- Looking northeast with existing trail and path in photo right and at the 1999 remediation areas 4 and 5 on the left side of the trail showing established vegetation over the formerly excavated and backfilled areas

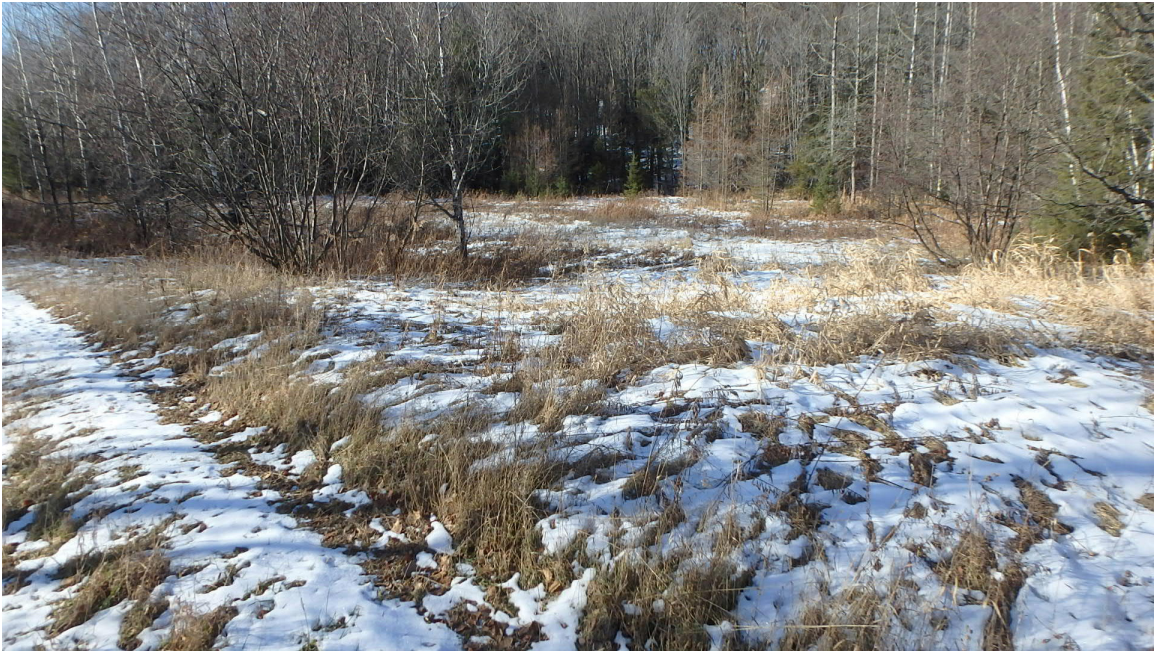
Photo PC030035- Looking southwest and additional view of established cover and vegetation at the 1999 remediation areas 4 and 5. The existing trail is in photo left.

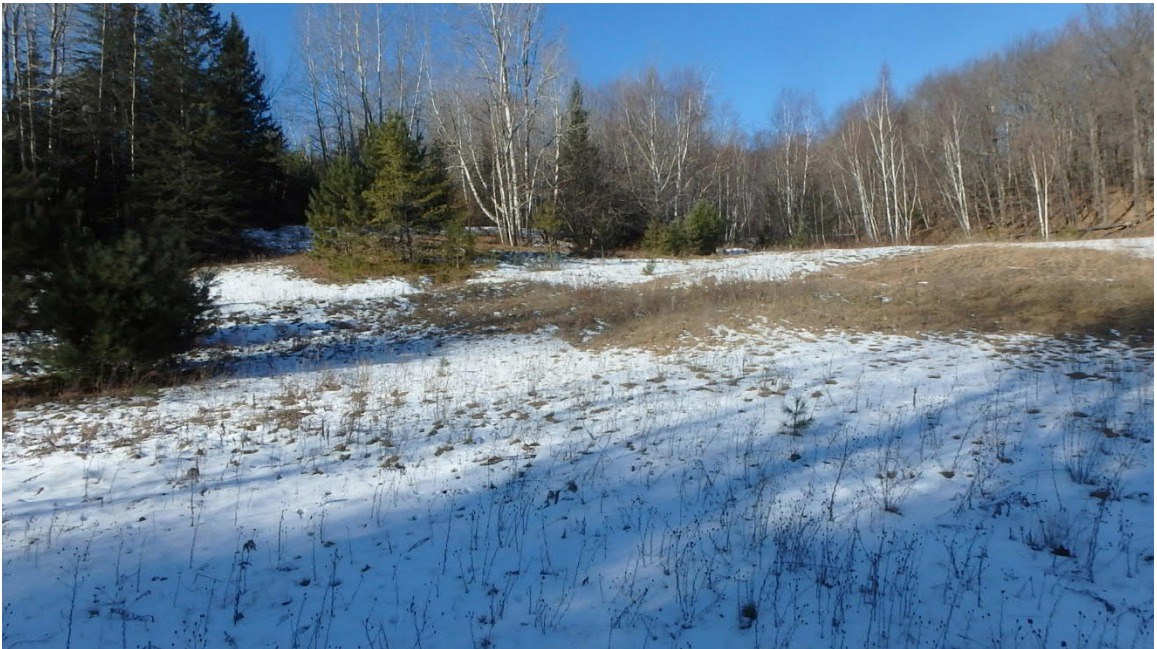
Photo PC030053- Looking west at the area of the proposed parking lot and pit toilet of the trailhead project.

- During site excavation activities to install the proposed pit toilet and prepare the recreational vehicle unloading area, soils will be screened for contamination using a photoionization detector (PID). If signs of contamination are noted during excavation activities (soil staining, petroleum odors, elevated PID readings, etc.), contaminated soils will be segregated, stockpiled and sampled for proper management (i.e. off-site landfill disposal).

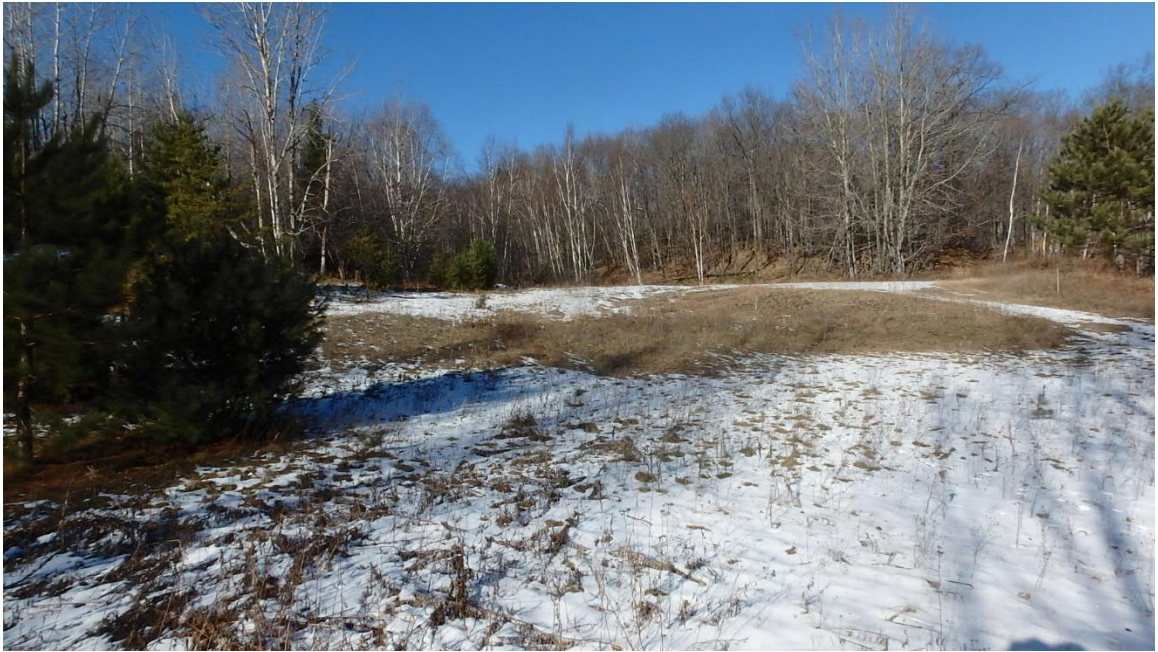
Photo PC030062- Looking west at the area of the proposed parking lot and pit toilet of the trailhead project.

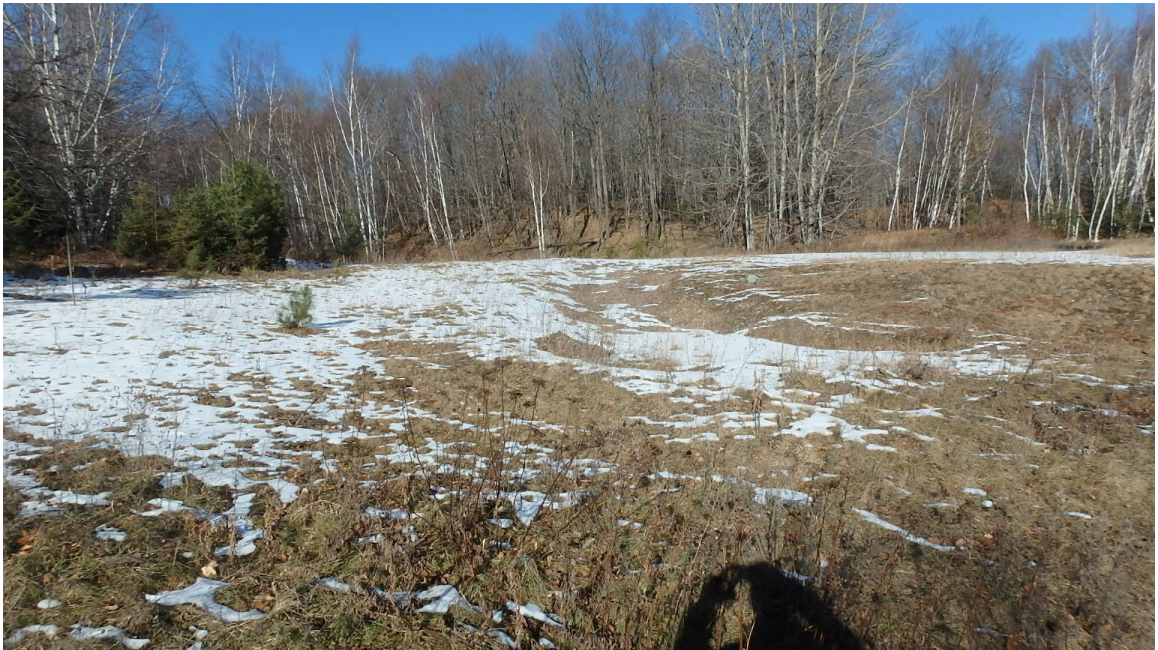
Photo PC030064- Looking west at the area of the proposed parking lot and pit toilet of the trailhead project.
