Technical Memorandum

To: Alex Smith, Enbridge Energy
From: Ryan Erickson
Subject: Superior Terminal Tank 10 Line Response
WDNR SERTS ID: 20180726NO16-1
Date: January 14, 2019
Project: 49161374.04 019 001

This memorandum summarizes the environmental response activities performed by Barr Engineering (Barr) at the request Enbridge Energy (Enbridge) following the discovery of a Tank 10 line subsurface crude oil release within the tank containment basin at the Enbridge Superior Terminal (Terminal) in Superior, Wisconsin (Figure 1).

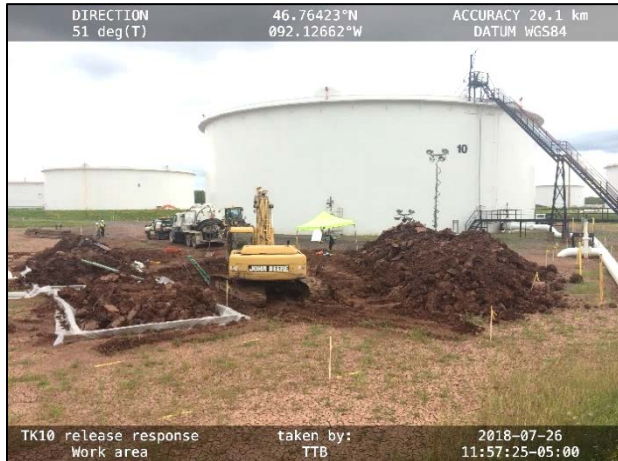
Photo 1

Photo 1: Release response excavation location in the western corner of the Tank 10 containment basin. Photo taken facing northeast on 7/26/2018.

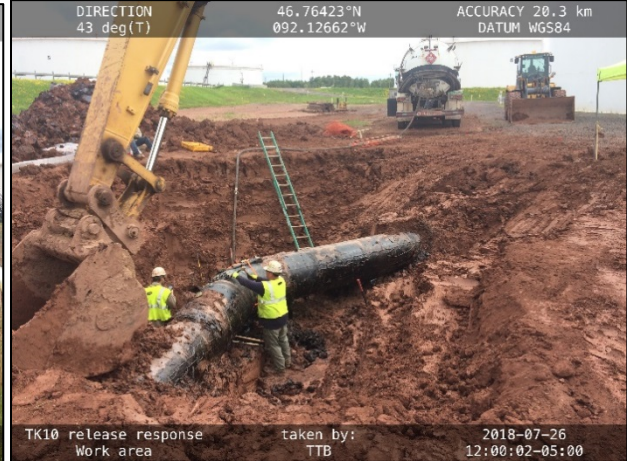
Photo 2

Photo 2: Release response excavation. Photo taken facing northeast on 7/26/2018.

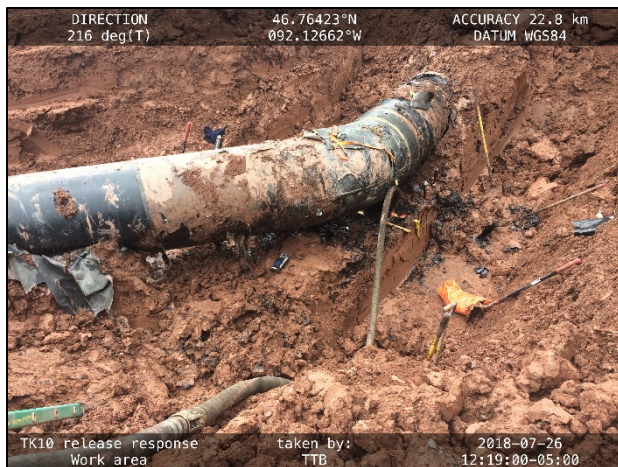
Photo 3

Photo 3: Tank 10 pipeline with a product recovery basin (beneath pipe bend) and vacuum hose (bottom left to center of photo) and hydrocarbon impacted soil (black staining as shown in Photo 4). The release point is near the bend in the pipe. Photo taken facing southwest on 7/26/2018.

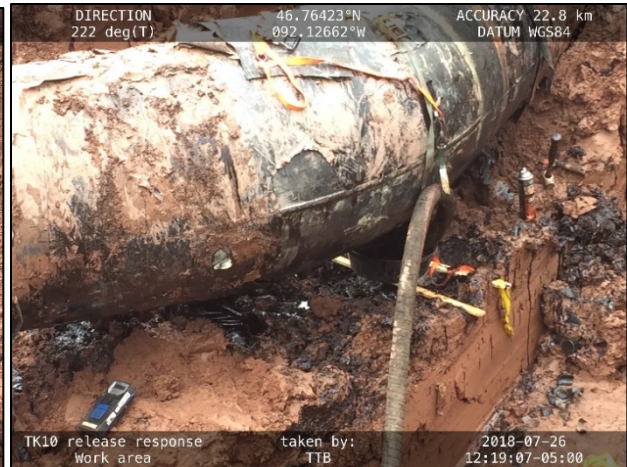
Photo 4

Photo 4: Hydrocarbon impacted soil (black staining) and a product recovery basin and vacuum hose beneath pipeline release location. Photo taken facing southwest on 7/26/2018.

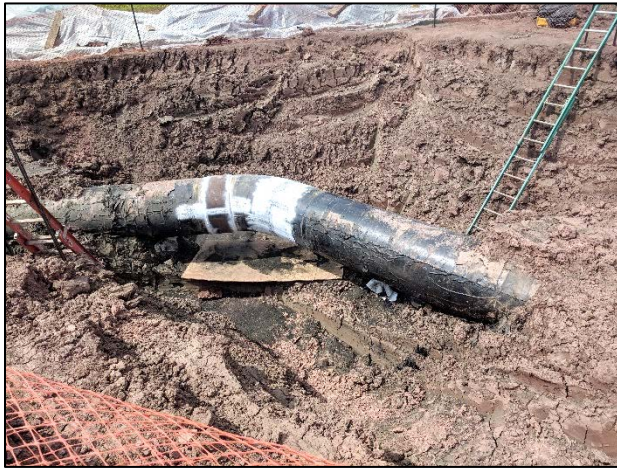
Photo 5

Photo 5: Pipeline repairs (white section near bend) and the northern excavation sidewall. Photo taken facing north on 7/30/2018.

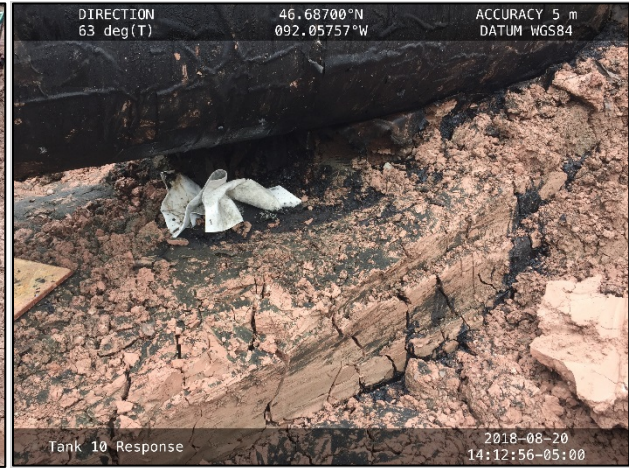
Photo 6

On July 26, July 30, August 20, and November 14, 2018, Barr documented the conditions at the site. Soil with residual crude oil impacts was observed beneath the ends of the exposed pipeline in July and August (Photo 6); therefore additional remedial excavation was requested. The final remedial excavation was completed in November. The final excavation was approximately 50 feet long by 25 feet wide by up to 10 feet deep (Photos 7 and 8; Figure 2; Attachment B). Soil in the excavation bottom and sidewalls was a fat clay. Groundwater was not observed in the excavation.

Photo 6: Residual hydrocarbon impacted soil near white oil absorbent pads beneath the Tank 10 pipeline. Note that the black media located away from the pads is blasting sand and not hydrocarbon impacts. Photo taken facing east on 8/20/2018.

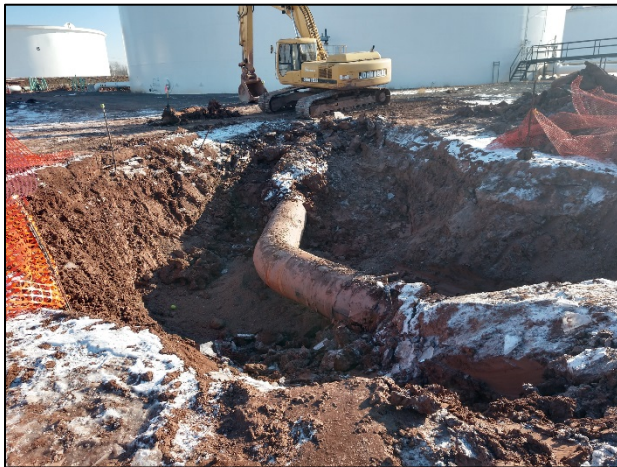
Photo 7

Photo 7: Final excavation extents. Photo taken facing east on 11/14/2018.

Based on the field screening results and the field observations, remedial excavation activities were concluded and the excavation was backfilled with clean fill material.

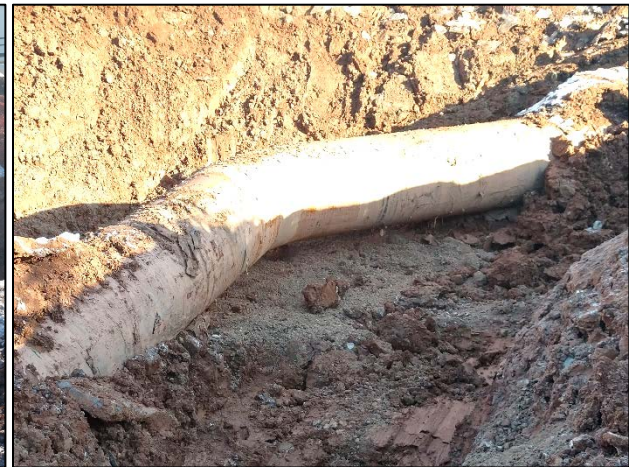
Photo 8

Photo 8: Bottom of the final project and remedial excavation. No residual hydrocarbon impacts were observed. Photo taken facing northeast on 11/14/2018.
