## Technical Assistance, Environmental Liability Clarification or Post-Closure Modification Request

Property Name				FID No. (if known)	
1818 W. National Avenue				241878450	
BRRTS No. (if known)			Parcel Identification Number		
0241583465			4339927111		
Street Address			City	State	ZIP Code
1818 W. National Avenue			Milwaukee	WI	53204
County	Municipality where the Property is located		Property is composed of:		Property Size Acres
Milwaukee	<input checked="" type="radio"/> City <input type="radio"/> Town <input type="radio"/> Village of Milwaukee		<input checked="" type="radio"/> Single tax parcel <input type="radio"/> Multiple tax parcels		8

Project Title:  
NEW BUILDING FOR:  
CRISTO REY JESUIT HIGH SCHOOL  
CRISTO REY - MILWAUKEE  
1818 W. NATIONAL AVE. MILWAUKEE, WI 53024

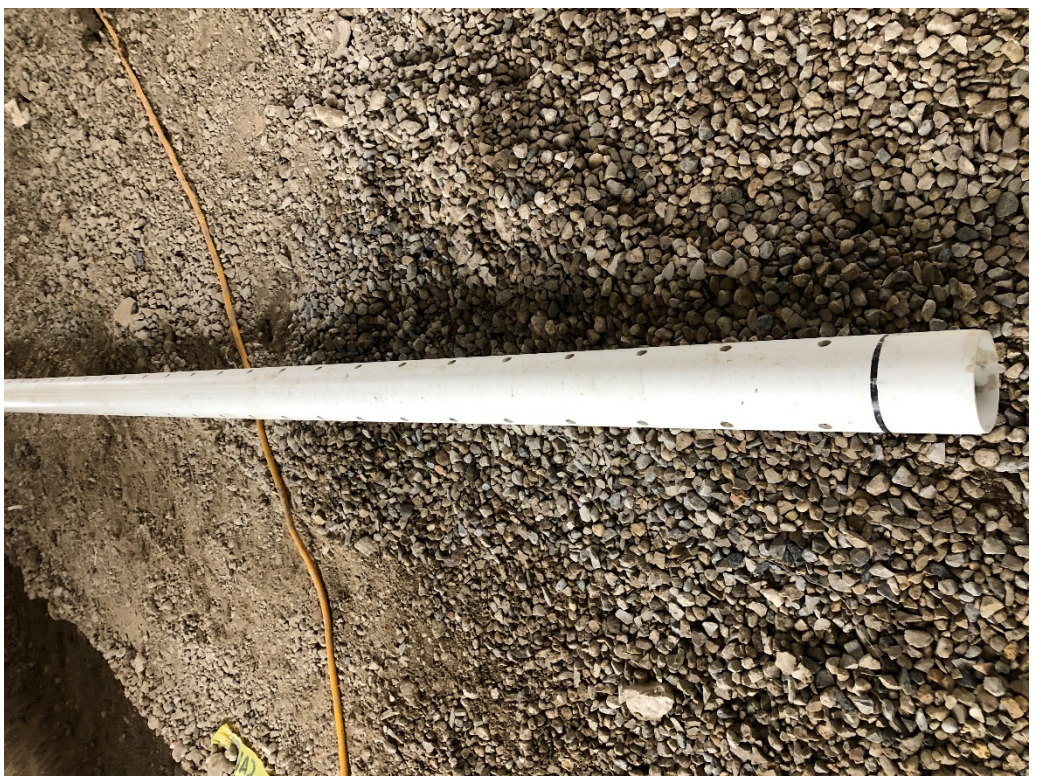
Photo # 6	Date 01/15/20

<p><b>Description</b> Subject Property: Typical perforated PVC section of sub-slab vapor mitigation system installed.</p>

The area will be maintained to be sure the existing engineered barriers (cap) remains in place and without defect. Additionally, part of the proactive construction plan included installation of a sub-slab ventilation system designed to easily be converted to an active depressurized system should the need arise, and obvious volatile contaminated soils be encountered during construction. The system is currently operating in a passive mode though a wind driven turbine style vent has been installed to facilitate vapor removal as another proactive measure.

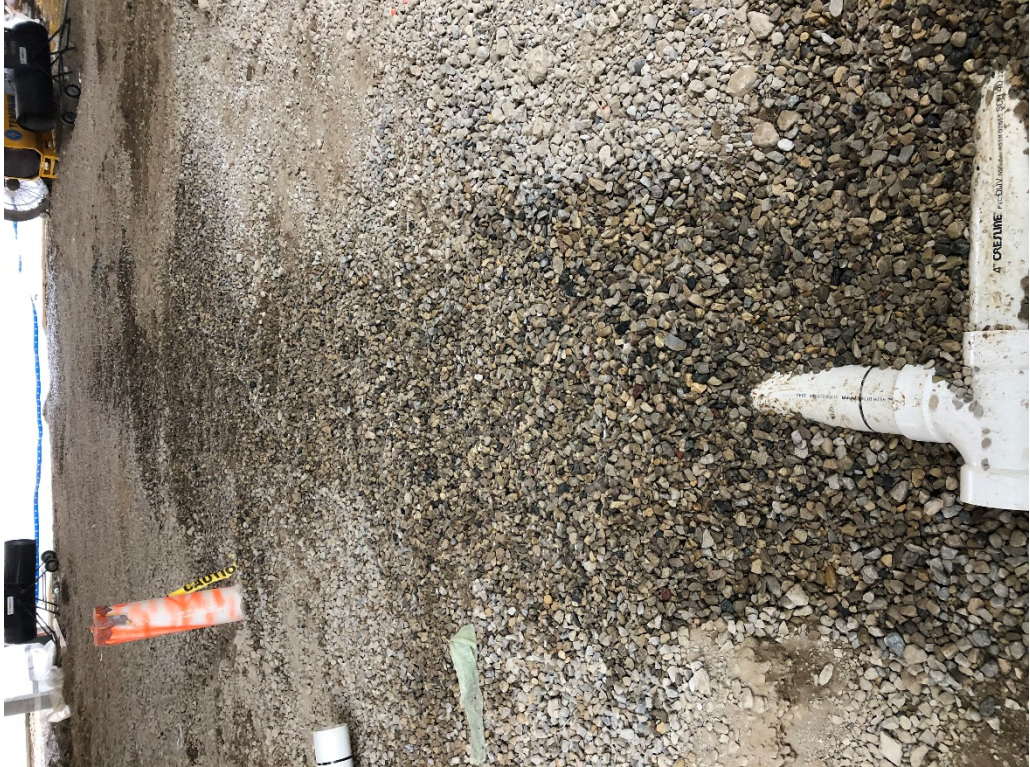
Photo # 7	Date 01/12/20	
<p><b>Description</b></p> <p>Subject Property: Typical installation and backfill material utilized in the sub-slab vapor mitigation system installation (facing north).</p>

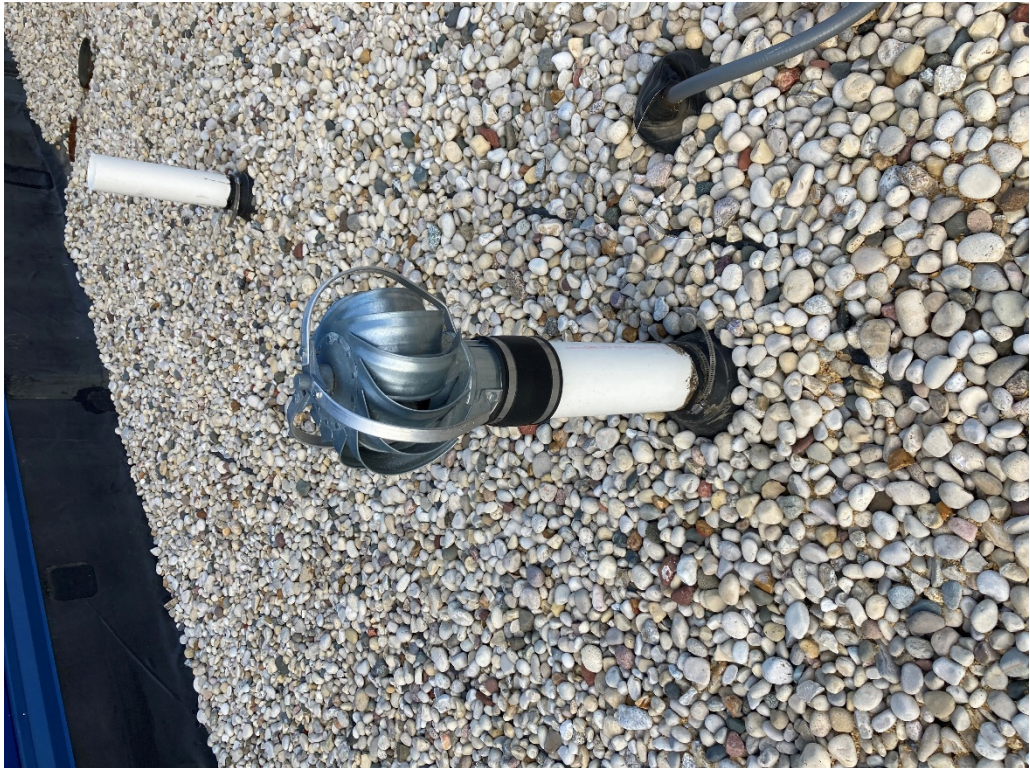
Photo # 8	Date 04/07/21	
<p><b>Description</b></p> <p>Subject Property: Wind driven turbine ventilation fan connected to riser section of sub-slab vapor mitigation system. Note electric cabling on roof top to allow for conversion to active status if conditions would change and needed in future.</p>

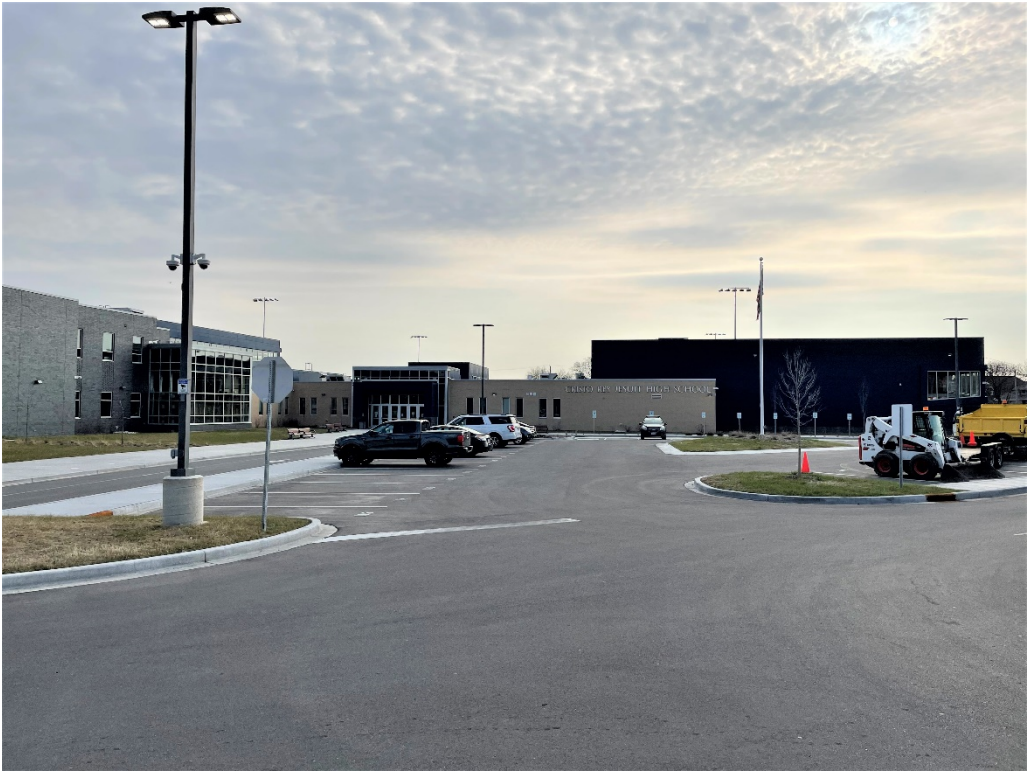
Photo #	Date	
9	04/07/21

<b>Description</b>		
Subject Property: Completed building and grounds construction (facing east).

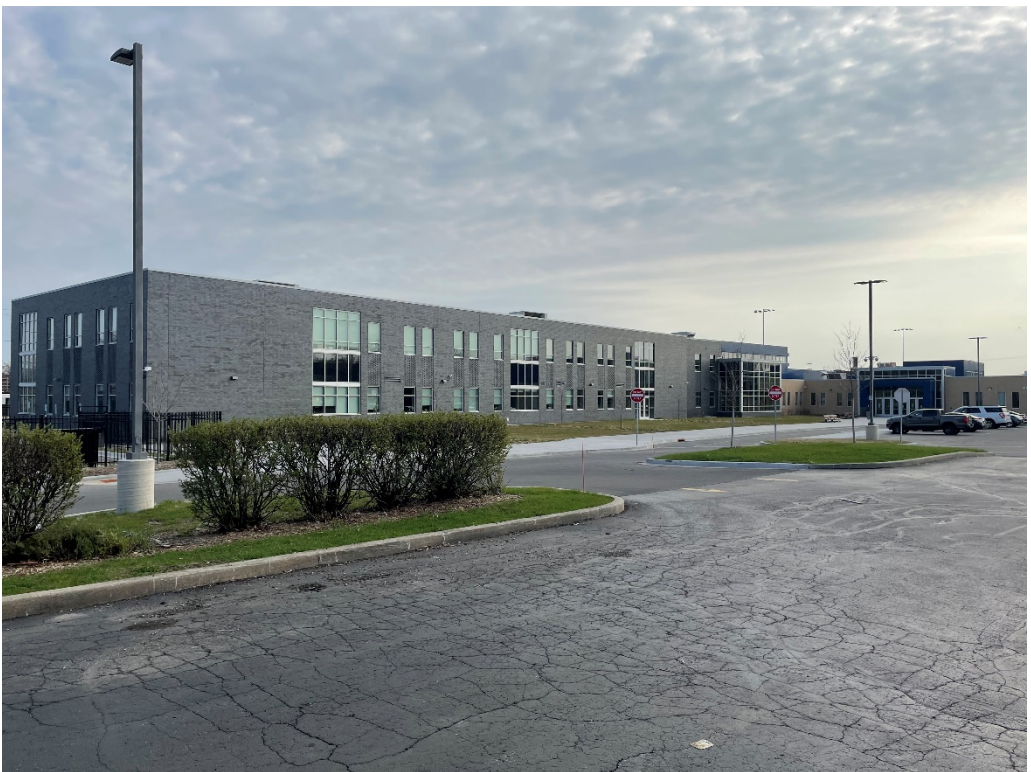
Photo #	Date	
10	04/07/21

<b>Description</b>		
Subject Property: Completed building and grounds construction looking from adjoining SW property (facing northeast).

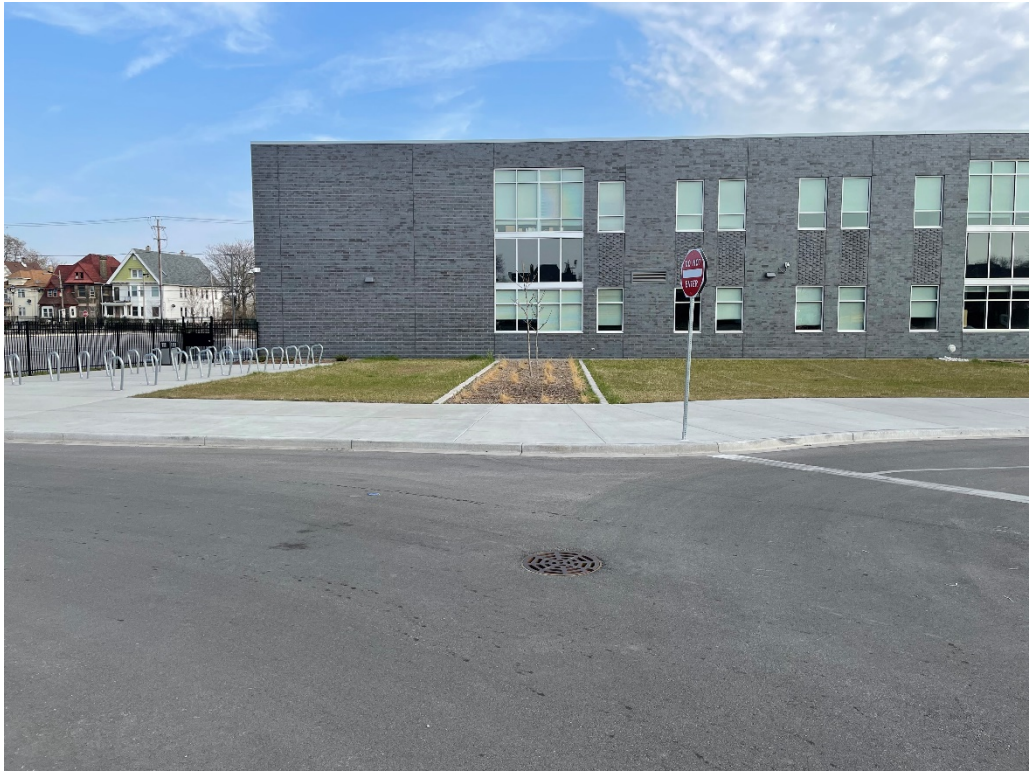
Photo #	Date	
11	04/07/21

<b>Description</b>		
Subject Property: Area of ERP identified limited impacted soil north of stormwater inlet located under concrete sidewalk and asphalt drive (facing north).

The area in question is now located mostly, if not entirely under an engineered barrier of asphalt driveway and concrete walkway. Research of the site history and potential contaminant source has been performed and though no clear point source for the petroleum contamination has been identified, the impacts are most likely attributed to historic filling (waste fill/foundry sand) that occurred onsite as previous commercial buildings were being razed and site grading was completed.

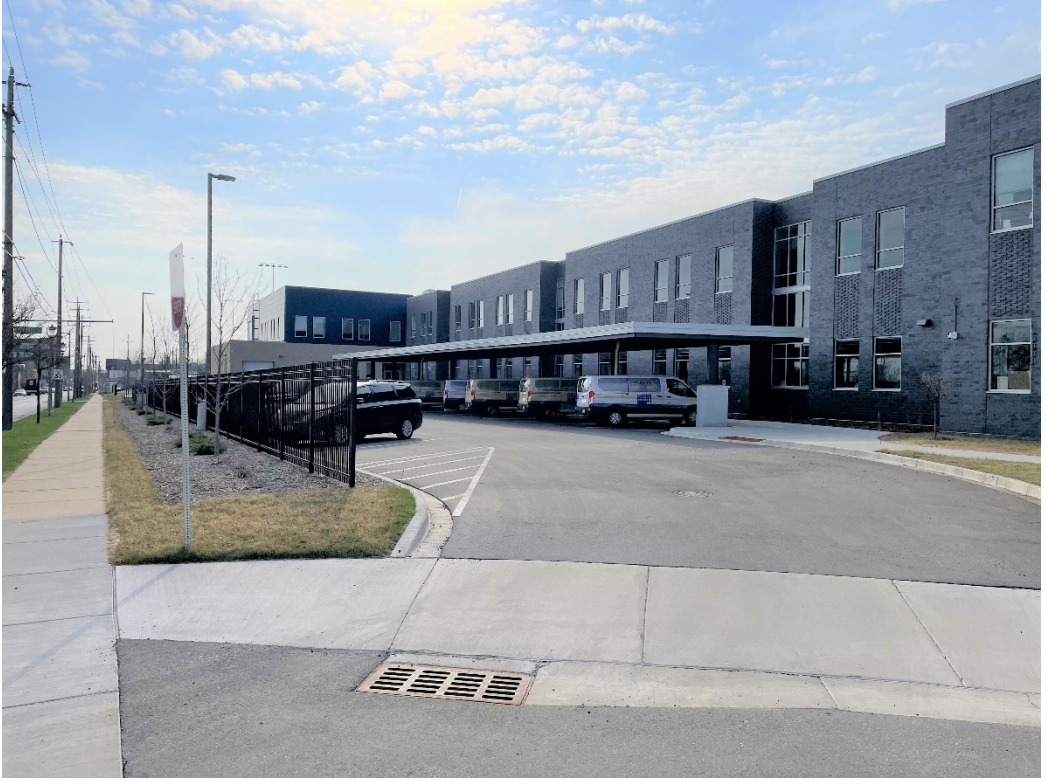
Photo #	Date	
13	04/07/21

<b>Description</b> Subject Property: Completed building and grounds construction looking from adjoining city sidewalk (facing southeast).
